September 15, 2021

Project No. 19119232

Re: **MONTHLY STATUS UPDATE – ENGLEWOOD INTERMODAL YARD – NAPL COLLECTION SYSTEM/CONCRETE CAP REPAIRS  
UNION PACIFIC RAILROAD HOUSTON WOOD PRESERVING WORKS FACILITY  
4910 LIBERTY ROAD FACILITY, HOUSTON, TEXAS  
POST-CLOSURE CARE PERMIT NO. HW-50343; INDUSTRIAL SWR NO. 31547**

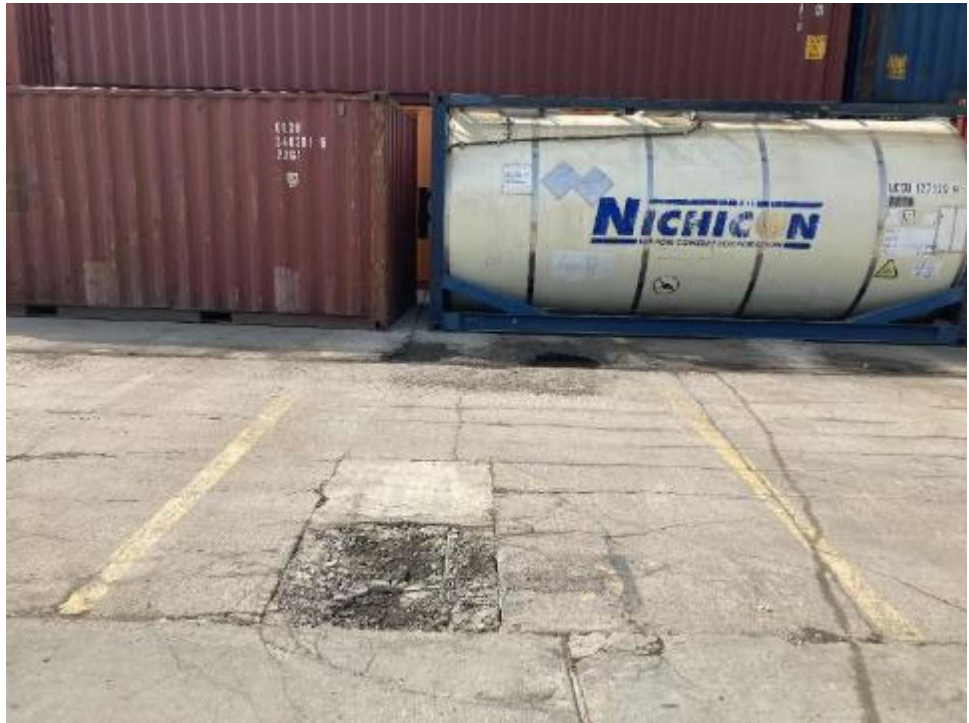
<b>Photo No.</b> <b>1</b>	<b>Date:</b> 8/4/2021
------------------------------	--------------------------

Slot A010, no tar-like material seeps observed where test pit conducted (July 2020), test pit pavement damaged, looking southeast.

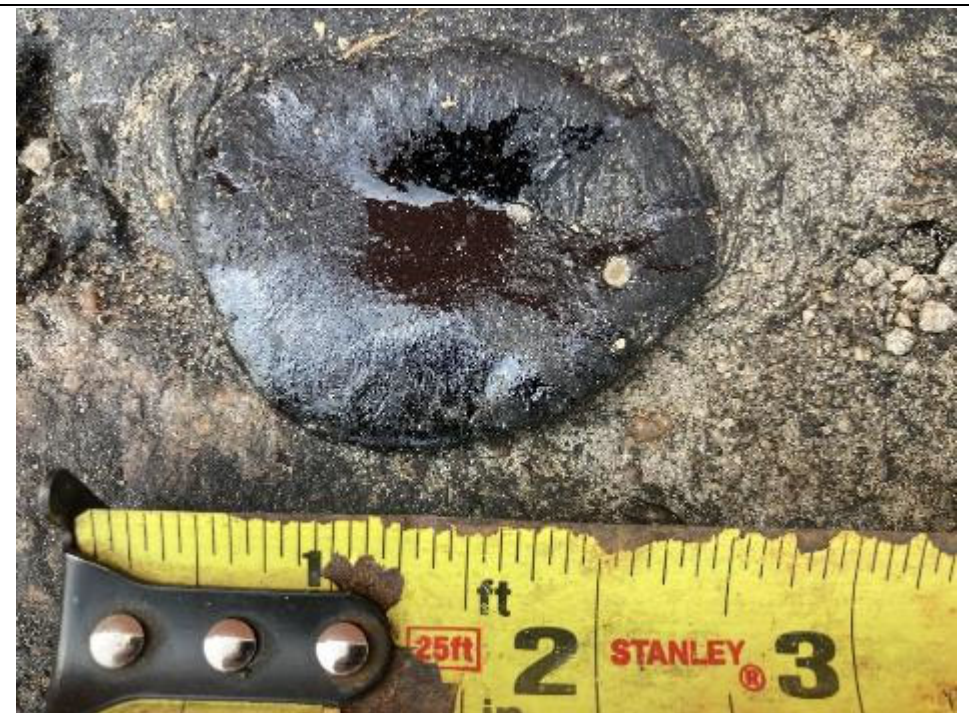
<b>Photo No.</b> <b>2</b>	<b>Date:</b> 8/4/2021
------------------------------	--------------------------

Slot A022, very small amount of tar-like material seeping at asphalt crack, material was removed.

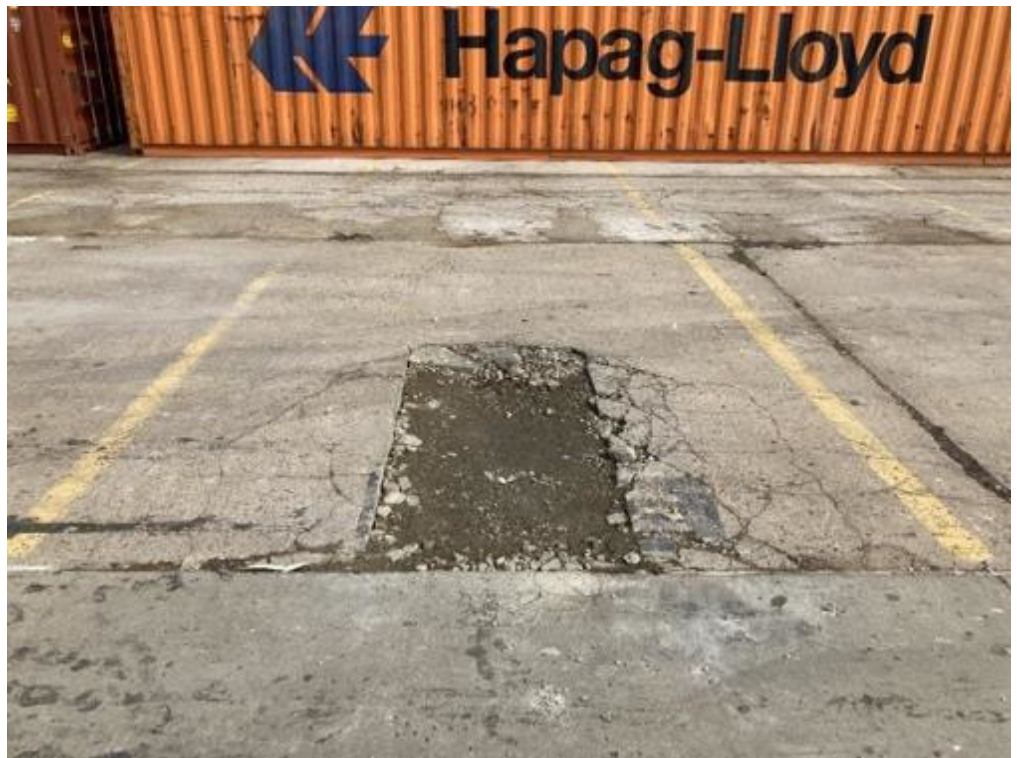
**Photo No.**  
3

Slot B096, no tar-like material seeps observed where test pit conducted (July 2020), test pit pavement damaged, looking northwest.

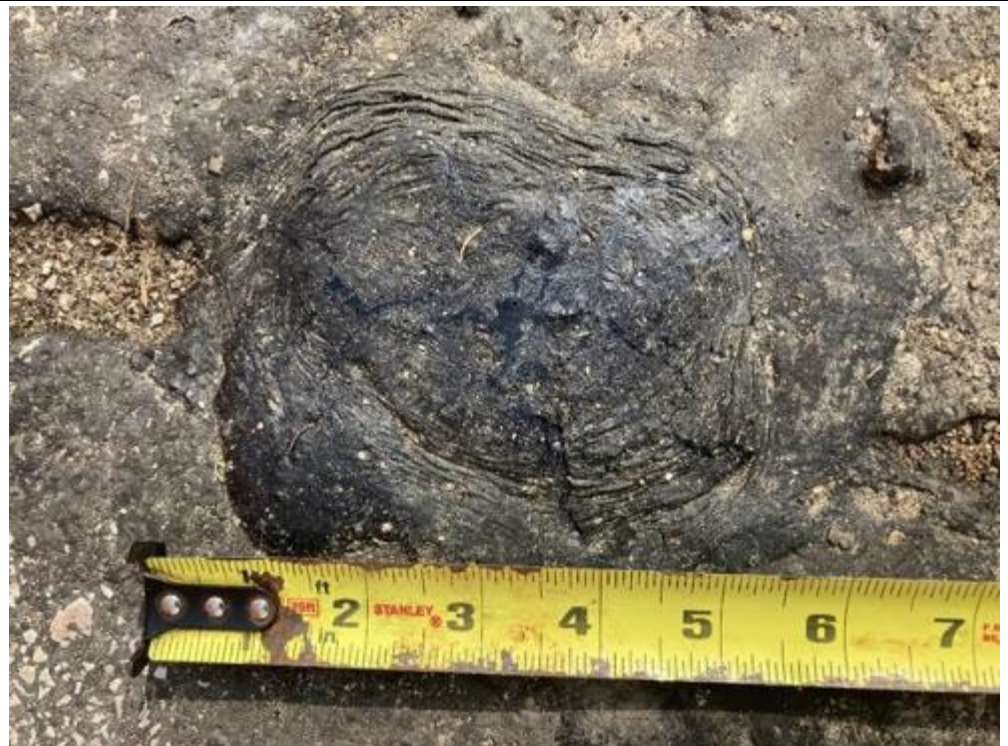
**Photo No.**  
4

Slot B101, small amount of tar-like material seeping at asphalt crack, material was removed.

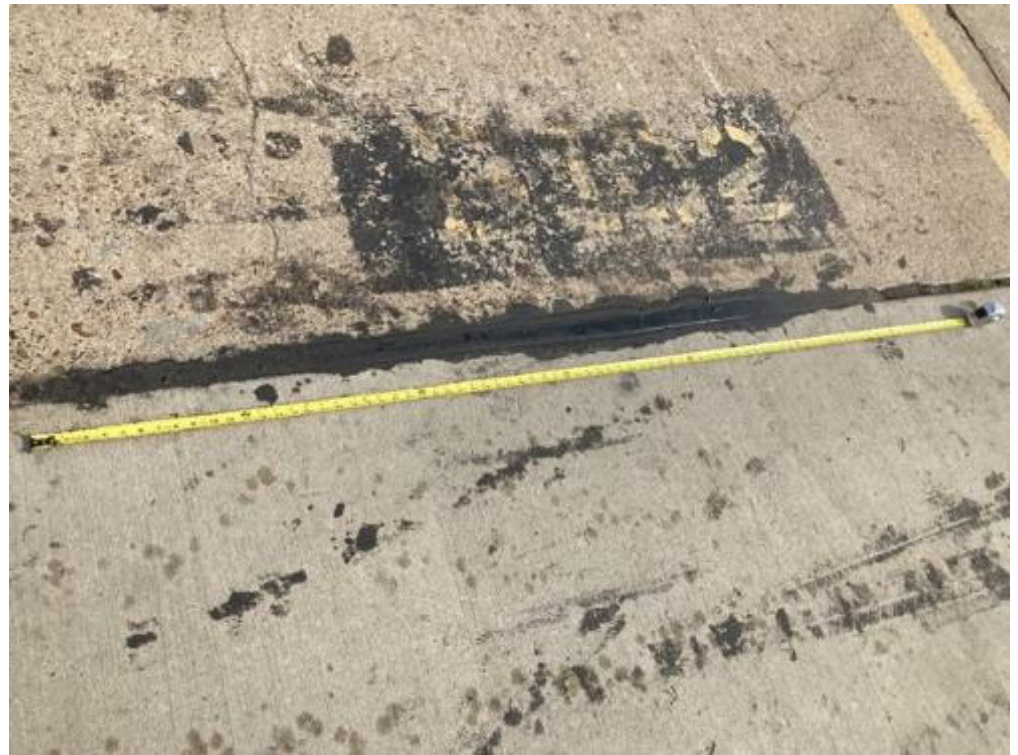
**Photo No.**  
**5**

Slot B102, small amount of tar-like material seeping at pavement joint, material was removed.

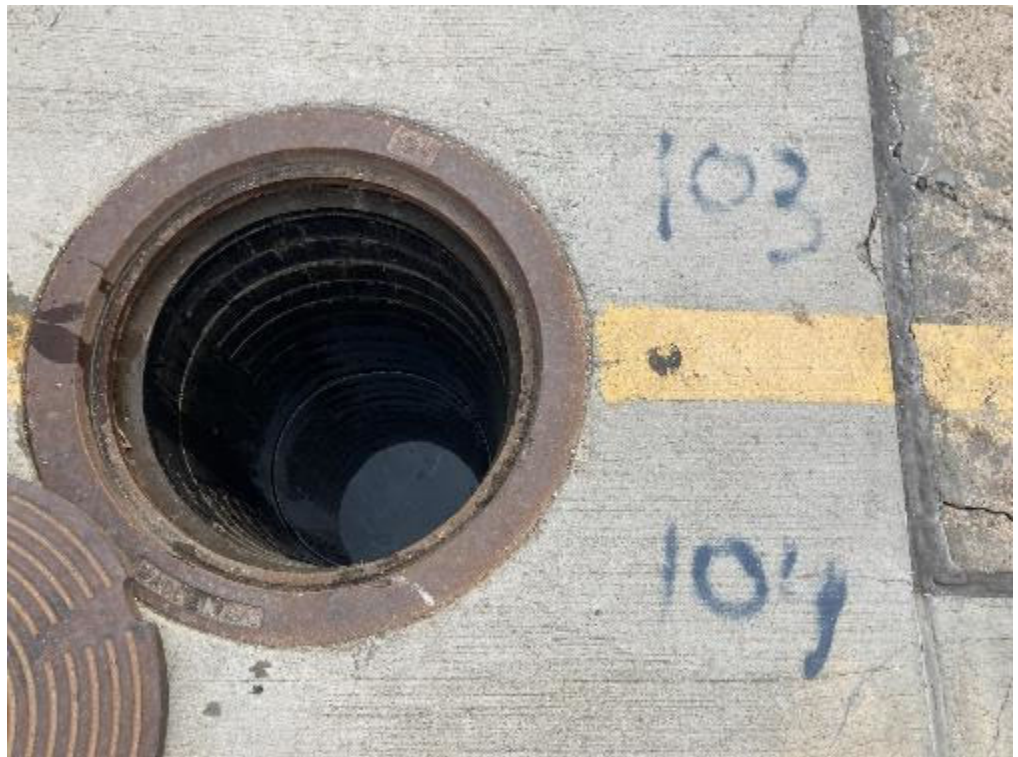
**Photo No.**  
**6**

- Sump 1 (B099/B100 slots), Sump 2 (B103/B104 slots), and Sump 3 (B107/B108 slots) were pumped down on July 15, 2021. The water level in Sump 1 recovered to the top of the sump by July 21, 2021 and has remained there through August 25, 2021. The water levels in Sumps 2 and 3 increased through the month of August, recovering to 20 and 22 inches from the top of the sumps, respectively, by the August 25<sup>th</sup> inspection. Water level data for the sumps are available in Table 1. The water in the sumps was observed as being brown in color. A sheen was observed on the water in Sumps 2 and 3 on August 4, 2021 (Photo Nos. 6 and 8). No odors were reported during the August 2021 inspections.

Sump 2 (B103/B104), 36 inches of freeboard in sump. Sheen visible on water in sump. No odors noted.

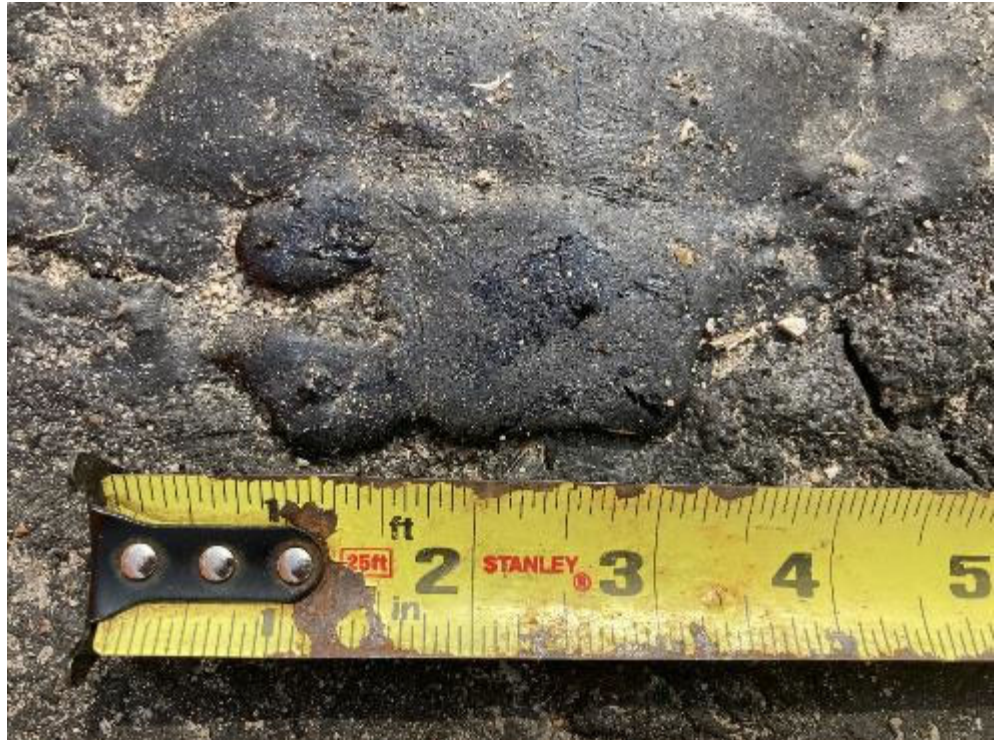
**Photo No.**  
**7**

- A very small tar-like NAPL surface seep was observed near the NAPL Collection System area in stall B105 during two of the four inspections in August (August 4<sup>th</sup> and 25<sup>th</sup>) (Photo Nos. 7 and 31). A very small amount of tar-like NAPL was also observed near the NAPL Collection System area in stalls B103 (Photo No. 15) and B107 (Photo No. 16) during the August 11<sup>th</sup> inspection. For areas outside the NAPL Collection System, small amounts of tar-like material were observed on the concrete surface in stalls A022 and B102 during three of the four inspections in August (August 4<sup>th</sup>, 18<sup>th</sup>, and 25<sup>th</sup>). A small amount of tar-like NAPL was observed in stall B057 on August 25<sup>th</sup> and stall B101 on August 4<sup>th</sup> and August 25<sup>th</sup>. Tar-like material observed during the inspection events was recovered using a hand tool to scrape up the material. During August, the number of tar-like material seeps observed during inspections and the total amount of material removed from the concrete surface increased compared to the July inspections. A total of approximately 2.4 gallons of tar-like material was recovered for the month and placed in a drum for disposal. The drum is staged at the Container Storage Area (CSA).

Slot B105, small amount of tar-like material seeping at asphalt crack, material was removed.

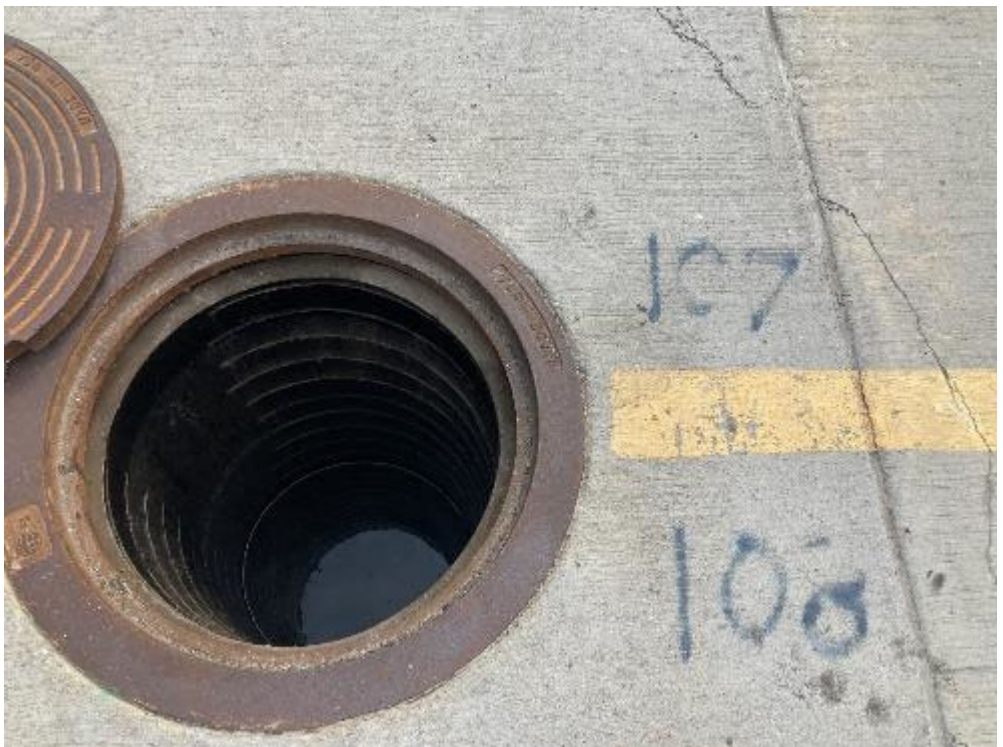
**Photo No.**  
**8**

Sump 3 (B107/B108), 34 inches of freeboard in sump. Sheen visible on water in sump. No odors noted. No tar-like material recovered.

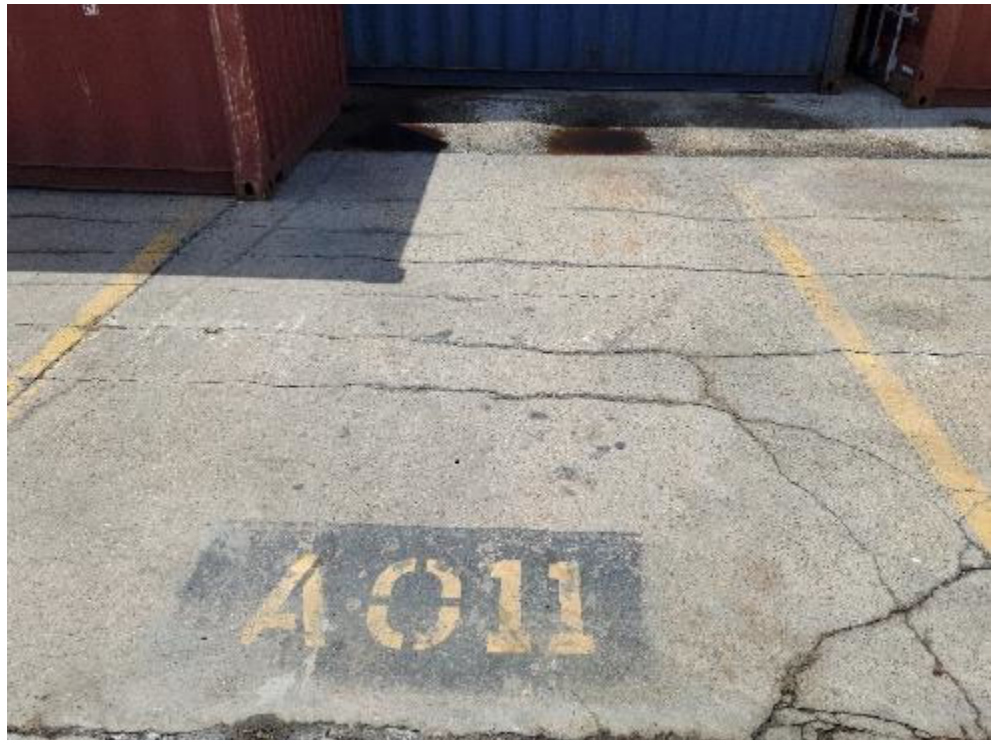
**Photo No.**  
**9**

Slot A011, brown water observed in depressions in asphalt, looking southeast.

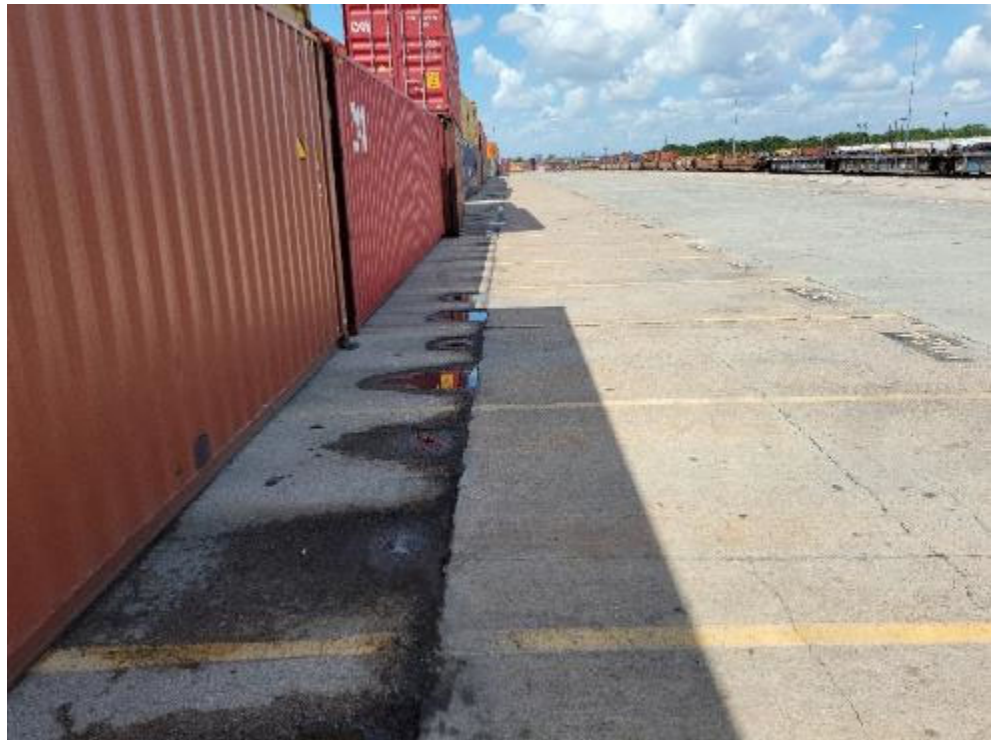
**Photo No.**  
**10**

Slot A022-A050, brown water observed in depressions in asphalt, looking west.

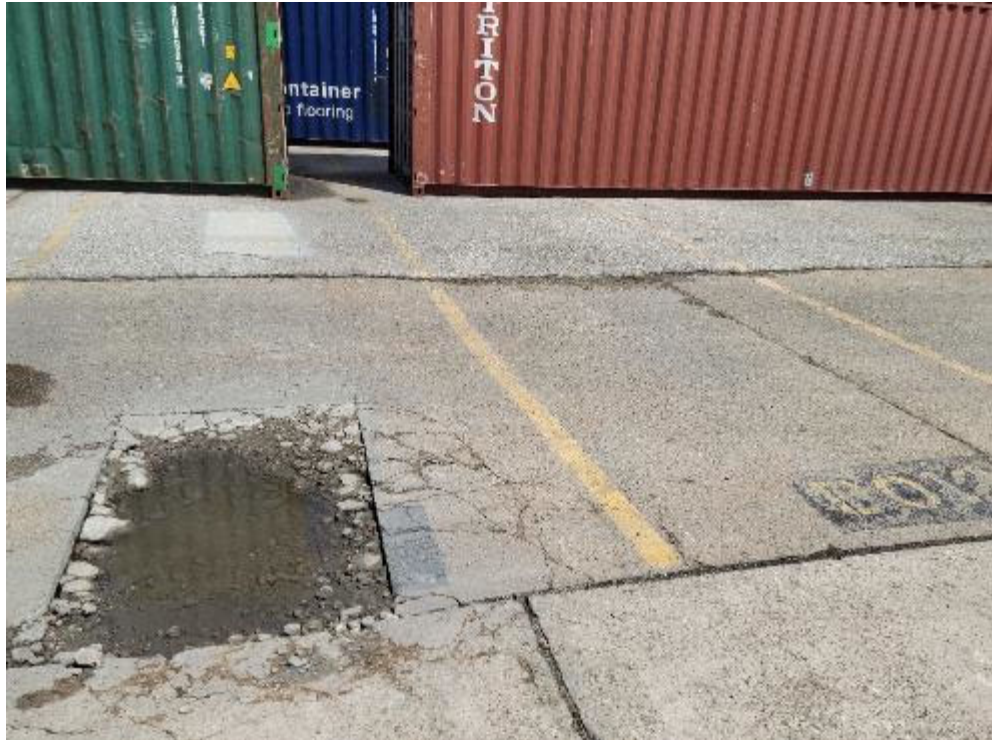
**Photo No.**  
**11**

Slot B013, no tar-like material seeps observed where test pit conducted (July 2020), test pit pavement damaged, water from recent rain event, looking north.

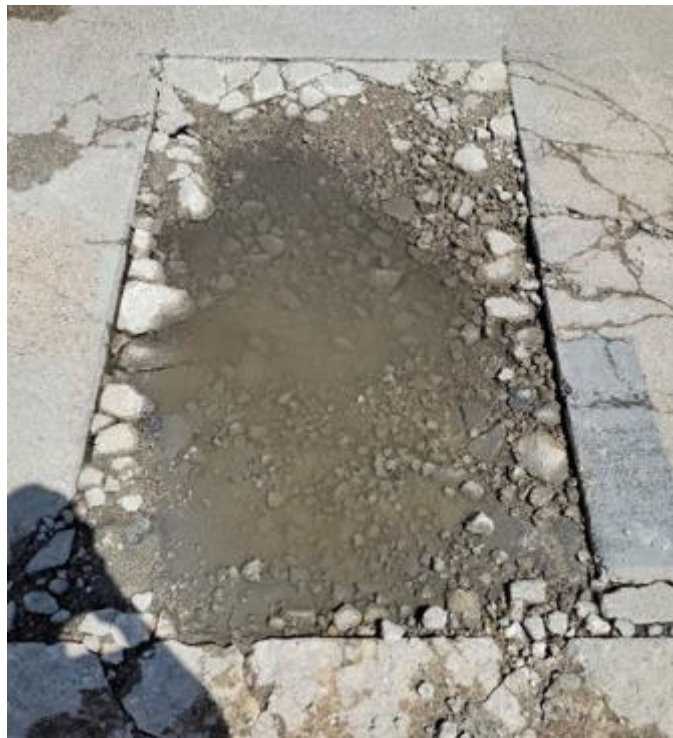
**Photo No.**  
**12**

Slot B057, no tar-like material seeps observed where test pit conducted (July 2020), historical seep location covered by shipping container, test pit pavement damaged, water from recent rain event, looking northwest.

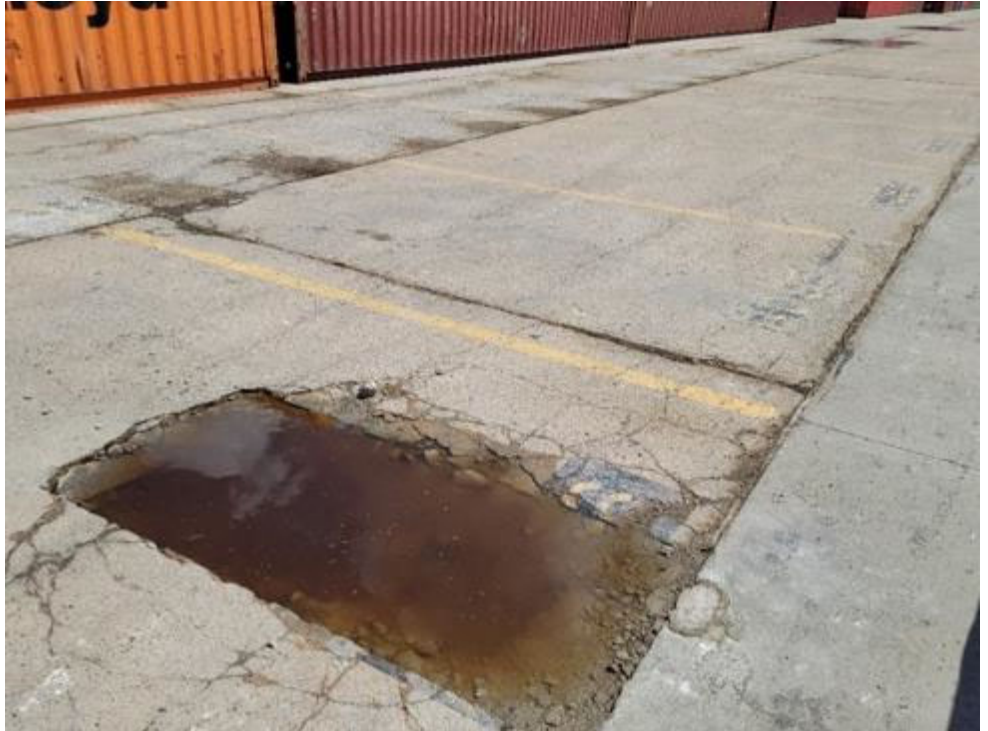
**Photo No.**  
**13**

Slot B096-B085, brown water observed in damaged B096 test pit pavement and along asphalt cracks, looking northeast.

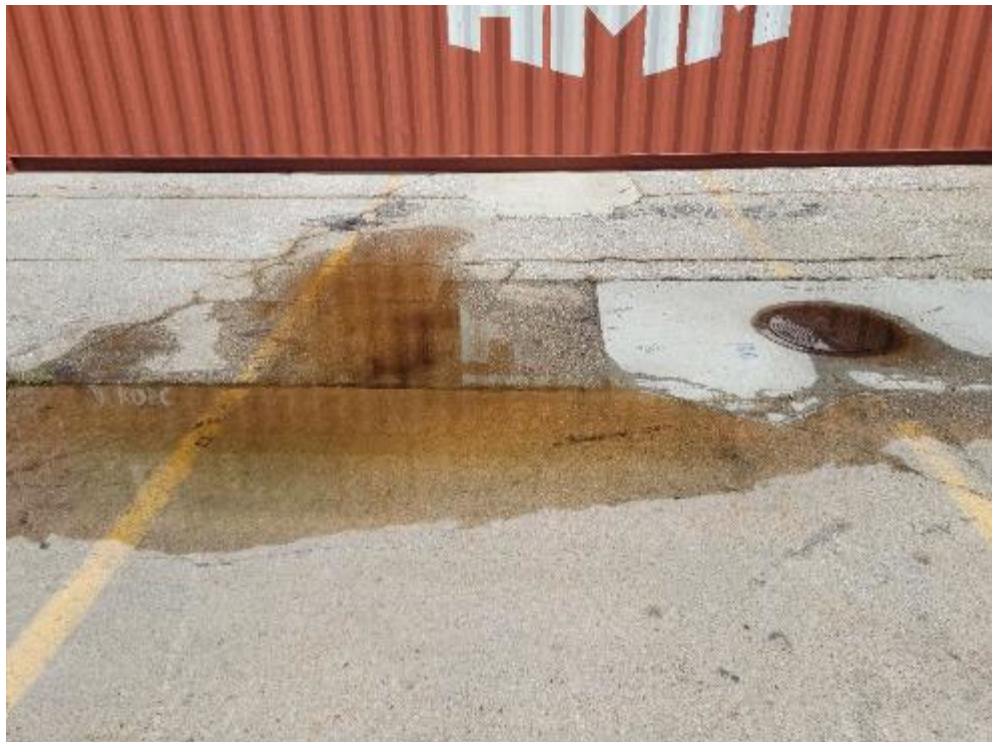
**Photo No.**  
**14**

Slot B100, brown stained water observed on standing on pavement and on B099/B100 sump, looking northwest.

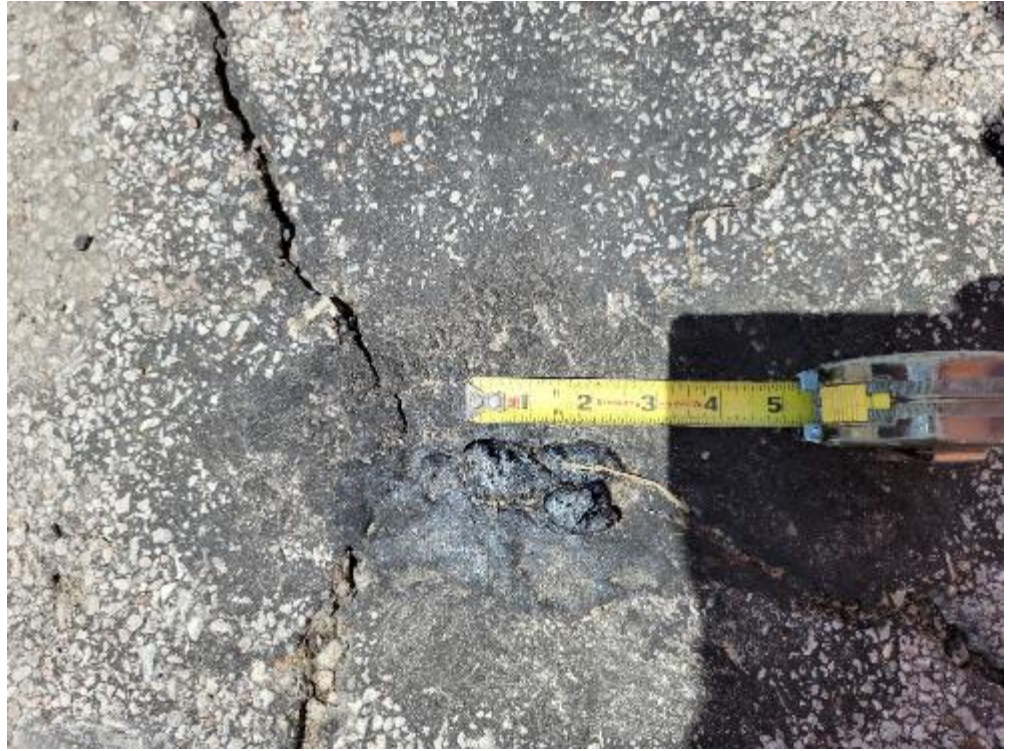
**Photo No.**  
**15**

Slot B103, very small amount of tar-like material seeping at asphalt crack, material was removed.

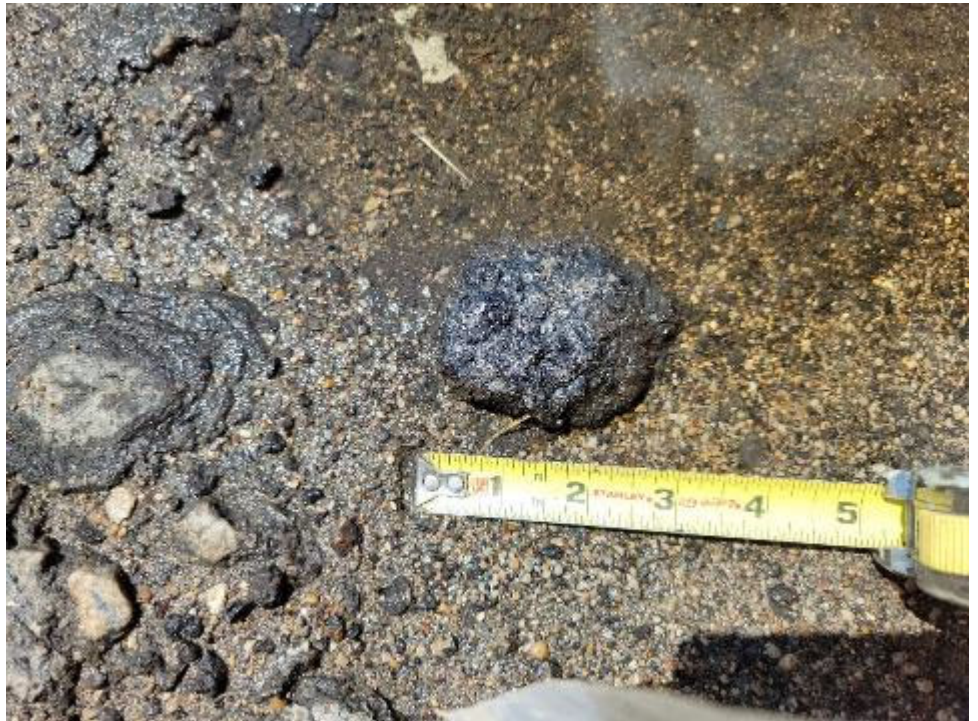
**Photo No.**  
**16**

Slot B107, small amount of tar-like material seeping at asphalt crack, material was removed.

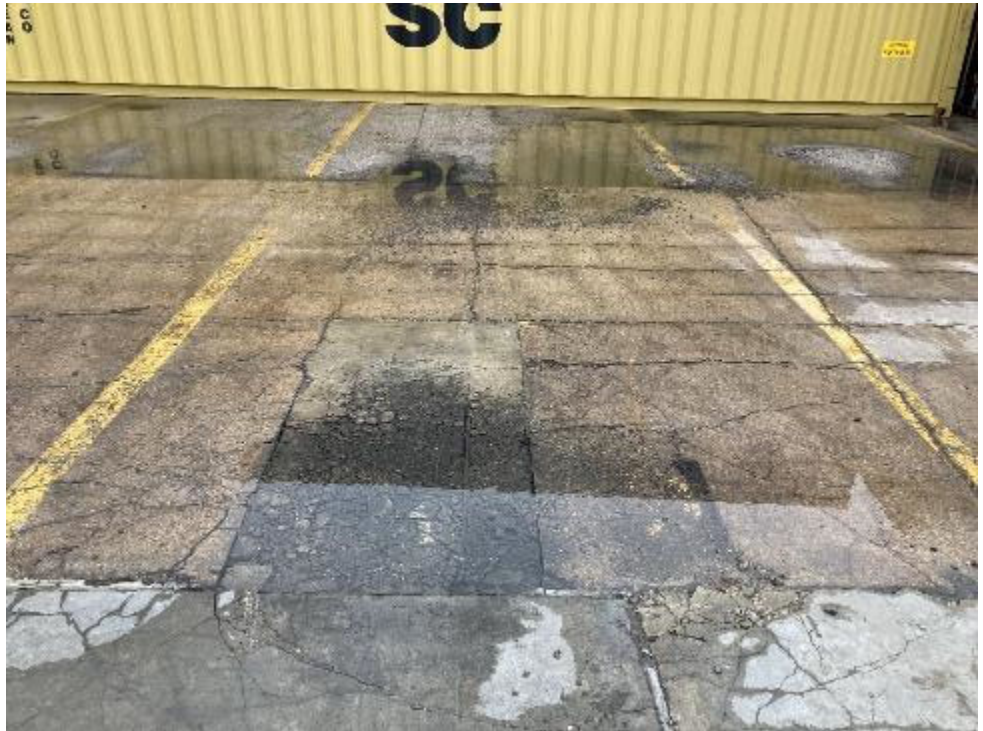
**Photo No.**  
**17**

Slot A010, no tar-like material seeps observed where test pit conducted (July 2020), test pit pavement damaged, water on pavement from recent rain event, looking southwest.

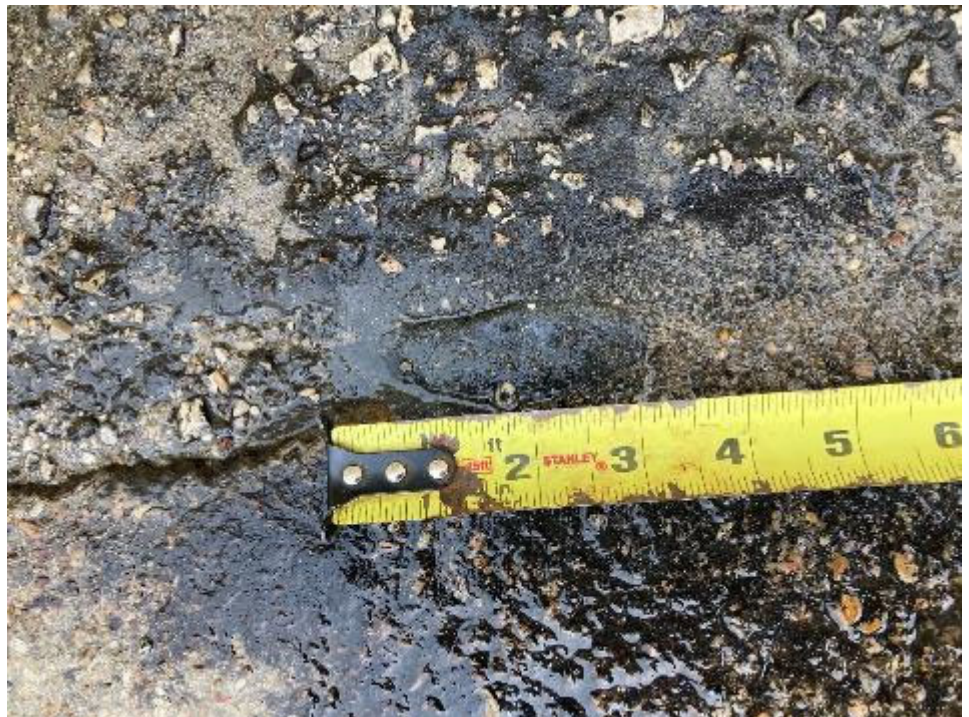
**Photo No.**  
**18**

Slot A022, very small amount of tar-like material seeping at asphalt crack, material was removed, pavement wet from recent rain event.

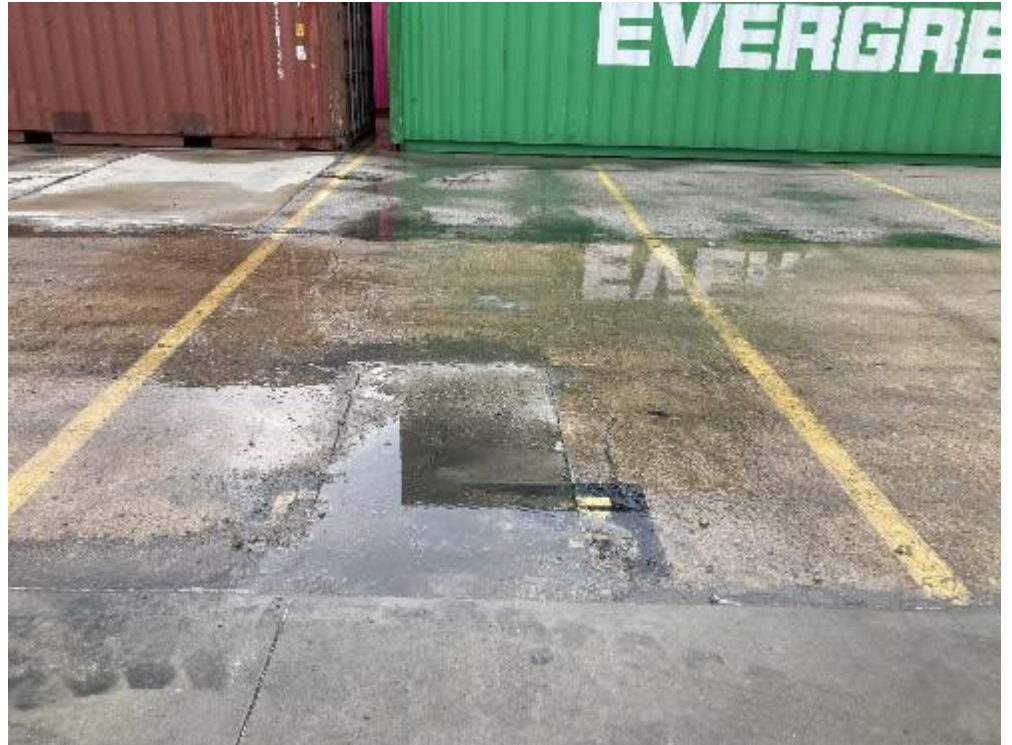
**Photo No.**  
**19**

Slot B057, no tar-like material seeps observed where test pit conducted (July 2020), test pit pavement damaged, water on pavement from recent rain event, looking northwest.

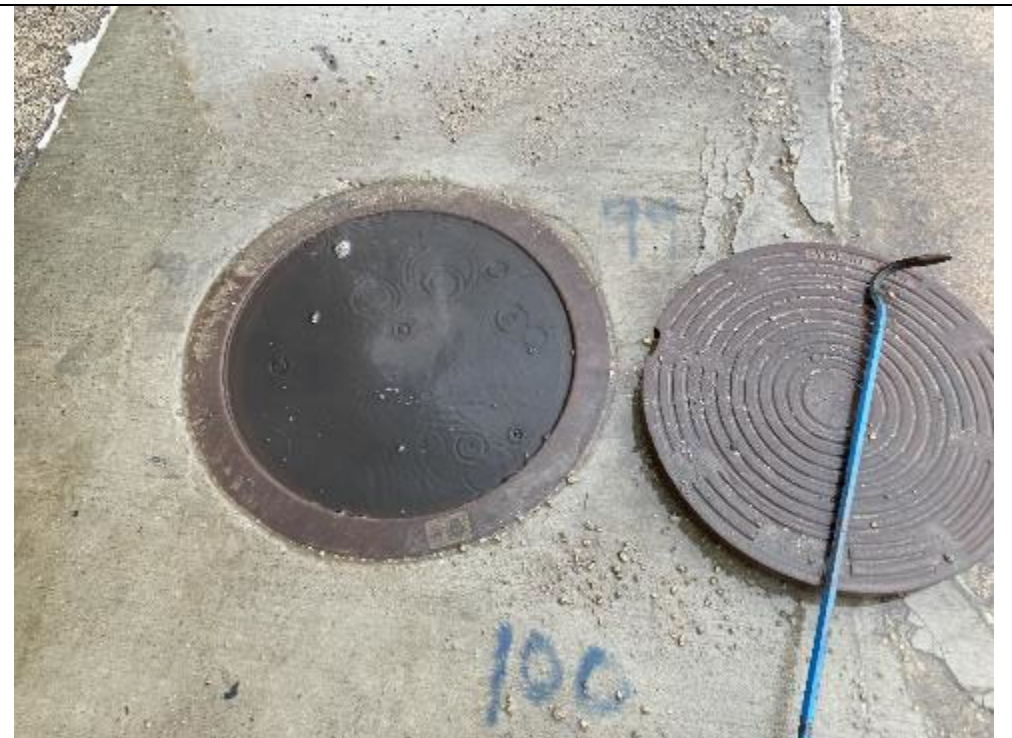
**Photo No.**  
**20**

Sump 1 (B099/B100), 0 inches of freeboard in sump, no sheen or odor noted, water on pavement from recent rain event.

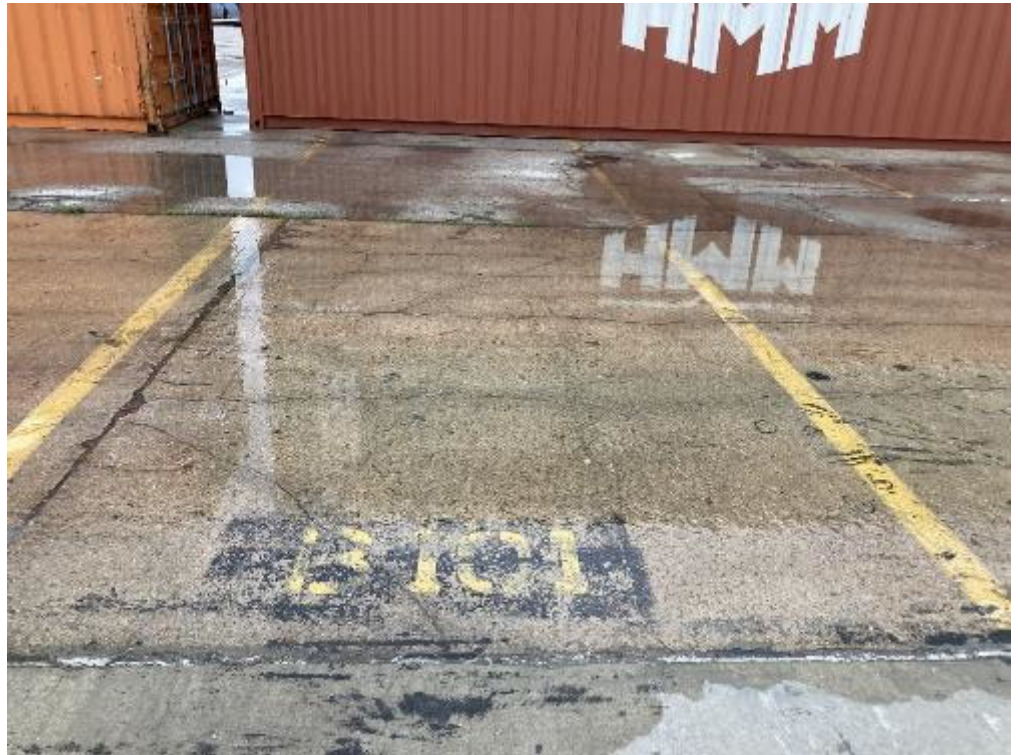
**Photo No.**  
**21**

Slot B101, no tar-like material seeps observed, water on pavement from recent rain event, looking northwest.

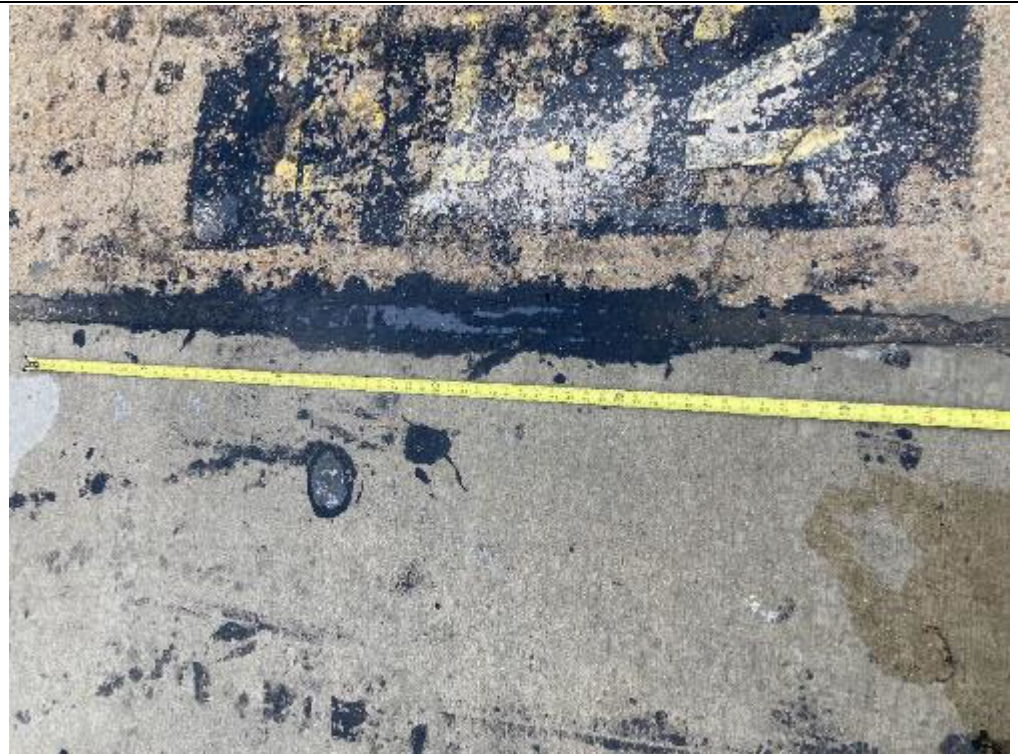
**Photo No.**  
**22**

Slot B102, small amount of tar-like material seeping at pavement joint, material was removed, water on pavement from recent rain event.

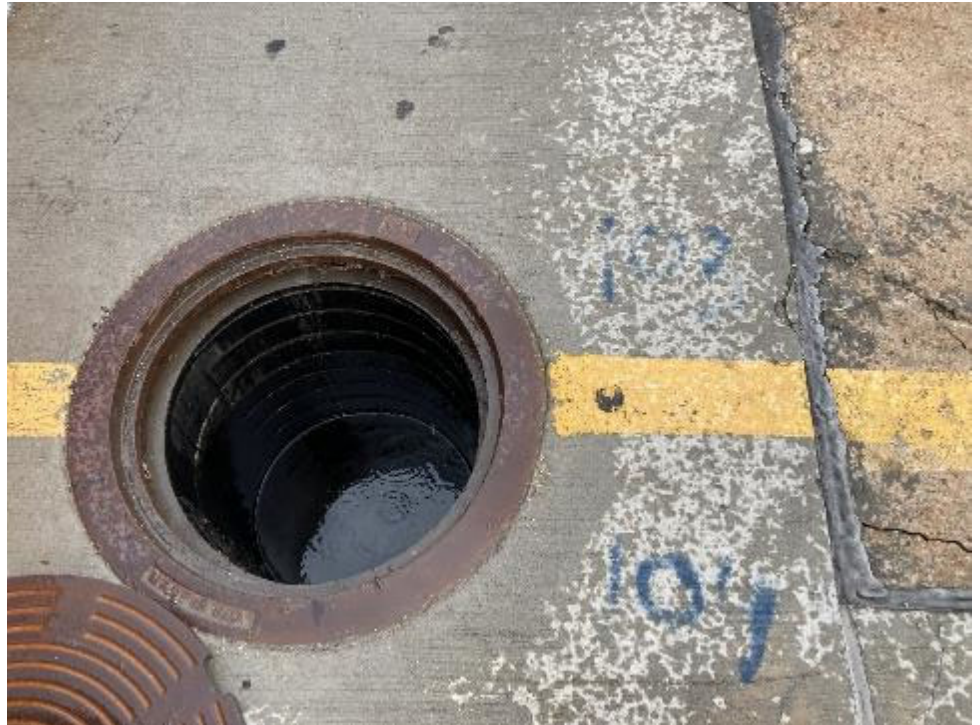
**Photo No.**  
**23**

Sump 2 (B103/B104), 25 inches of freeboard in sump. No sheen or odors noted. Pavement wet from recent rain event.

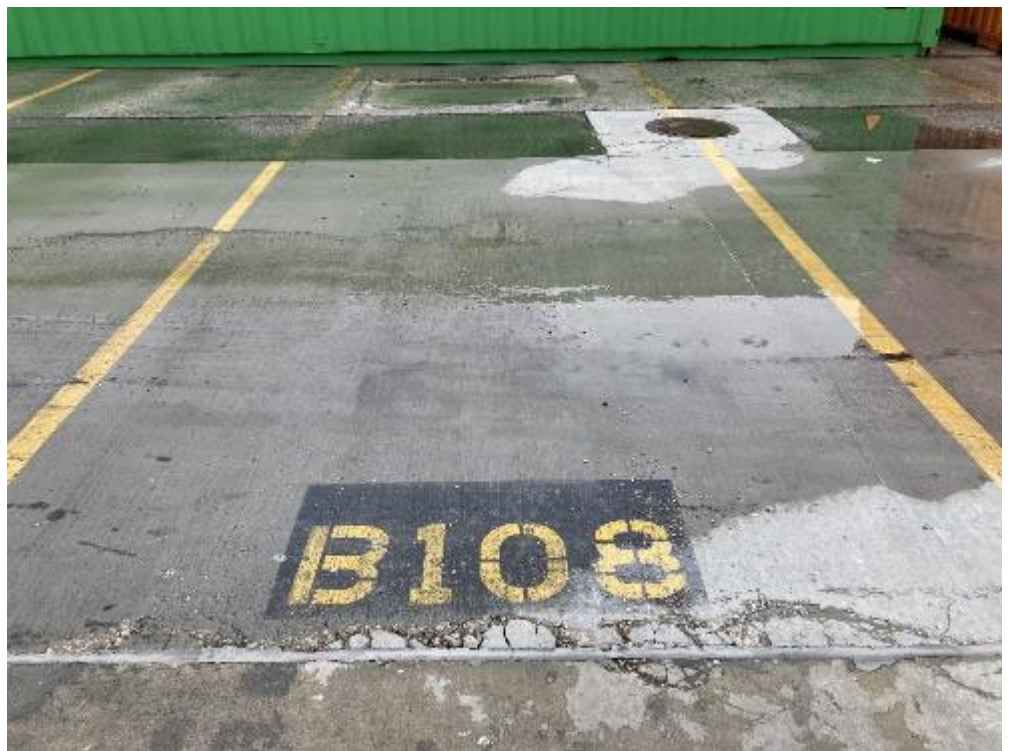
**Photo No.**  
**24**

Slot B108, view of NAPL Collection System (Sump B107/B108 and test pit in background). No tar-like material seeps observed where test pit (July 2020) conducted, water on pavement from recent rain event, looking northwest.

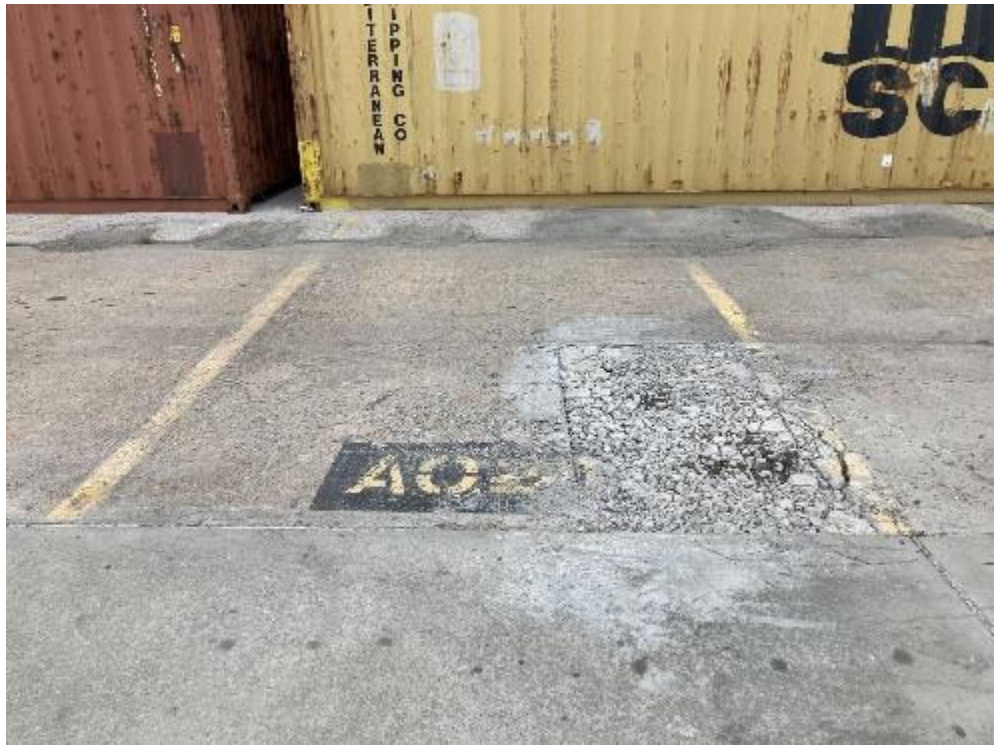
<b>Photo No.</b> <b>25</b>	<b>Date:</b> 8/25/2021
-------------------------------	---------------------------

Slot A021, no tar-like material seeps observed where test pit conducted (July 2020), test pit pavement damaged.

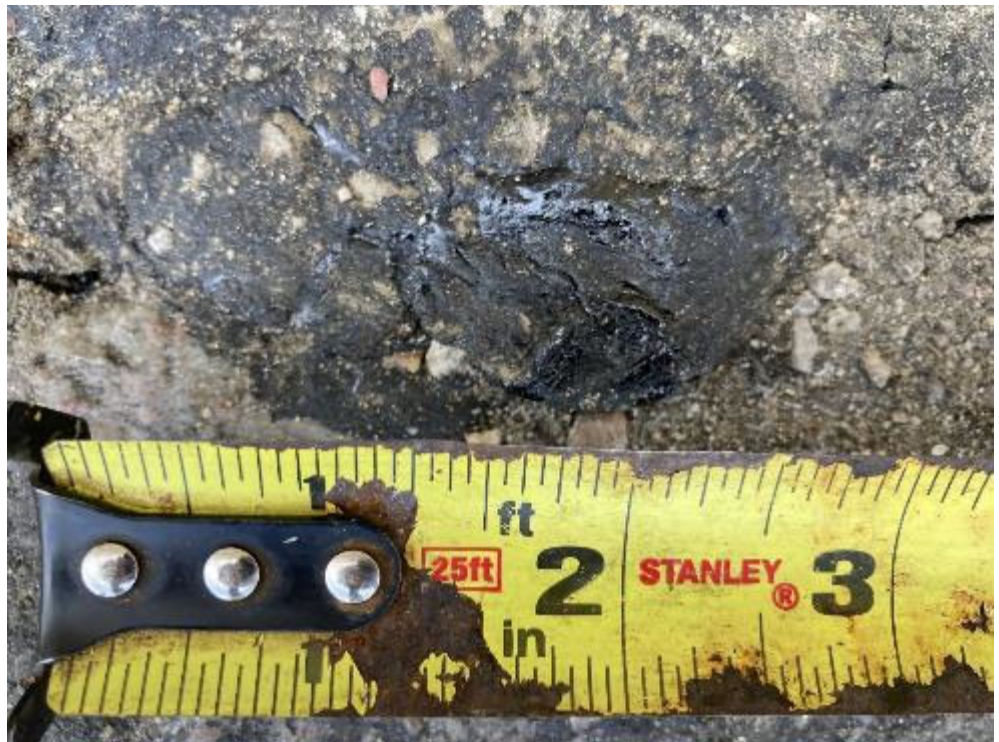
<b>Photo No.</b> <b>26</b>	<b>Date:</b> 8/25/2021
-------------------------------	---------------------------

Slot A022, very small amount of tar-like material seeping at asphalt crack, material was removed.

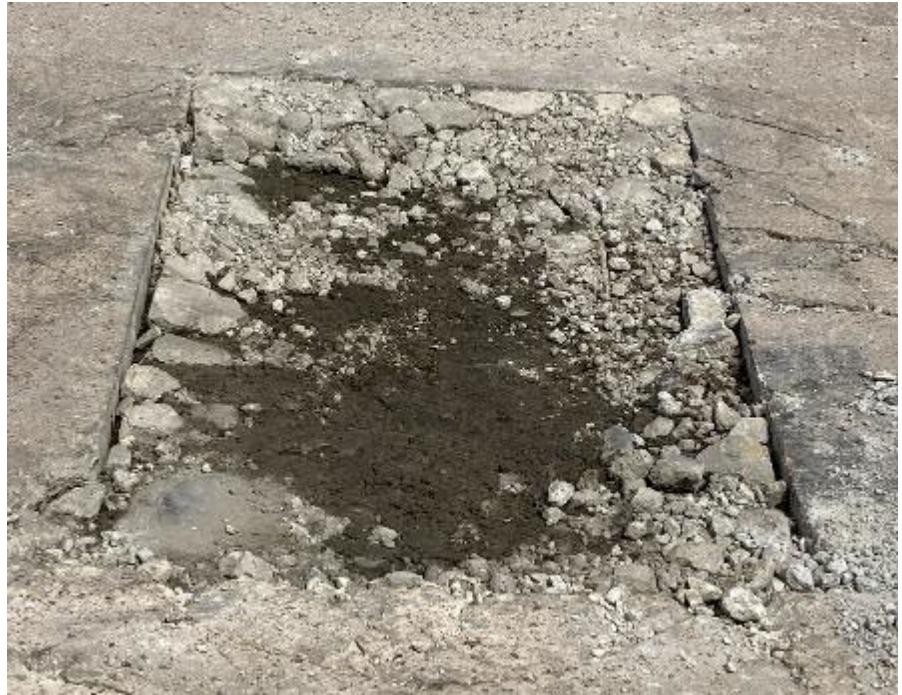
**Photo No.**  
**27**

Slot B013, no tar-like material seeps observed where test pit conducted (July 2020), test pit pavement damaged.

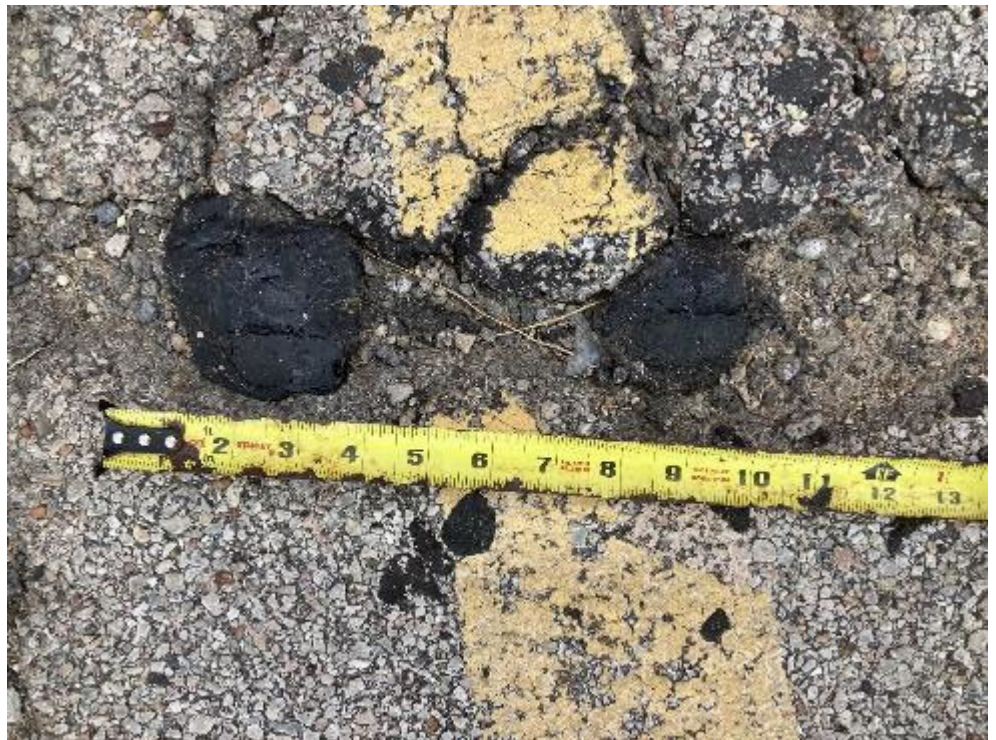
**Photo No.**  
**28**

Slot B057, small amount of tar-like material seeping at asphalt crack (not at July 2020 test pit location), material was removed.

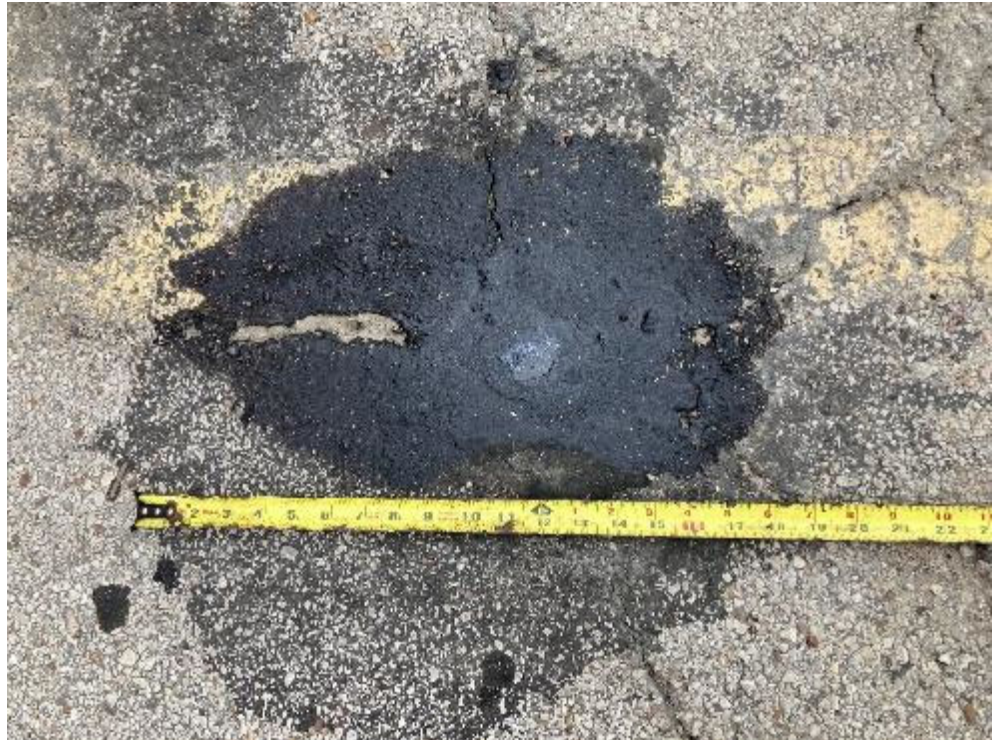
**Photo No.**  
**29**

Slot B101, small amount of tar-like material seeping at asphalt crack, material was removed.
