September 15, 2021

Project No. 19119232

Re: **MONTHLY STATUS UPDATE – ENGLEWOOD INTERMODAL YARD – NAPL COLLECTION SYSTEM/CONCRETE CAP REPAIRS  
UNION PACIFIC RAILROAD HOUSTON WOOD PRESERVING WORKS FACILITY  
4910 LIBERTY ROAD FACILITY, HOUSTON, TEXAS  
POST-CLOSURE CARE PERMIT NO. HW-50343; INDUSTRIAL SWR NO. 31547**

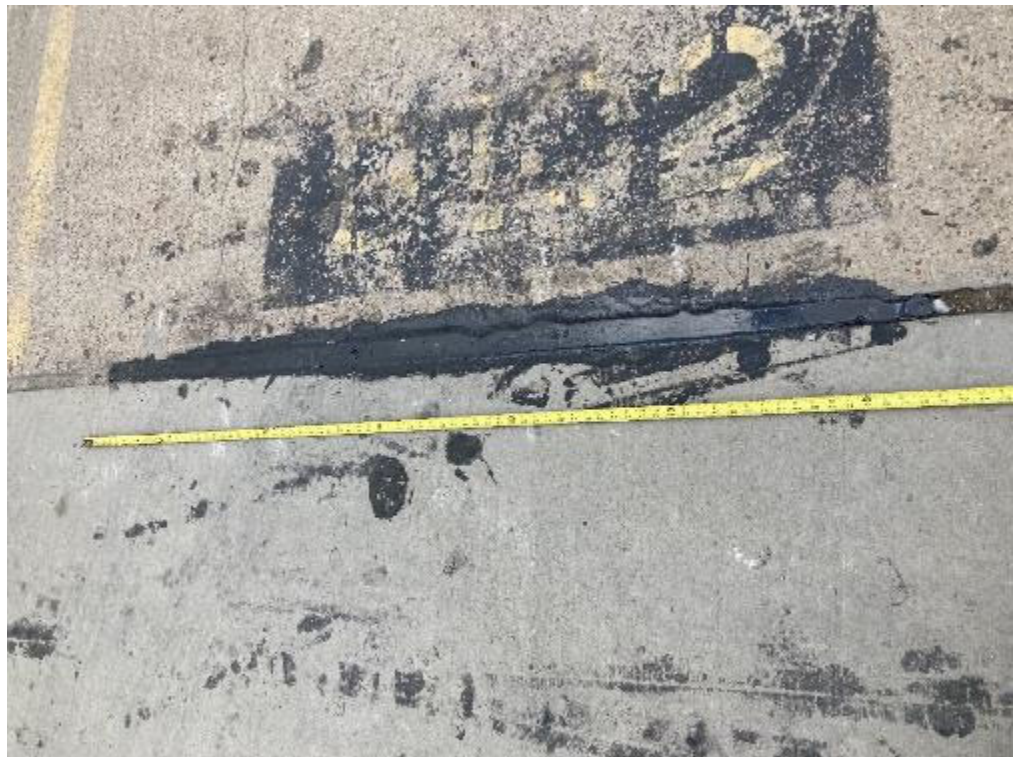
**Photo No.**  
**30**

Slot B102, small amount of tar-like material seeping at pavement joint, material was removed.

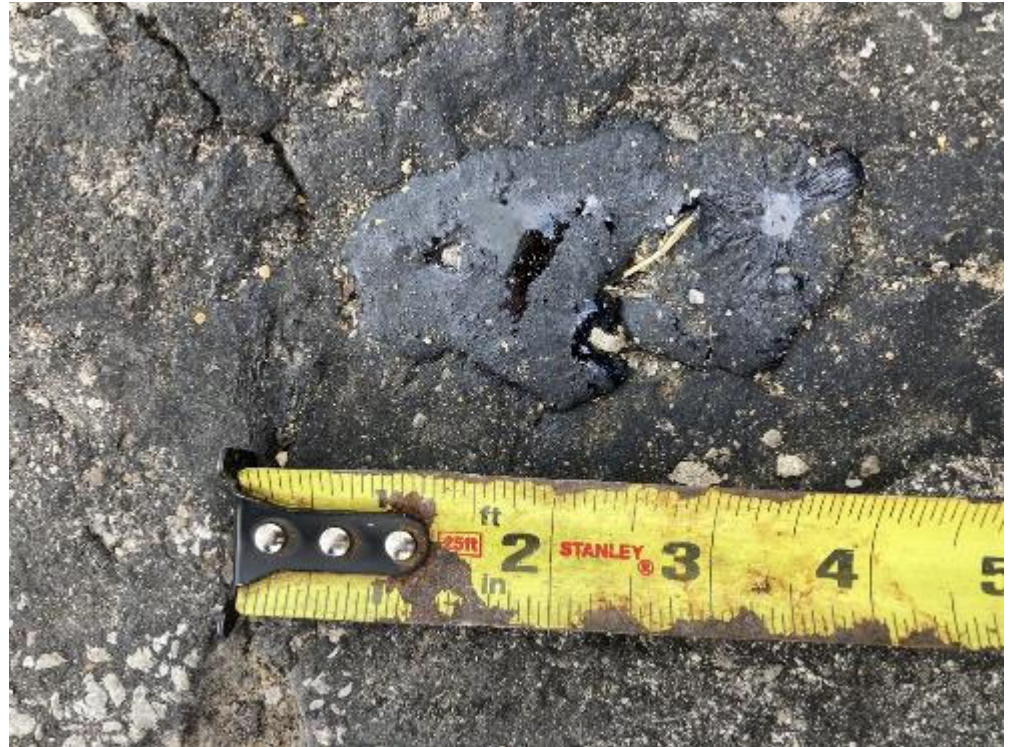
**Photo No.**  
**31**

- A very small tar-like NAPL surface seep was observed near the NAPL Collection System area in stall B105 during two of the four inspections in August (August 4<sup>th</sup> and 25<sup>th</sup>) (Photo Nos. 7 and 31). A very small amount of tar-like NAPL was also observed near the NAPL Collection System area in stalls B103 (Photo No. 15) and B107 (Photo No. 16) during the August 11<sup>th</sup> inspection. For areas outside the NAPL Collection System, small amounts of tar-like material were observed on the concrete surface in stalls A022 and B102 during three of the four inspections in August (August 4<sup>th</sup>, 18<sup>th</sup>, and 25<sup>th</sup>). A small amount of tar-like NAPL was observed in stall B057 on August 25<sup>th</sup> and stall B101 on August 4<sup>th</sup> and August 25<sup>th</sup>. Tar-like material observed during the inspection events was recovered using a hand tool to scrape up the material. During August, the number of tar-like material seeps observed during inspections and the total amount of material removed from the concrete surface increased compared to the July inspections. A total of approximately 2.4 gallons of tar-like material was recovered for the month and placed in a drum for disposal. The drum is staged at the Container Storage Area (CSA).

Slot B105, very small amount of tar-like material observed seeping observed at asphalt crack, material was removed.

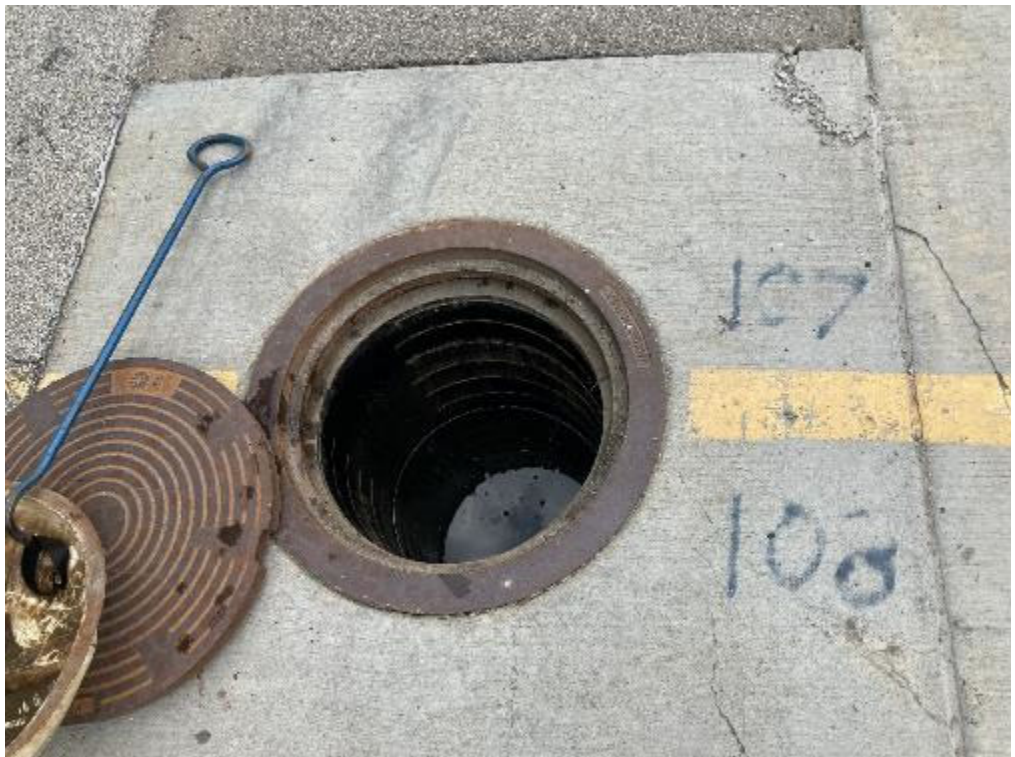
**Photo No.**  
**32**

Sump 3 (B107/B108), 22 inches of freeboard in sump. No sheen or odors noted. No tar-like material recovered.
