**Region 5 Enforcement and Compliance Assurance Division  
SDWA DRINKING WATER INSPECTION REPORT**

City of Benton Harbor  
Berrien County, Michigan

Inspection Date(s):	November 10, 2021		
Owner/Company Name:	City of Benton Harbor		
System Name	Benton Harbor PWS		
System Location	601 North Ridgeway Drive		
City, State, Zip Code	St. Joseph, Michigan 49085		
County	Berrien		
Mailing Address:	601 North Ridgeway Drive		
City, State, Zip Code	St. Joseph, Michigan 49085		
System Contact	Ellis Mitchell, City Manager		
	(269) 927-8457		
PWS ID No:	MI0000600		
Personnel Participating in Inspection:			
Jonathan Moody	Environmental Engineer, Lead	<a href="mailto:Moody.Jonathan@epa.gov">Moody.Jonathan@epa.gov</a>	312-886-7570
Abul Ahmed	Operator in Charge Treatment System	<a href="mailto:aahmed@fv-operations.com">aahmed@fv-operations.com</a>	616-588-2900
EPA Lead Inspector Signature/Date			
<b>Reviewed by:</b> Team Leader Signature/Date			
<b>Approved by:</b> Section Chief Signature/Date

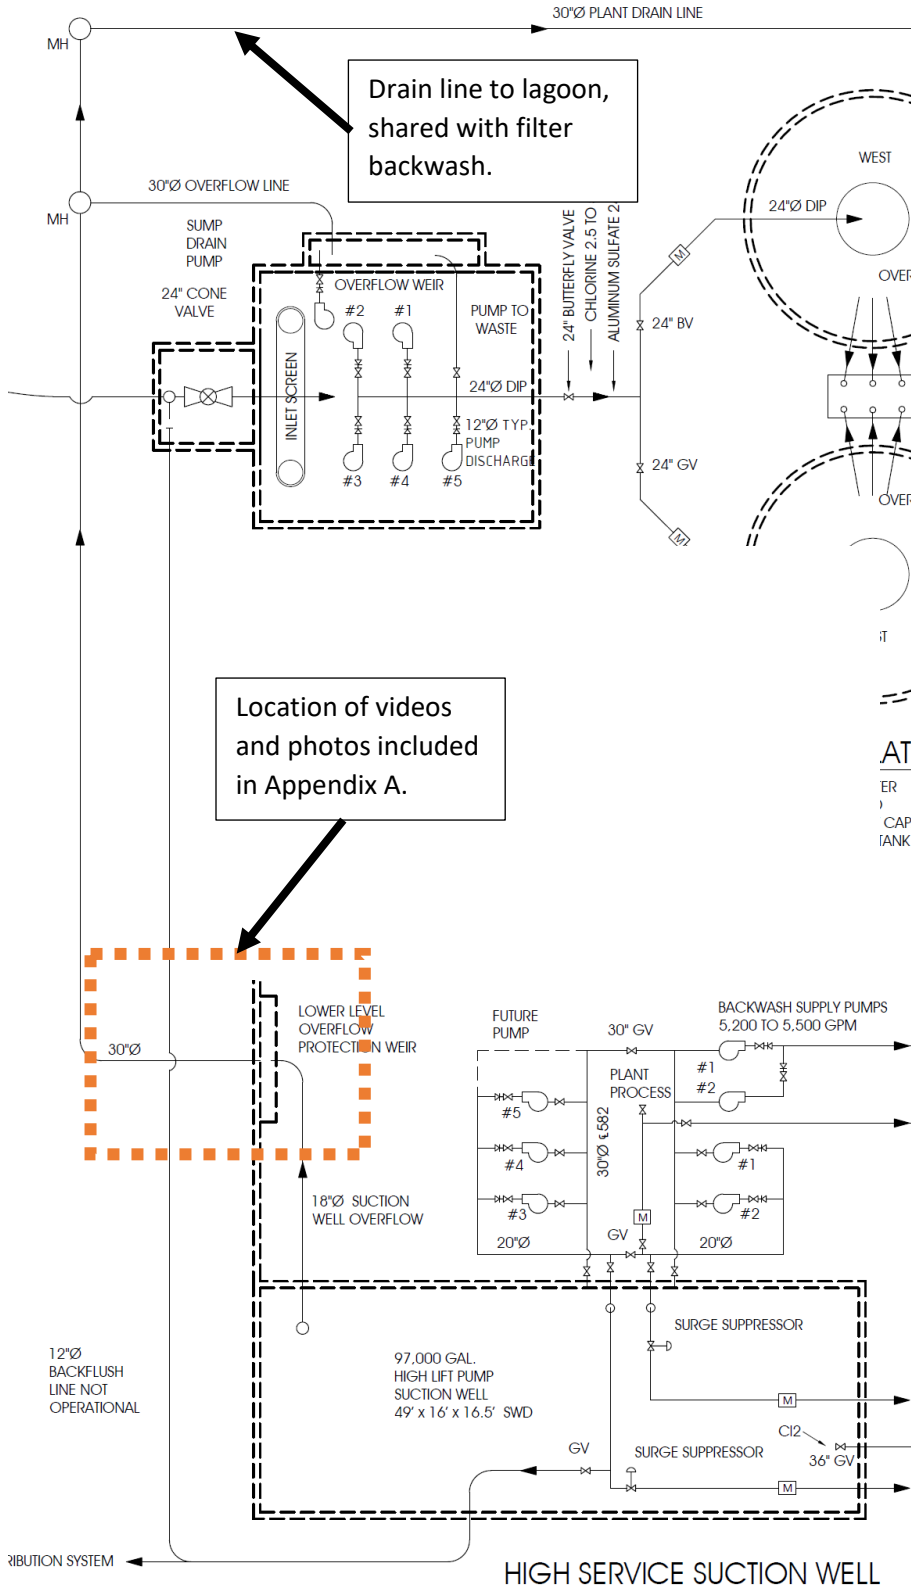
I - Excerpt of Plant Flow Schematic

- Potential cross connection between the high service suction well and the water treatment plant drain line. Additionally, the overflow pipe is not screened to prevent contamination from entering the finished water storage.

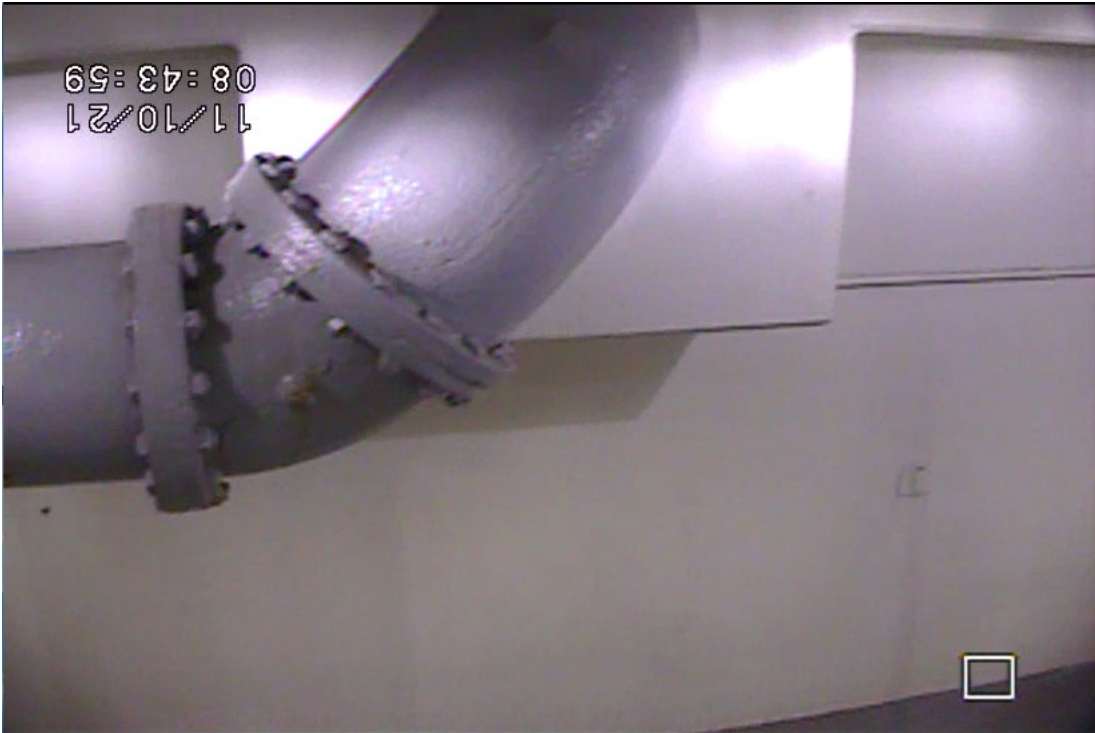
2: 4349.PNG

Description: Video of overflow pipe from the high service suction well. The grey pipe is labeled 'overflow' and is connected to a concrete weir. Image is a screen shot and has been rotated 180 degrees.

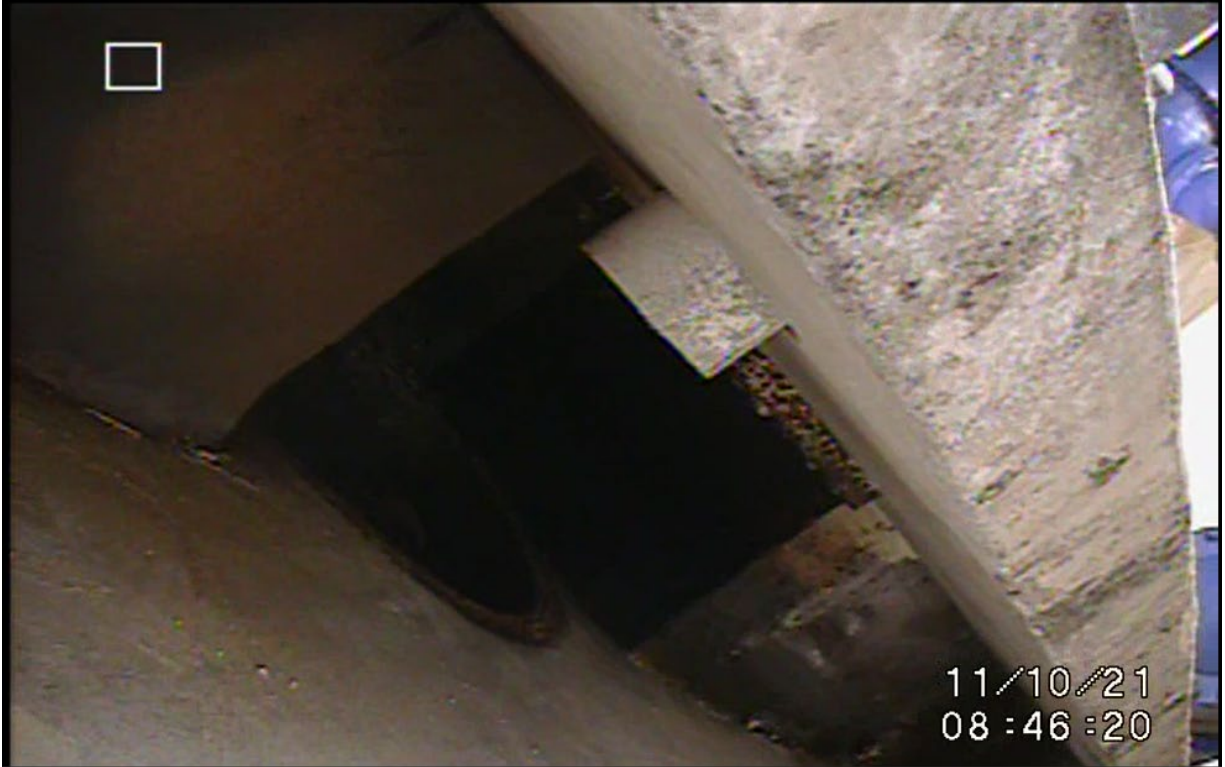
3: 4600.PNG

Description: Image is a screenshot from the video and is looking inside the concrete weir box where the overflow pipe is connected.

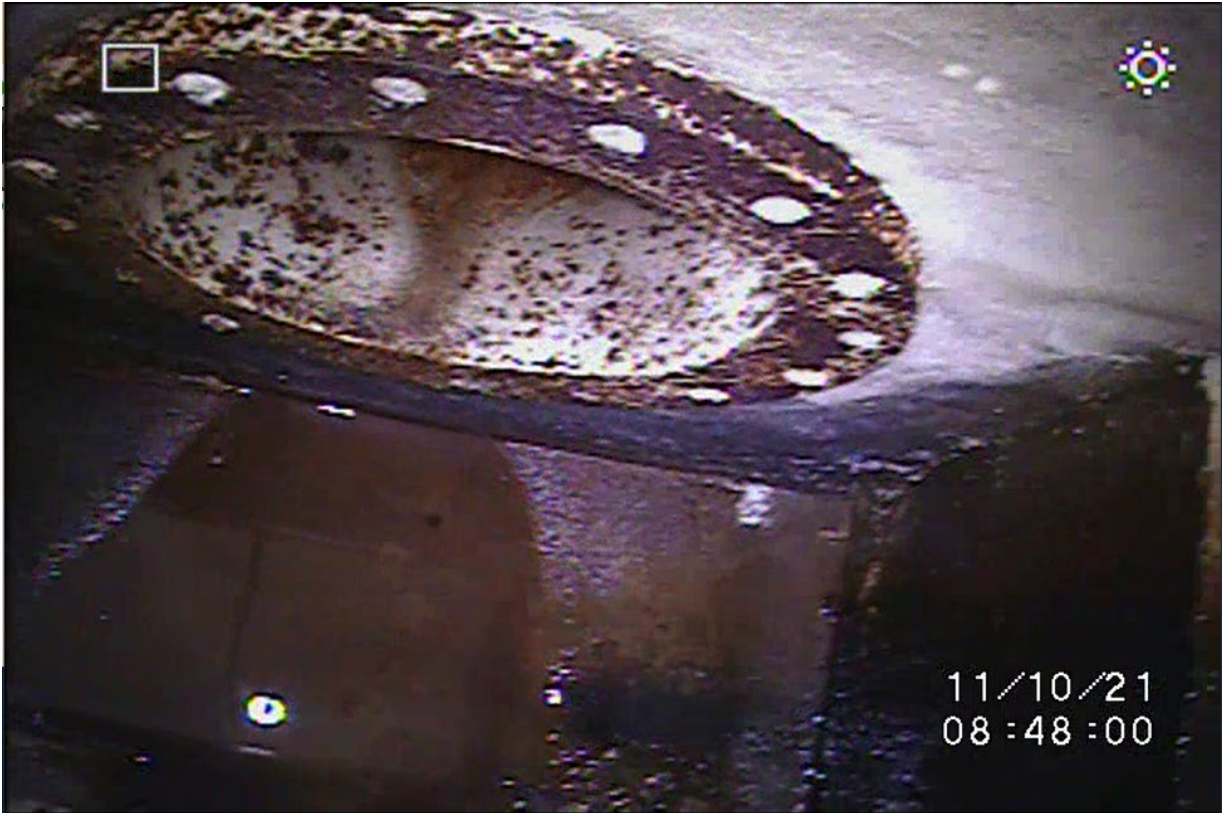
4: 4746.PNG

Description: Image is a screen shot looking down at the outlet from the grey pipe into the concrete weir.

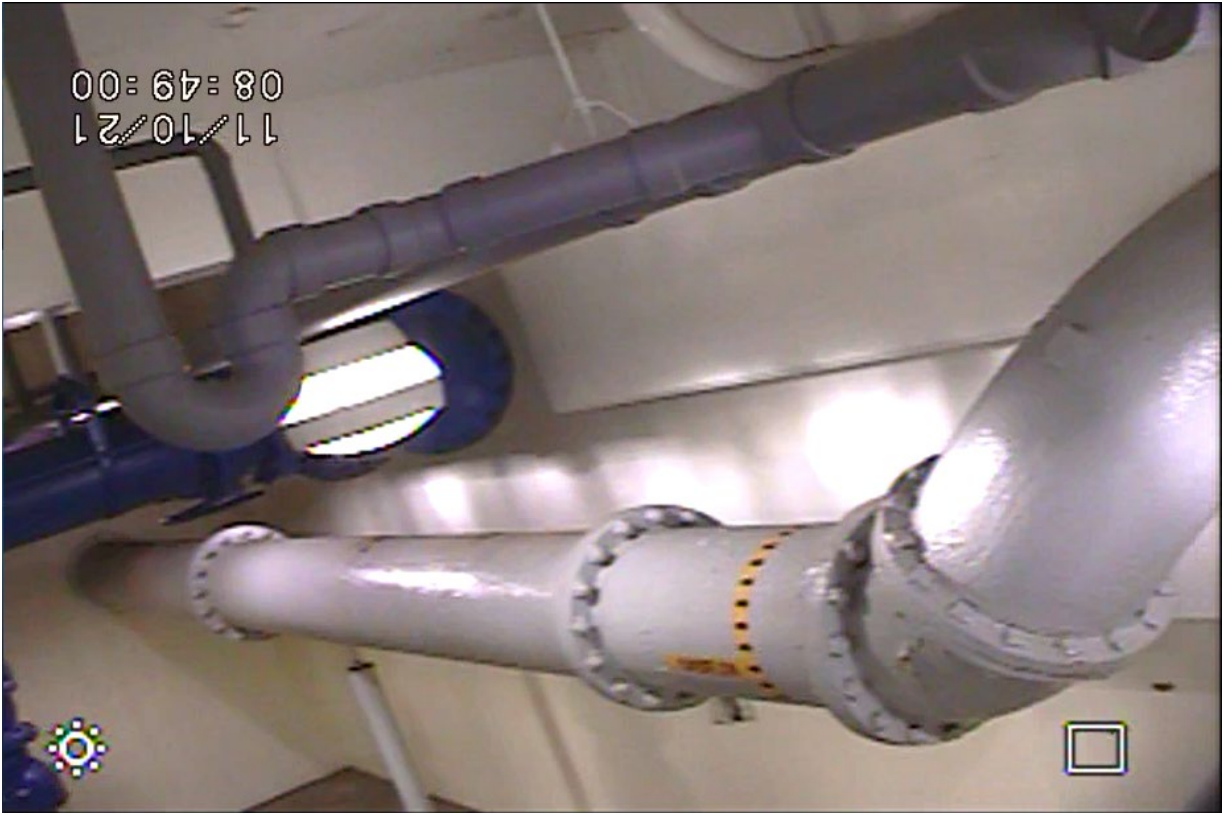
5: 4855.PNG

Description: Image is a screenshot showing the grey overflow pipe coming out of the high service suction well.

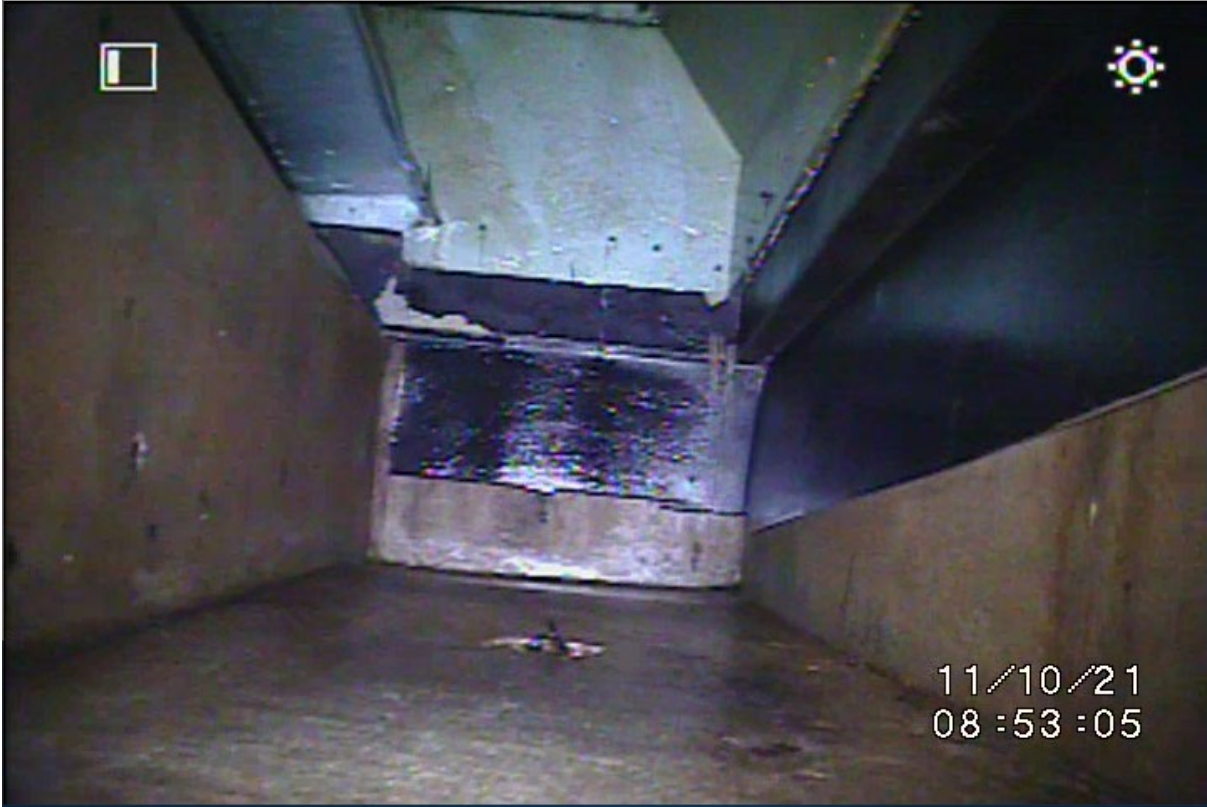
6: 5246.PNG

Description: Video of the trench receiving waste from the bar screen at the headworks of the treatment plant. Image is a screenshot of the inside of the trench.

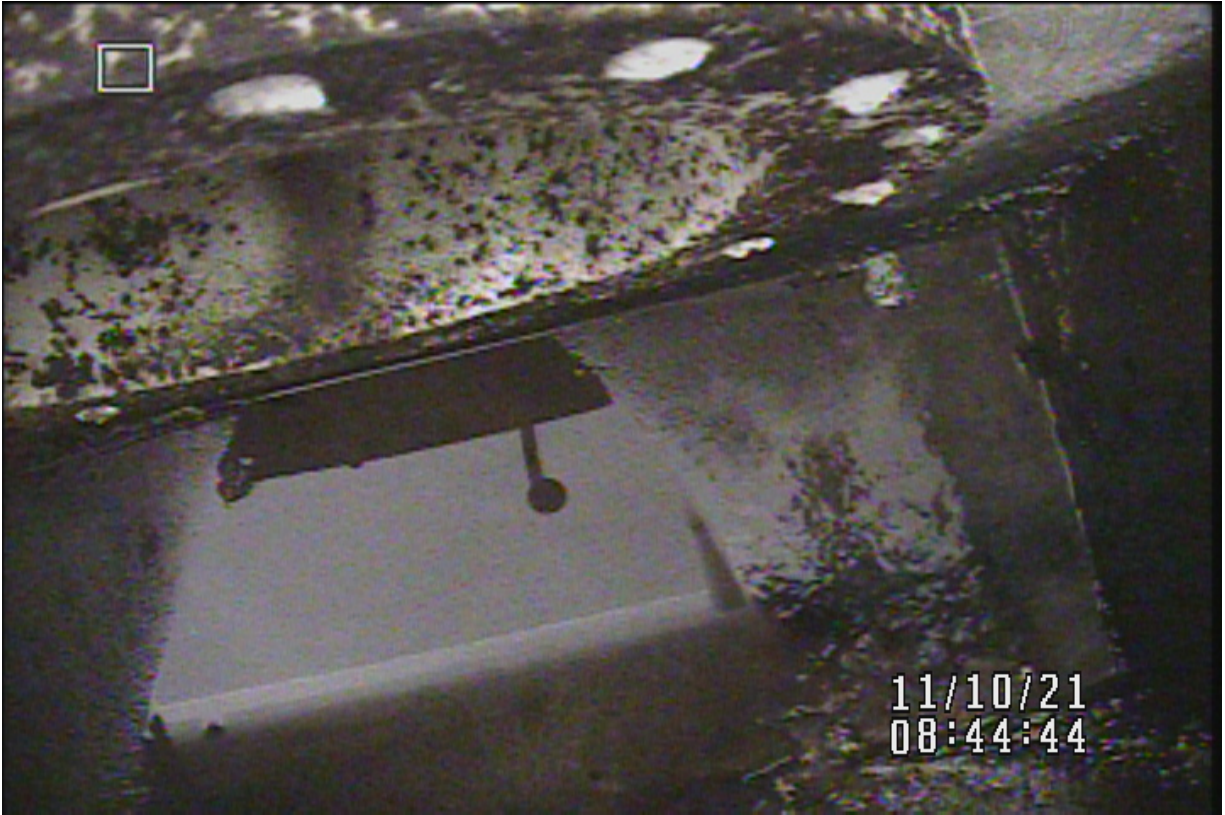
7: 084444.JPG

Description: At the concrete weir with the overflow from the high service suction well. Water was present in the bottom of the weir box.

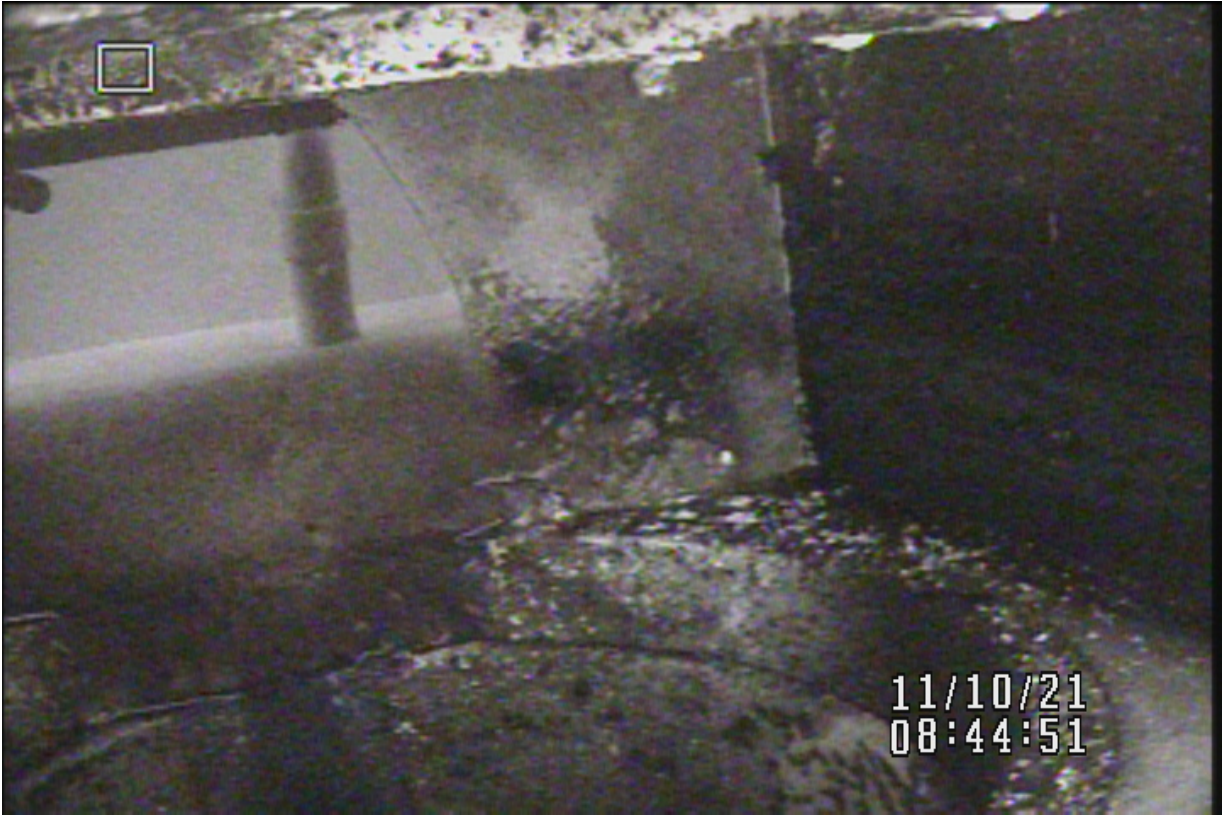
8: 084451.JPG

Description: At the concrete weir with the overflow from the high service suction well. Water was present in the bottom of the weir box. Both the upstream and downstream pipe flanges are visible in this image. The flow of water would be from the top of the photo to the bottom.

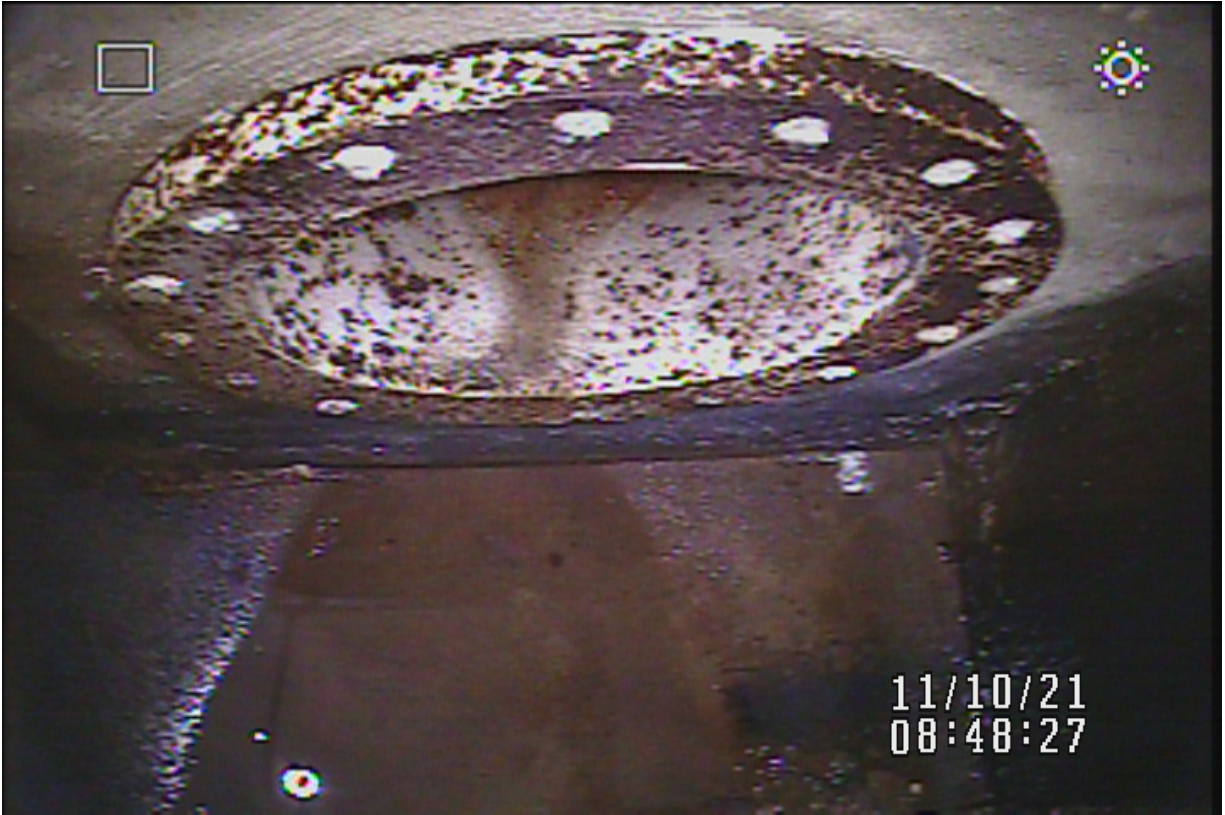
10: 084827.JPG

Description: At the concrete weir with the overflow from the high service suction well. Water was present in the bottom of the weir box. This pipe is connected to the grey overflow pipe and is the upstream side of the concrete weir box.

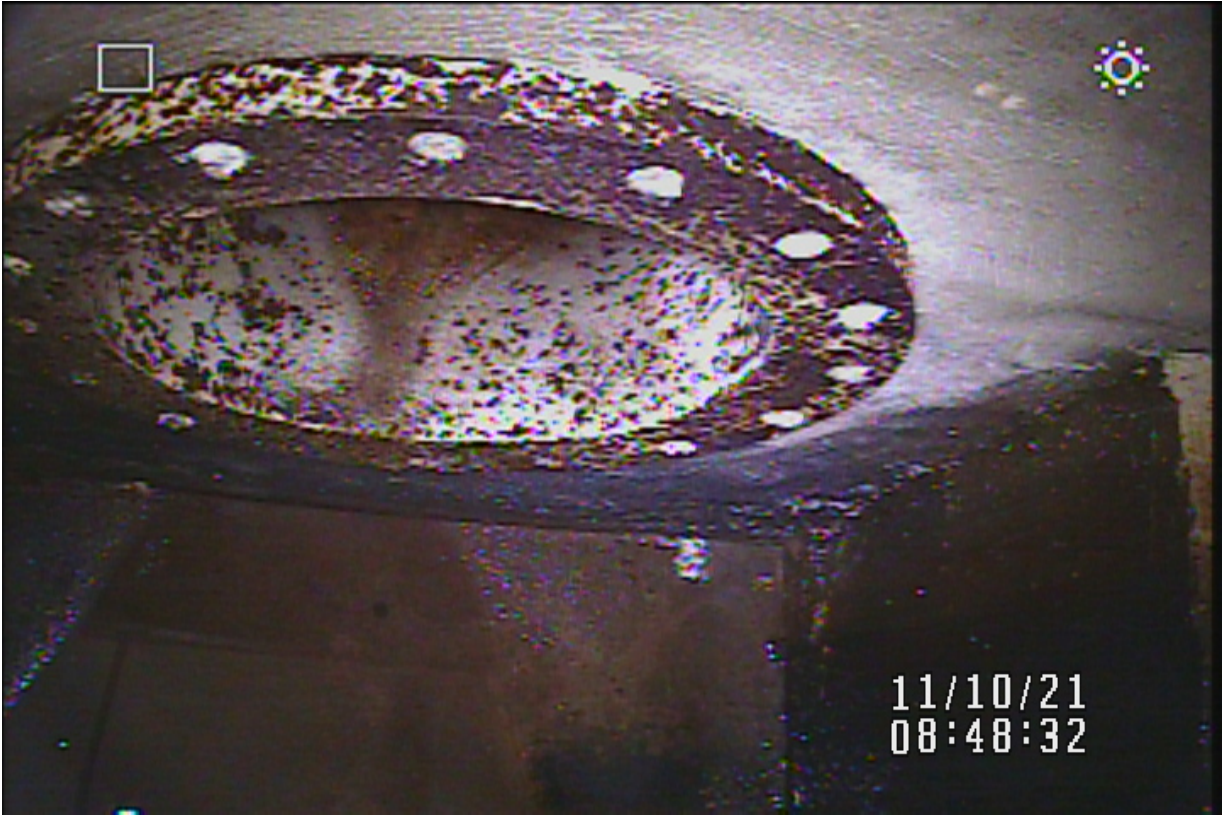
11: 084832.JPG

Description: At the concrete weir with the overflow from the high service suction well. Water was present in the bottom of the weir box. This pipe is connected to the grey overflow pipe and is the upstream side of the concrete weir box.
