Subject: May 4-6, 2022 Inspection Trip Report for City of Cahokia Heights

Purpose: NPDES SSO Inspection Trip Report

Facility: City of Cahokia Heights, Illinois

Dates of Inspection: May 4, 2022 – May 6, 2022

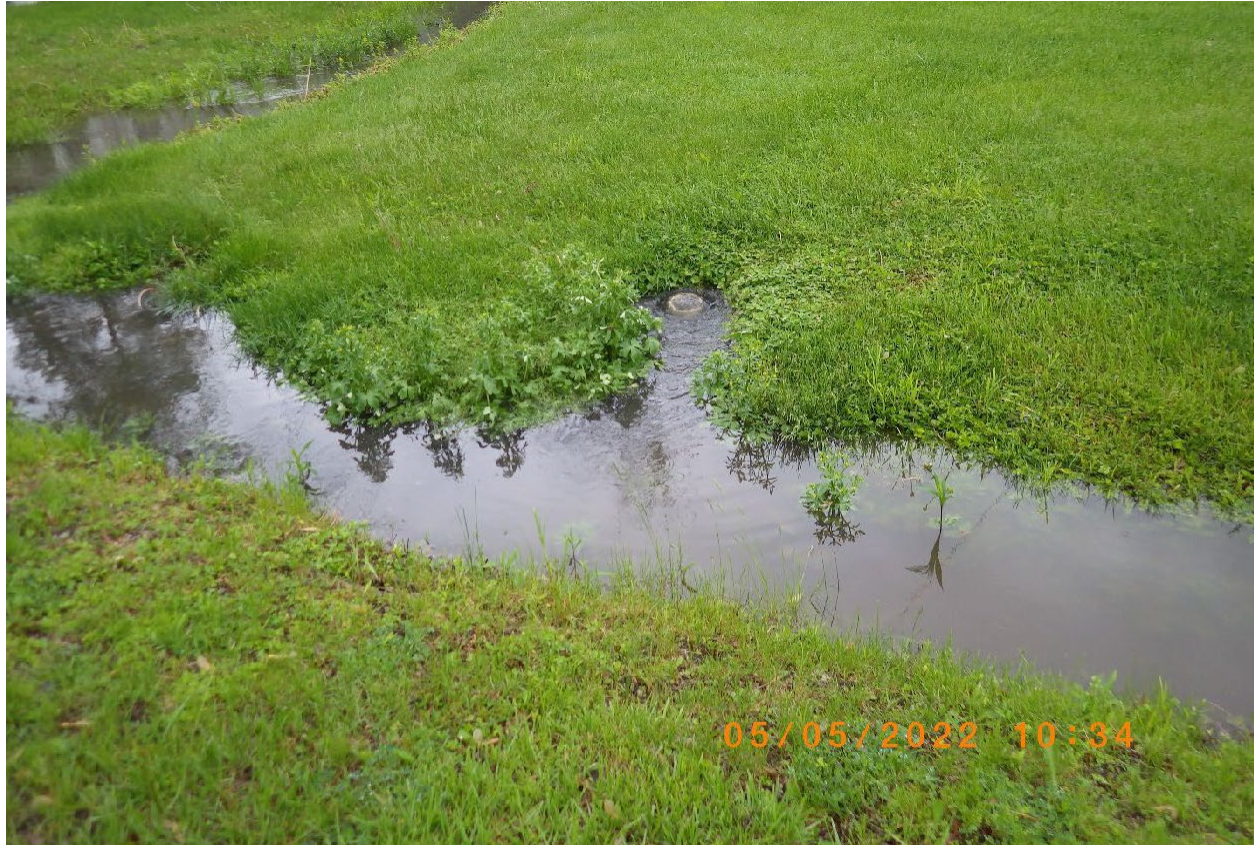
1: BELL0001 (edited to remove Personally Identifiable Information (PII))

Description: SSO from the cleanout on North 82nd Street.

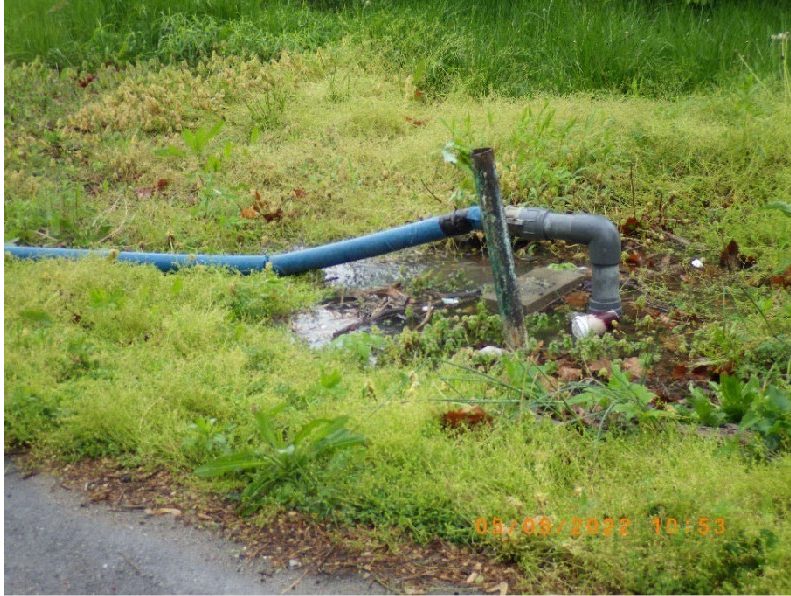
2: BELL0002

Description: The non-functioning lift station at Lake Street and 71st Street was being bypassed by the City of Cahokia Heights personnel. The hose used to bypass the lift station leaked sewage. One of the leaks of sewage went into the ditch by the side of the 71st Street.

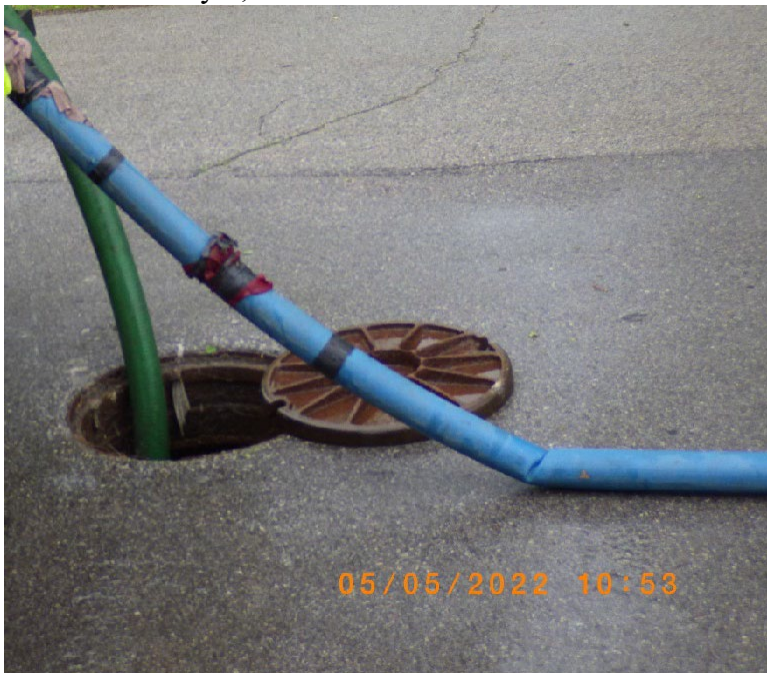
3: BELL0003 (edited to remove PII)

Description: Two other hose leaks from the bypass hose dripped back into the wet well.

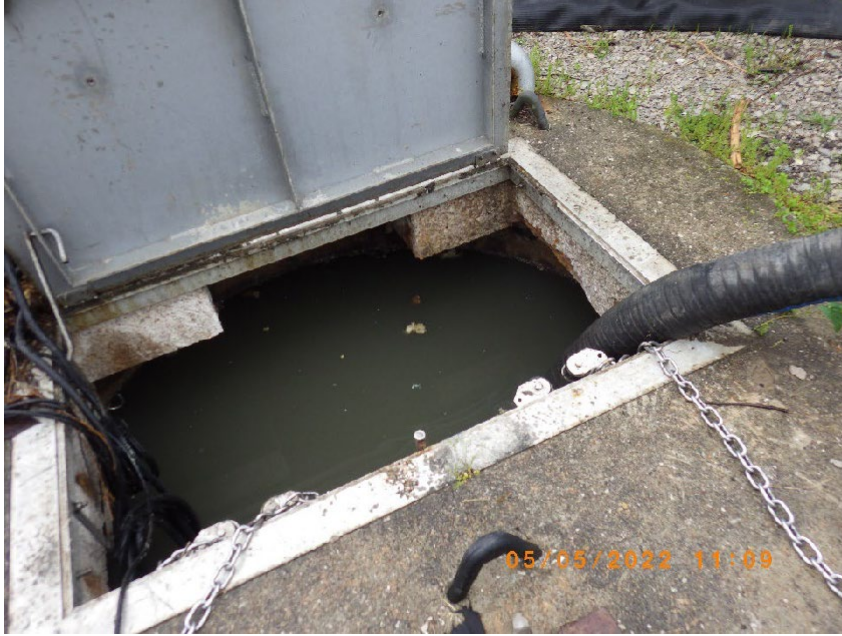
4: BELL0004

Description: The wet well at the Golden and Dorsey lift station was almost full.

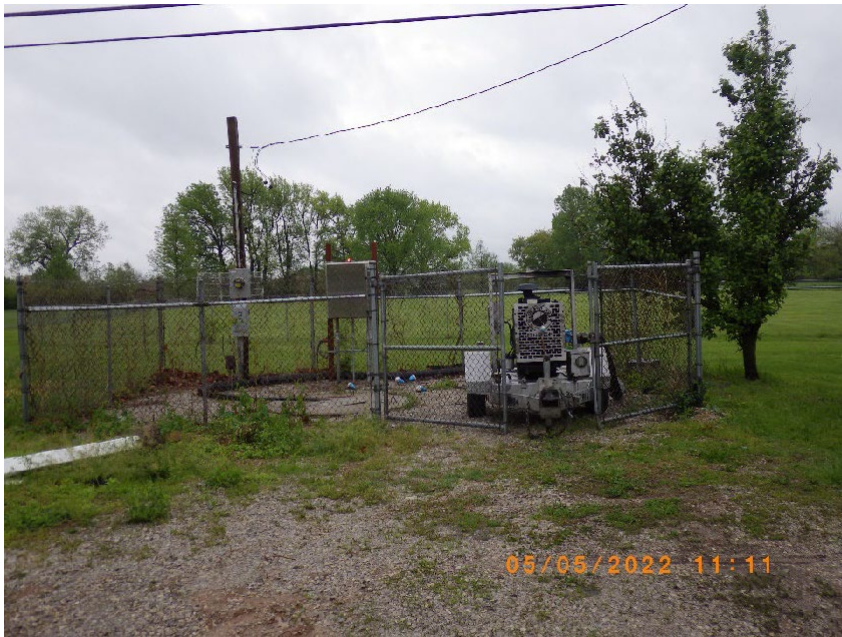
5: BELL0005

Description: A tow behind pump was parked at the Golden and Dorsey lift station. City personnel manually turn it on to dewater the wet well.

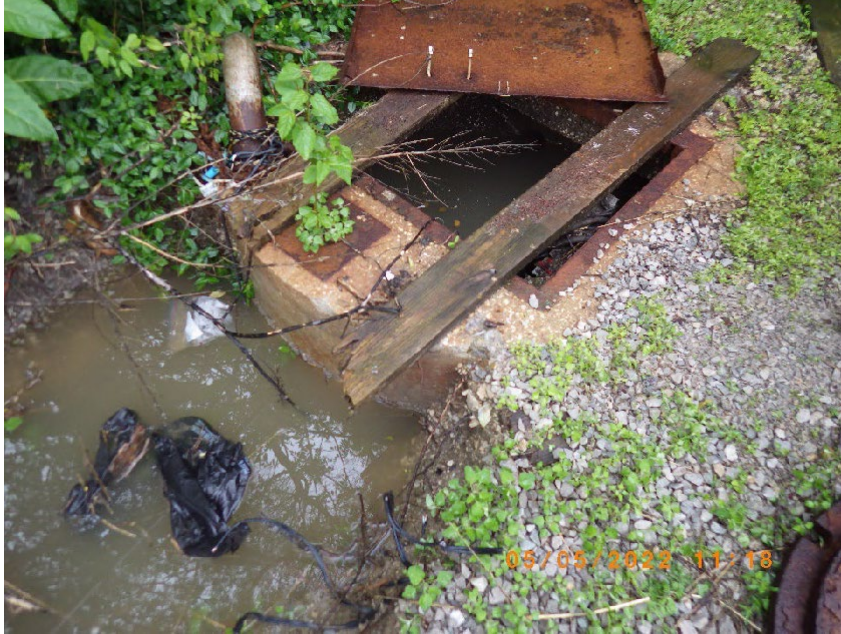
6: BELL0006

Description: The wet well at the Pocket Road lift station was approximately 90% full.

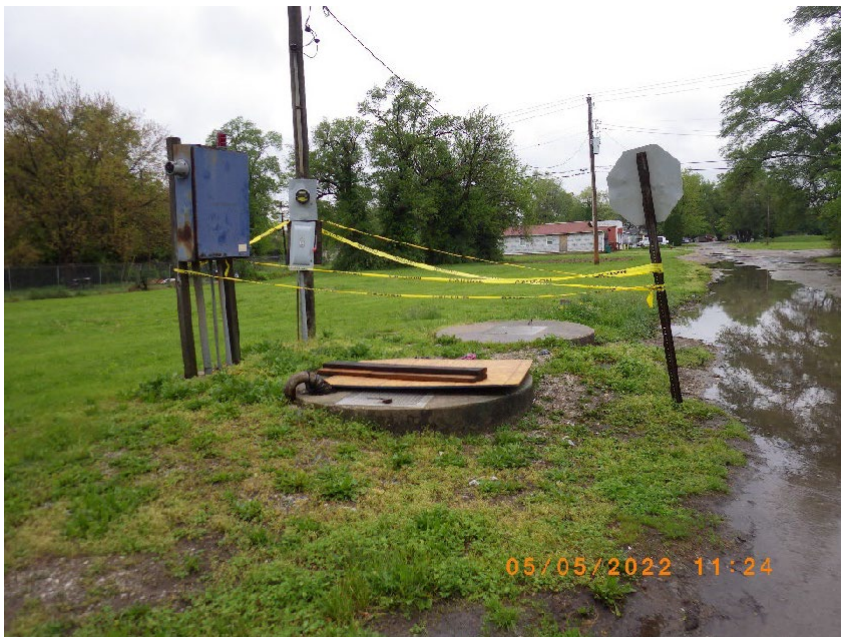
7: BELL0007

Description: Jackson Street lift station is non-functioning and needs to be manually dewatered by City personnel.

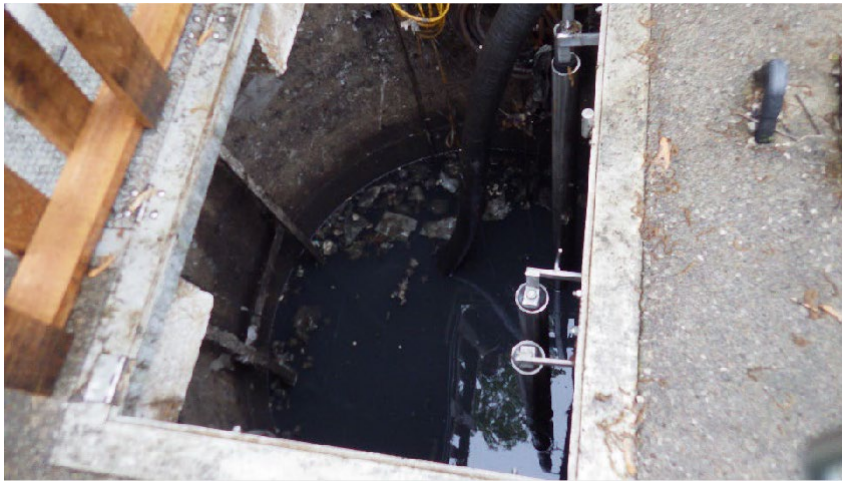
8: BELL0008

Description: The Pfeffer Street wet well level was low on the day of the inspection.

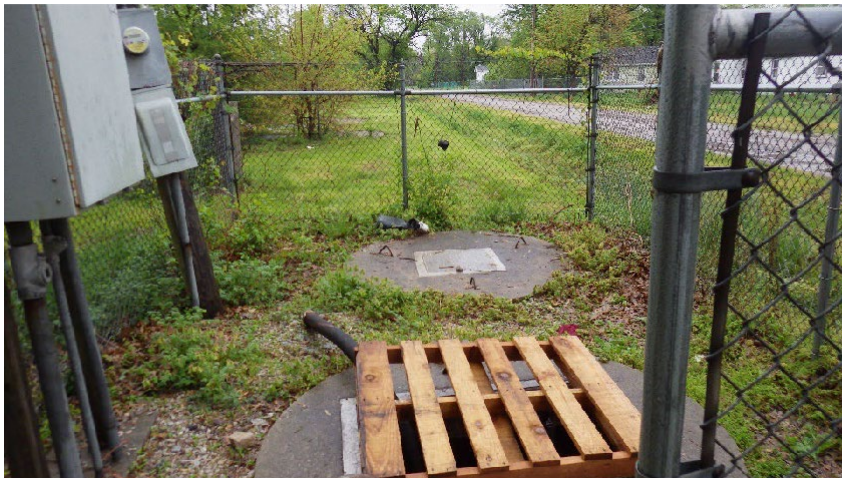
9: BELL0009

Description: An overview of the Pfeffer Street Lift Station.

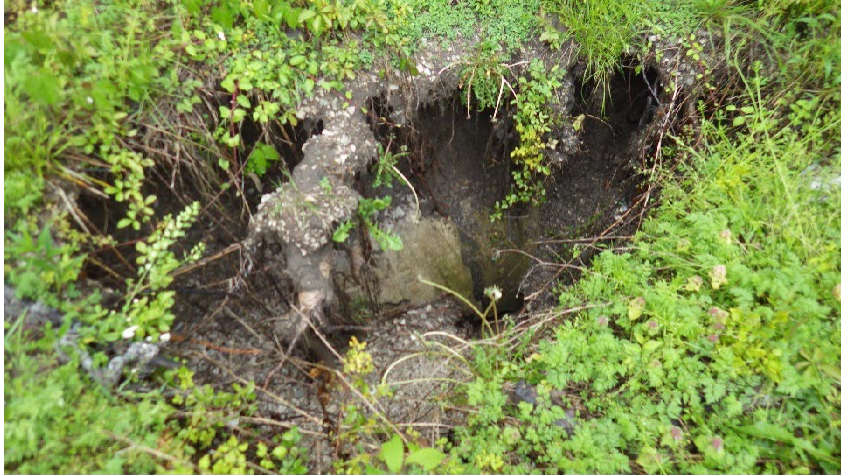
10: BELL0010

Description: Open erosional hole by a storm water pipe near the Diversion Station. There is a crack in the pipe that was first observed by EPA in April, 2022.
