Subject: May 25, 2022 Reconnaissance Inspection Report for Cleveland-Cliffs Burns Harbor, NPDES Permit Number IN0000175

**CWA COMPLIANCE EVALUATION INSPECTION REPORT  
U.S. ENVIRONMENTAL PROTECTION AGENCY, REGION 5**

Cleveland Cliffs Burns Harbor, LLC  
250 US-12  
Burns Harbor, Indiana 46304  
Porter County  
41.625, -87.117

IN0000175

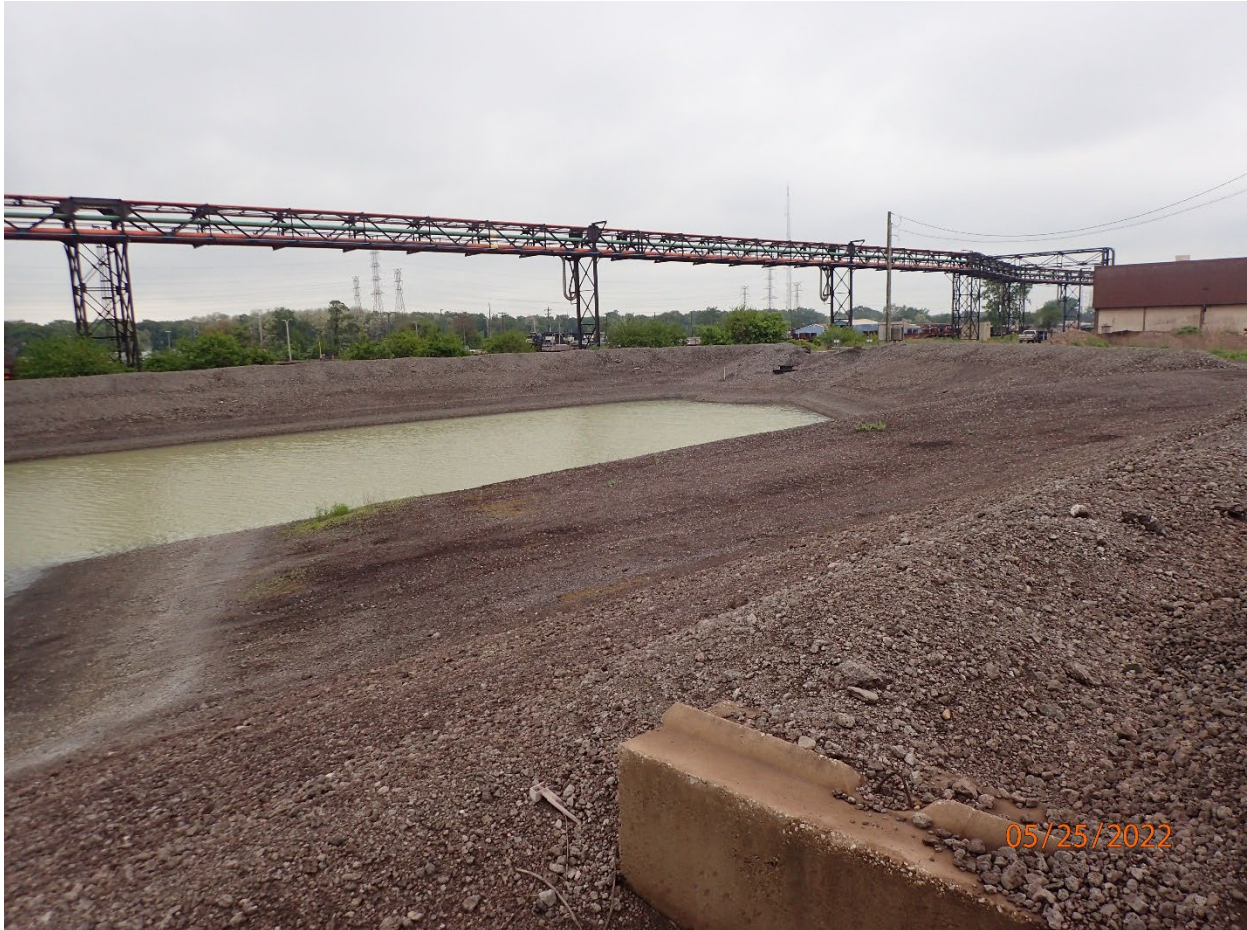
1: P5250254

EPA and IDEM arrived at the Deerfield Pond at 11:14 A.M. The pond was holding 61” of water. A pressure sensor on the pump measures the head to determine the depth of the water in the pond.

Description: The Deerfield Pond is holding 61" of water.

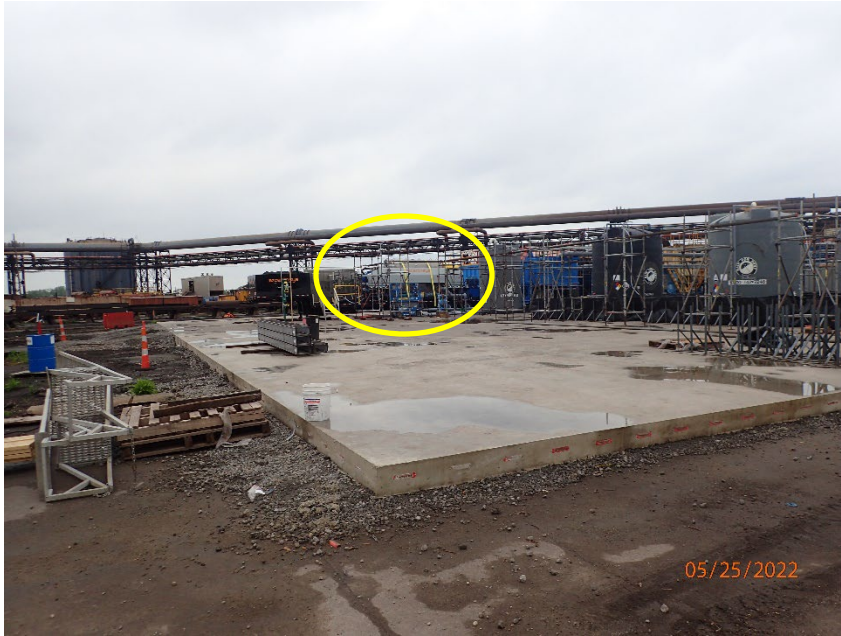
2: P5250255

EPA and IDEM arrived at the Ammonia Treatment System at 11:30 A.M. Previously, dewatering boxes were used to dewater the solids from the clarifiers. Now there are centrifuges. The centrifuges remove the calcium and iron.

Description: The centrifuges (circled with a yellow circle) at the Ammonia Treatment System are used to dewater the solids from the clarifiers.

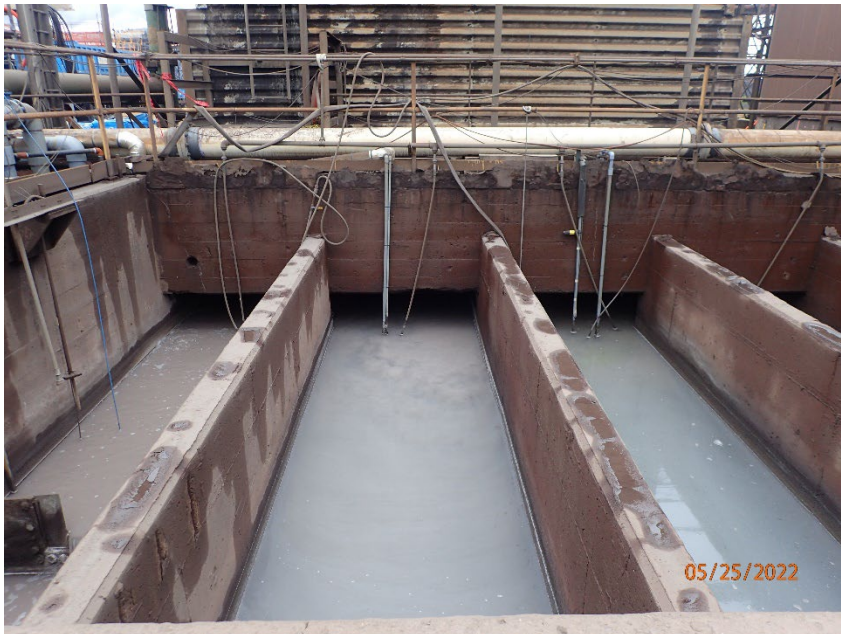
3: P5250256

Description: Cell #4, the last cell for the blowdown before it goes to the SWTP.

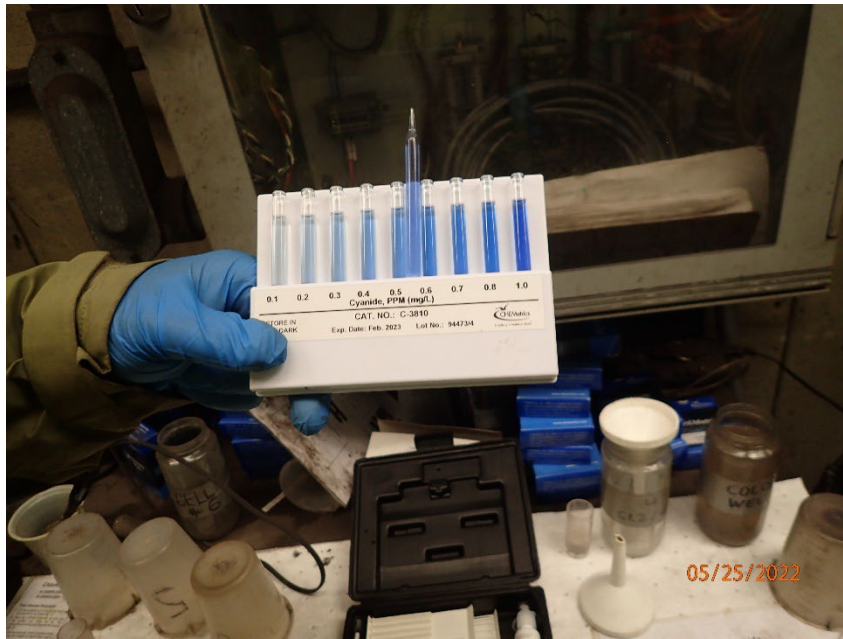
4: P5250257

EPA and IDEM observed Mr. Gorman take a sample from the cold well at 11:59 A.M. Mr. Gorman pulled the sample and performed the procedures to test for cyanide. After 15 minutes of waiting, Mr. Gorman used the colorimeter to estimate that the cyanide level was 0.6 ppm.

Description: Sample vial is compared with colorimeter tubes. Sample taken during the inspection appeared to show 0.6 mg/L of cyanide.

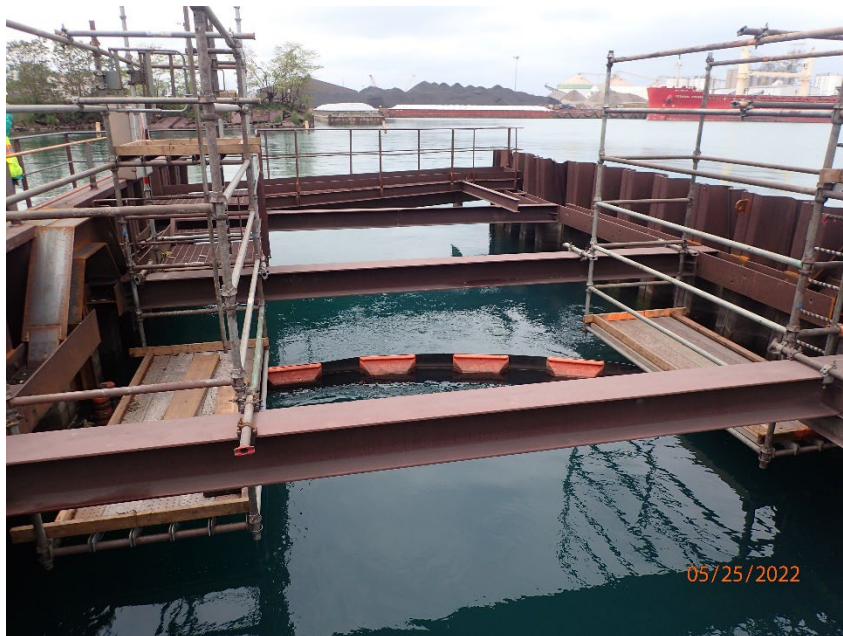
5: P5250258

The inspectors followed the facility personnel to Outfall 002 and arrived at 12:35 P.M. There was no foam, sheen, or odor in the water in the outfall on the day of the inspection. EPA observed the boom moved into the outfall structure.

Description: The boom has been moved inside the Outfall 002 structure.

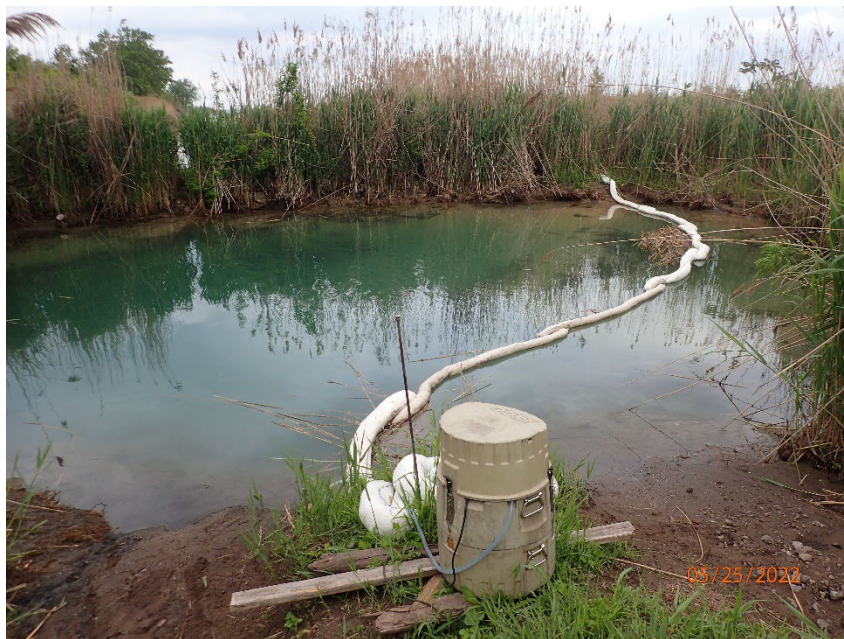
6: P5250259

The inspectors followed the facility personnel to Outfall 003 and arrived at 12:58 P.M. EPA observed a small amount of substance on the surface to the right of the boom. There was no rainbow effect in this substance and no odor on the day of the inspection.

Description: There was a substance on the surface to the right of the boom at Outfall 003.

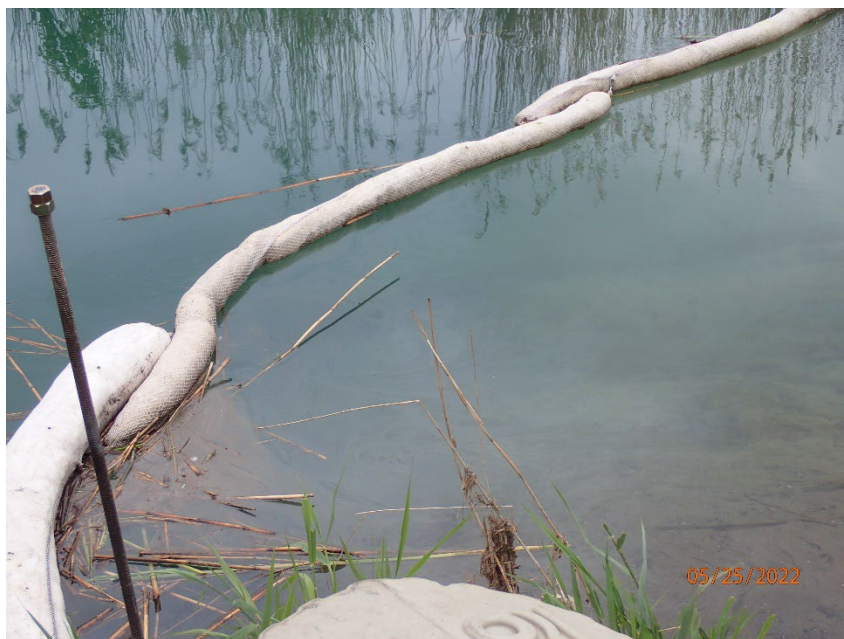
7: P5250260

Description: The substance at Outfall 003 is piled up at the boom and a small amount is swirled in the water.

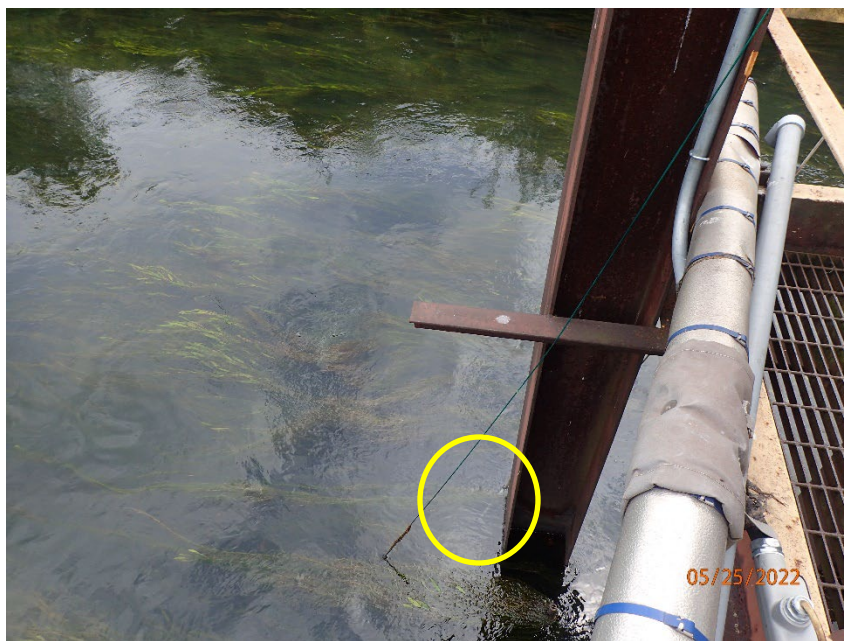
8: P5250261

The inspection team arrived at Outfall 011 with the facility personnel at 1:41 P.M. EPA and IDEM inspectors observed the composite sampler. The temperature on the display of the sampler was 3.4°C, and the inside temperature, as read from a thermometer in water, was 3.5°C. The refrigerator where samples are kept was 0.5°C. The inspectors noted that the tubing for the composite sampler was changed every quarter. The last four tubing changes were March 2, 2022, December 2, 2021, October 20, 2021, and August 30, 2021. The tube was not discolored on the day of the inspection, but the intake end of the tube was caught in the stream vegetation. The water by Outfall 011 was clear on the day of the inspection.

Description: The intake end of the composite sampler tube is entangled with the stream vegetation (circled with a yellow circle).

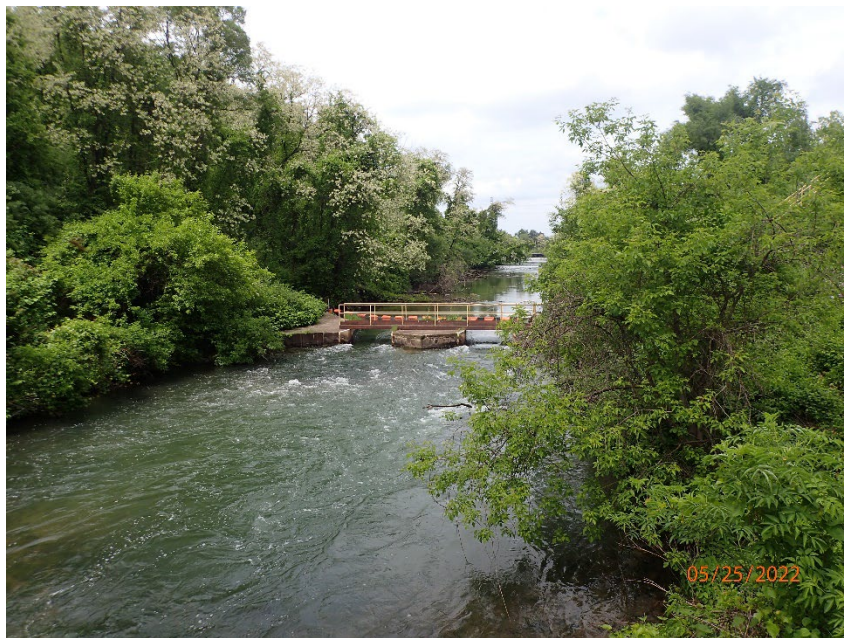
9: P5250262

At 2:02 P.M., the inspection team arrived at Outfall 001. EPA did not observe a sheen in the receiving waterbody. EPA observed that the temperature in the auto-sampler was 1°C while the display read 0.3°C. EPA observed the readings for the stream temperature (67.6°F) and pH (8.22). The inspectors noted that the tubing for the composite sampler was changed every quarter. The last four tubing changes were March 2, 2022, November 30, 2021, October 21, 2021, and August 30, 2021. The tube was not discolored on the day of the inspection.

Description: Looking upstream from the sample location for Outfall 001.
