Subject: June 23, 2022 Reconnaissance Inspection Report for Cleveland-Cliffs Burns Harbor, NPDES Permit Number IN0000175

**CWA COMPLIANCE EVALUATION INSPECTION REPORT
U.S. ENVIRONMENTAL PROTECTION AGENCY, REGION 5**

Cleveland Cliffs Burns Harbor, LLC
250 US-12
Burns Harbor, Indiana 46304
Porter County
41.625, -87.117

IN0000175

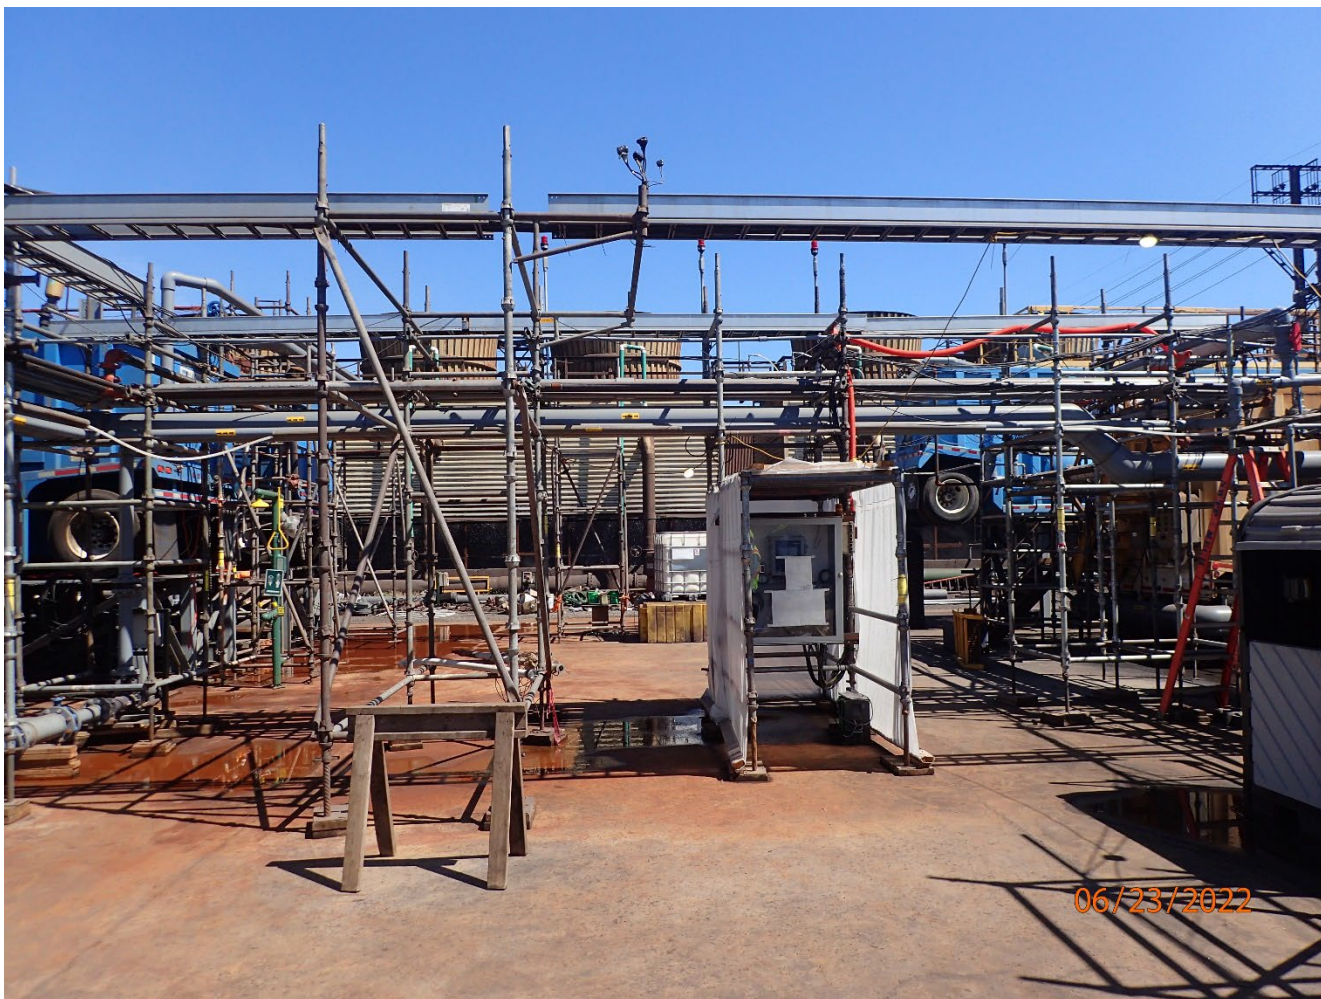
1: P6230263

Description: The new Ammonia Treatment consists of a series of tanks where chlorine dioxide can be introduced to destruct cyanide, lower or raise pH and add flocculent to precipitate solids, before flowing over cooling towers to remove ammonia. The final stages of the treatment allow for additional pH adjustment and additional cyanide removal.

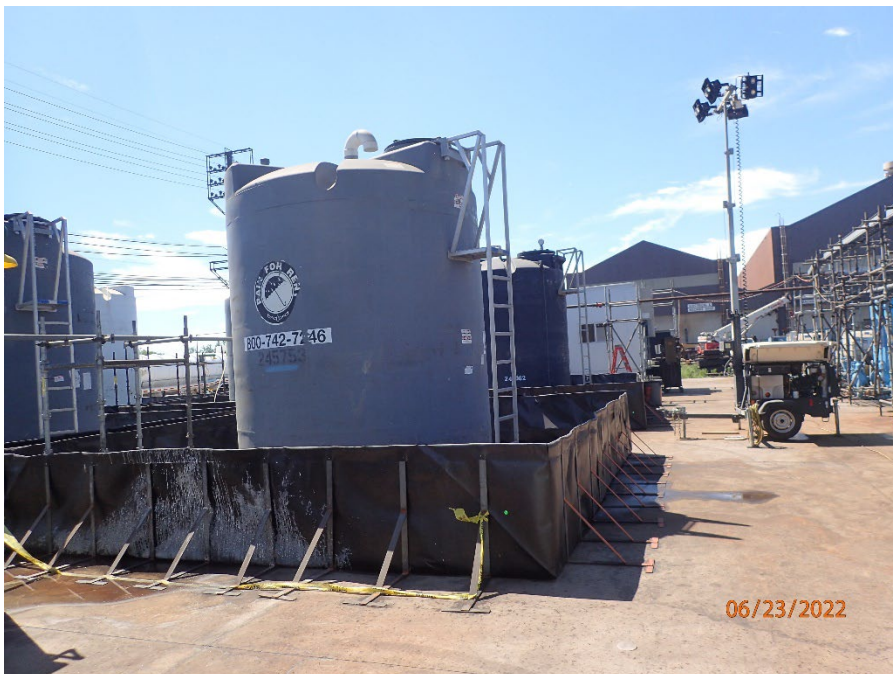
2: P6230264

Description: Hydrochloride and sulfuric acid tanks have secondary containment.

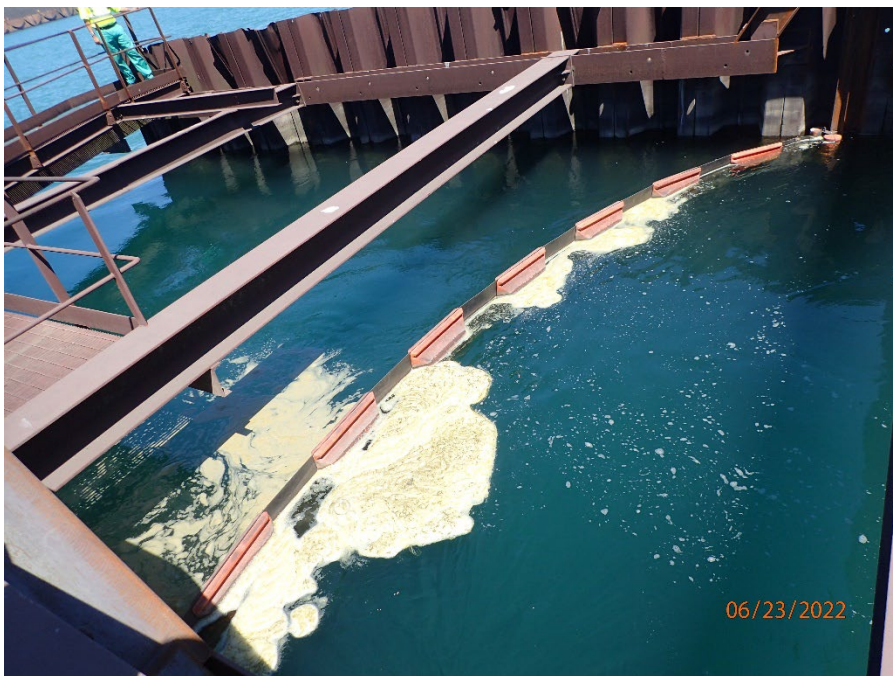
3: P6230265

The inspectors followed the facility personnel to Outfall 002 and arrived at 11:01 A.M. On the day of the inspection there was foam by the outfall wall and smaller amounts at the boom within the outfall structure. There was foam on the outside of the boom, but that foam appeared to be different than the foam inside the boom.

- A. Foam was observed inside and outside the boom of Outfall 002.
- B. In a comparison between the SWPPP Annual Review and the list of CPARs, the SWPPP Annual Review lists a CPAR 600 for deficiencies with the Storm Ditch booms located near the Plate Mill. This CPAR is not in the spreadsheet list of CPARs.

Description: There was foam on the boom inside the Outfall 002 structure on the day of the inspection.

Facility personnel stated that they observe this outfall every day and they will send a vac truck to suck out the foam from the outfall. They stated that they would send photos after removing the foam.

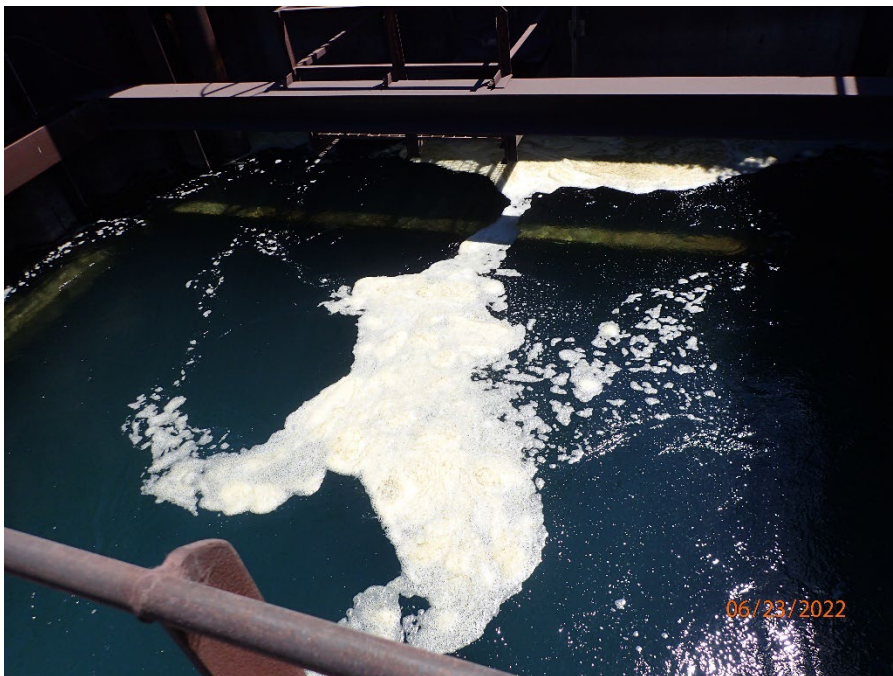
4: P6230266

Description: The flow from Outfall 002 is below the water surface. There was foam along the outfall wall and within the boom on the day of the inspection.

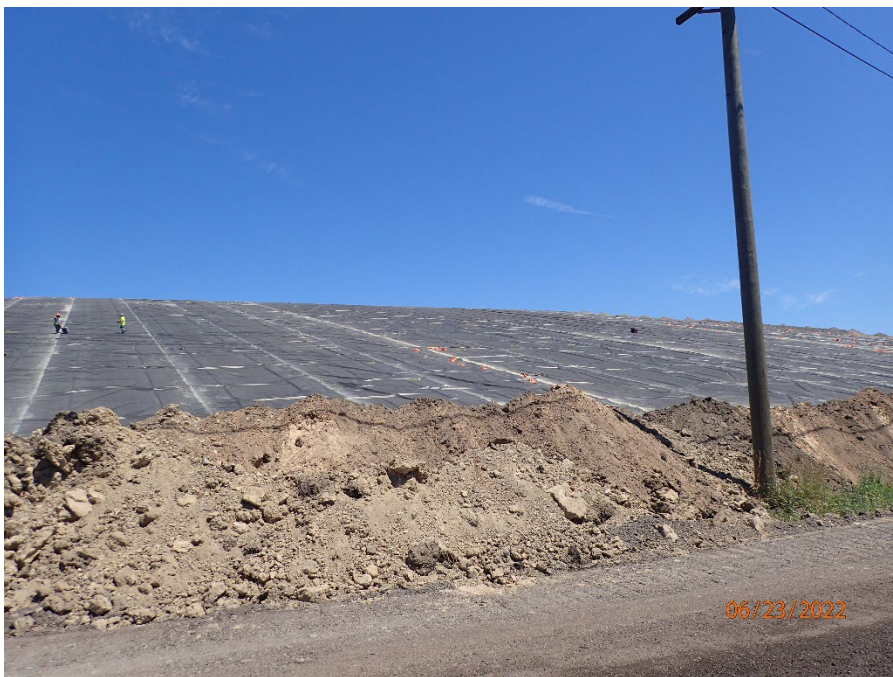
5: P6230267

Description: The cap for Phase 1 of the Deerfield Landfill is being installed.

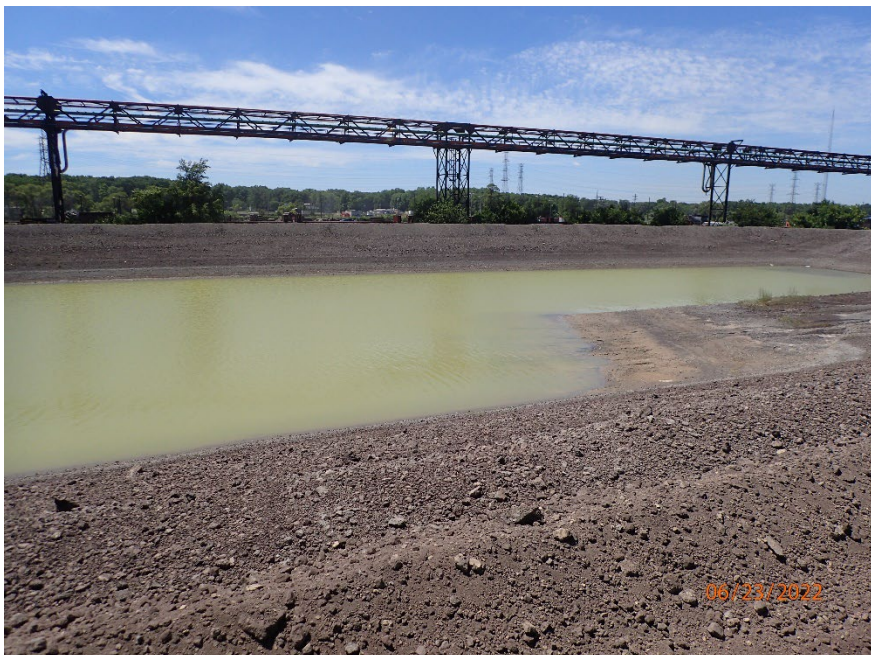
6: P6230268

EPA and IDEM arrived at the Deerfield Pond at 11:40 A.M. The pond was holding 48" of water. The inspection team observed workers applying the cap to the Deerfield Landfill. The inspectors also noted that the water in the pond was a sandy color. The facility personnel stated that there was runoff from the tan clay that went on top of the landfill before the polyurethane cap.

Description: The water in the Deerfield Pond was very sandy colored on the day of the inspection. Facility representatives stated that runoff from the clay that went on the landfill caused the discoloration.

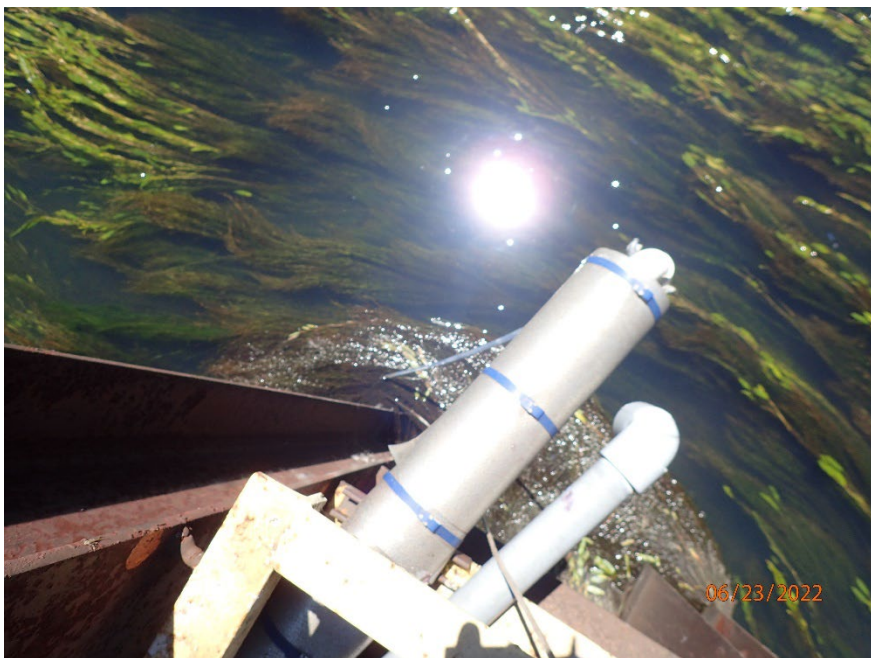
7: P6230269

EPA and IDEM inspectors observed the composite sampler. The temperature on the inside, as read from a thermometer in water, was 4.0°C. The tubing was last changed on June 1, 2022. The tube was not discolored on the day of the inspection, but the intake end of the tube was caught in the stream vegetation. The water by Outfall 011 was clear on the day of the inspection.

Description: The sample tube for the composite sampler at Outfall 011 was caught in the vegetation of the stream.
