## Third Party Assessment Final Presentation Meeting (100%)

# RED HILL - ASSESSMENT

FINAL ASSESSMENT PRESENTATION - 100%

## RED HILL UNDERGROUND STORAGE TANK FACILITY ASSESSMENT

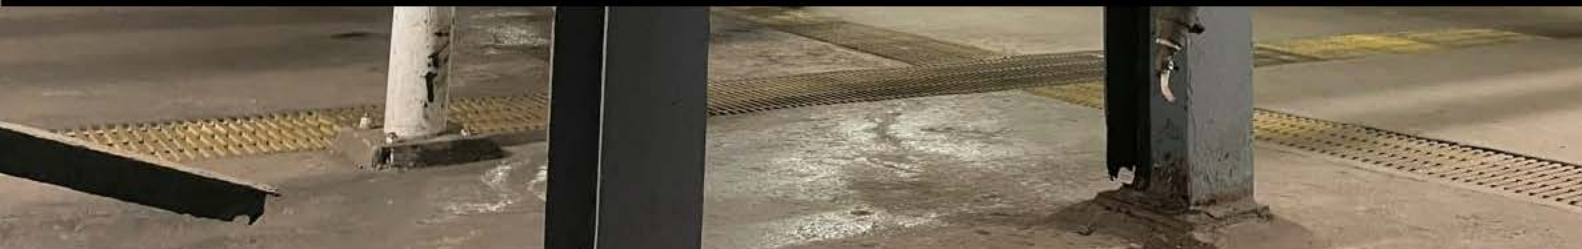
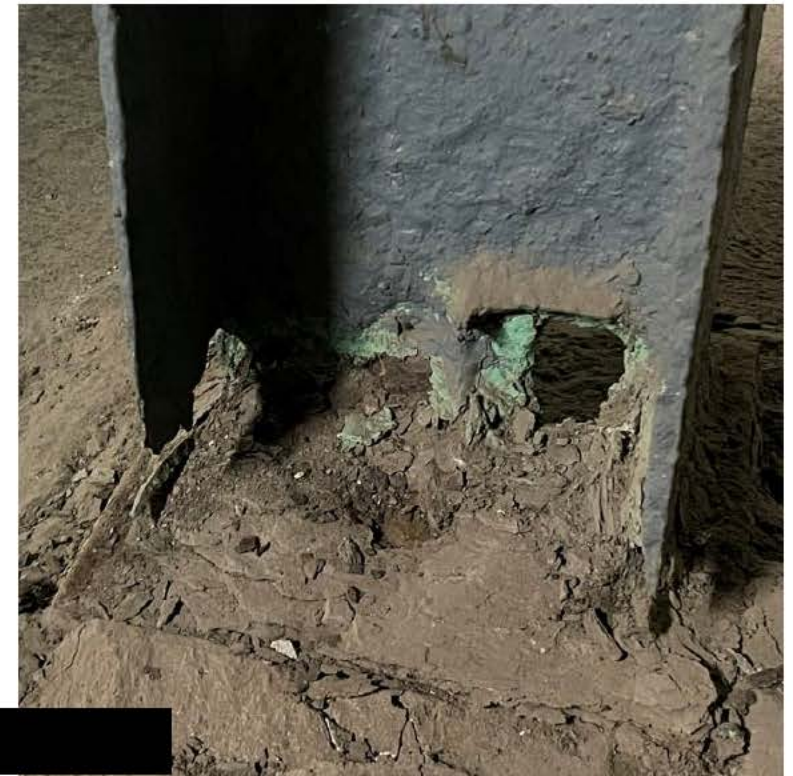
### Significantly Corroded Pipe Supports and Braces

- Supports 47 and 48 near Tanks 9/10
- Evaluated adequacy of heavy valve support and developed retrofit design

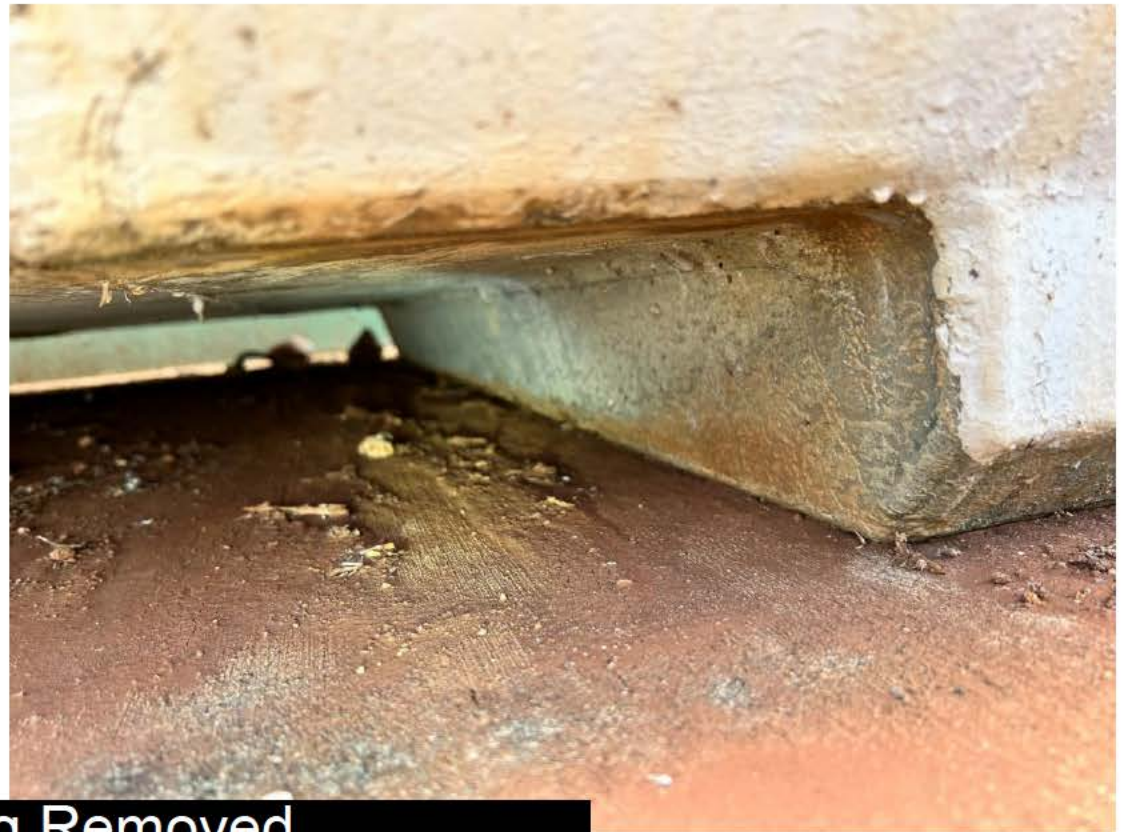
### Pumphouse - Diesel Tank for Emergency Generator

- No apparent anchorage between tank and foundation; retrofit required

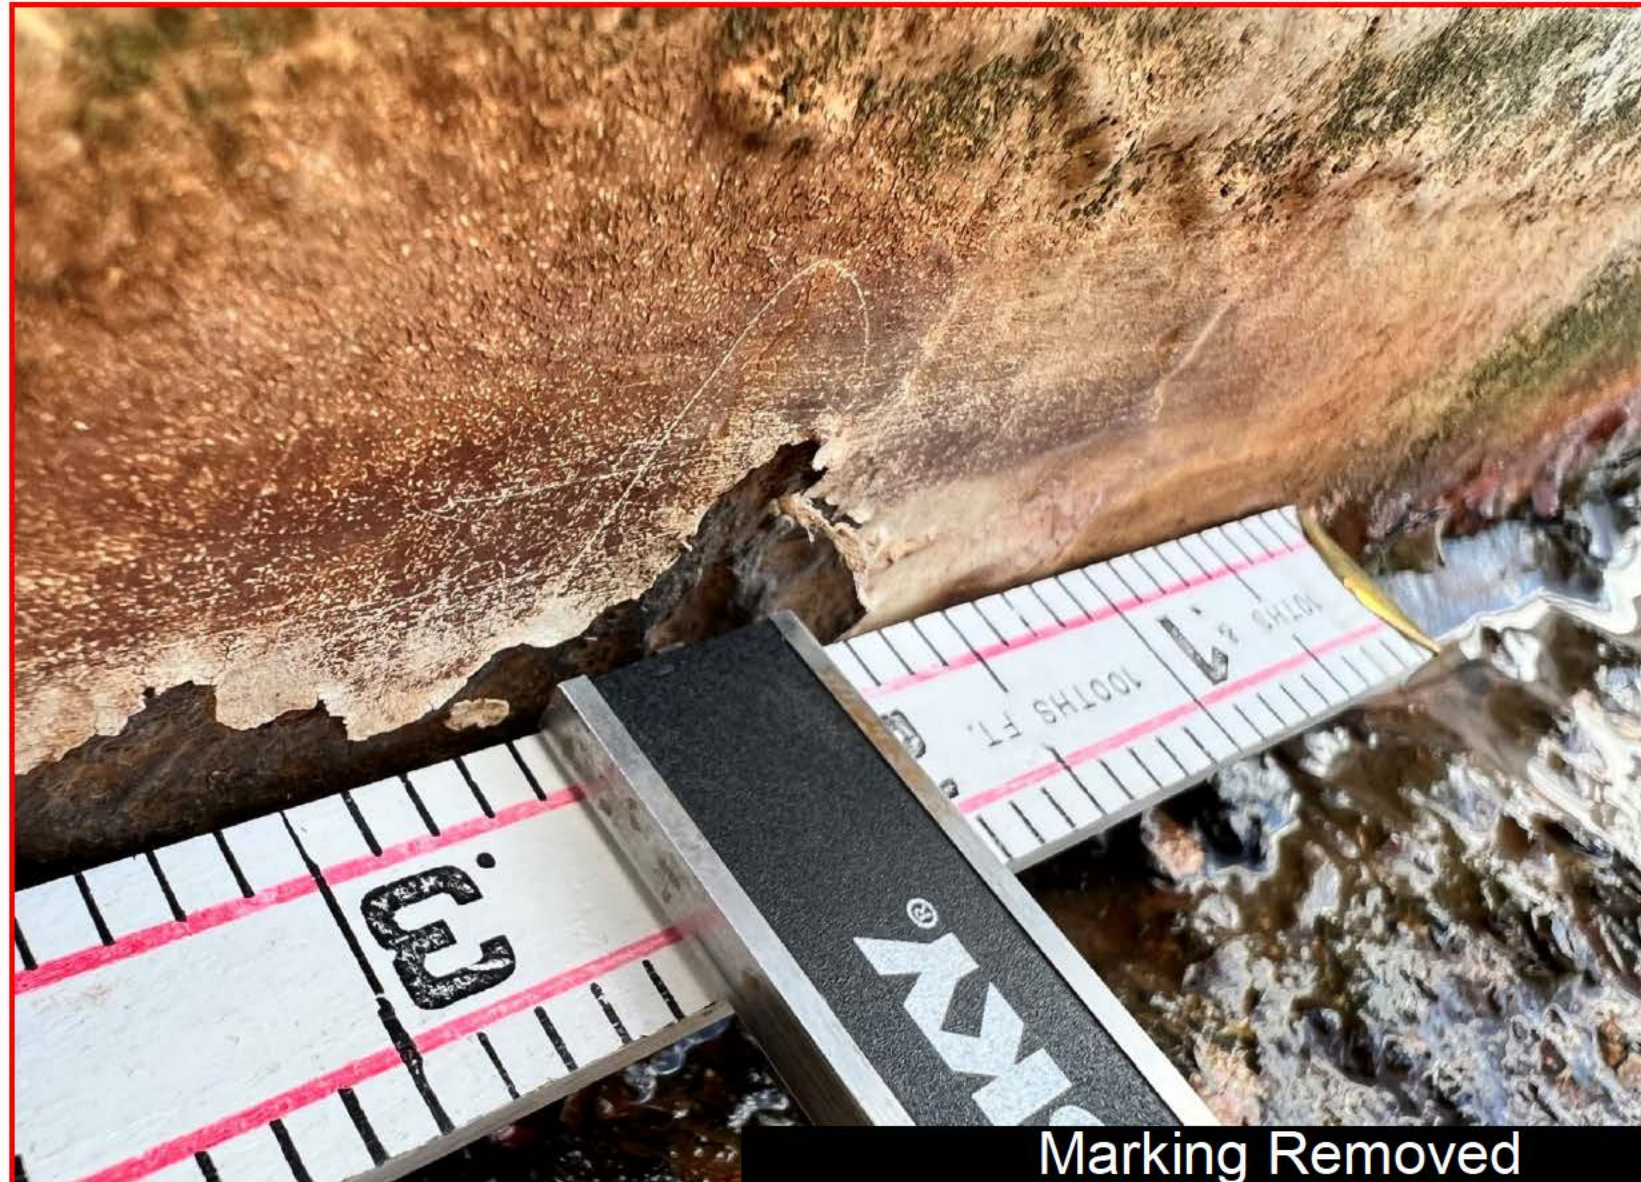
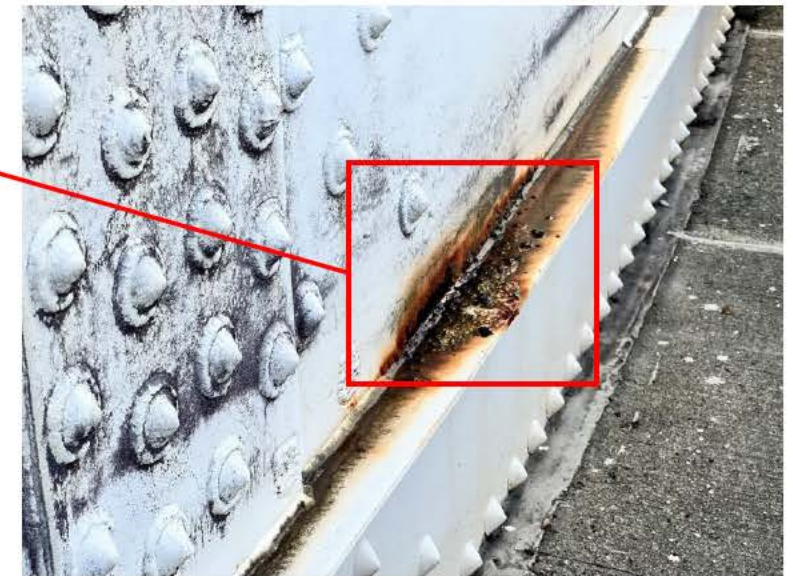
### Tank 47, Upper Tank Farm

- Measured pit depth at surface corrosion location on new tank double bottom annular ring

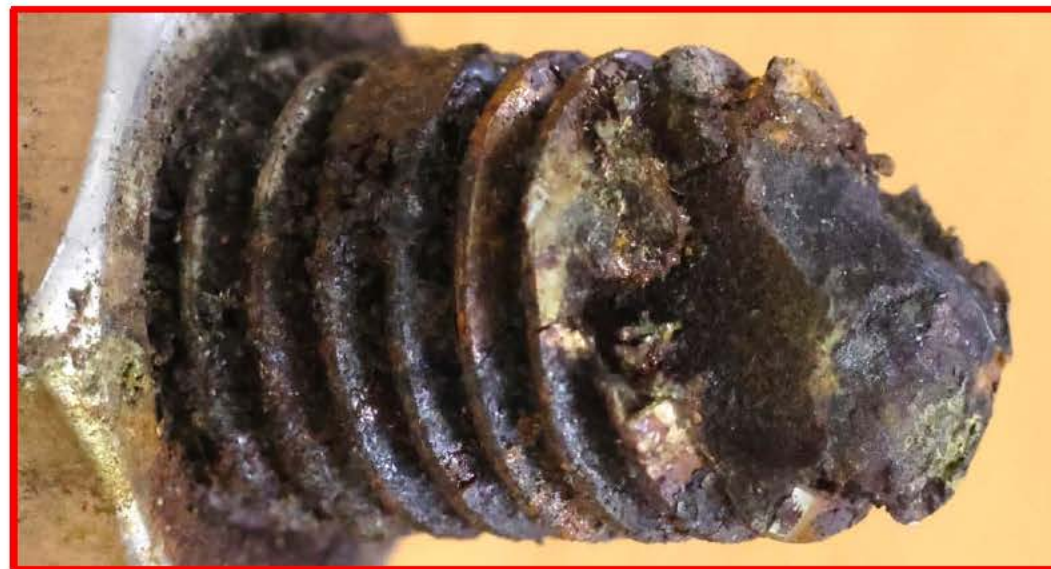
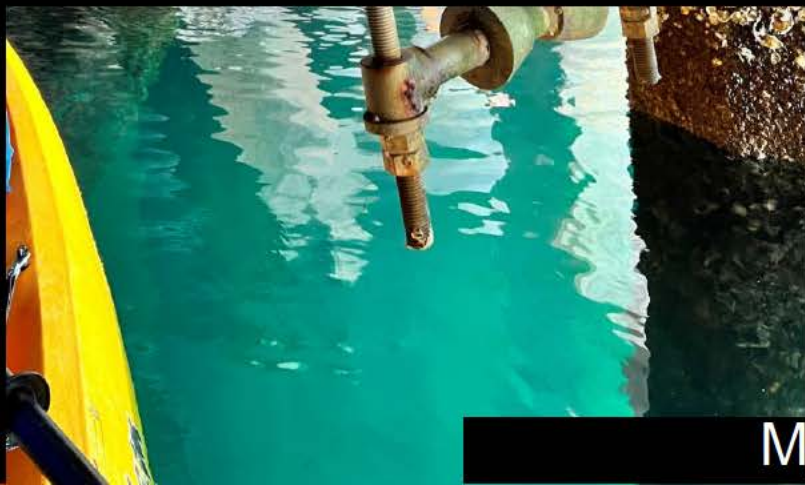
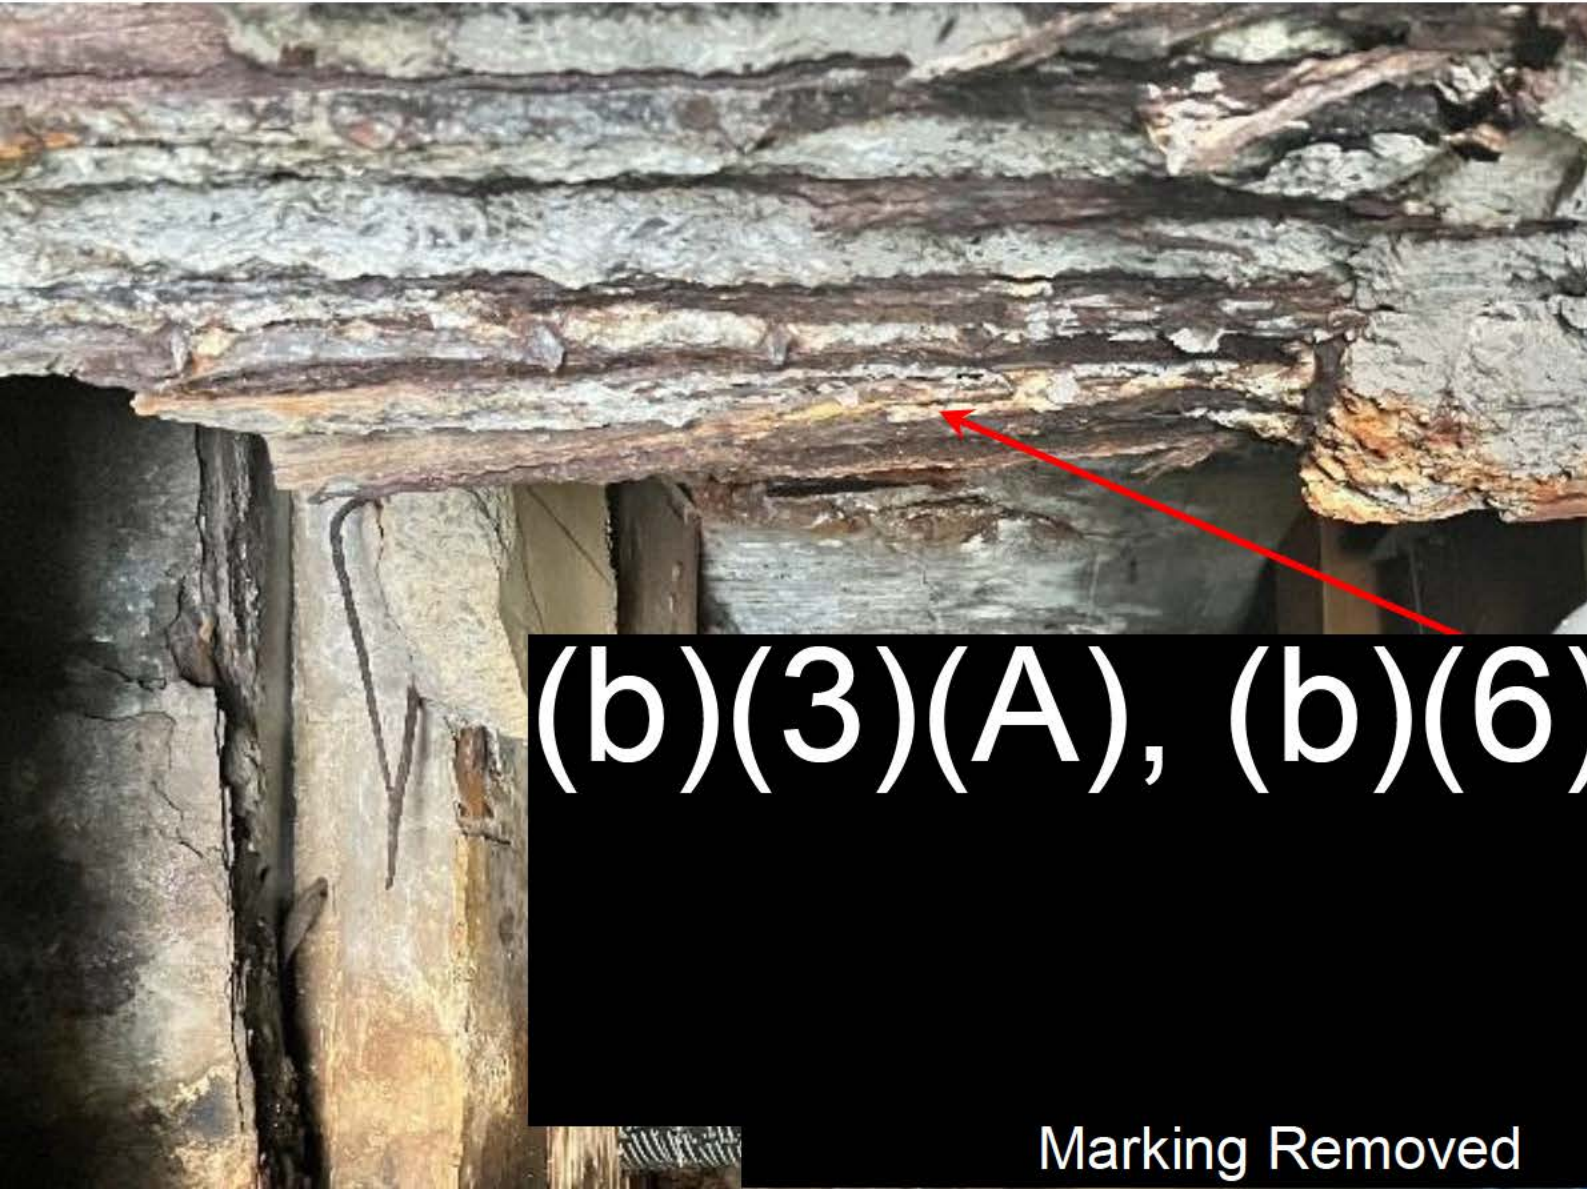
### Kilo Pier

- Missing fuel pipe support anchor bolts
  - Increases unsupported length, increases demand on remaining anchor bolts
  - Probable stress corrosion cracking

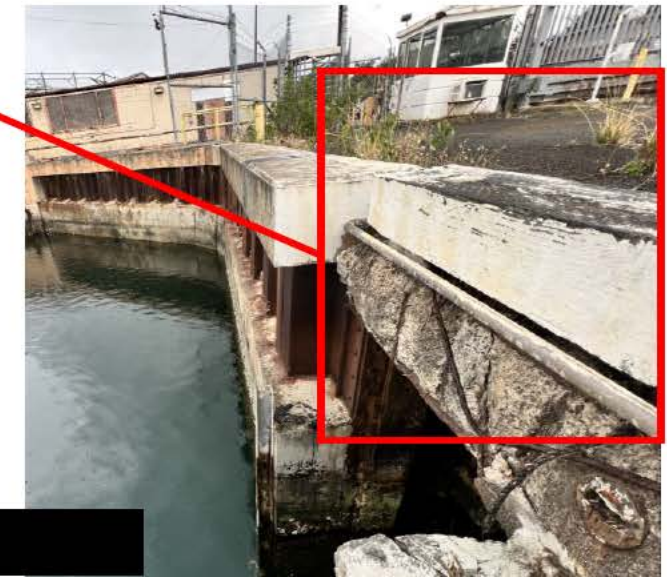
### Mike Dock – Deck

- End of Mike Dock (b)(3)(A)
- Exposed and corroding reinforcing bars on the underside of the deck reduces the deck capacity to withstand heavy loads

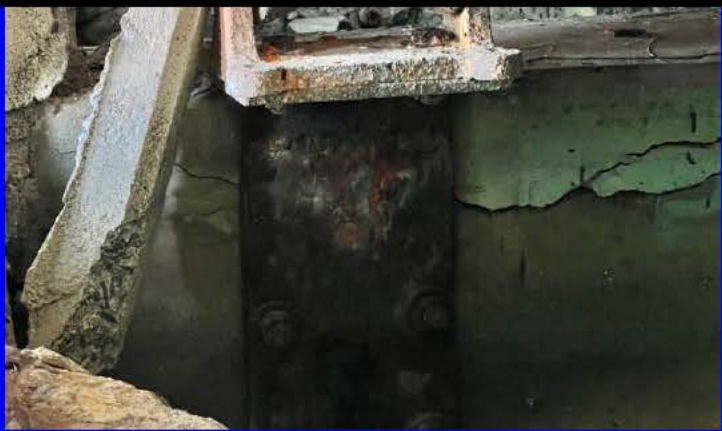
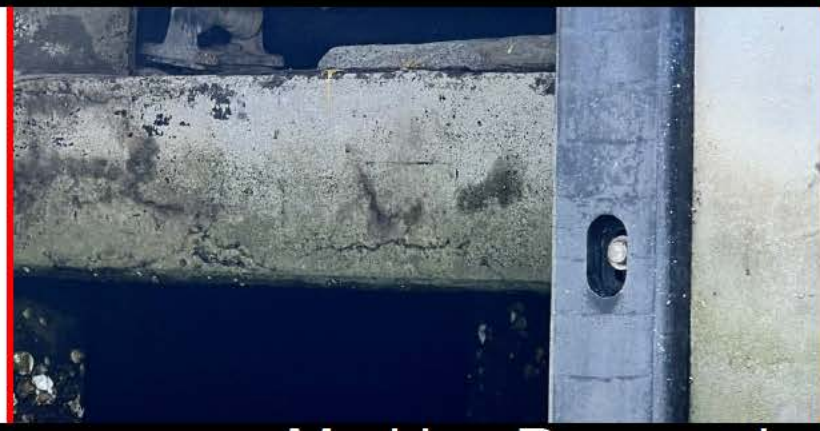
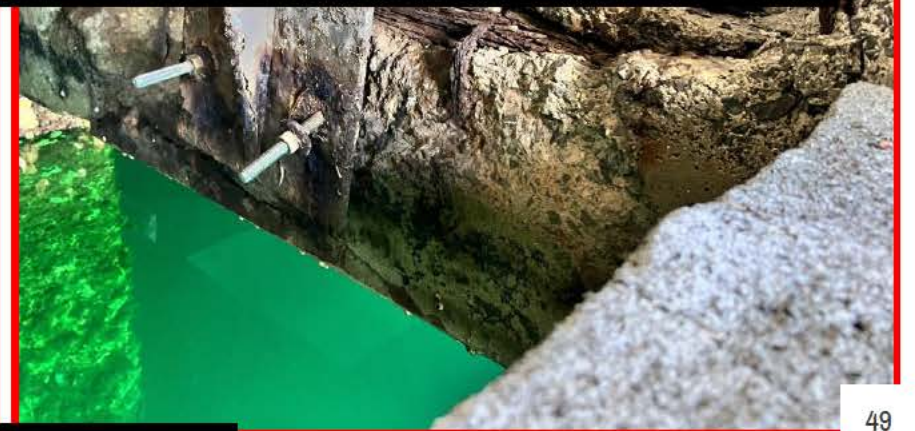
## Mike Dock – Pipe Supports

- Missing roller supports, uneven roller supports, damaged support beam, failed coating, exposed reinforcing on pipe support beam

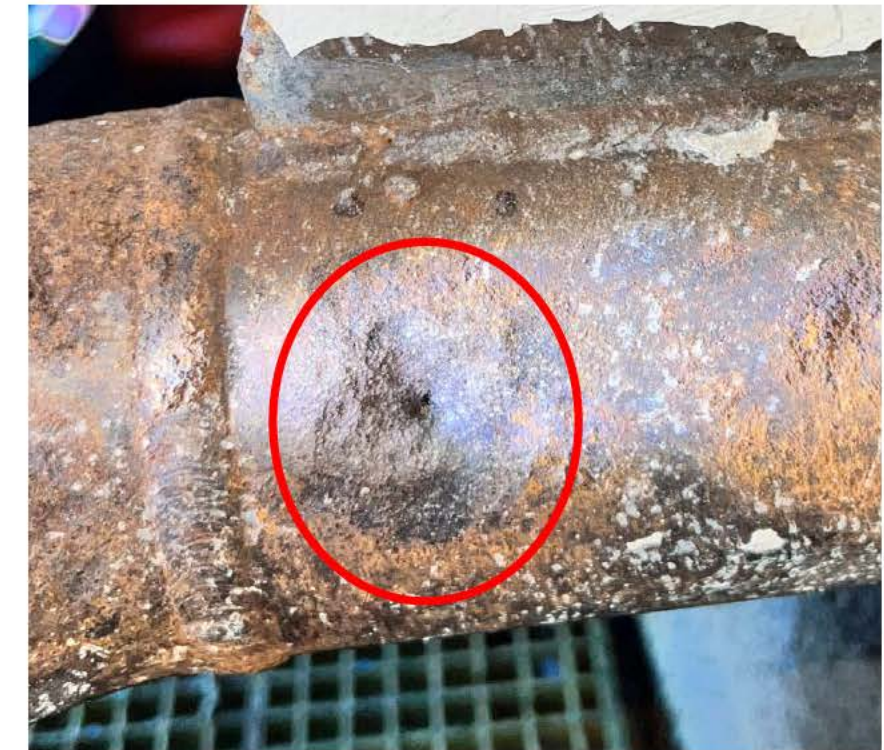
### Bravo Dock – Riser Pipe

- Corrosion and pitting observed on riser pipe and low-point-drain pipe, extending from fuel pipe

- All measured corrosion pits passed the Level 1 assessment, apart from:
  - The pit in the riser of Bravo Pier, which had penetrated through 93% of the wall thickness
  - The two pits in the HT **(b)(3)(A)** diameter F-76 line also failed by a small margin
- We then reassessed using a Level II approach. The Harbor Tunnel pipe passed this assessment.

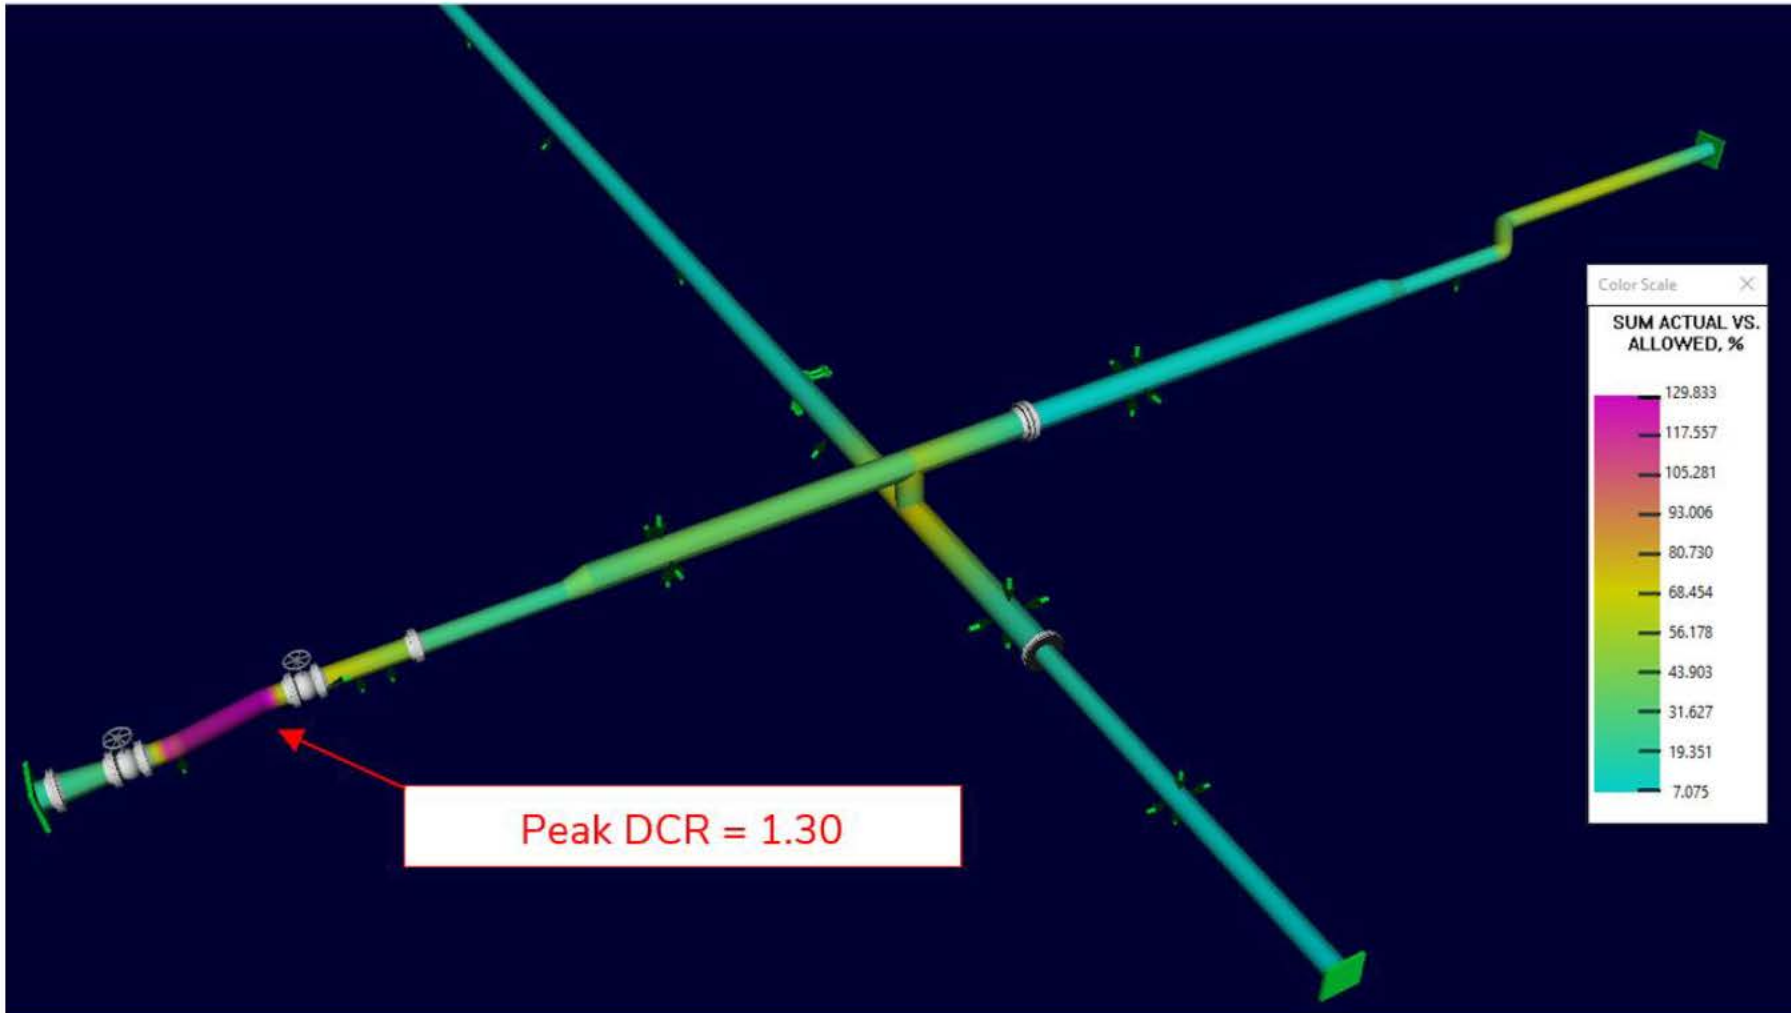
## Surge Load Applied to Tank 20 Ball Valve

Based on our evaluation, piping with bends at the tank entrances is susceptible to potential overstress due to surge loads.

We recommend further investigation to determine the extent of the issue and potential mitigation for all tanks.
