Ready for Reuse Basis of Decision Former FJ Doyle Salvage Transformers Facility EPA ID TXD980865109 Leonard, Fannin County, Texas

The United States Environmental Protection Agency (EPA) Region 6 has determined that the former FJ Doyle Salvage Transformers Facility, located at 905 North Poplar Street in Leonard, Texas (the "Property") is Ready for Reuse. The Property meets the criteria for the Ready for Reuse Determination since conditions on the Property are protective of human health and the environment, based on its current and future use, consistent with the deed notice filed in the Real Property Records in the Fannin County Clerk's Office.

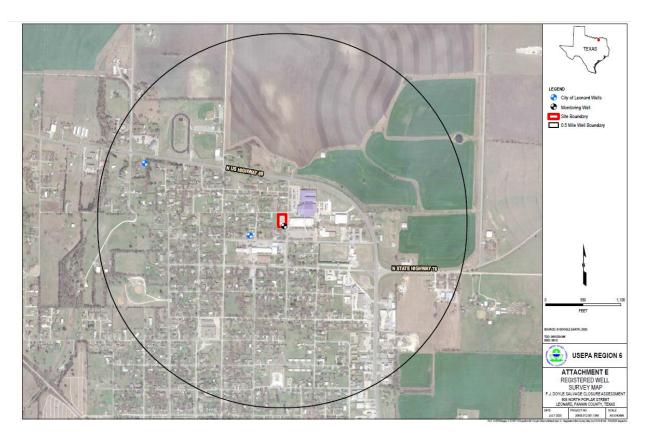
Figure 4: Locations of the two identified public water supply wells for the City of Leonard taken from F.J Doyle Salvage Closure Assessment (TDD No. 0001/20-346).

Weston Solutions found the two registered City of Leonard public water supply groundwater wells within 0.5 miles of the site (see Figure 4). As stated above, both registered wells were tapped into the Woodbine Formation around 1,464 feet below ground surface. Because the two public water supply wells are 1,464 ft below ground surface and are securely cemented, there is low permeability of the formations underlying the site, and PCBs are relatively insoluble in water and not likely mobilized, Weston concluded that PCBs were unlikely to contaminate the groundwater supply of the City of Leonard.

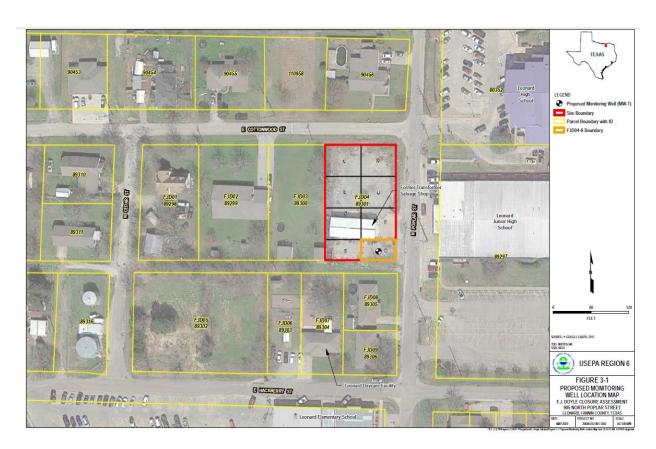
Figure 5: Location of the site-specific groundwater monitoring well that was installed and subsequently plugged and abandoned. Taken from F.J Doyle Salvage Closure (Assessment TDD No. 0001/20-346).

Weston identified no unregistered groundwater wells within the survey area during this assessment. In June 2020, Weston installed a groundwater monitoring well 32 feet below ground surface at the site. Groundwater was not observed in the monitoring well during any of the

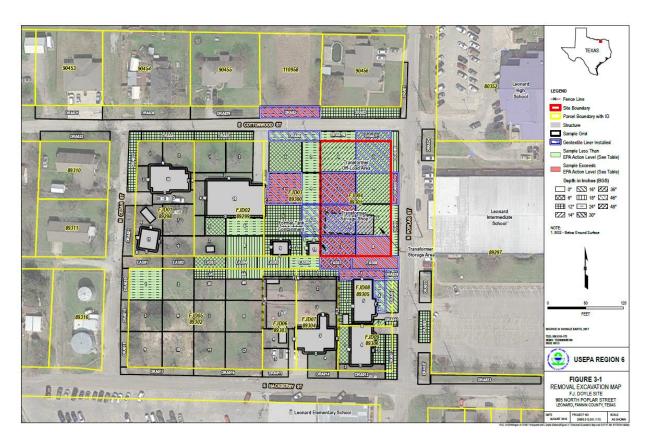
Figure 6: Removal excavation map depicting the grids where excavation activities ensued including depth, the sampled grids, and the location of the highly visible orange protection barrier remaining in the ground. Taken from the F.J Doyle Salvage Site Removal Action Report (TDD No. 0001/18-175).

Most of the contaminated soil has been removed from the site. The remaining contaminated soil lies below the ground surface underneath a highly visible orange warning barrier that is, itself, covered with clean soil. The locations of the orange warning barrier underneath sections of the Property can be found in Figure 6. PCB concentrations in soils that could not be removed and are covered by the orange warning barrier range from 0.0 ppm to 32 ppm.

If excavation of contaminated soils could not be completed due to hitting bedrock or the presence of underground utilities, a highly visible, orange warning barrier was placed directly above the soil still exceeding cleanup goals to protect both human contact and the above clean soil from coming into contact with the contaminated soil (see Figure 6). PCB concentrations that remain covered under the orange warning barrier range from 0.0 ppm to 32 ppm. Activities completed by EPA at the FJ Doyle site included:

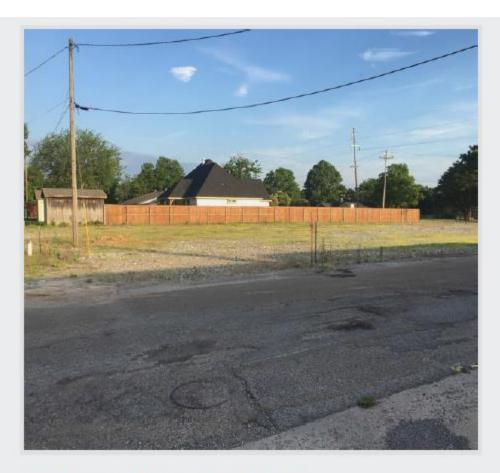
Figure 8: Photograph of current site conditions taken from F.J Doyle Salvage Closure Assessment (TDD No. 0001/20-346).

The site currently has no buildings or structures. It has gravel overlying most of the surface, with patches of vegetation and a wooden fence separating a residential property from the site on the western side of the Property. There are property markers located on all corners of the site. As stated above, a plugged and abandoned well is located in the southeast corner of the site (see Figure 10). Additional photos of current site conditions are provided at Figures 8 and 9.

Longitude: -96.242880 Photographer: Austin Lindsey Witness: Derrick Cobb Caption: View of site.

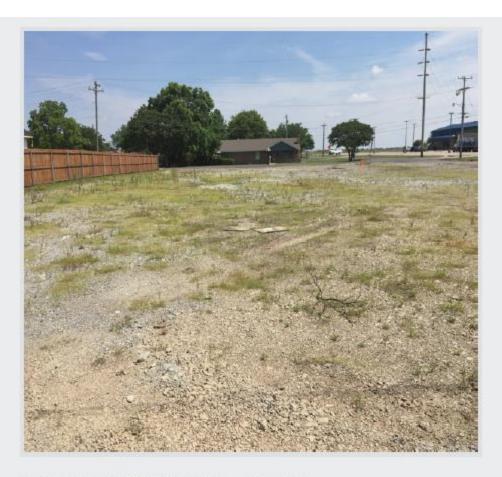
Figure 9: Photograph of current site conditions taken from F.J Doyle Salvage Closure Assessment (TDD No. 0001/20-346).

Longitude: -96.243155 Photographer: Austin Lindsey Witness: Derrick Cobb Caption: View of site.

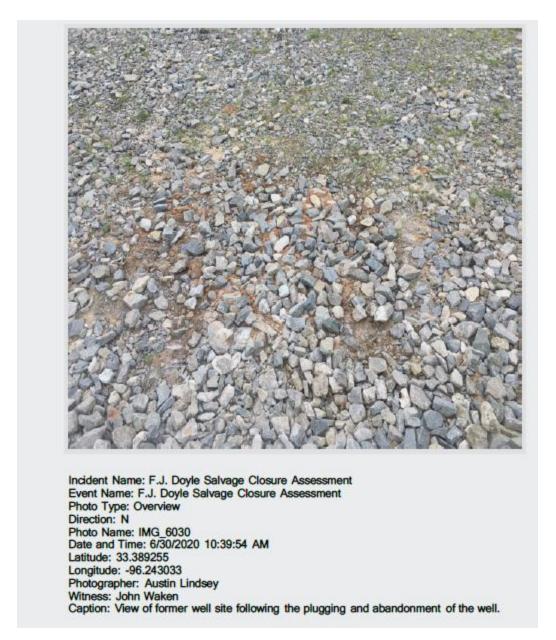
Figure 10: Photograph of the plugged and abandoned well taken from F.J Doyle Salvage Closure Assessment (TDD No. 0001/20-346).

sampling events that month and, on June 30, 2020, the groundwater monitoring well was plugged and abandoned (see Figure 10).
