UNITED STATES ENVIRONMENTAL PROTECTION AGENCY
REGION IX
75 Hawthorne Street
San Francisco, CA 94105-3901

Re: Transmittal of the Spill Prevention, Control and Countermeasure and Underground Storage Tank Inspection Reports for Joint Base Pearl Harbor-Hickam

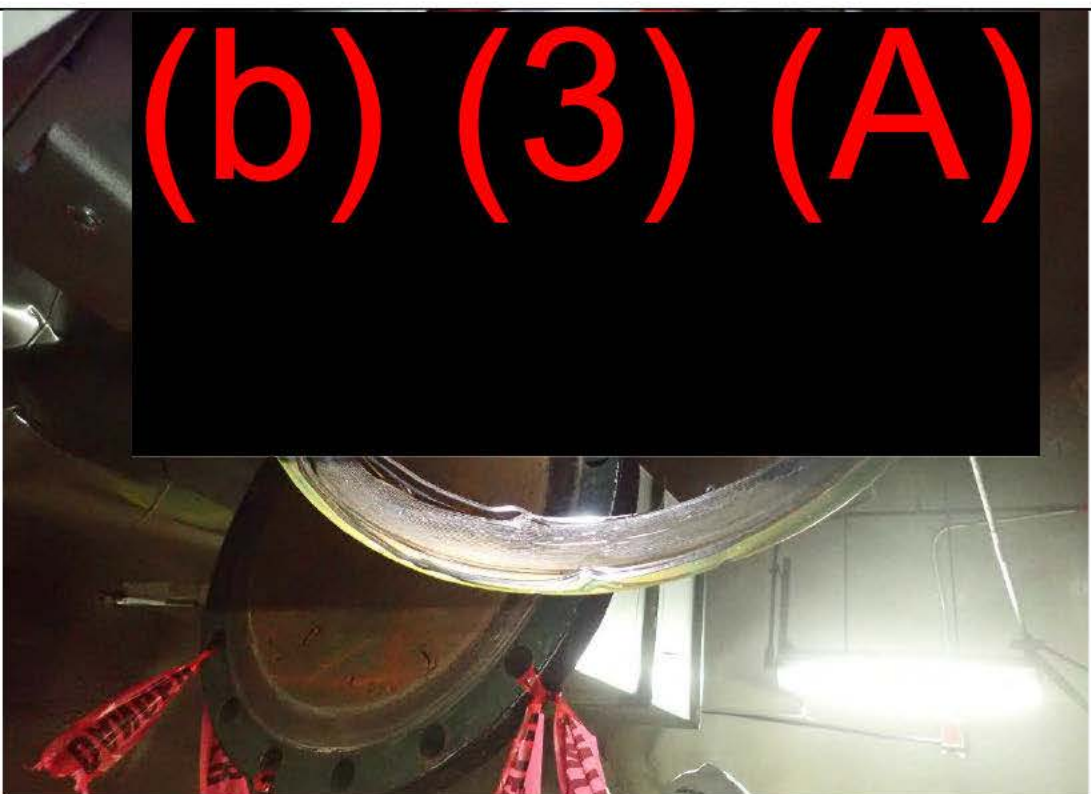
Photographer: WITUL	
Photo No. 47	Time: 1052
Direction Photo Taken: In Lower Tunnel	
Photo Description: Close-up view of failed spiral-wound gasket.

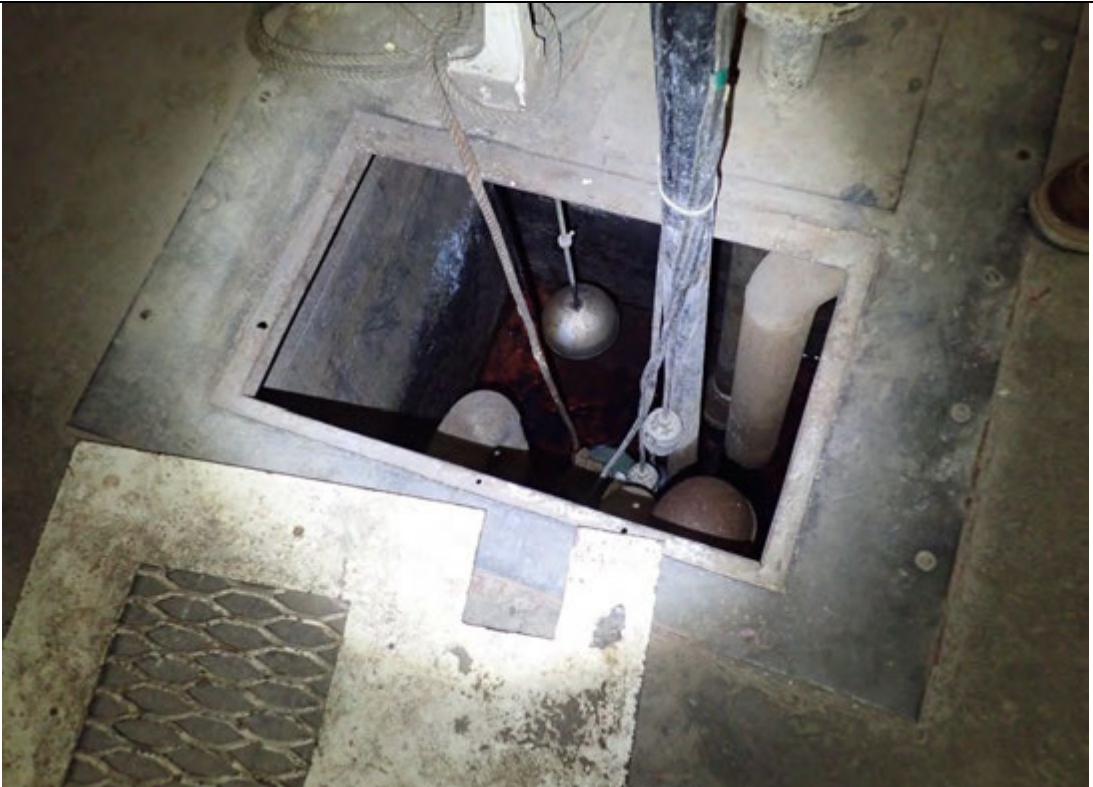
Photo No. 52	Time: 1108
Direction Photo Taken: In Lower Tunnel	
Photo Description: Fuel oil recovery sump with approximately 2" standing liquid.

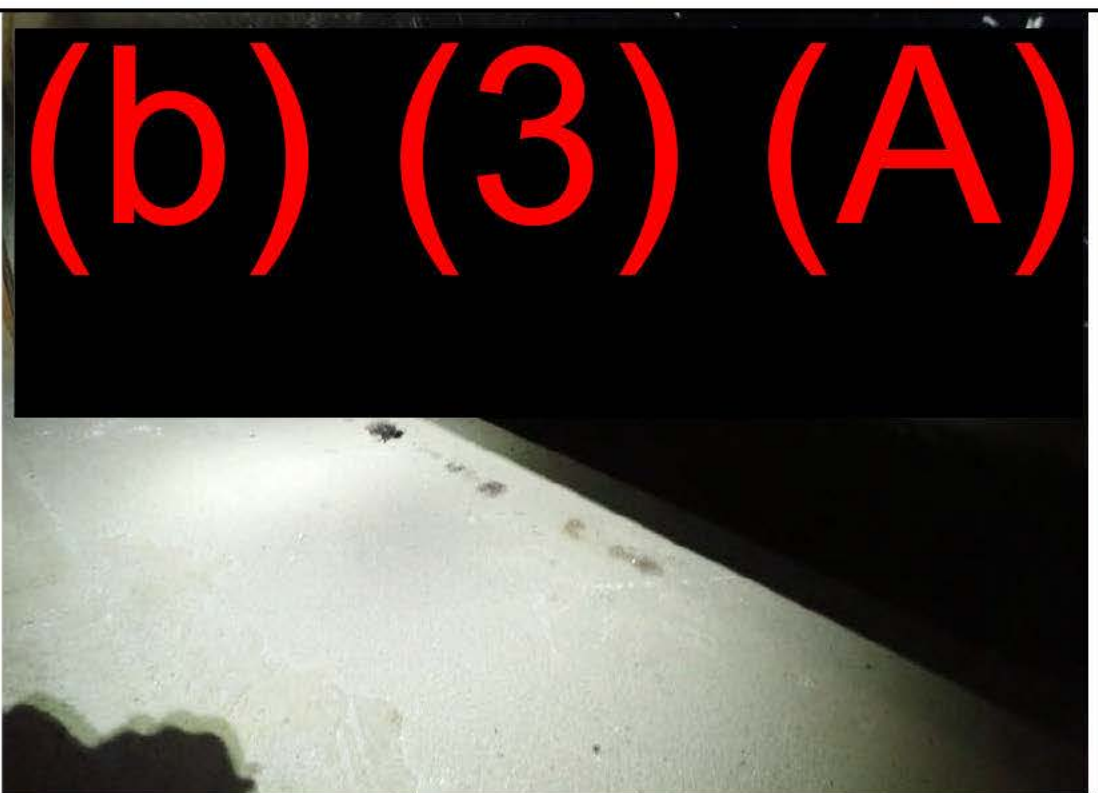
Photographer: WITUL	
Photo No. 41	Time: 1419
Direction Photo Taken: In Red Hill tunnel	
Photo Description: Deterioration/damage to pipe coating and possibly pipe.

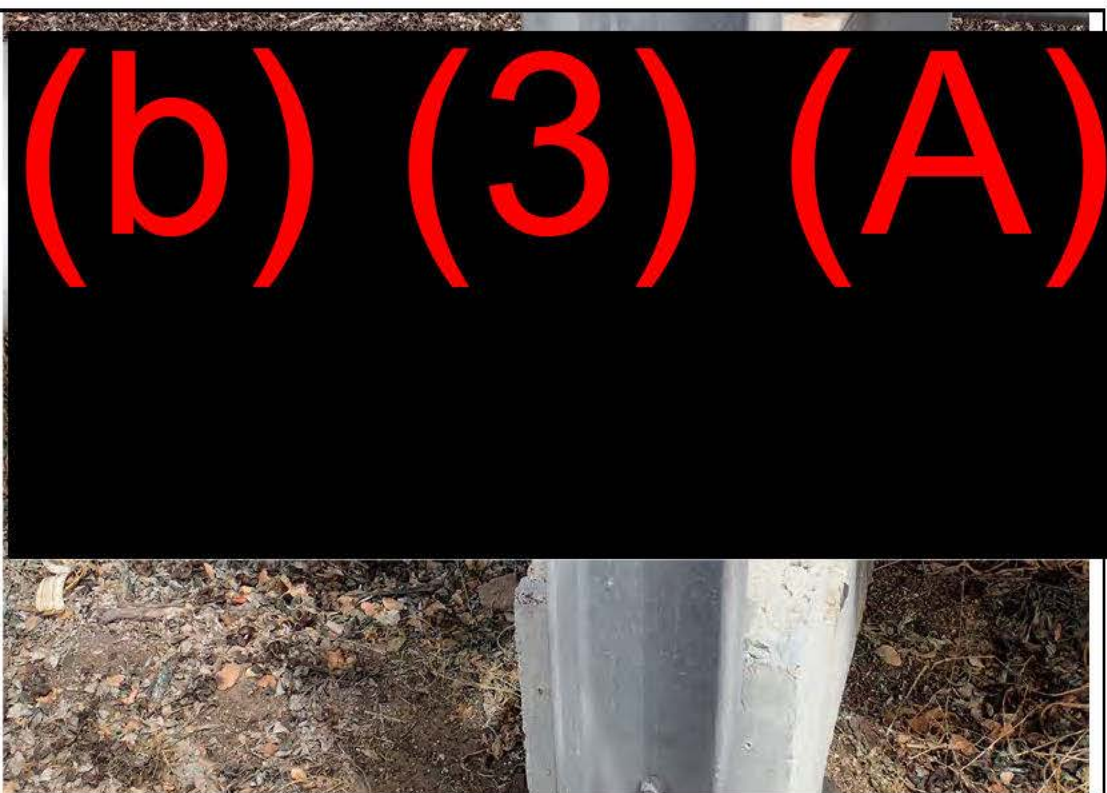
Photographer: WITUL	
Photo No. 7	Time: 1344
Direction Photo Taken: Close-up	
Photo Description: Damaged pipe pads, and areas of pipe damage. Metal on concrete may have caused damage to pipe, requiring inspection of line.
