Region 6 - Enforcement & Compliance Assurance Division
INSPECTION REPORT

Inspection Date(s):	04/13/2022	
Media Program:	Air	
Regulatory Program(s)	SIP, Title V, NESHAP, NSPS	
Company Name:	Phillips 66 Company	
Facility Name:	Lake Charles Refinery	
Facility Physical Location:	2200 Old Spanish Trail	
(city, state, zip code)	Westlake, Louisiana, 70669	
Mailing address:	2200 Old Spanish Trail P.O. Box 37	
(city, state, zip code)	Westlake, Louisiana, 70669	
County/Parish:	Calcasieu Parish	
Facility Phone Number	337-491-4742	
Facility Contact:	Erin Strang Erin.T.Strang@P66.com	Environmental Team Lead
FRS Number:	110000539757	
Identification/Permit Number:	AI#: 2538 / 2626V-17; 2623-V19	
Media Identifier Number:	2201900005	
NAICS:	324110	
SIC:	2911	
Personnel participating in inspection:		
James Haynes	EPA ECD-AT	Inspector
Ben Rosenthal	EPA ECD-AT	Inspector
Erin Strang	Phillips 66 Company	Environmental Team Lead
Tricia Rapp	Phillips 66 Company	Environmental Specialist – Air Lead
John Tarasiewicz	Phillips 66 Company	Environmental Specialist – Tanks Lead

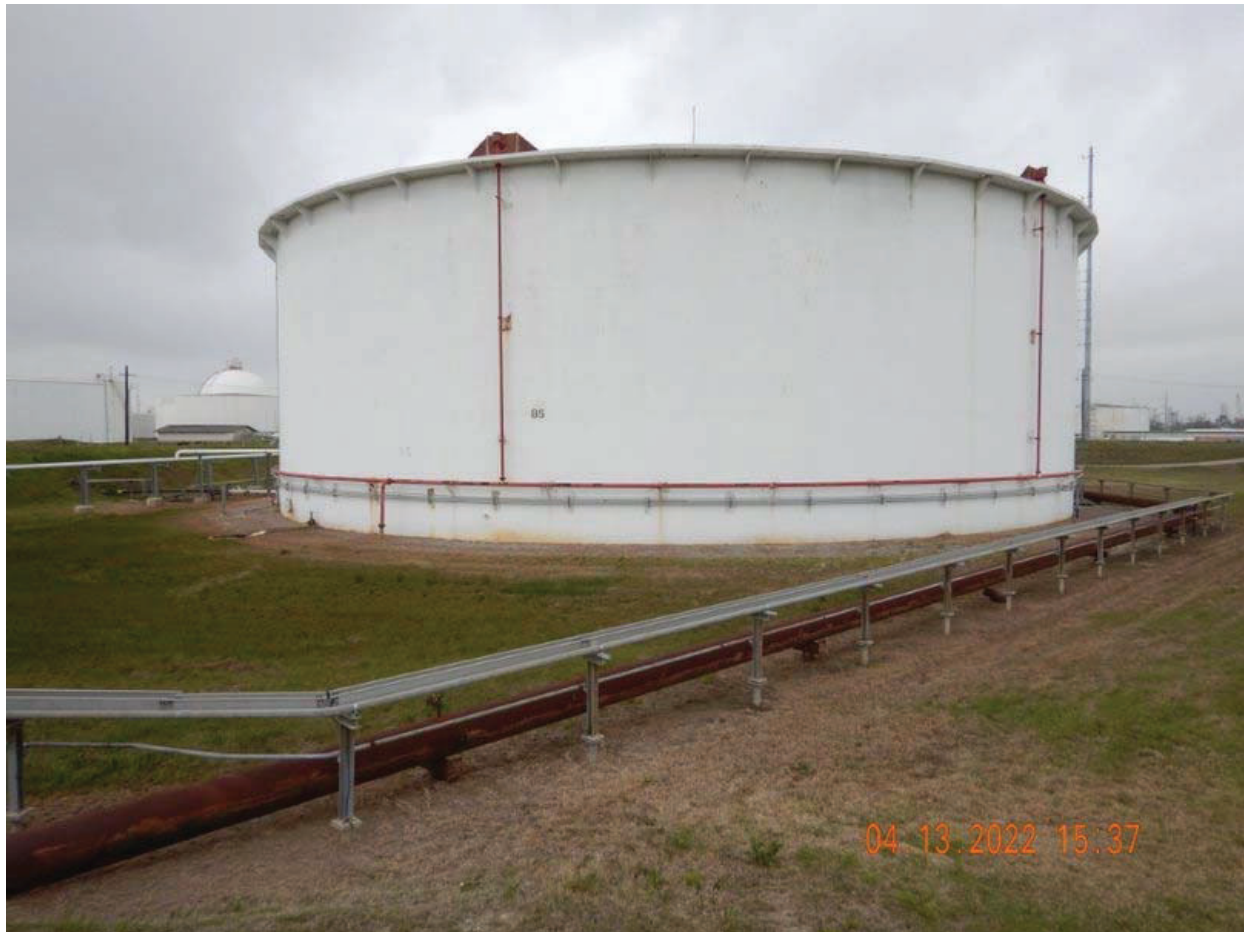
Photo No. 1

We observed hydrocarbon emissions using the OGIC at three tanks: T-82, T-85, and T-86. The OGIC video suggests that the tanks may not be effectively controlling emissions. Information provided by the facility indicates T-85 and T-86 failed respective visual inspections. See Appendix 3 – Phillips 66 Lake Charles Refinery April 2022 EPA Inspection Response, for the T-85 and T-86 inspection report. T-86 was noted to have a 6-inch gap between the edge of the primary seal and the tank wall. T-85 was noted to have an oily substance on the roof, a deficient gasket at the guide pole, and a deficient gasket at the vacuum breaker. T-85 and T-86 are classified as Group 1 storage vessels under 40 CFR Part 63 Subpart CC (MACT CC) – National Emission Standards for Hazardous Air Pollutants (“NESHAP”) From Petroleum Refineries which subjects them to the provisions of 40 CFR Part 63 Subpart WW – National Emission Standards for Storage Vessels (Tanks) - Control Level 2.

Description: Tank T-85. OGIC-visualized hydrocarbon emissions were observed on the roof of the tank.

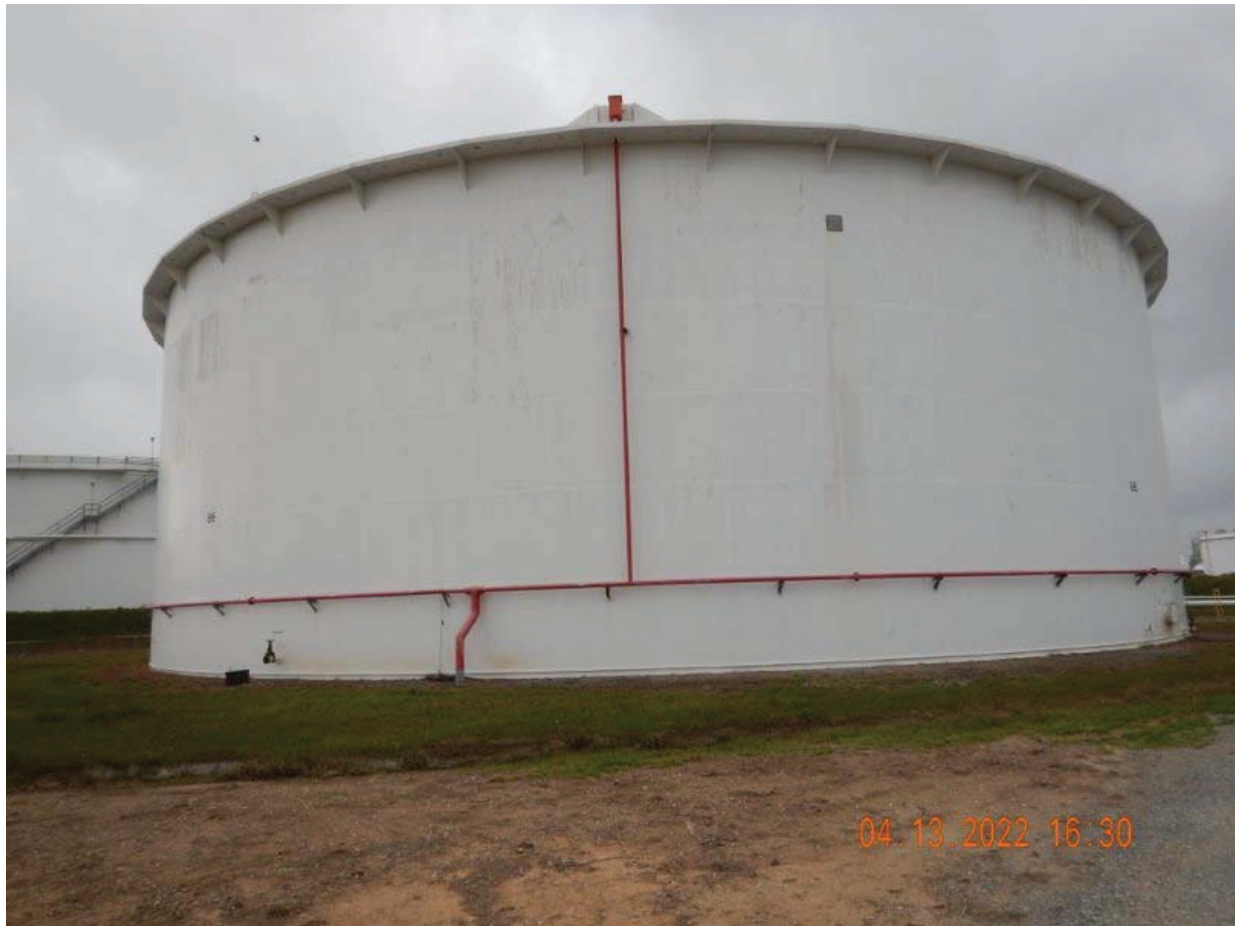
Photo No. 2

Description: Tank T-86. OGIC-visualized hydrocarbon emissions were observed on the roof of the tank.

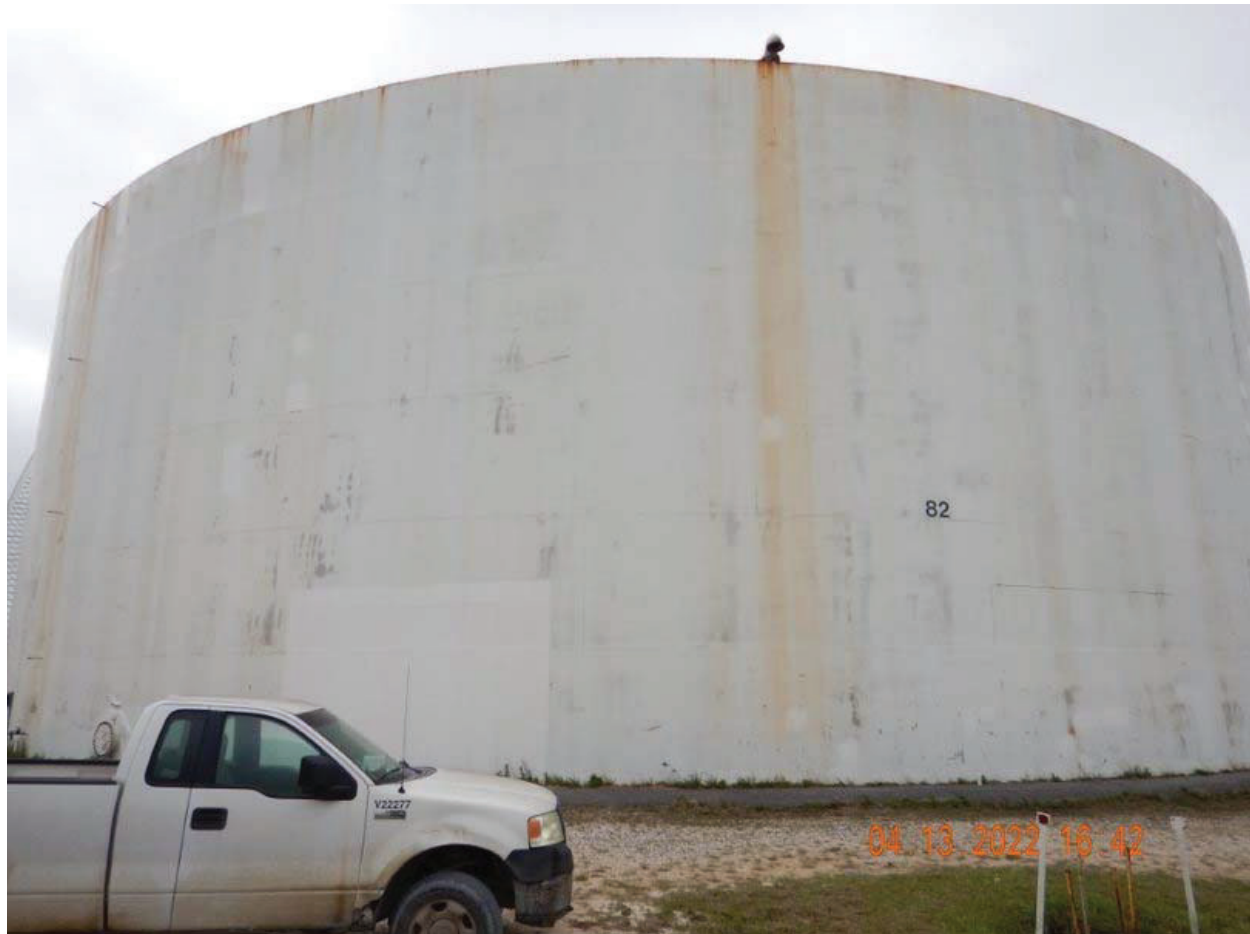
Photo No. 3

Tanks can be physically distorted when large openings are cut into a tank shell. Force displacements from this type of disruption can cause flattening above the door sheet itself, bulging at the corners of the door sheet, and could cause the tank shell to deform into a more oval shape (Lieb, John M. *Importance of Door Sheet Stiffening*). Without proper stabilization of the tank shell, these changes in design characteristics could lead to excess emissions.

Description: Tank T-82. OGIC-visualized hydrocarbon emissions were observed exiting the gooseneck valve at the top of the tank. Two door sheets are visible at the base of the tank.

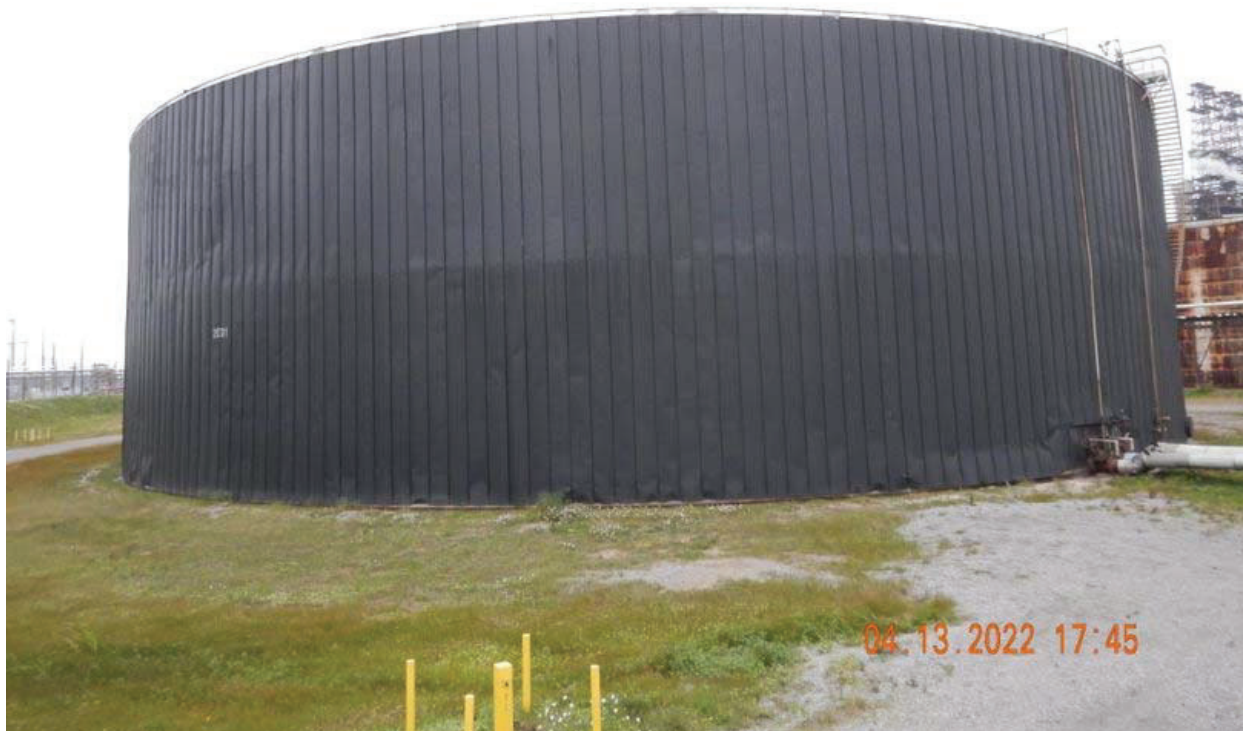
Photo No. 4

A facility LDAR technician observed readings over 30,000 ppm, or above 3% of the sampled air, at a hatch on the roof of T-2001. The tank is not currently classified or monitored as a MACT CC Group 1 storage vessel. The facility must record any data, assumptions and procedures used to make the determination that the weight percent total of the HAP of the stored liquid is less than or equal to 4 percent. Additionally, the Facility should maintain best practical housekeeping and maintenance practices to the highest possible standards to reduce the quantity of organic compound emissions pursuant to the practices listed in Title 33 of the Louisiana Administrative Code Section 2113.

Description: Tank T-2001.

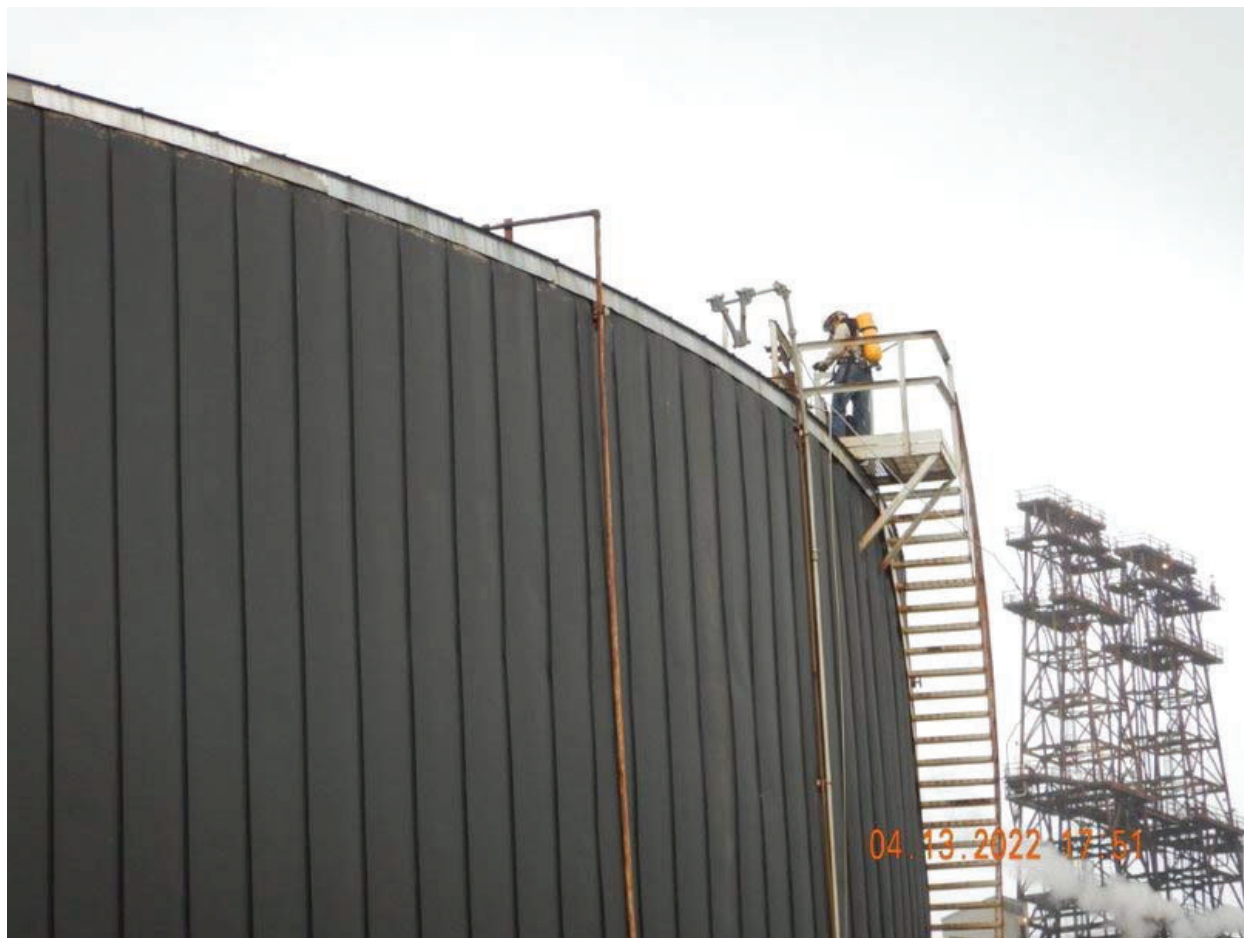
Photo No. 5

with a flame ionization detector. The technician did not observe detectable emission from the regulator flanges or connectors in proximity to the top of the stairwell. A high reading of 31,886 parts per million volatile organic compounds (“VOC”) was observed along the observation hatch. The technician attempted to lift and re-seat the hatch, which she described as loose and vibrating. The technician was unsure if the hatch was gasketed or the connection at the opening was metal to metal. See AOC 3.

Description: Facility LDAR technician using handheld monitoring equipment at the top of T-2001.

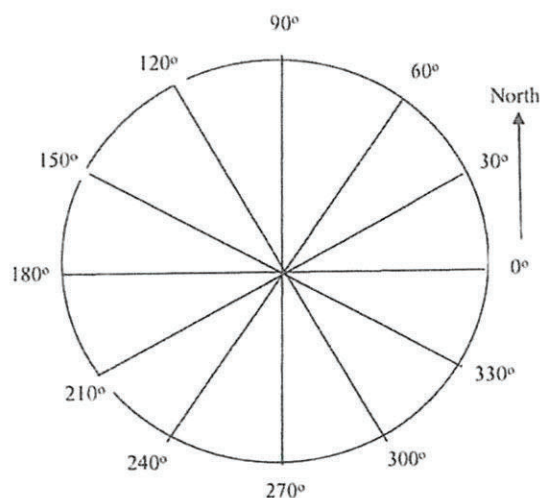
Primary Seal Gaps

The measured primary gap width exceeded the maximum allowable gap width. Repairs have been initiated within 7 days by assessing the primary seal and scheduling work to complete the repair. Repairs will be completed within 45 days or the tank will be taken out of service.

Gap Location (clock position)	Gap length L (inches)	Max. widths W (inches)	Total Gap A (sq. inches)
0	20'	x 6	= 120
210	12"	x .5	= 6
180	12"	x .5	= 6
150	12"	x .5	= 6
		x	=
		x	=
Total Gap (Square Inches) =			138
Max. Gap Width, inches =			120
