Subject: Safe Drinking Water Act EPA Inspection Report

On October 18, 2022, the U.S. Environmental Protection Agency conducted a compliance evaluation inspection of Cahokia Heights Public Water System (“System”), PWSID IL1635000 located in Cahokia Heights, Illinois. The purpose of the inspection was to make observations about the site conditions, operation, and monitoring of the System to evaluate compliance with the Safe Drinking Water Act (“SDWA”) and regulatory requirements. Please see the enclosed copy of our inspection report.

INSPECTION REPORT

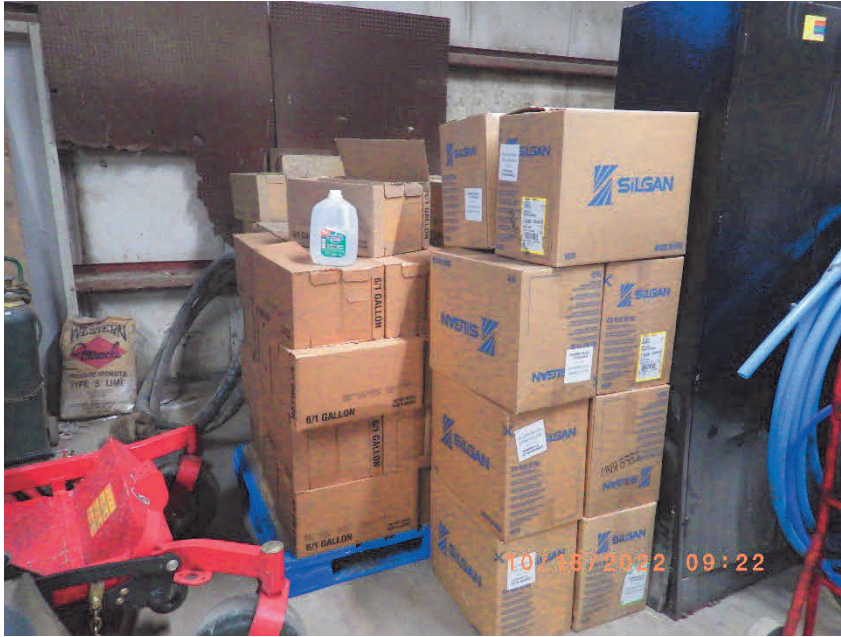
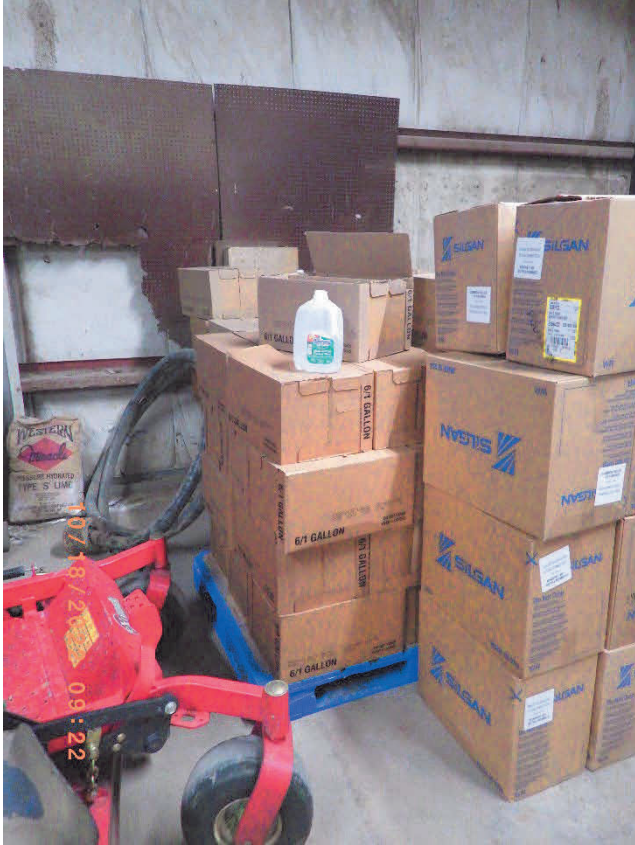
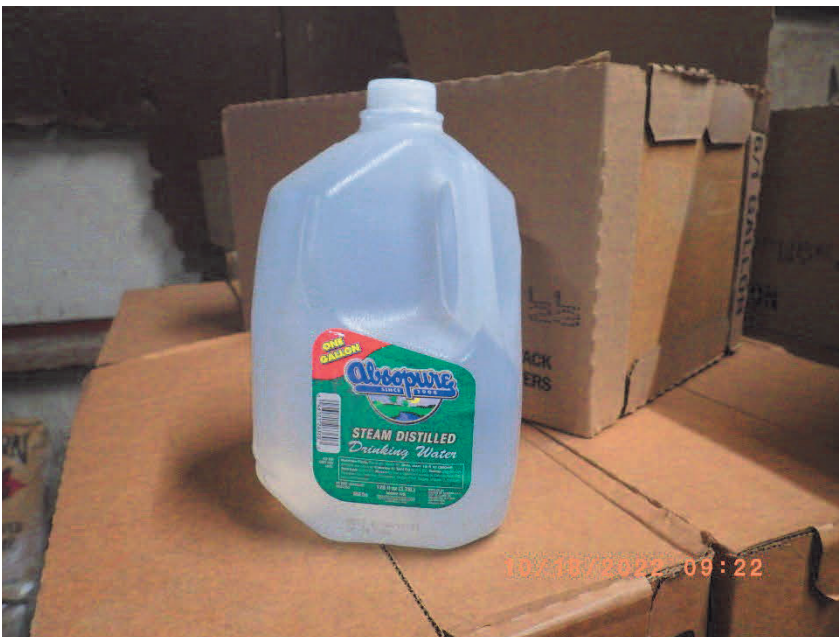
Area: Main Office Warehouse	
Reference #: OB-001	AOC: No
The main building of the public works department houses a maintenance area that also functions as a small storage warehouse. The warehouse is used to store bottled water in accordance with the System's Alternative Water Source Plan, created in response to the UAO. In the event of pressure loss, a violation of the revised total coliform rule, or a water emergency, bottled water from this supply can be delivered to customers within the City of Cahokia Heights.	
Photo(s): Appendix A Photo # 1-3

Description: Emergency Bottled Water

Description: Emergency Bottled Water
Location: 2525 Mousette Lane, East St. Louis, Illinois 62206
Date/Time: 10-18-2022

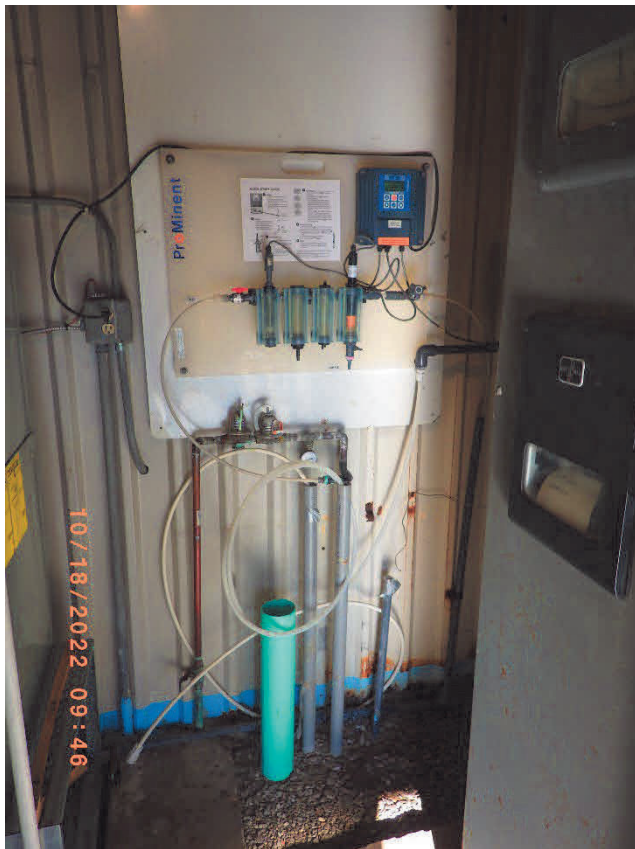
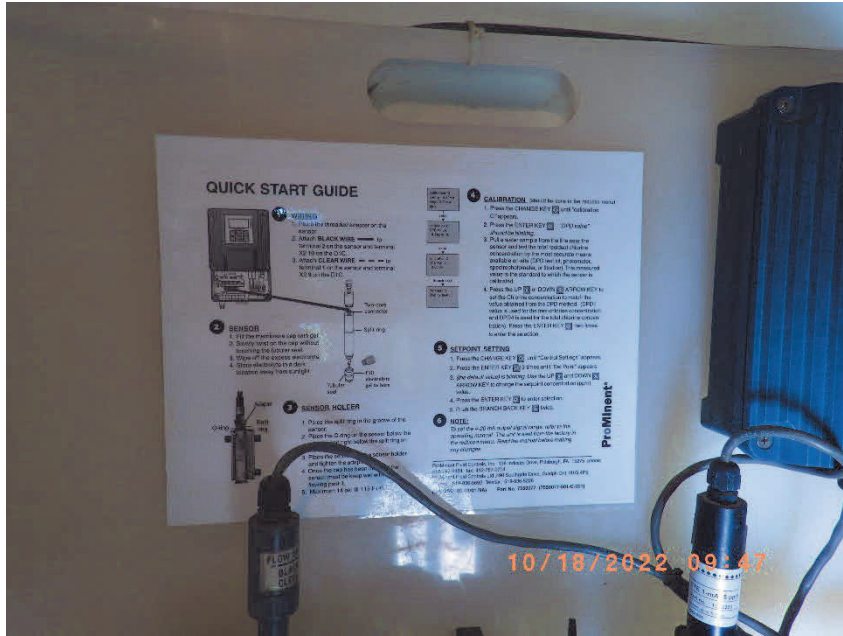
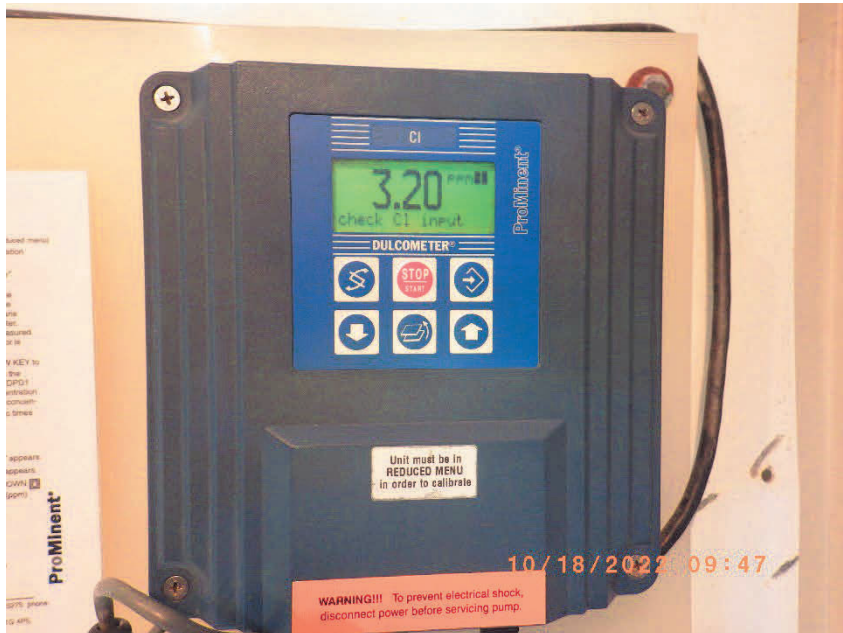
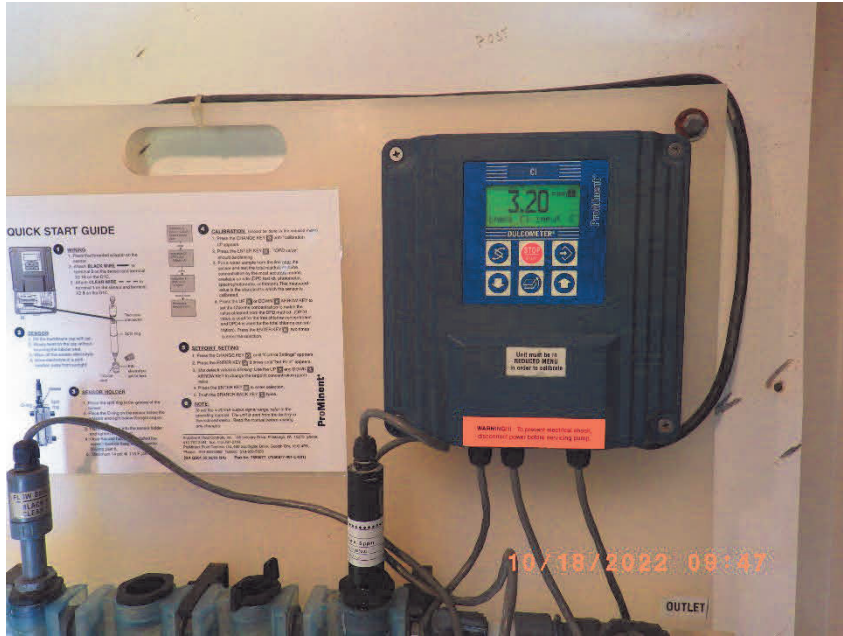
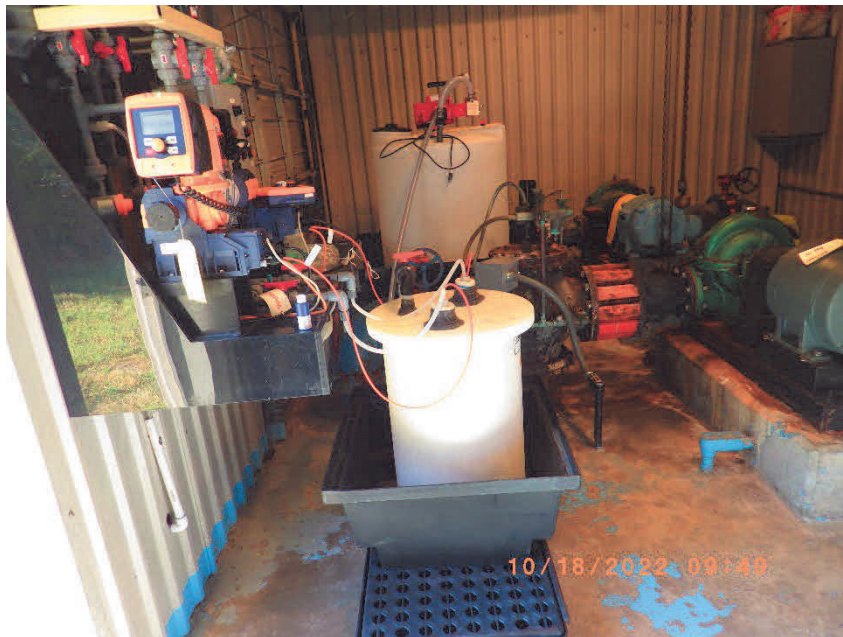
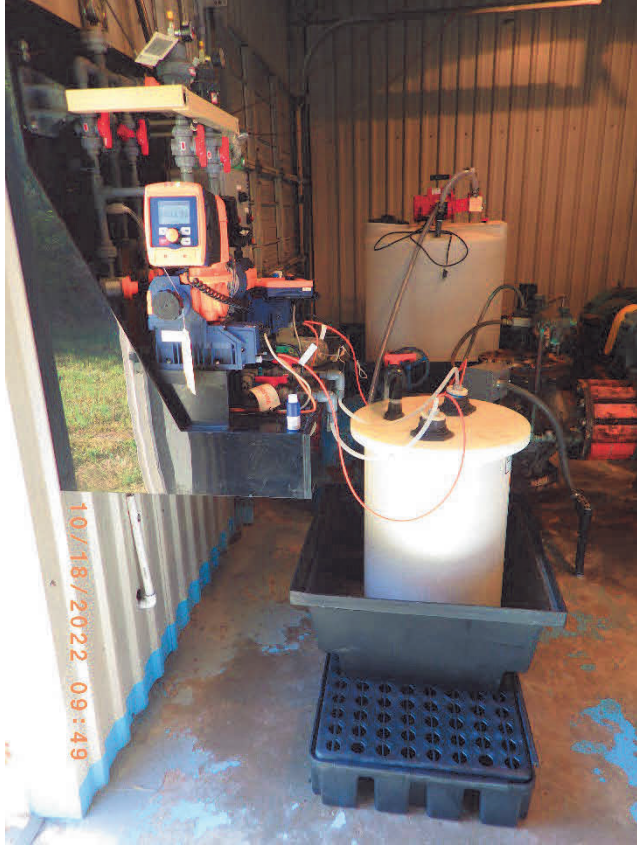
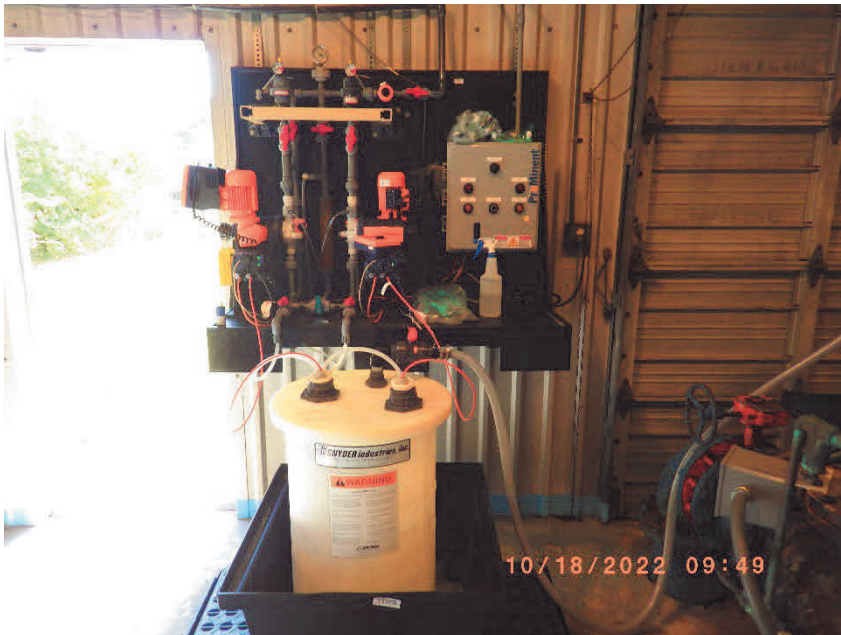
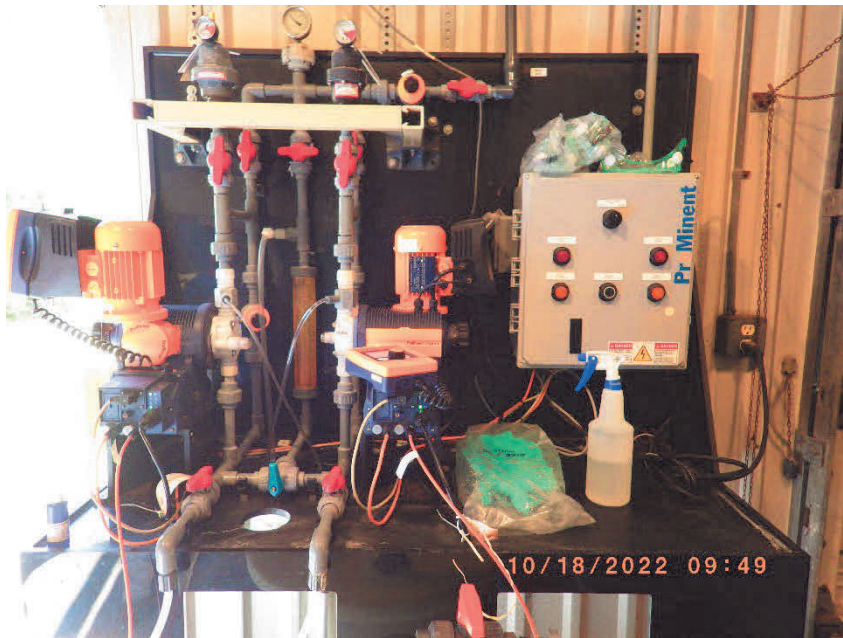
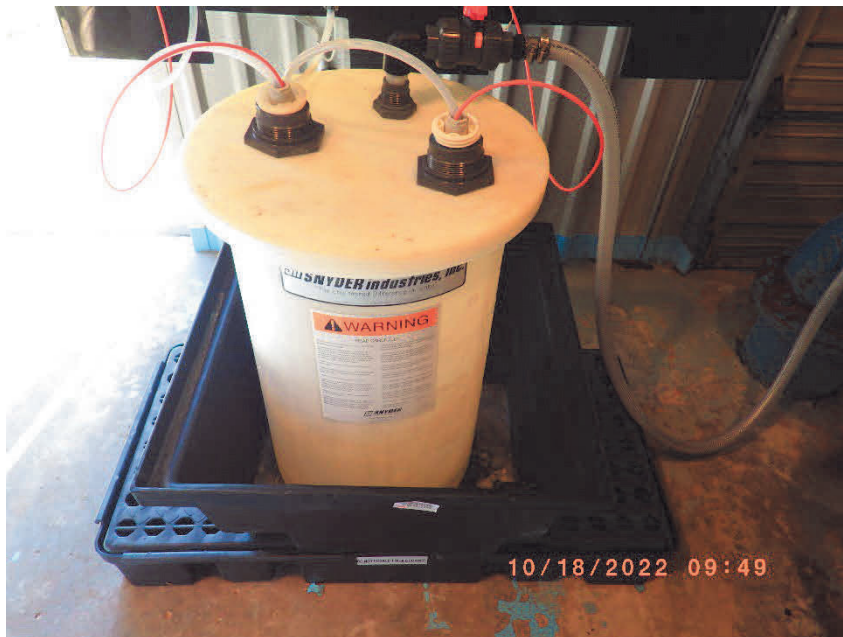
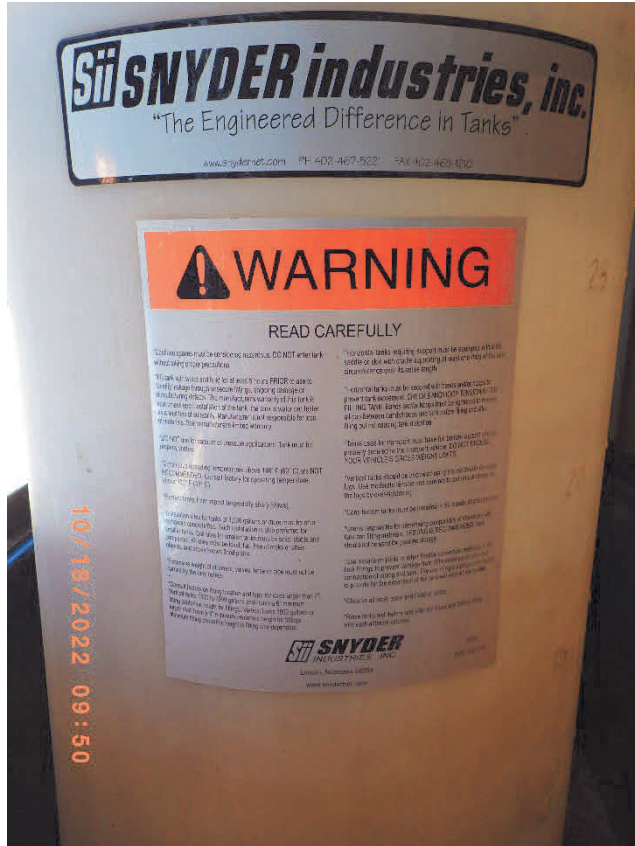
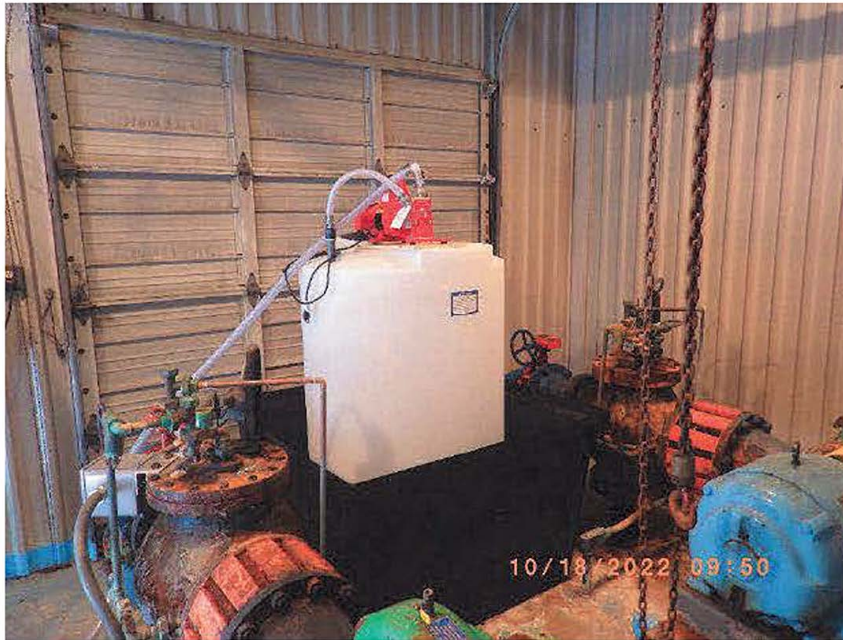
Area: Falling Springs Booster Station	
Reference #: OB-002	AOC: Yes
<p>At the booster station, the System adds additional chlorine to finished water from the upstream provider, Illinois American - East St. Louis. Illinois American - East St. Louis uses chloramines as a disinfectant.</p> <p>At the time of inspection, the digital chlorine analyzer displayed a chlorine concentration of 3.2 PPM and no booster chlorine was being added. In order to maintain a chlorine residual in the furthest points of the system, the operator sets the chlorine feed to activate when the value is at 1.75 ppm. The chlorine storage totes appeared to be in good condition and were held in an area with secondary containment.</p>	
<p>Photo(s): Yes Appendix A Photo # 4-14</p>	
Reference #: OB-003	AOC: Yes
<p>The

Area: O&M - Treatment	
AOC Reference #: IN-006, OB-002	
Regulation:	35 Illinois Administrative Code Section 604.725(c)
Community water supplies must not mix water sources with free chlorine and combined chlorine residual.	
AOC: The System is mixing water with a free chlorine residual into water utilizing chloramines. The System is also practicing "breakpoint" chlorination, the addition of free chlorine until a free chlorine residual is established. The chlorine feed rate is automatically adjusted based on chlorine readings taken at the feed site using a digital analyzer. This practice has the potential to alter the ratio of chlorine to ammonia, which could cause a drop in disinfectant residuals or increased taste and odors.	
The System's long-term goal is to add its upgrade its own treatment to have the ability to add chloramines, but it is unknown when the System will have this capability.	
Adding booster chlorine without ammonia to chloraminated water was also described as a significant deficiency in paragraph 55(j) of the UAO.

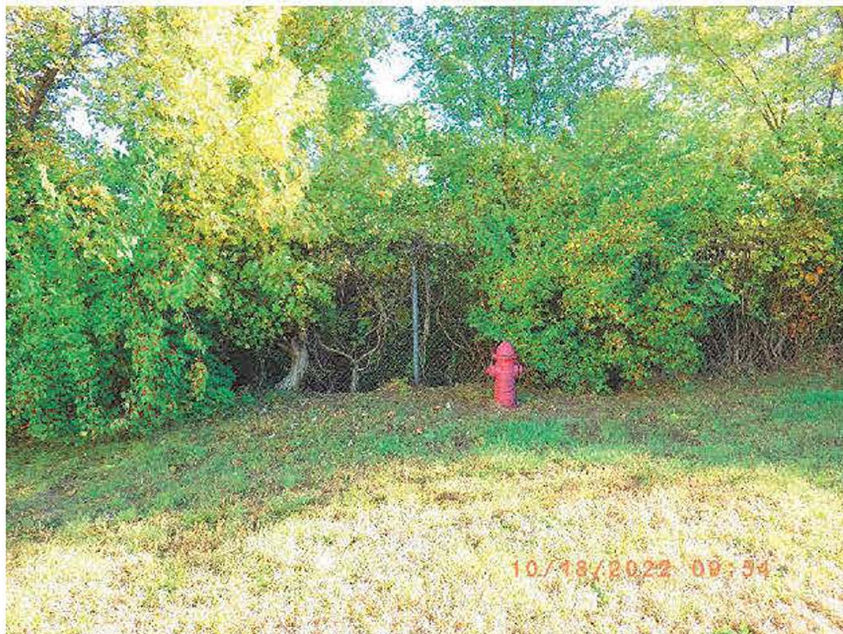
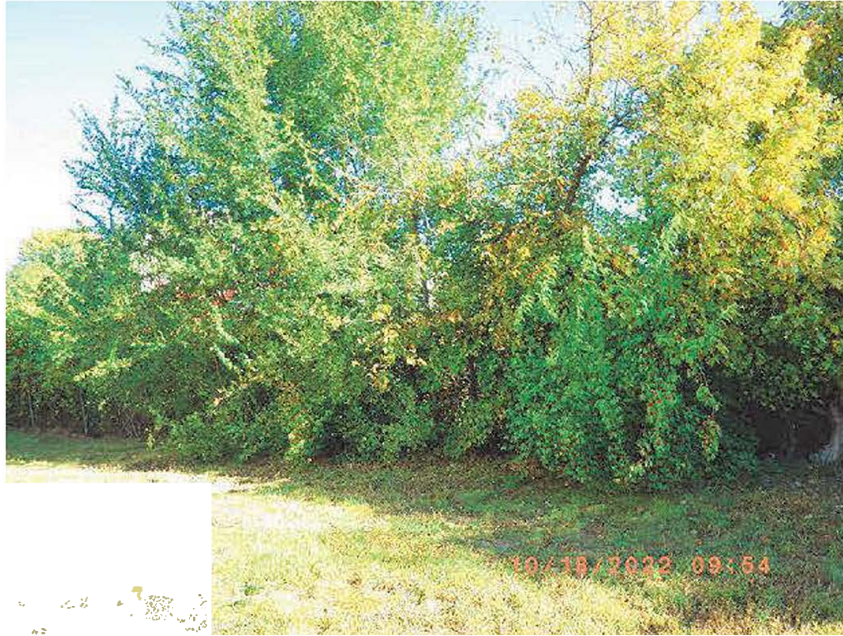
Springs booster station is contained within a fenced off area. The UAO identified two significant deficiencies in this area, 1) abandoned chlorine cylinders and 2) overgrown and damaged fencing. The chlorine cylinders were removed on August 4, 2021, resolving one significant deficiency. However, portions of the site fencing still appeared to be overgrown with vegetation during the inspection.</p>

AOC: The [redacted] Springs booster station is contained within a fenced off area. Portions of the site fencing appeared to be overgrown with vegetation during the inspection (See photos 15-16).

Description: Fencing and Vegetation Surrounding [REDACTED] Springs Booster Station

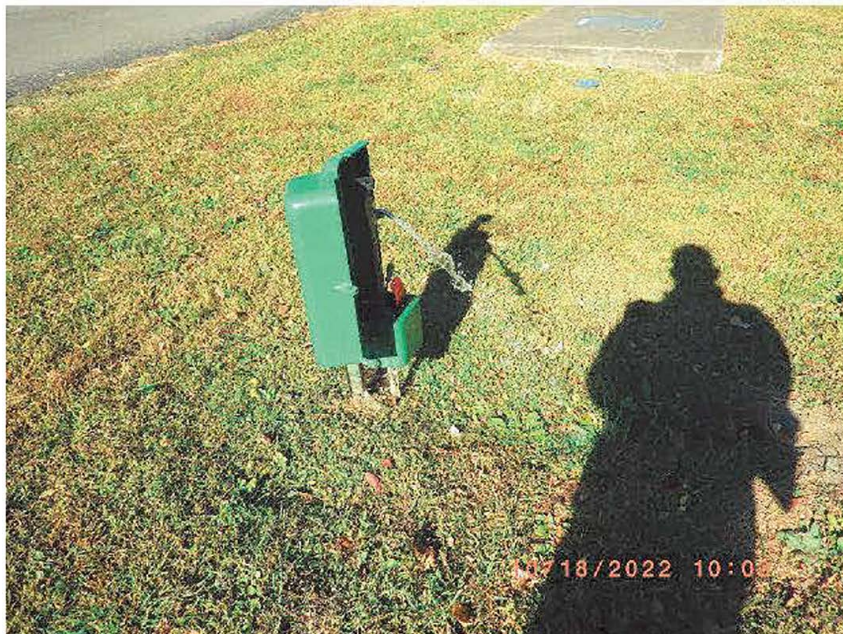
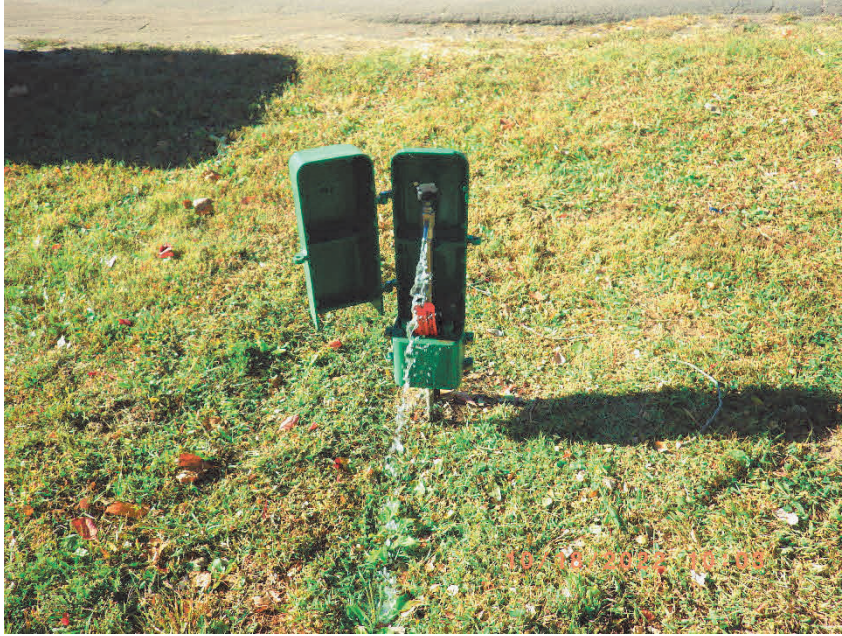
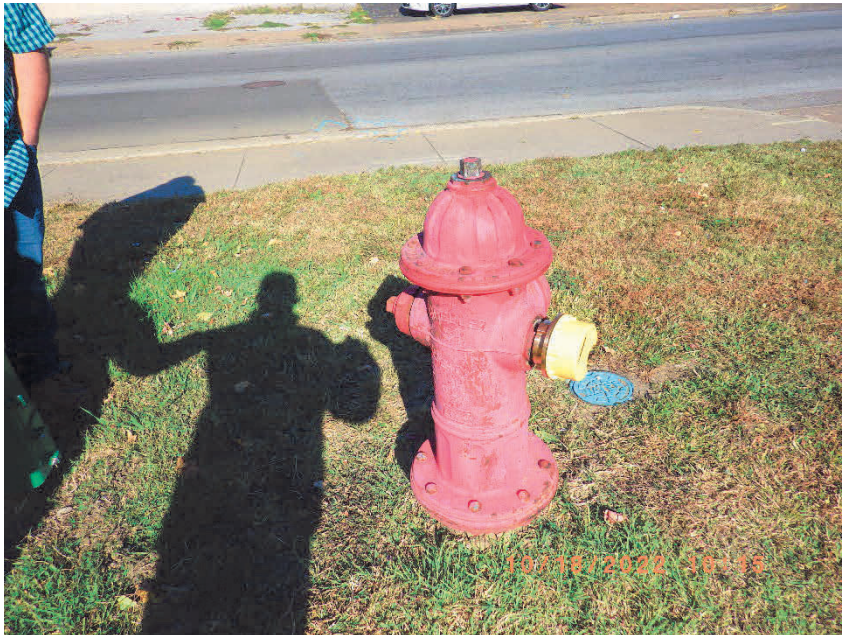
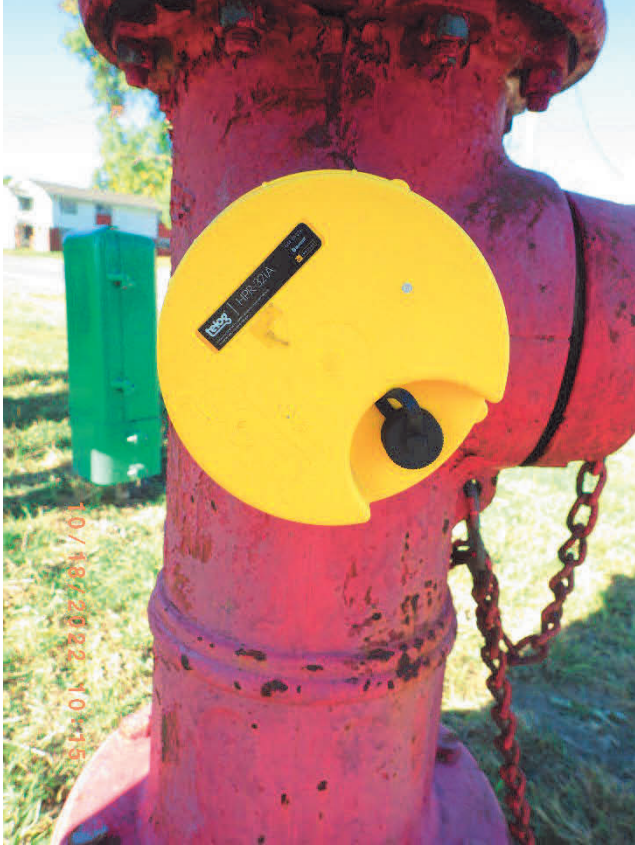
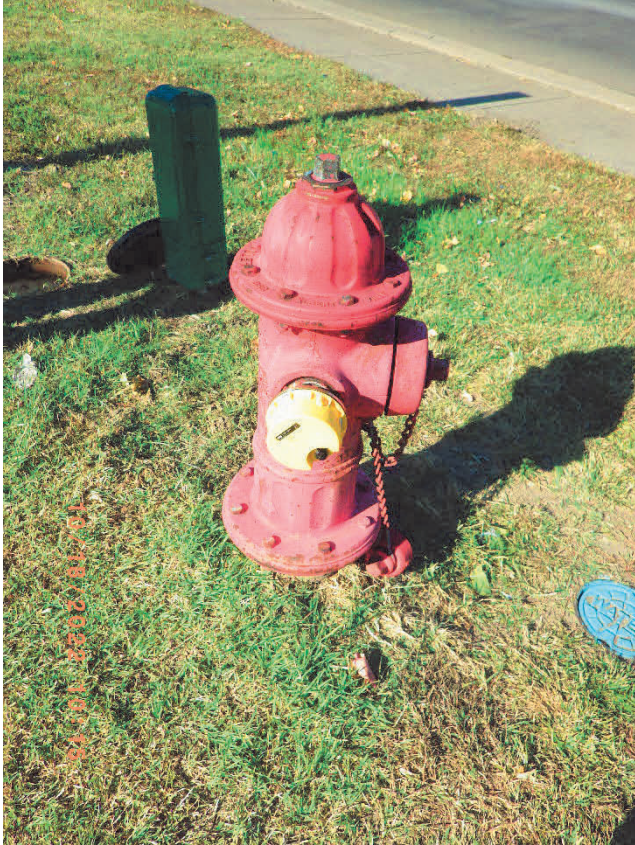
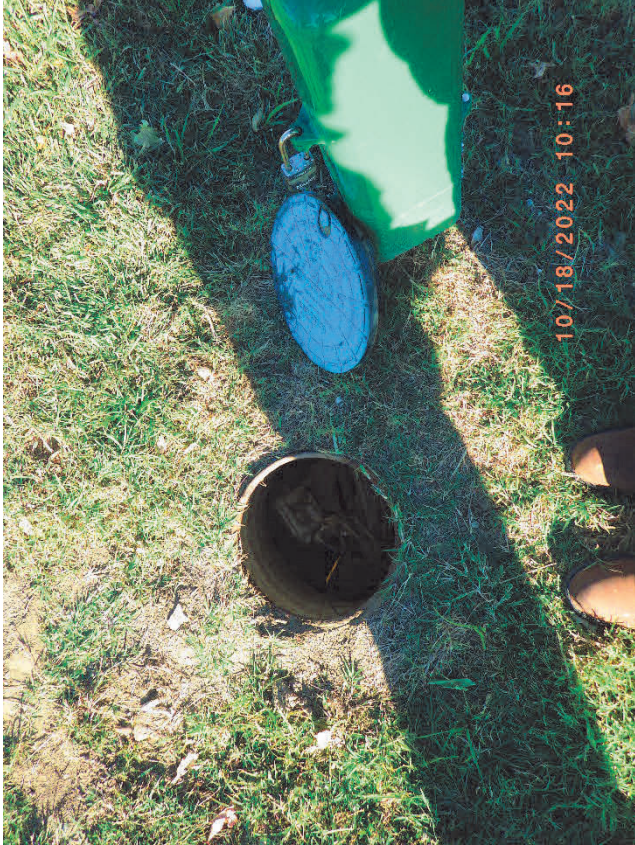
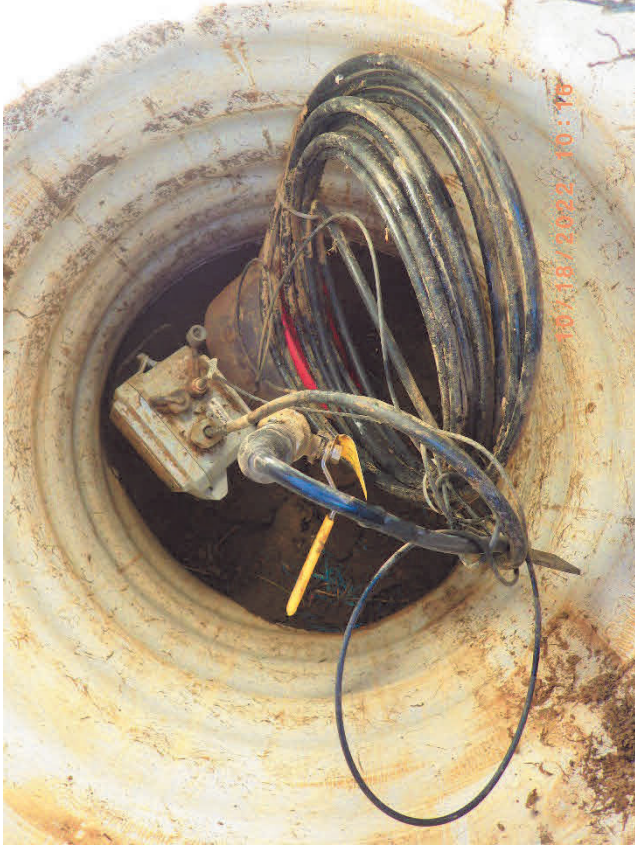
Area: Distribution System Monitoring Stations	
Reference #: OB-004	AOC: No
<p>During the inspection, multiple bacterial sample stations were observed. The System uses these locations to collect both routine monthly samples and samples collected immediately following an SSO. System staff verified chlorine residual levels at these locations using a Hach SL1000. Chlorine residuals and locations are detailed in Section IV – Sampling and Field Monitoring Activities. EPA inspectors also observed a site used for continuous pressure monitoring. The pressure monitor was located below ground and appeared to be connected to the water main. System representatives confirmed that the monitor was functioning correctly and was in good condition with no current maintenance trouble.</p>	
<p>Photo(s): Appendix A Photo # 17-23</p>

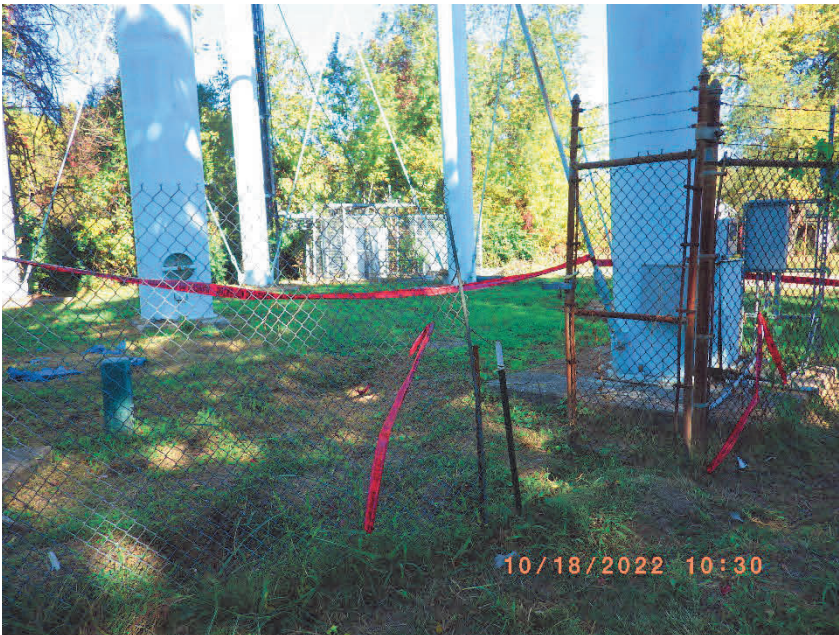
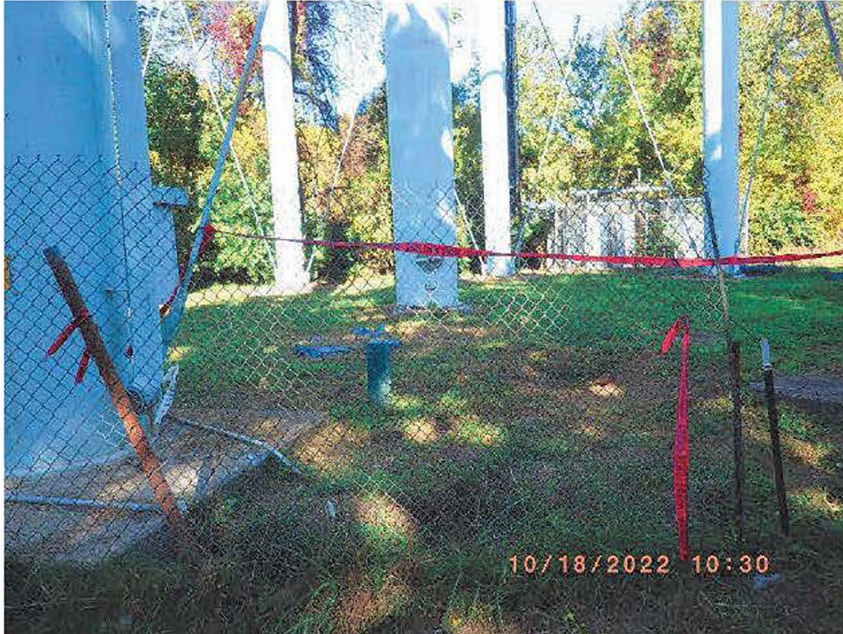
Area: Spring Mullen Water Tower	
Reference #: OB-005	AOC: Yes
<p>The UAO cited the condition of this tower as a significant deficiency. The tower underwent maintenance in May 2022 to address this and other critical maintenance issues. These repairs included replacing the weir box and fixing the overflow pipe, tightening windage rods, replacing the interior access ladder, replacing the roof vent, performing interior sediment cleanout and disinfection, and reweld the overflow pipe. Repaired welds on connection joints on the tower’s exterior as well as newly installed overflow screening were observed.</p>

The fencing surrounding this site near the entrance appeared damaged and no longer completely encloses the site.	
Photo(s): Yes Appendix A Photo # 24-31

The [redacted] Mullen water tower is contained within a fenced off area. Fencing near the site entrance gate appeared damaged and other sections were overgrown with vegetation during the inspection (see photos 24-25).

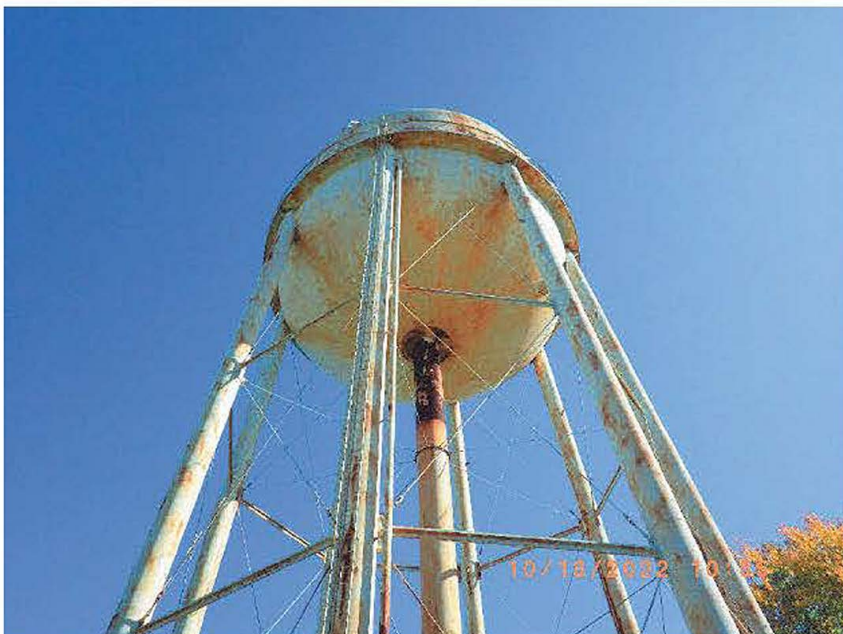
Area: Church Road Water Tower	
Reference #: OB-006	AOC: Yes
The UAO cited the condition of this tower as a significant deficiency. Since then, the tower has been inspected and some critical maintenance items corrected. The System is planning a full rehab of the tank to resolve all remaining maintenance items both inside and outside of the structure. This rehab project is currently in the planning and bidding stage and work is expected to begin sometime in 2023. During the inspection, site fencing appeared to be overgrown with vegetation.	
Photo(s): Yes Appendix A Photo # 34-37

Description: 0.5-MG [REDACTED] Road Elevated Storage Tank

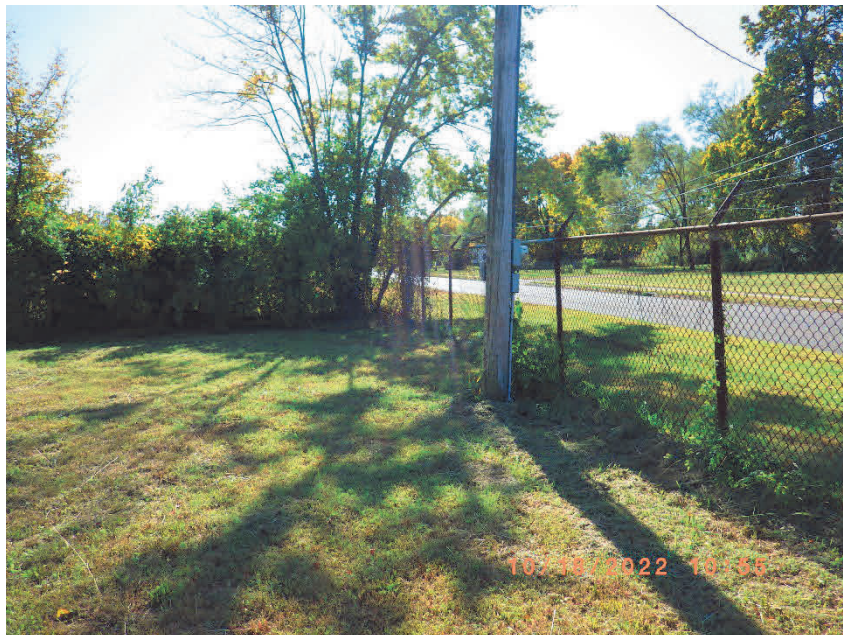
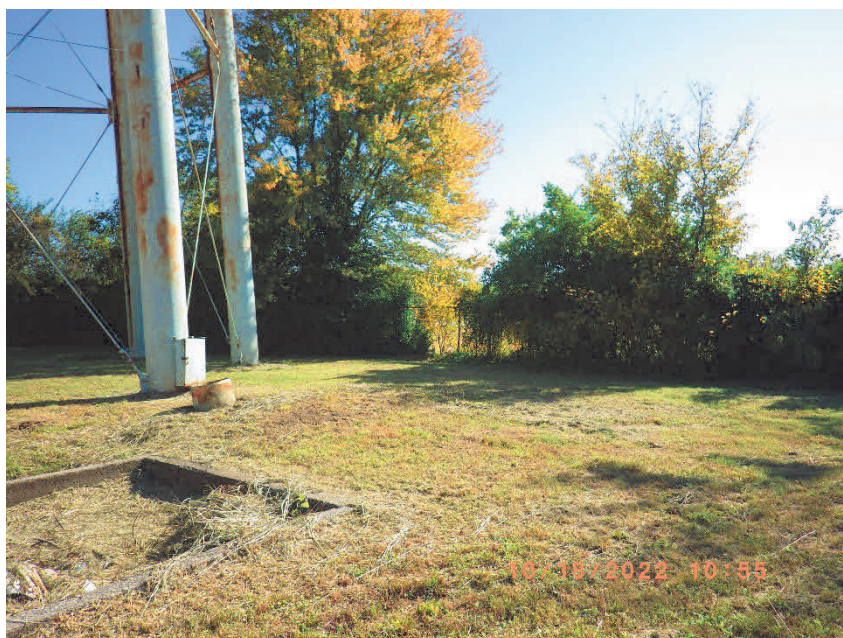
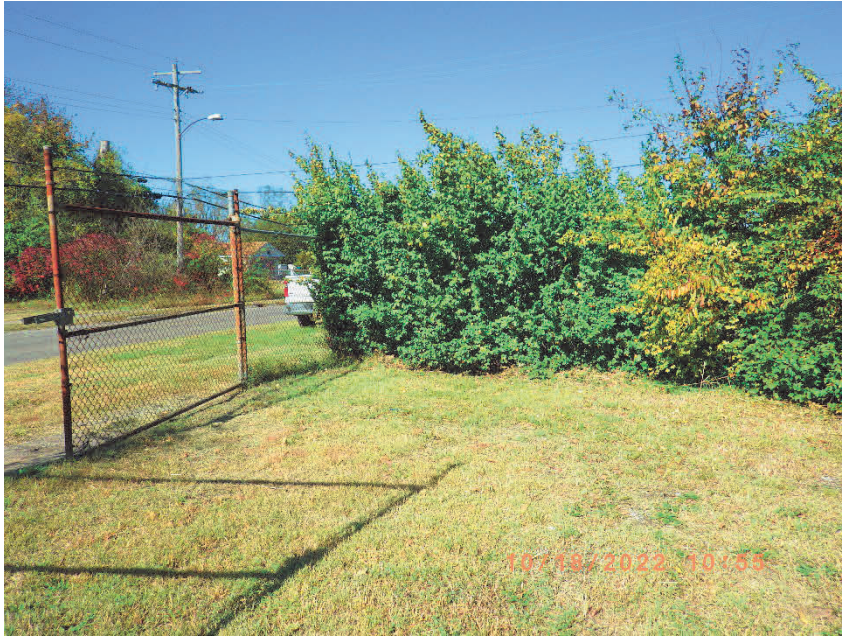
The [redacted] Road water tower is contained within a fenced off area. Portions of the site fencing appeared to be overgrown with vegetation during the inspection (see photos 35-37).

Description: Fencing and Vegetation Surrounding 0.5-MG Ex 7f (Water Infra) Road Elevated Storage Tank

Description: Fencing and Vegetation Surrounding 0.5-MG Ex 7f (Water Infra) Street Elevated Storage Tank
