Subject: February 8-9, 2023, NPDES SSO Inspection Trip Report for City of Cahokia Heights

Facility: Cahokia Heights, Illinois

Date of Inspection: February 8-9, 2023

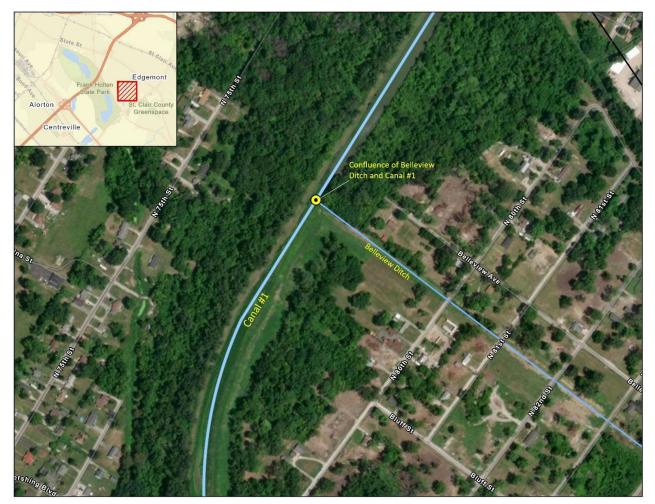
Figure 1. Aerial photograph showing confluence of Belleview Ditch and Canal #1, in Cahokia Heights.

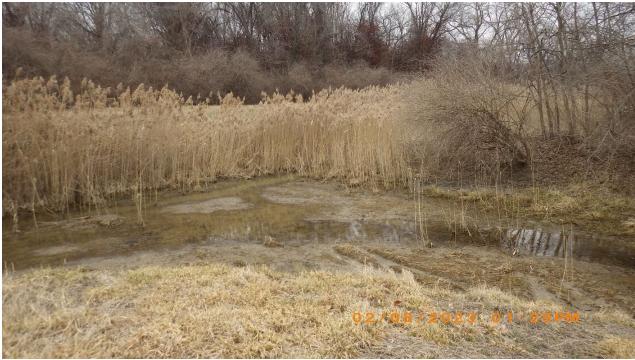
1: CCHT0171 Description: Confluence of Canal #1 and Belleview Ditch. Water was flowing from the ditch into Canal #1. Location: Northwest of corner of Belleview Ave. and 80th St. (38.589984°N; 90.075693°W). Camera Direction: 348°.

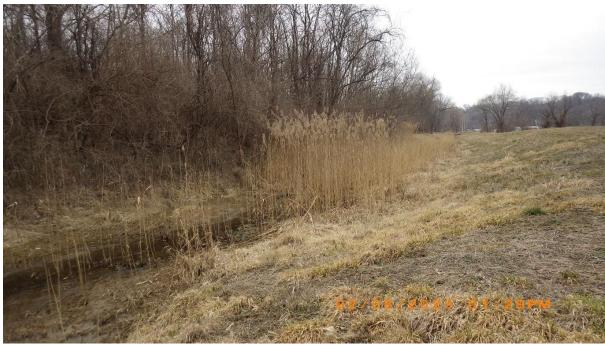
Description: Upstream view of Belleview Ditch from confluence with Canal #1. Location: Northwest of corner of Belleview Ave. and 80<sup>th</sup> St. (38.589984°N; 90.075693°W). Camera Direction: 94°.

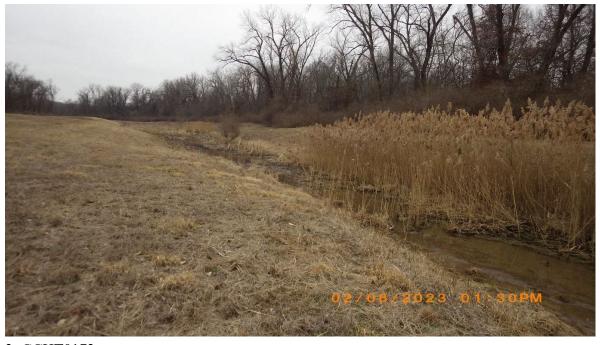
### 3: CCHT0173 Description: Downstream view of Canal #1 from outlet of Belleview Ditch. Location: Northwest of corner of Belleview Ave. and 80<sup>th</sup> St. (38.589984°N; 90.075693°W). Camera Direction: 238°. Date/Time: February 8, 2023/ 1:30 P.M.

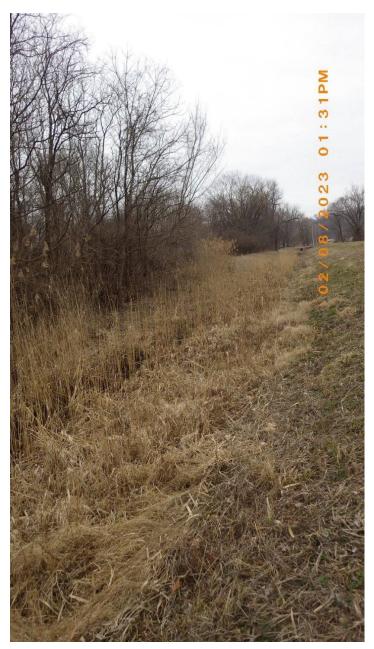
4: CCHT0174 Description: Upstream view of Belleview Ditch toward 80<sup>th</sup> St. Water in ditch flowing toward Canal #1. Location: Northwest of corner of Belleview Ave. and 80th St. Camera Direction: 98°.

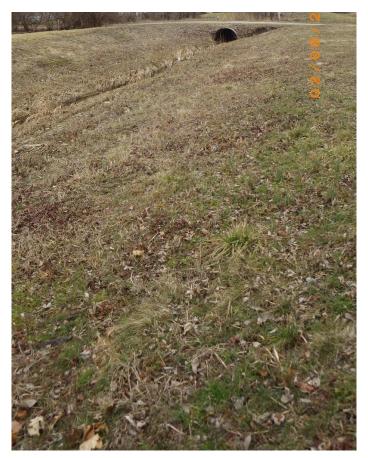
Description: Upstream view of Belleview Ditch just northwest of 80<sup>th</sup> St. Note 80<sup>th</sup> St. culvert. (Photo cropped to remove Personally Identifiable Information or "PII") Location: Northwest of 80<sup>th</sup> St. Camera Direction: 106°. Date/Time: February 8, 2023/1:34 P.M.

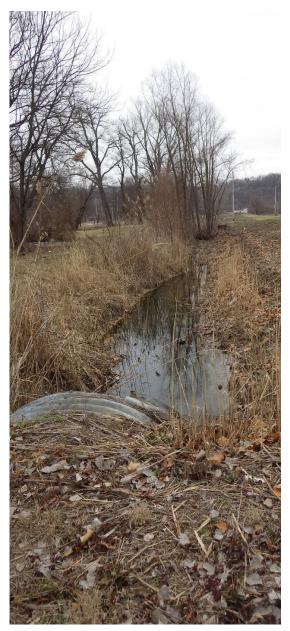
Description: Upstream view of Belleview Ditch from 80<sup>th</sup> St. (Photo cropped to remove PII.) Location: 80<sup>th</sup> St. where Belleview Ditch flows through culvert. Camera Direction: 100°. Date/Time: February 8, 2023/ 1:35 P.M.

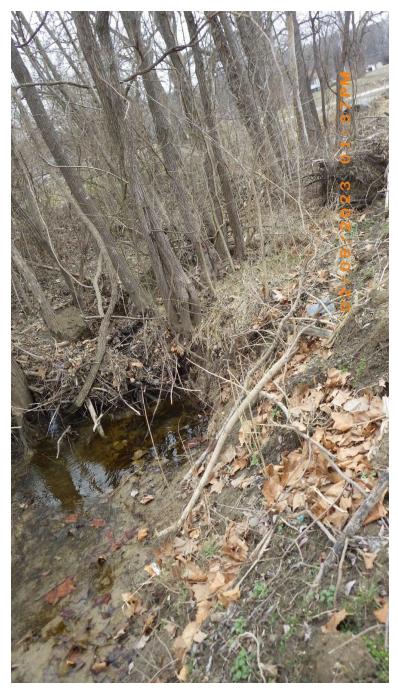
7: CCHT0179 Description: Debris and vegetation growth in Belleview Ditch. Location: Just south of 81<sup>st</sup> St. Camera Direction: 165°. Date/Time: February 8, 2023/ 1:37 P.M.

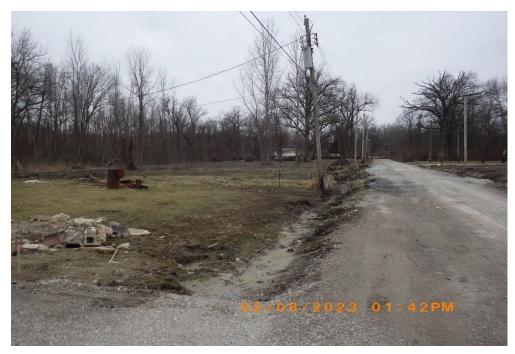
EPA inspectors arrived at the location of a recently reported SSO in the vicinity N. 80st St. and Bluff St. at 1:40 P.M. EPA inspectors observed standing water in the ditch next to the street. They did not observe any sanitary sewer overflows in the area.

8: CCHT0180
Description: Location of a recent SSO reported by the City of Cahokia Heights. (Photo cropped to remove PII) No SSO discharge was observed. Location: N. 80<sup>th</sup> St. just south of Bluff St. Camera Direction:196°.
Date/Time: February 8, 2023/1:42 P.M.

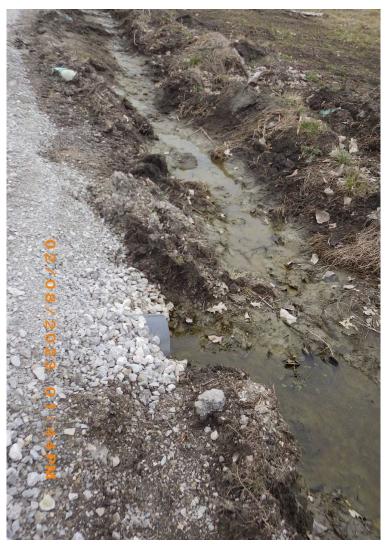
9: CCHT0181 Description: Upstream view of roadside ditch with water flowing from the location of a recent SSO reported by the City of Cahokia Heights (top of image). (Photo cropped to remove PII.) Location: Roadside ditch on east side of N. 80<sup>th</sup> St. Camera Direction: 20°. Date/Time: February 8, 2023/ 1:44 P.M.

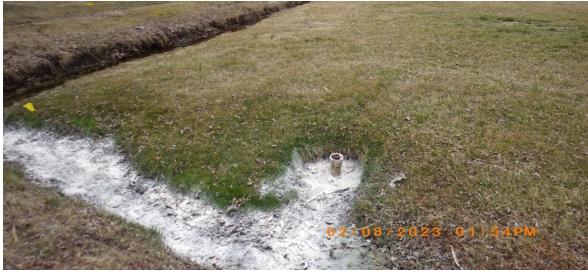
EPA inspectors arrived at the cleanout overflow location on N. 82<sup>nd</sup> St. at 1:53 P.M. The sewer cleanout was not discharging. EPA observed toilet paper debris around the base of the cleanout pipe and in the roadside ditch. EPA also observed what appeared to be lime spread around the cleanout pipe and ditch.

Description: The cleanout on N. 82<sup>nd</sup> St. was not flowing on the day of the recon inspection. Note the toilet paper debris and what appeared to be lime around the base of the cleanout pipe and in the roadside ditch. (Photo cropped to remove PII.)

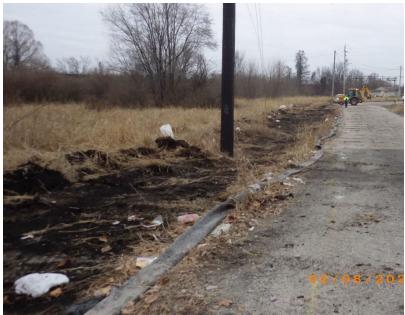
Description: City of Cahokia Heights Sewer Department staff installing temporary sewer line bypass hose along east side of 63<sup>rd</sup> St. Sewer staff mentioned that the 63<sup>rd</sup> St. lift station will be replaced soon. (Photo cropped to remove PII.) Location: 63<sup>rd</sup> St.

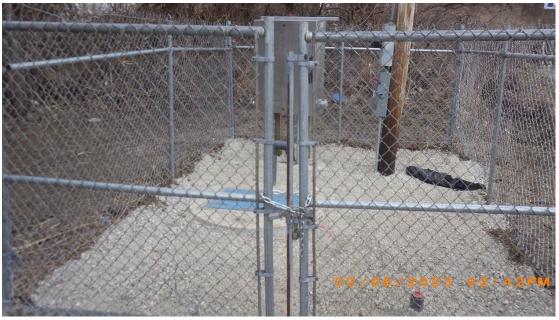
#### 12: CCHT0184 Description: Refurbished Pocket Rd. Lift Station, including new security fencing. Location: Pocket Rd. near Missouri Ave. Camera Direction: 127°. Date/Time: February 8, 2023/ 2:42 P.M.

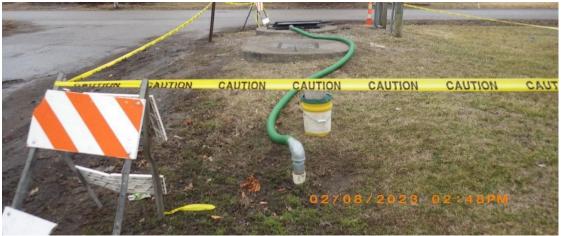
13: CCHT0185 Description: Jackson and Pocket Rd. Lift Station. Note bypass hose. (Photo cropped to remove PII.)

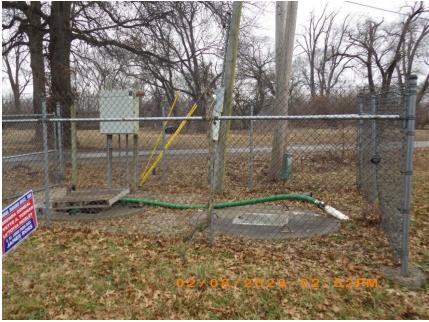
### 14: CCHT0186

Description: Pfieffer and Johnson Ln. Lift Station. Note bypass hose. (Photo cropped to remove PII.)

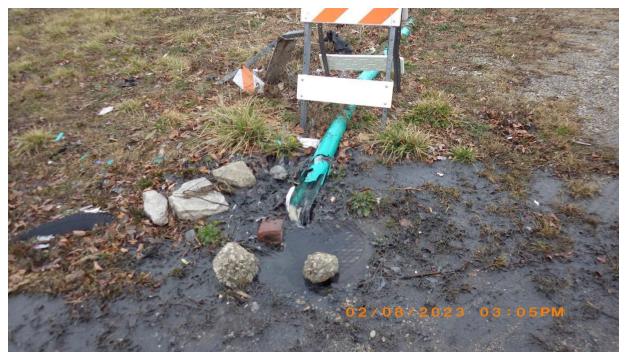
Description: Lady of Snows Lift Station. Note damaged bypass pipe conveying sewage from lift station to sewer manhole along Old Missouri Ave. Sewer staff arrived at 3:10 P.M. to repair damaged pipe.

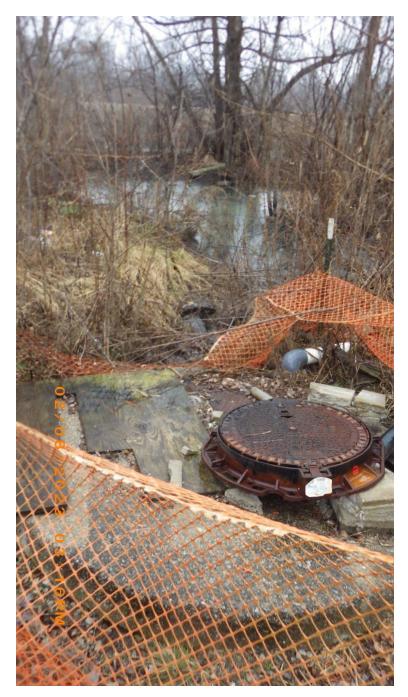
16: CCHT0188
Description: Lauralee and Violet Dr. Lift Station.
Location: Lauralee Dr. and Violet Dr.
Camera Direction: 84°.
Date/Time: February 8, 2023/ 3:16 P.M.

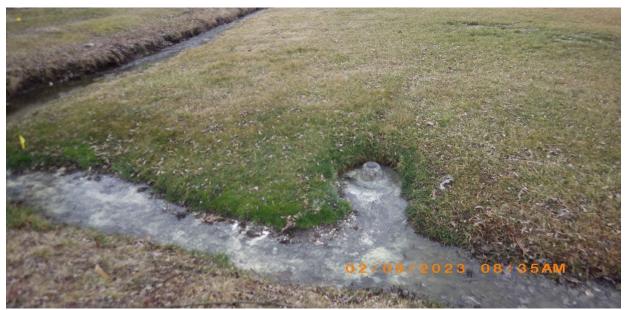
# 17: CCHT0189

During the evening of February 8 and the early morning hours of February 9, a total of 0.85" of rain was recorded at KCPS. EPA inspectors arrived at the sewer cleanout on N. 82<sup>nd</sup> St., south of Bluff St. at 8:35 A.M. on February 9, 2023. The cleanout was overflowing and the ditch leading from the cleanout was flowing. The EPA inspectors noted toilet paper debris in and around the ditch.

Description: The cleanout on N. 82<sup>nd</sup> St. was flowing on February 9, 2023. Note the toilet paper debris around the base of the cleanout pipe and in the roadside ditch. (Photo cropped to remove PII.)

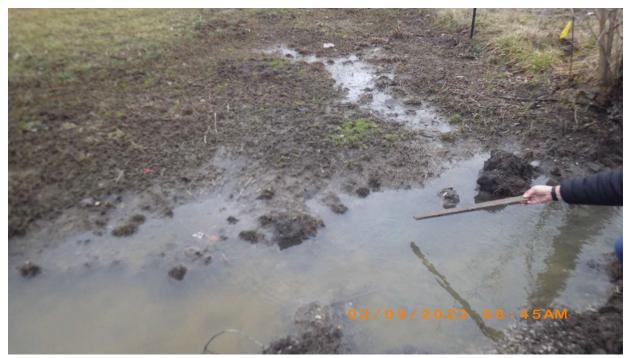
18: CCHT0190

EPA inspectors arrived at the location of a recently reported SSO in the vicinity of N. 80<sup>st</sup> St. and Bluff St. at 8:40 A.M. on February 9, 2023. EPA inspectors observed water in the ditch next to the street and observed a bubbling discharge in the roadside ditch on the east side of N. 80<sup>th</sup> St. EPA inspectors captured the discharge on video (CCHT0191). EPA inspectors followed the flow of the water in the ditch southwest towards the twin culverts crossing under N. 80<sup>th</sup> St.

Description: Location of a recent SSO reported by the City of Cahokia Heights. EPA inspectors observed a bubbling discharge in the roadside ditch on east side of N. 80<sup>th</sup> St. Location: Roadside ditch on east side of N. 80<sup>th</sup> St. Camera Direction:160°.

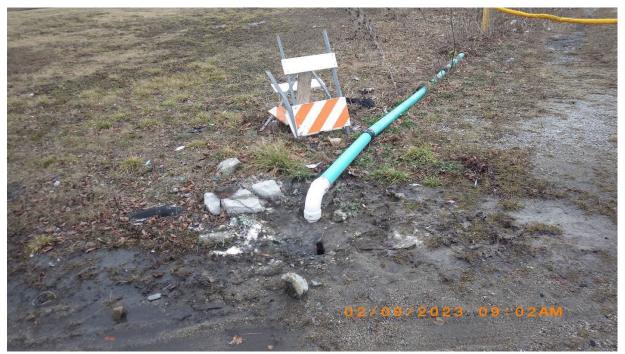
19: CCHT0192

Description: Lady of Snows Lift Station. Note the repaired bypass pipe conveying sewage from lift station to sewer manhole along Old Missouri Ave. Location: Old Missouri Ave. Camera Direction: 107°. Date/Time: February 9, 2023/ 9:02 A.M.

EPA inspectors arrived at the Lady of Snows Lift Station at 9:00 A.M. on February 9, 2023, and observed the repaired bypass pipe conveying sewage from lift station to sewer manhole along Old Missouri Ave.
