UNITED STATES ENVIRONMENTAL PROTECTION AGENCY
REGION 5
77 WEST JACKSON BOULEVARD
CHICAGO, IL 60604-3590

Subject: July 25-28, 2022, MS4 Inspection Report for the City of Cahokia Heights

MS4 Inspection Report

Cahokia Heights MS4

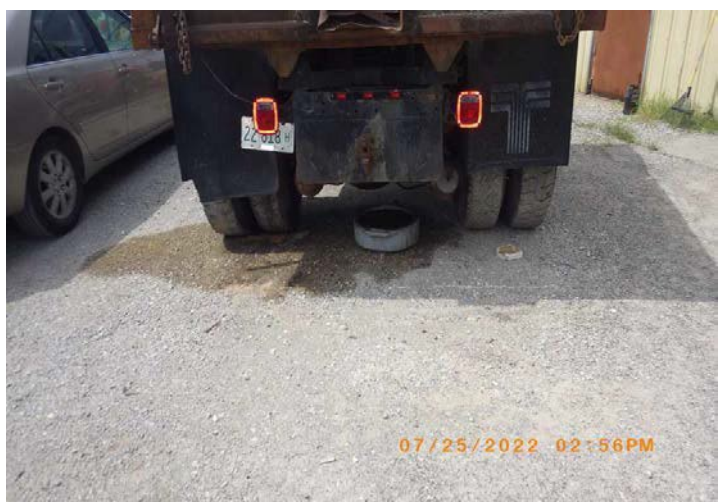
We observed staining on the gravel ground beneath a public works truck. At the time of the inspection there was a pan underneath the truck collecting oil dripping from the rear of the vehicle (see Photo Log image CCHM001).

<p>We observed staining on the gravel ground beneath a parked public works truck. At the time of the inspection there was a pan underneath the truck collecting oil dripping from the rear of the vehicle (see Photo Log image CCHM001).</p>

Staining on gravel parking lot beneath Public Works truck.
CCHM001.JPG
07/25/2022 02:56 PM (CT)
Dean Maraldo
Public Works Facility /Pollution Prevention/Good Housekeeping for Municipal Operations
No CBI
No PII

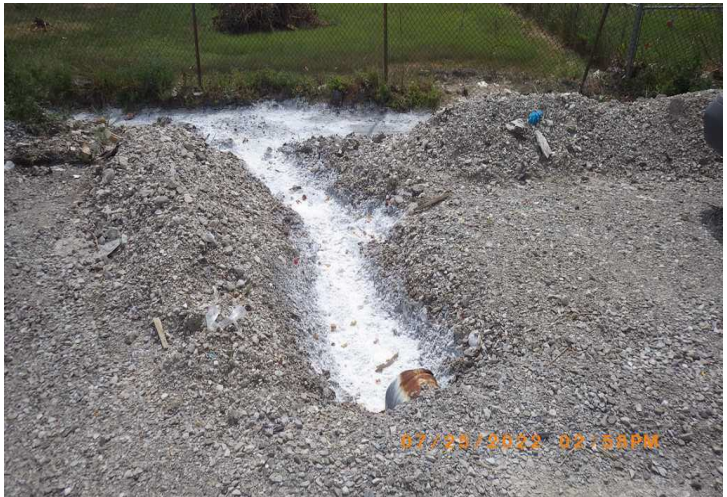
Outlet of corrugated metal pipe draining salt storage area.
CCHM002.JPG
07/25/2022 02:58 PM (CT)
Dean Maraldo
Public Works Facility /Pollution Prevention/Good Housekeeping for Municipal Operations
No CBI
No PII

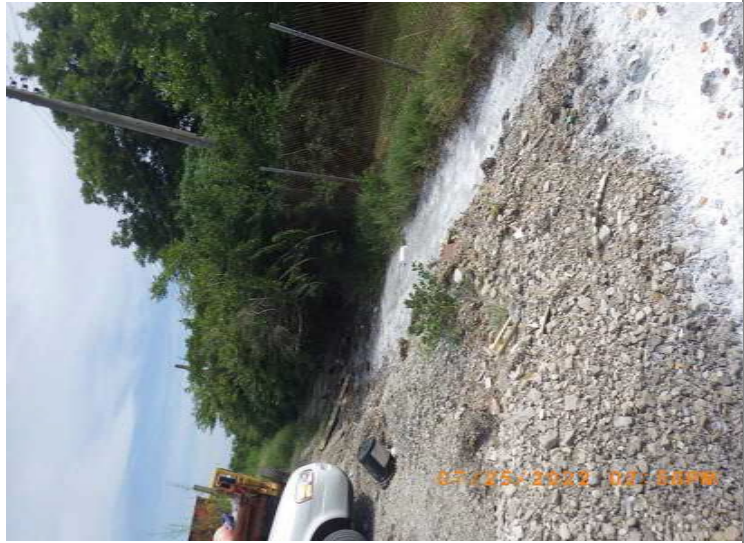
The group walked over to the salt storage area and I observed a corrugated metal pipe inlet in front of the salt storage structure (see Photo Log image CCHM004). The salt storage structure was covered, but the front of the structure was exposed and salt debris was observed within the inlet of the corrugated metal pipe. The pipe led to a ditch running along the southwest boundary of the facility. I observed the outlet of the metal corrugated pipe and noticed white staining and debris on the gravel at the outlet and leading into and along the ditch (see PhotoLog image CCHM002). The ditch continued southeast toward the rear of the facility and I-255. The white staining and debris continued along the ditch (see Photo Log image CCHM003).

Ditch along southwest boundary of the facility.

Note white staining and debris along ditch.

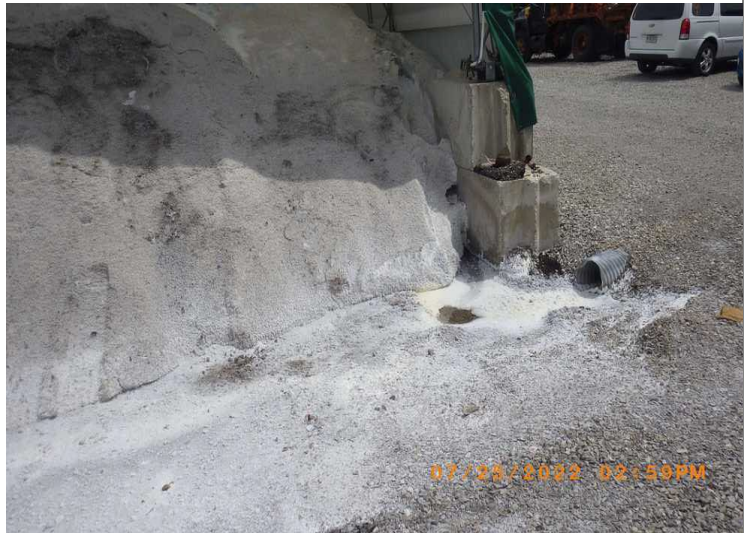
Front of salt storage structure and inlet of corrugated pipe.

Note salt observed within the corrugated metal pipe which drains to the ditch along the southwest boundary of the facility.

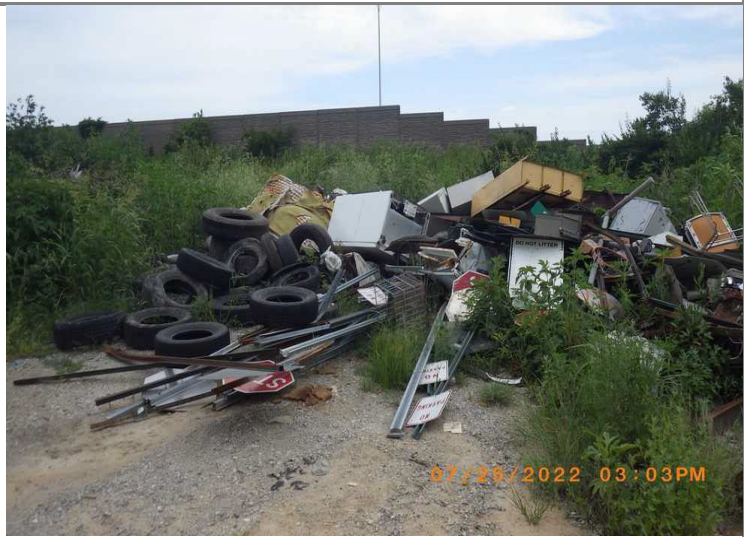
We walked toward the rear of the public works yard and noticed some large debris and waste piles (See Photo Log images CCHM005). U.S. EPA inspector Joan Rogers asked about the Public Works department's waste and debris collection practices. The Director said the crews pick up trash all day and deliver all waste here to the Public Works yard. They haul waste daily to a nearby landfill. The Director said they separate tires and twice a year send tires to the County as part of a state tire recycling program. Inspector Rogers noted that they may want to consider shredding or covering tires while temporarily stored on site to minimize potential insect breeding.

Debris pile in rear of facility.

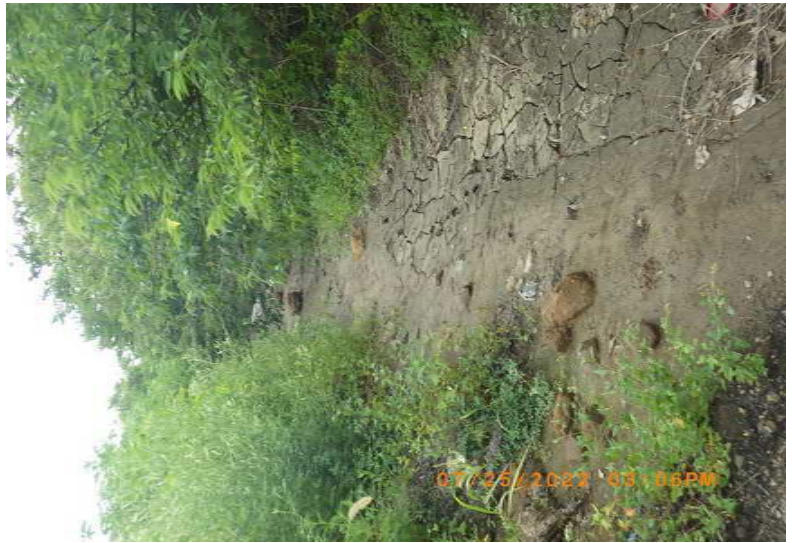
Walking along the southwest boundary of the facility, I observed the ditch running along the boundary. I took a photograph of the ditch (see Photo Log image CCHM006) looking southeast and downgradient from the point we observed the corrugated metal pipe from the salt storage structure.

Ditch running along the southeast boundary.
CCHM006.JPG
07/25/2022 03:06 PM (CT)
Dean Maraldo
Public Works Facility /Pollution Prevention/Good Housekeeping for Municipal Operations
No CBI
No PII
View looking southeast toward rear of property and I-255, and downstream from the point we observed the corrugated metal pipe from the salt storage structure.

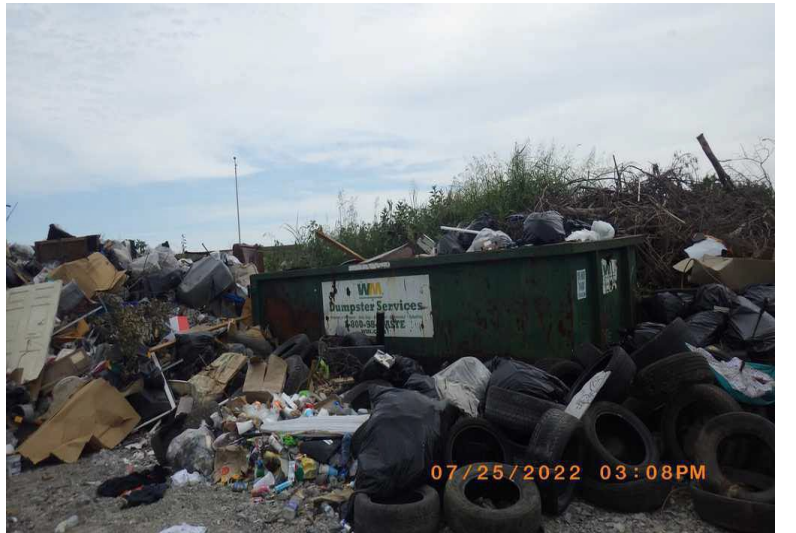
The group then headed across the yard toward the northeast and observed another large debris pile and two uncovered dumpsters filled with debris (see Photo Log images CCHM007 and CCHM 008).

Debris pile and uncovered dumpster.
CCHM007.JPG
07/25/2022 03:08 PM (CT)
Dean Maraldo
Public Works Facility /Pollution Prevention/Good Housekeeping for Municipal Operations
No CBI
No PII

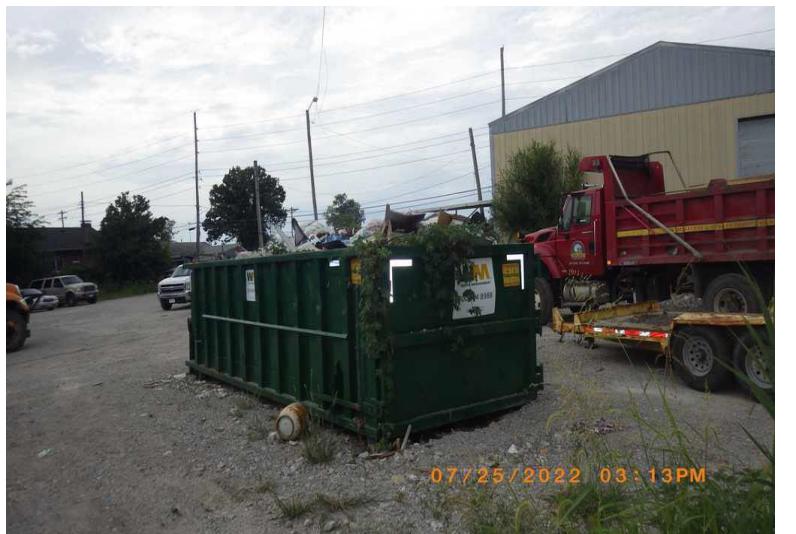
Uncovered dumpster.
CCHM008.JPG
07/25/2022 03:13 PM (CT)
Dean Maraldo
Public Works Facility /Pollution Prevention/Good Housekeeping for Municipal Operations
No CBI
No PII

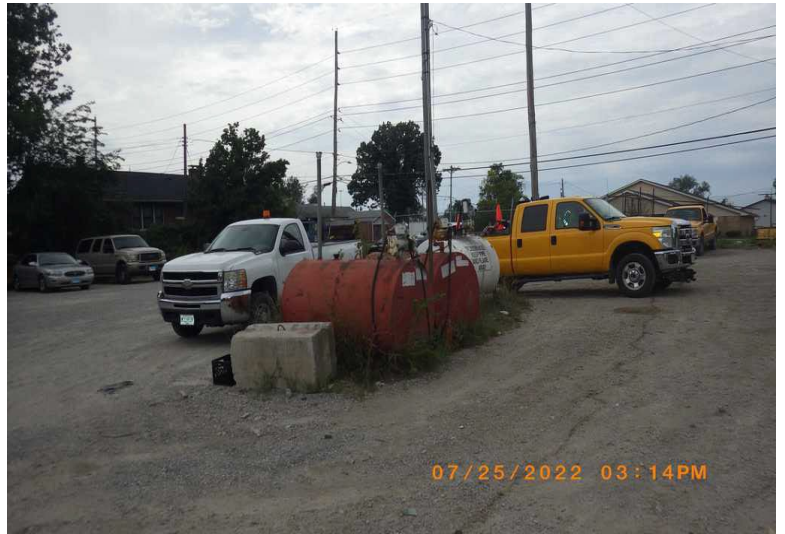
As we walked back toward the facility garage I observed three above-ground tanks (two diesel and one gas tank) in the center of the lot (see Photo Log image CCHM009). The Director said the tanks are abandoned and no longer used. He said the diesel tanks are empty and they are waiting for a pump to drain whatever is

remaining in the gas tank.

Abandoned diesel and gas tanks.
CCHM009.JPG
07/25/2022 03:14 PM (CT)
Dean Maraldo
Public Works Facility /Pollution Prevention/Good Housekeeping for Municipal Operations
No CBI
No PII

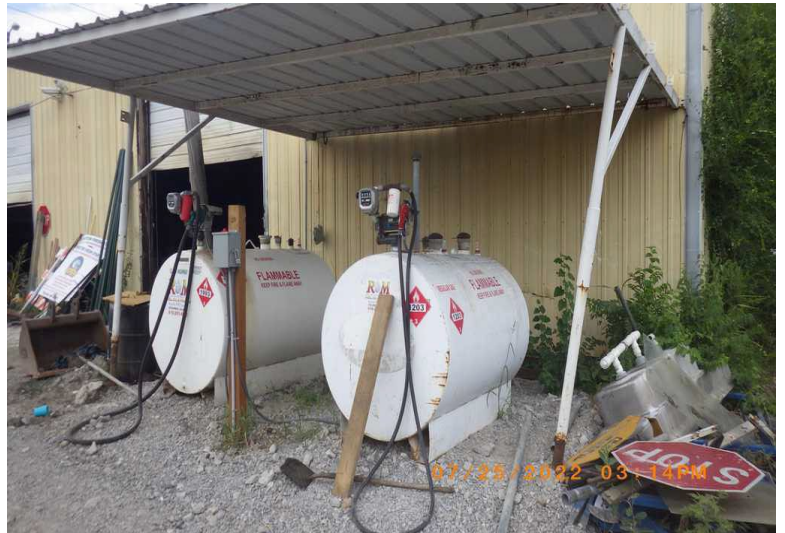
The last area observed was the new fuel storage area. The area is covered and contains two new above-ground fuel tanks (see Photo Log image CCHM010). The Director said the tanks were installed within the last three months. The new above-ground fuel tanks did not have secondary containment, but the Director believed they were double-walled tanks.

New Fuel Tank Storage Area.
CCHM010.JPG
07/25/2022 03:14 PM (CT)
Dean Maraldo
Public Works Facility /Pollution Prevention/Good Housekeeping for Municipal Operations
No CBI
No PII
The area is covered and contains two new above-ground fuel tanks.

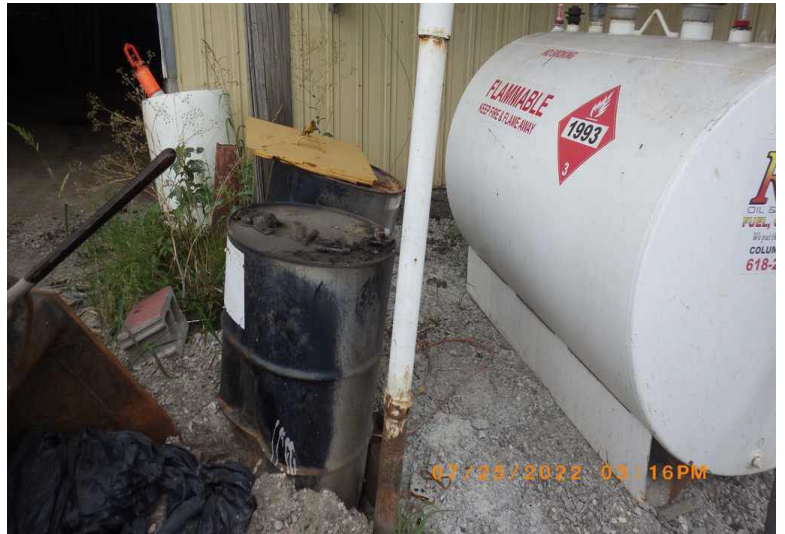
I also observed two damaged, uncapped, and nearly filled drums in the new fuel storage area (see Photo Log image CCHM 011). I asked the Director if he knew what was in the drums. Public Works Assistant Director Tom Hill dipped the drums and noted that the liquid appeared to be waste oil.

<p>Location: Public Works Facility, 726 S. 50th Street, Cahokia Heights</p>	<p>Area: Pollution Prevention/Good Housekeeping for Municipal Operations</p>
<p>DM1-OB-005</p>	
<p>I observed two damaged, uncapped, and nearly filled drums in the new fuel storage area (see Photo Log image CCHM011). Public Works Assistant Director Tom Hill dipped the drums and noted that the liquid appeared to be waste oil.</p>	<p>Citations: Illinois EPA GP ILR40; 40 CFR § 122.33</p>
<p>I observed two uncovered dumpsters filled with debris in northeast portion of the yard (see Photo Log images CCHM007 and CCHM008).</p>	
<p>Inspector Rogers noted that they may want to consider shredding or covering tires while temporarily stored onsite to minimize potential insect breeding.</p>	
<p>I observed a corrugated metal pipe inlet in front of the salt storage structure (see Photo Log image CCHM004). The salt storage structure was covered, but the front of the structure was exposed and salt debris was observed with the inlet of the corrugated metal pipe. The pipe led to a ditch running along the southwest boundary of the facility. I observed the outlet of the metal corrugated pipe and noticed white staining and debris on the gravel at the outlet and leading into and along the ditch (see Photo Log image CCHM002).</p> <p>The ditch continued southeast toward the rear of the facility and I-255. The white staining and debris continued along the ditch (see Photo Log image CCHM003).</p>

New Fuel Storage Area - waste oil drums
CCHM011.JPG
07/25/2022 03:16 PM (CT)
Dean Maraldo
Public Works Facility /Pollution Prevention/Good Housekeeping for Municipal Operations
No CBI
No PII
I observed two uncapped, filled, and damaged waste oil drums.

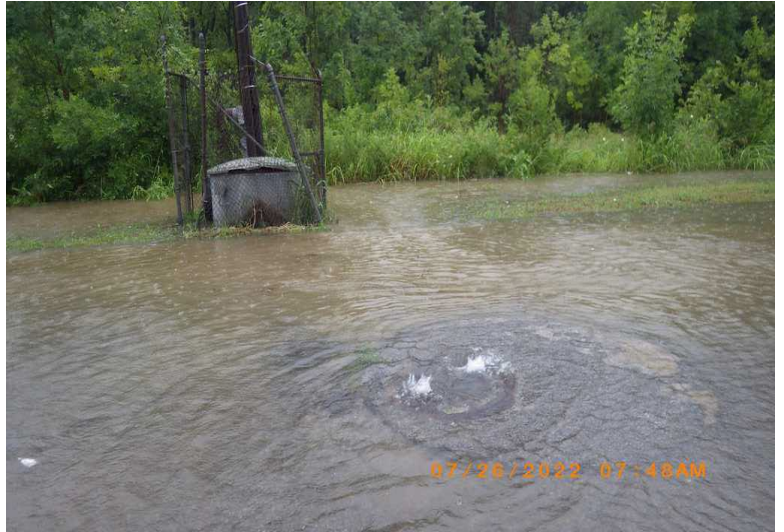
Location: Stormwater Observations/73rd Street, Cahokia Heights	Contains CBI: No
Observation #: DM1-OB-007	Date: 07/26/2022
On July 26, 2022, I observed a surcharging sanitary sewer manhole (see Photo Log image CHWW0030) on 73rd Street in Cahokia Heights. The roadside ditches along the street were completely inundated with floodwater, along with sanitary sewage discharging from the manhole. I also captured video of the surcharging manhole and inundated ditches on 73rd Street.	
Photo(s) 1. CHWW0030.JPG	
Location: Stormwater Observations/N 82 and Belleview Ave, Cahokia Heights	Contains CBI: No
Observation #: DM1-OB-008	Date: 07/26/2022
On July 26, 2022, I observed inundated roadside ditches and a partially submerged lift station structure on Belleview Ave (see Photo Log CHWW0038).	
Photo(s) 1. CHWW0038.JPG	
Location: Stormwater Observations/N. 82nd Street, Cahokia Heights	Contains CBI: No
Observation #: DM1-OB-006	Date: 07/26/2022

Surcharging sanitary sewer manhole on 73rd Street in Cahokia Heights.
CHWW0030.JPG
07/26/2022 07:48 AM (CT)
Joan Rogers
Stormwater Observations/73rd Street, Cahokia Heights
No CBI
No PII
The roadside ditches along the street were completely inundated with floodwater, along with sanitary sewage discharging from the manhole.

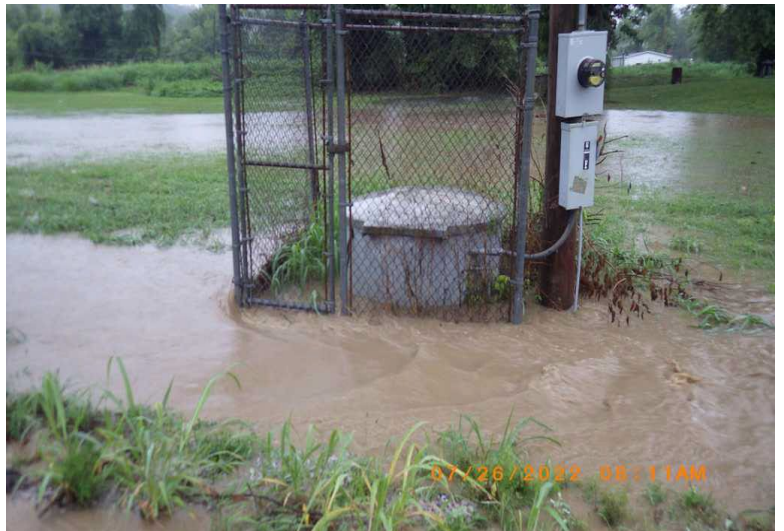
DM1-OB-008	
On July 26, 2022, I observed inundated roadside ditches and a partially submerged lift station structure on Belleview Ave (see Photo Log CHWW0038).	Citations: Section 301(a) of the Clean Water Act, 33 U.S.C. Section 1311(a)

N82nd and Belleview Ave.
CHWW0038.JPG
07/26/2022 08:11 AM (CT)
Dean Maraldo
Stormwater Observations/N 82 and Belleview Ave, Cahokia Heights
No CBI
No PII
Inundated roadside ditches and a partially submerged lift station structure on Belleview Ave.

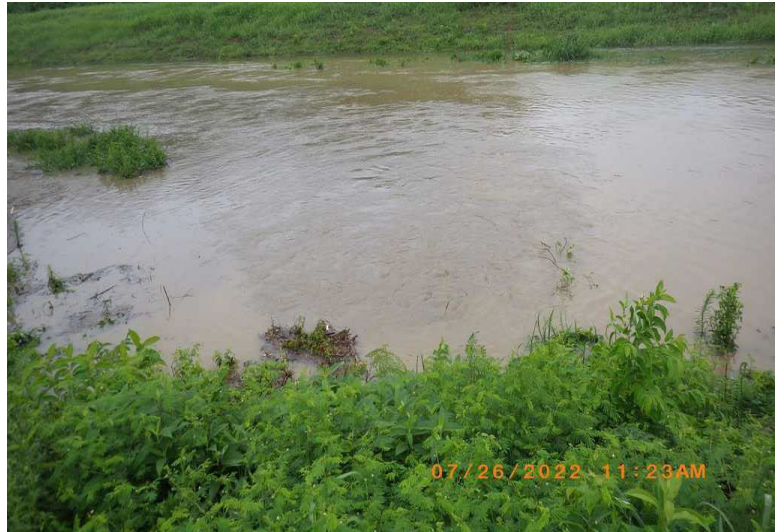
Stormwater discharge to Canal #1
CHWW0047.JPG
07/26/2022 11:23 AM (CT)
Dean Maraldo
Stormwater Observations/N. 82nd Street, Cahokia Heights
No CBI
No PII
Photo of stormwater discharge to Canal #1. Stormwater discharges through a pair of culverts under N. 80th Street. The stormwater collects from roadside ditches throughout the area, and includes discharge from a sanitary sewer overflow location on N. 82nd Street.

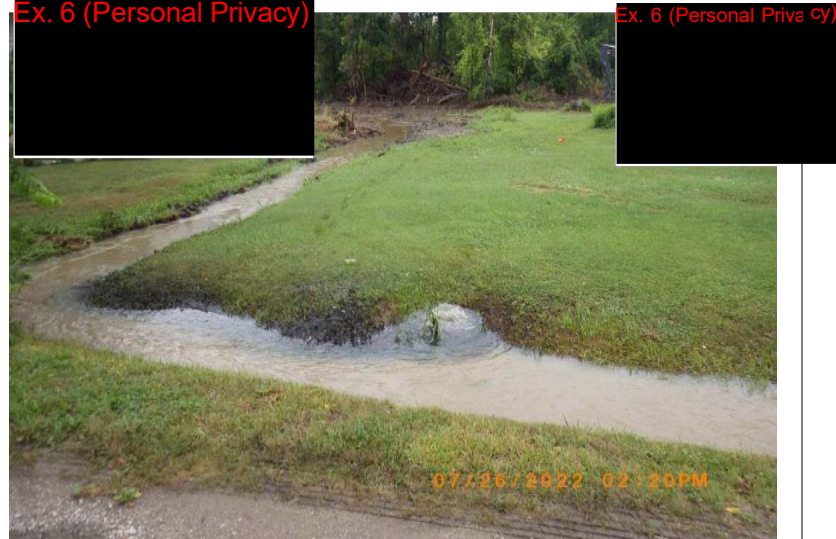
On July 26, 2022, I observed a sanitary sewer overflow (SSO) from sewer cleanout along N. 82nd Street. The SSO discharges into a roadside ditch (see Photo Log image CCWW0055) that discharged to a ditch that flowed through the backyards of a several homes and then through twin culverts under N. 80 th Street and into Canal #1 (see Photo Log image CHWW0047). I also captured video of both the SSO discharge and the ditch discharge to Canal #1.	
Photo(s) 1. CHWW0055.JPG 2. CHWW0047.JPG

Location: Stormwater Observations	Area: N. 82nd Street, Cahokia Heights
DM1-OB-006	
On July 26, 2022, I observed a sanitary sewer overflow (SSO) from sewer cleanout along N. 82nd Street. The SSO discharges into a roadside ditch (see Photo Log image CCWW0055) that discharged to a ditch that flowed through the backyards of a several homes and then into Canal #1 (see Photo Log image CHWW0047).	Citations: Section 301(a) of the Clean Water Act, 33 U.S.C. Section 1311(a)
Location: Stormwater Observations	Area: 73rd Street, Cahokia Heights
DM1-OB-007	
On July 26, 2022, I observed a surcharging sanitary sewer manhole (see Photo Log image CHWW0030) on 73rd Street in Cahokia Heights. The roadside ditches along the street were completely inundated with floodwater, along with sanitary sewage discharging from the manhole.	Citations: Section 301(a) of the Clean Water Act, 33 U.S.C. Section 1311(a)
Location: Stormwater Observations	Area: N 82 and Belleview Ave, Cahokia Heights

Sanitary sewer overflow (SSO) from sewer cleanout along N. 82nd Street
CHWW0055.JPG
07/26/2022 02:20 PM (CT)
Dean Maraldo
Stormwater Observations/N. 82nd Street, Cahokia Heights
No CBI
No PII
The SSO discharges into a roadside ditch that discharged to a ditch that flows through the back yards of a several homes and then into Canal #1 (see Photo Log image CHWW0047).
