Subject: December 12, 2022 Reconnaissance Inspection Report for Cleveland-Cliffs Burns Harbor, NPDES Permit Number IN0000175

**CWA COMPLIANCE EVALUATION INSPECTION REPORT  
U.S. ENVIRONMENTAL PROTECTION AGENCY, REGION 5**

Compliance Evaluation Reconnaissance Inspection

Cleveland Cliffs Burns Harbor, LLC  
250 US-12  
Burns Harbor, Indiana 46304  
Porter County  
41.625, -87.117

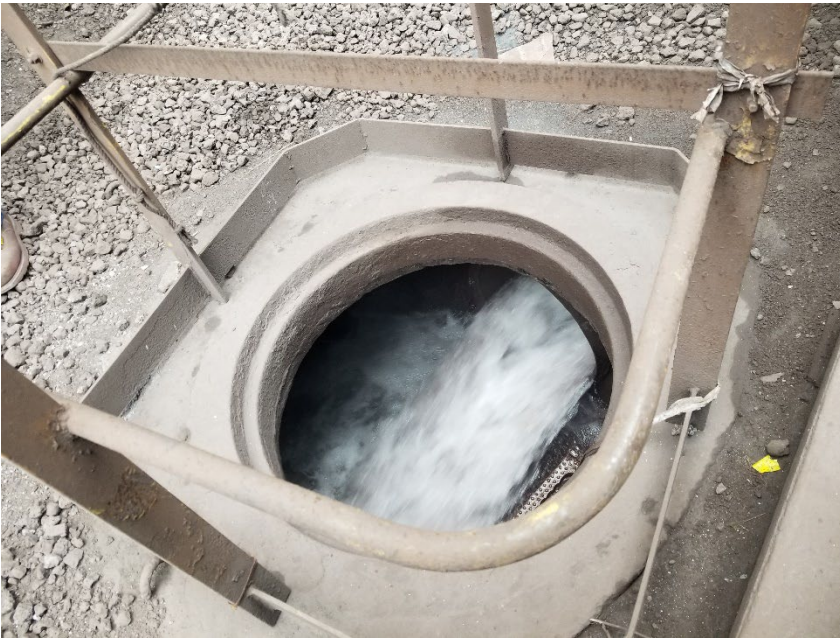
1: 20221212\_103205

EPA observed the manhole where the flow from the Hi-Cap Thickener overflow and Final Thickener overflow merge. EPA also observed the auto-sampler for TCDF samples on the walkway over the Final Thickener.

Description: Looking down into the manhole where the Hi-Cap Thickener overflow and Final Thickener overflow merge.

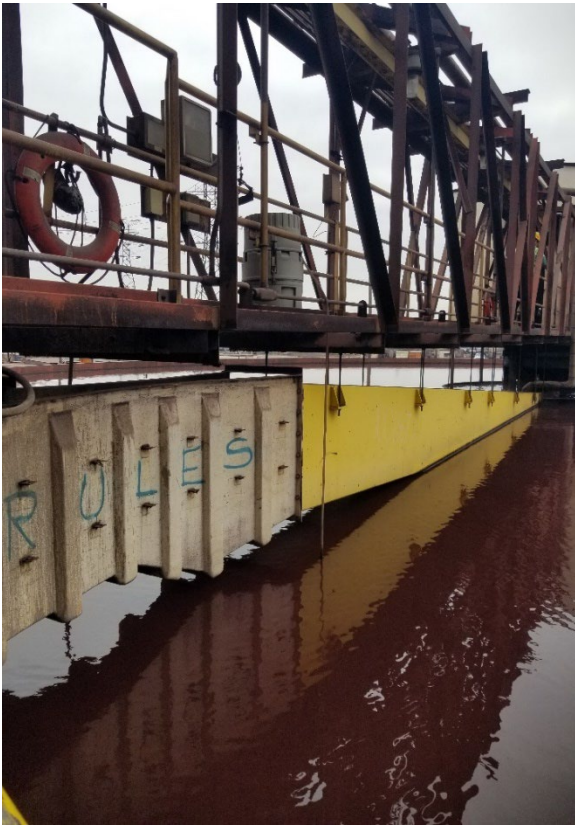
2: 20221212\_103316

Description: The TCDF sampling is taken from the Final Thickener. Note the auto-sampler on the walkway above the Final Thickener.

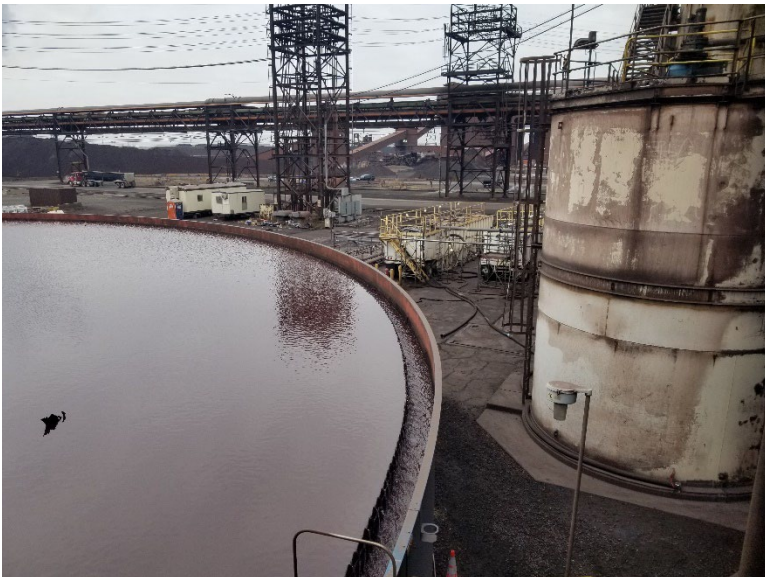
3: 20221212\_103622

Description: The Final Thickener is on the left and the Hi-Cap Thickener is on the right. Hi-Cap Thickener was being cleaned on the day of the inspection and was not in use.

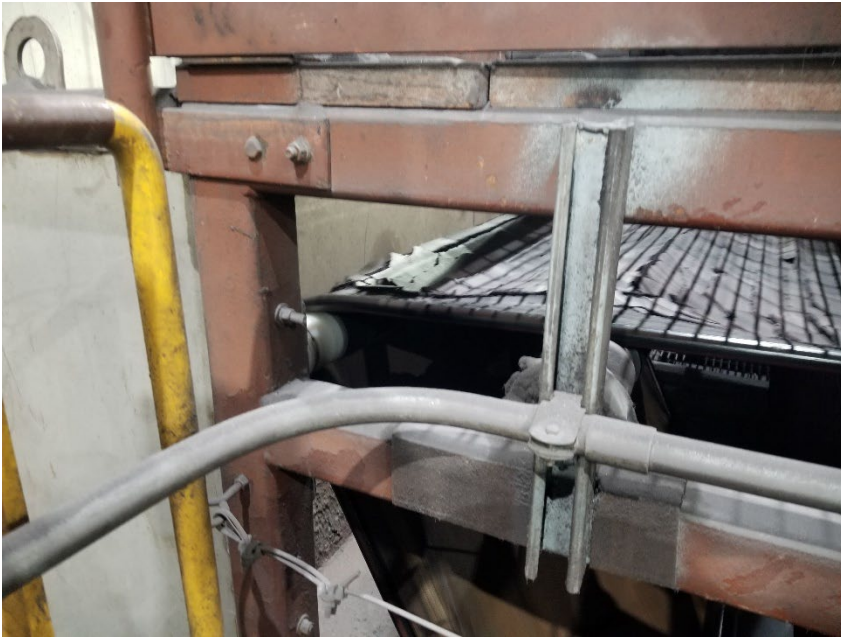
4: 20221212\_104852

Description: The cake from the vacuum press from the hydrocyclone underflows. The cake goes to the Sinter Plant for recycling.

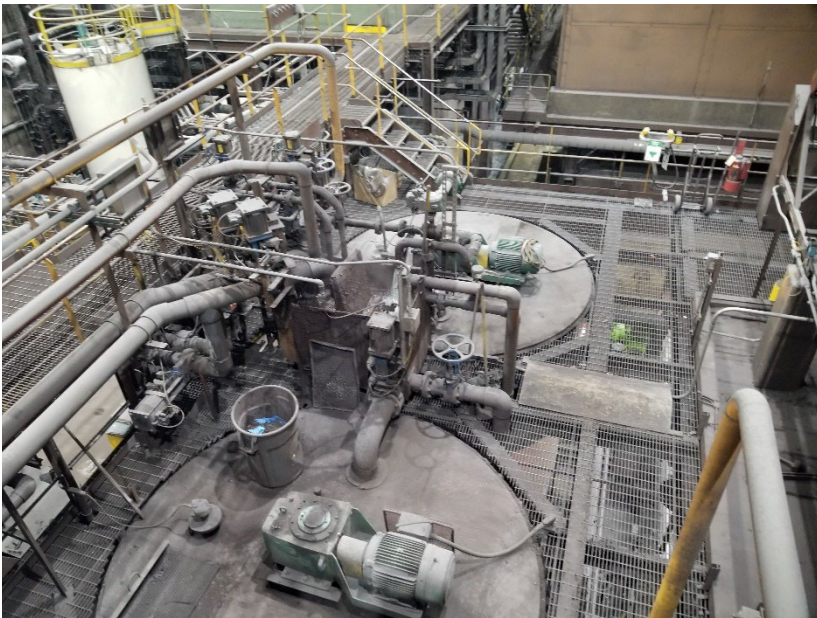
5: 20221212\_105005

Description: The underflow for each Blast Furnace Thickener goes to a tank and is then pumped to the hydrocyclones.

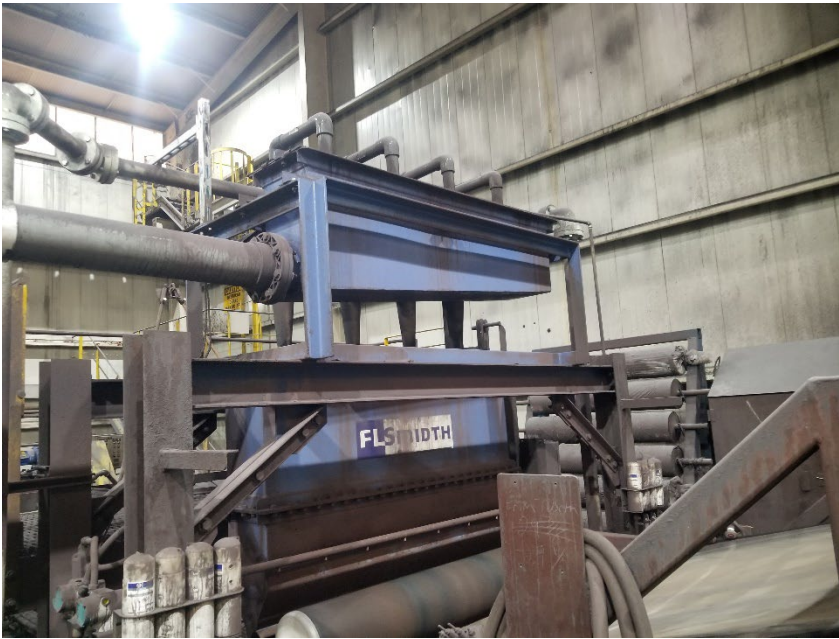
6: 20221212\_105216

Description: The four (of eight total) hydrocyclones spin off the solids from the Blast Furnace Thickener underflows.

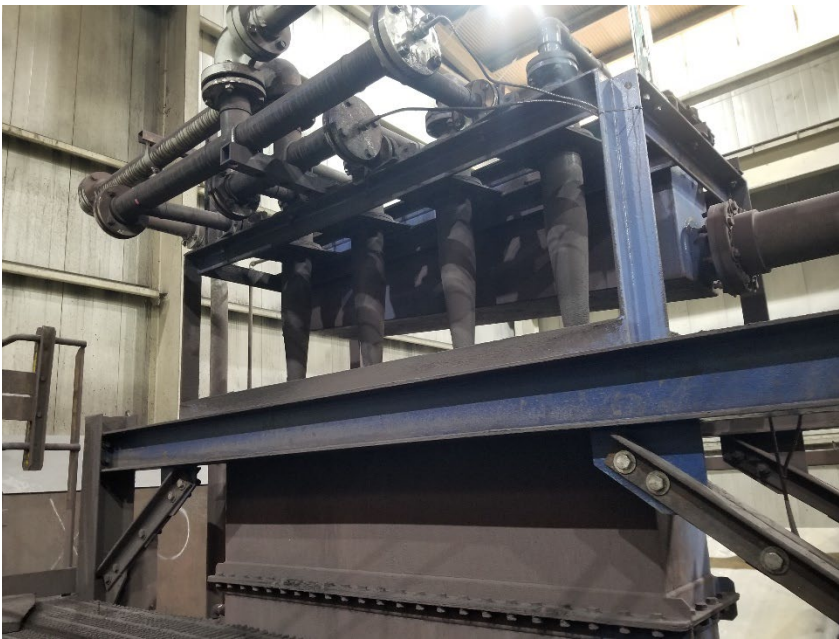
7: 20221212\_105356

Description: The four (of eight total) hydrocyclones spin off the solids from the Blast Furnace Thickener underflows.

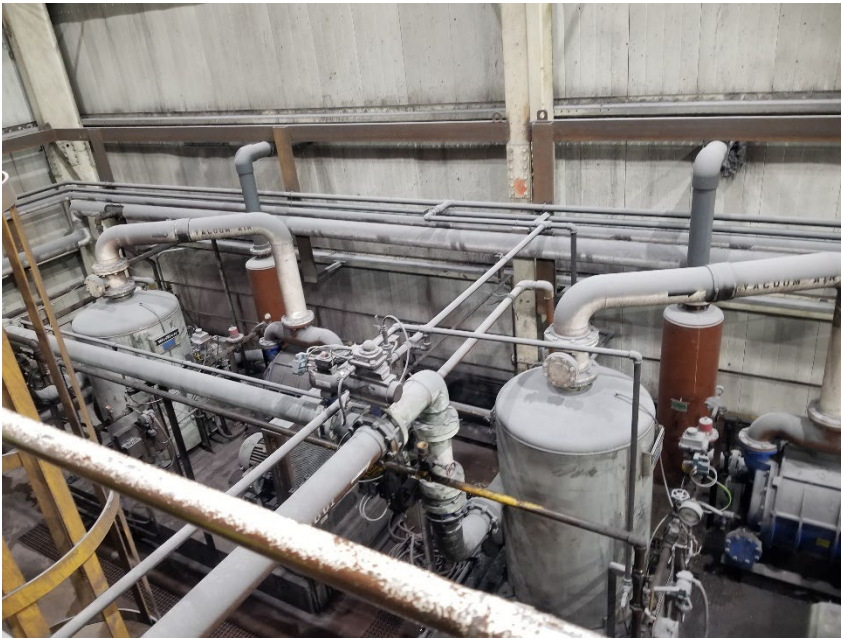
8: 20221212\_105845

Description: Two vacuum pumps for the two vacuum presses that press the liquid from the hydrocyclone underflow.

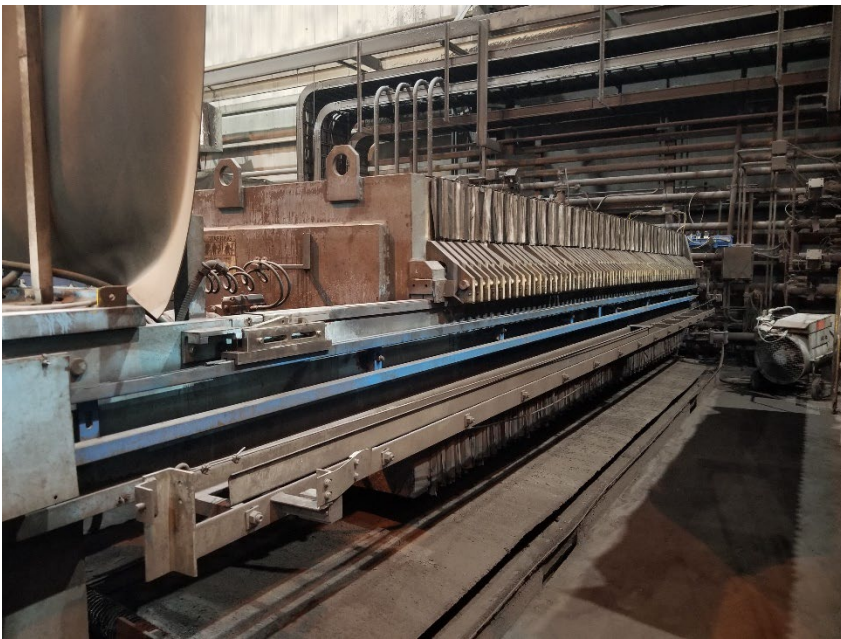
9: 20221212\_110328

Description: Plate and frame filter presses are used to remove liquid from the basic oxygen furnace sludge and the Final Thickener underflow. Two plate and frame filter presses are run at a time.

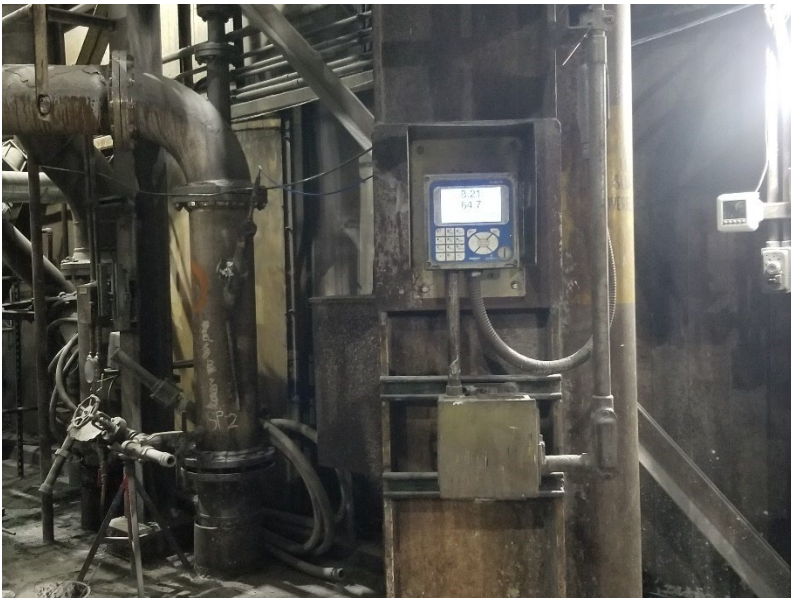
10: 20221212\_111355

Description: The pH meter and sampling point 2 (SP2).

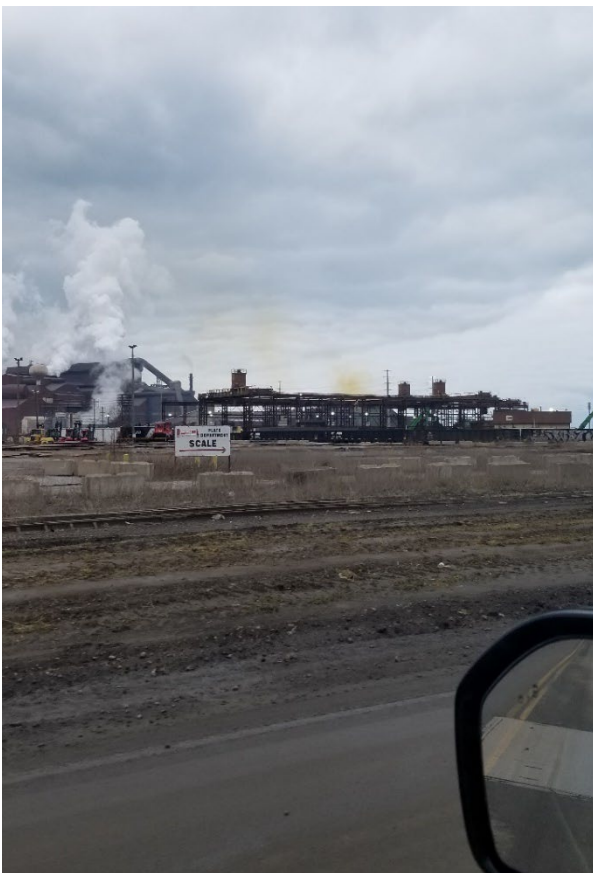
11: 20221212\_112249

Description: Brown air fumes observed on way to Outfall 003.

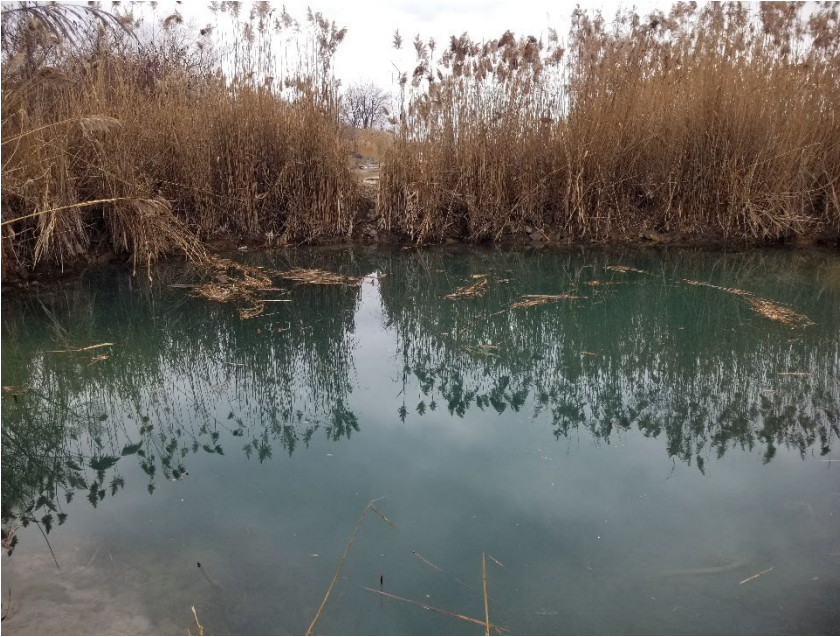
12: 20221212\_112920

EPA, IDEM and CCBH personnel then drove to Outfall 003 and arrived at 11:25 A.M. EPA observed that the water in Outfall 003 was clear.

Description: There was no sheen observed at Outfall 003 on the day of the inspection.

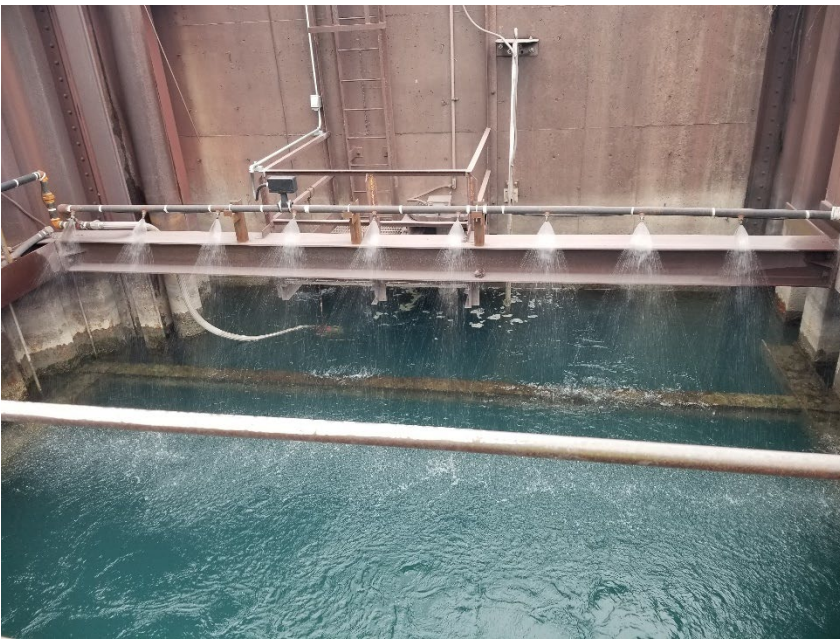
13: 20221212\_114649

The inspectors followed the facility personnel to Outfall 002 and arrived at 11:42 A.M. Prior to the July inspection, Mr. Barot designed and installed a spray bar at the head of the outfall structure. The spray consisted of recirculated lake water and was intended to knock down the foam in the outfall. Since then, Mr. Barot designed and installed a second spray bar closer to the end of the outfall structure. This spray bar is intended to knock down any foam that escapes the first spray bar. Both spray bars run continuously and Mr. Barot checks on the spray bars daily.

Description: Spray nozzles are intended to knock down any foam from Outfall 002 before it can leave the outfall structure.

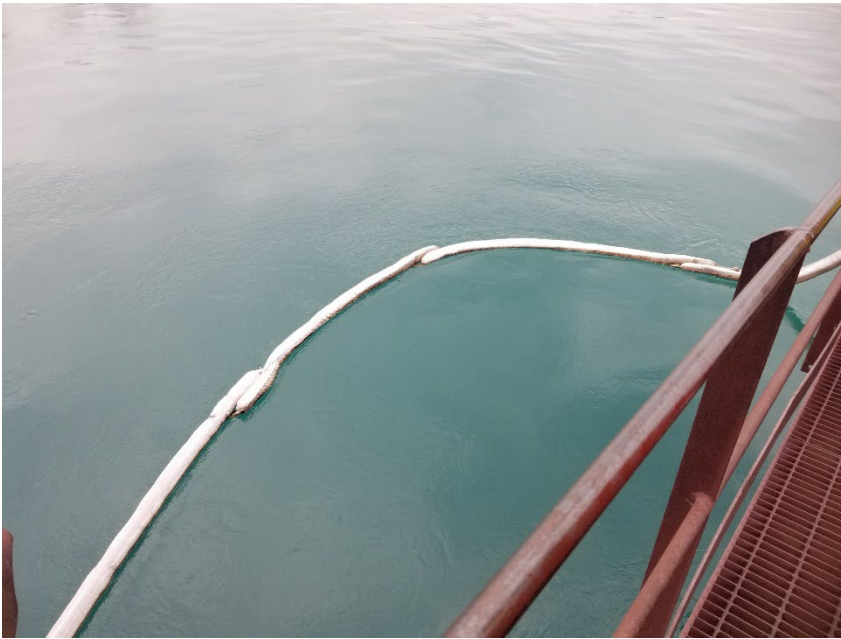
14: 20221212\_114811

There was no foam inside or outside the booms at Outfall 002 on the day of the inspection.

Description: The external boom at Outfall 002. EPA did not observe any foam on the day of the inspection.

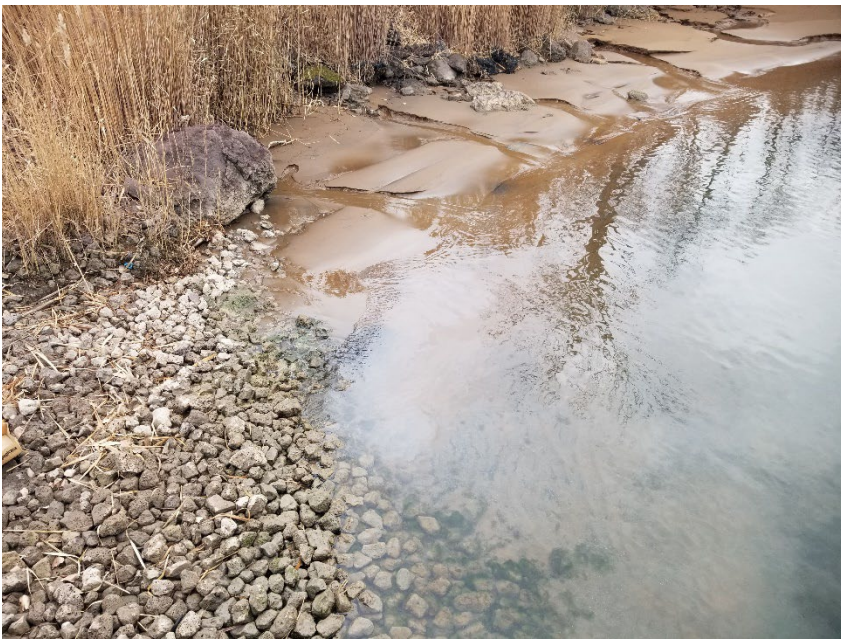
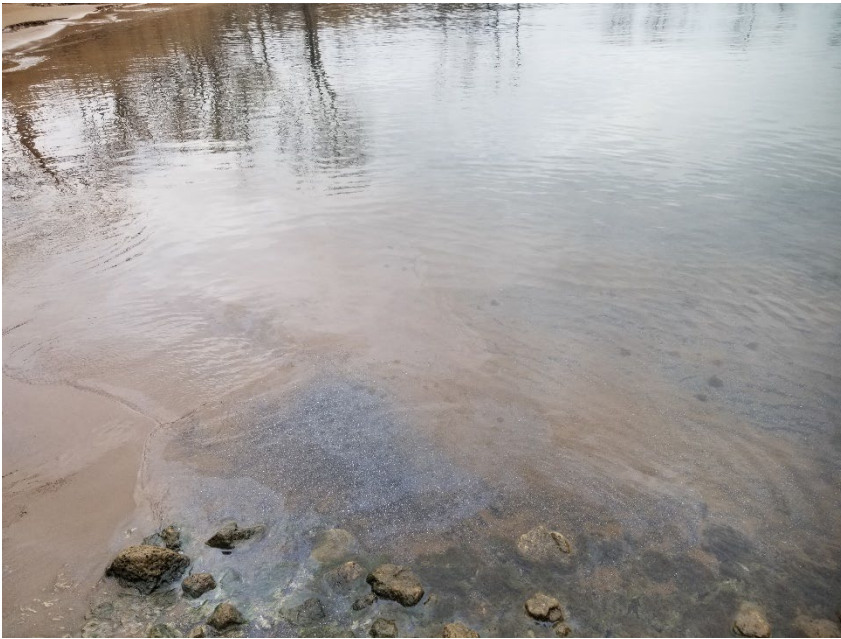
EPA and IDEM observed and documented material on the water near the shoreline outside of Outfall 002. It was very faint and did not have the rainbow coloring like an oil sheen.

Description: EPA observed material on the water near Outfall 002.

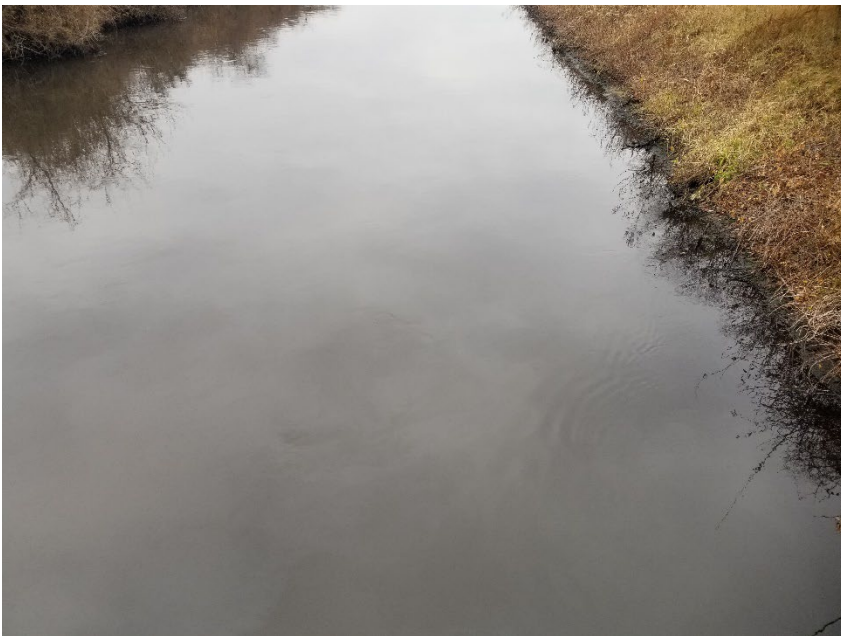
17: 20221212\_122338

EPA and IDEM then noted that there was a sheen on the water at Outfall 011. This sheen had the appearance of an oil sheen. The sheen was continuous on the water flowing past Outfall 011. EPA documented the sheen with photographs.

Description: Looking upstream at the water from Outfall 011.

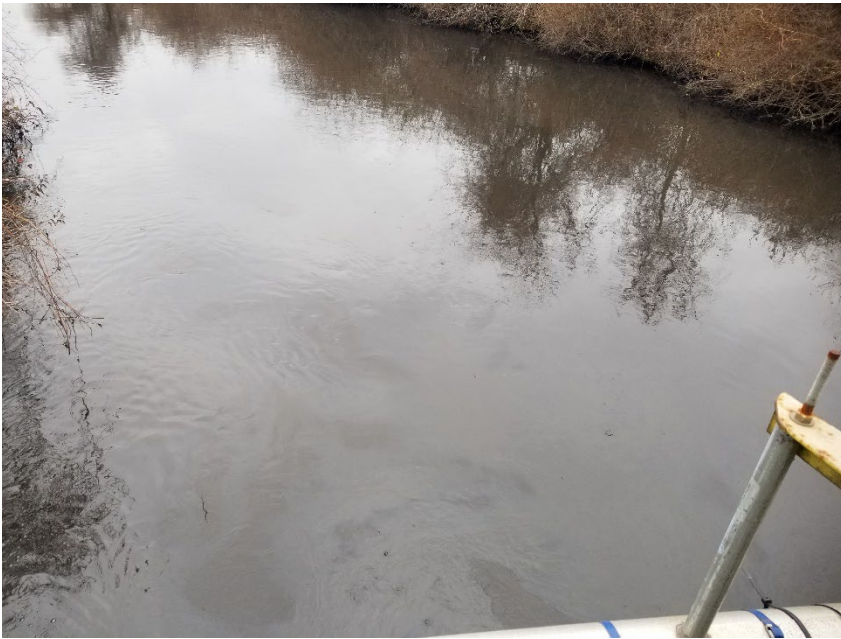
18: 20221212\_122346

Description: Looking downstream at the water from Outfall 011.

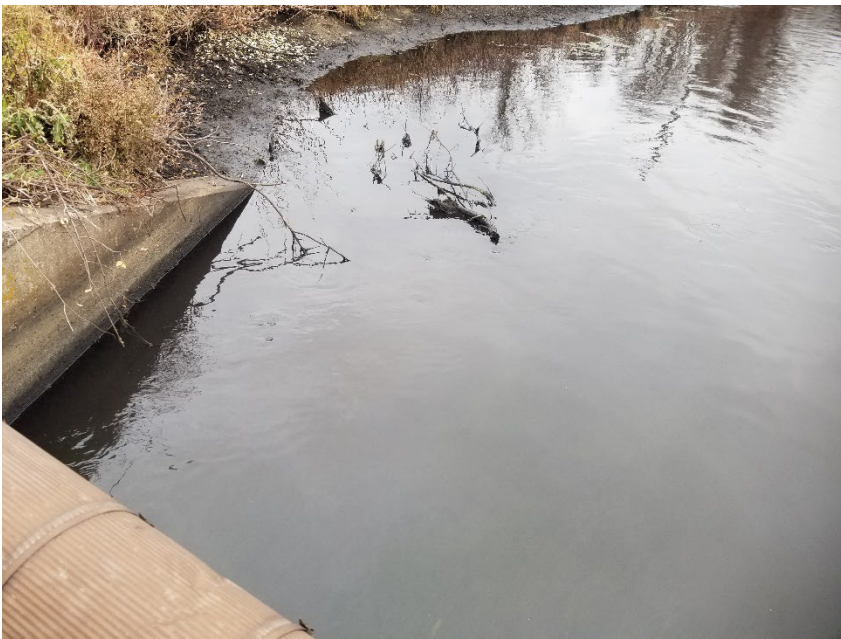
19: 20221212\_122830

EPA and IDEM then observed the overflows from the lagoons at 12:27 P.M. and observed that the sheen was present at that location, also. The overflow from the lagoons is upstream of Outfall 011.

- A. The sheen observed at the overflow from the lagoons and at Outfall 011 which is upstream of the external Outfall 001. There is no treatment after Outfall 011 which would prevent the sheen from exiting at Outfall 001.
- B. The vegetation on the weirs from the lagoons is still present.

Description: The sheen was observed at the overflow weirs from the lagoons before Outfall 011.

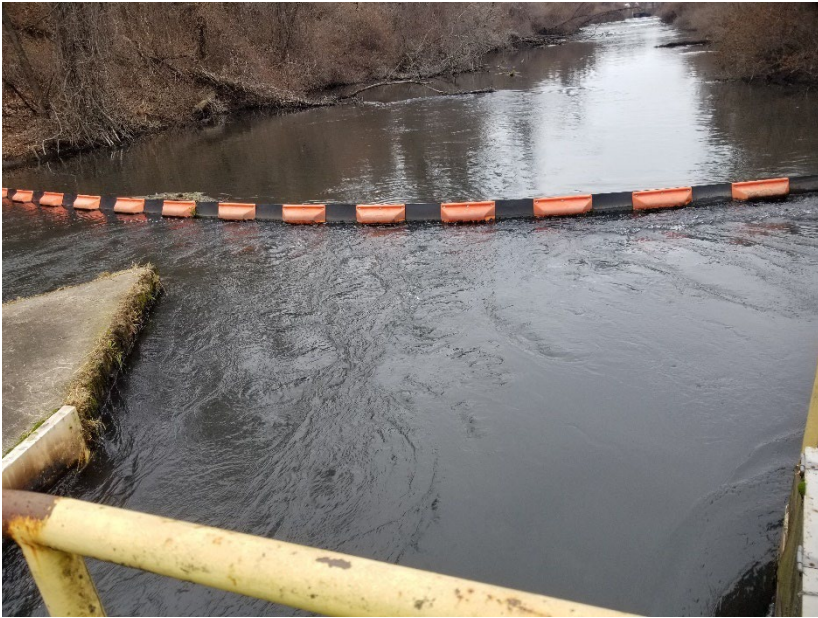
20: 20221212\_125511

The inspection team could not observe a sheen on the fast flowing and turbulent water at Outfall 001.

Description: Looking upstream, it was difficult to observe the sheen due to the velocity of the water at Outfall 001.

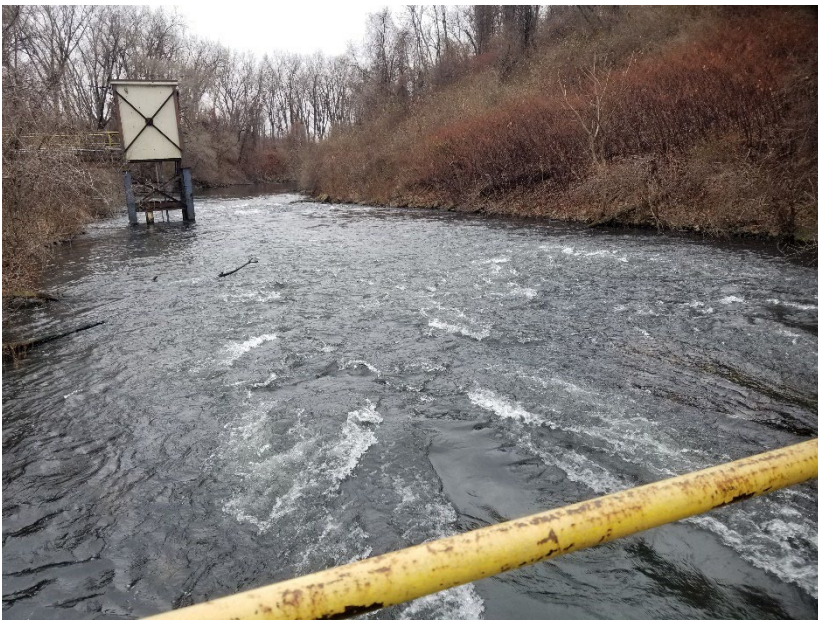
21: 20221212\_125557

Description: Looking downstream from Outfall 001, EPA could not discern a sheen due to the velocity of the water.
