Subject: November 14, 2022 Municipal Separate Storm Sewer System Inspection Report

Purpose: City of East St. Louis MS4 Inspection

Facility: City of East St. Louis, IL

NPDES Permit: ILR400332

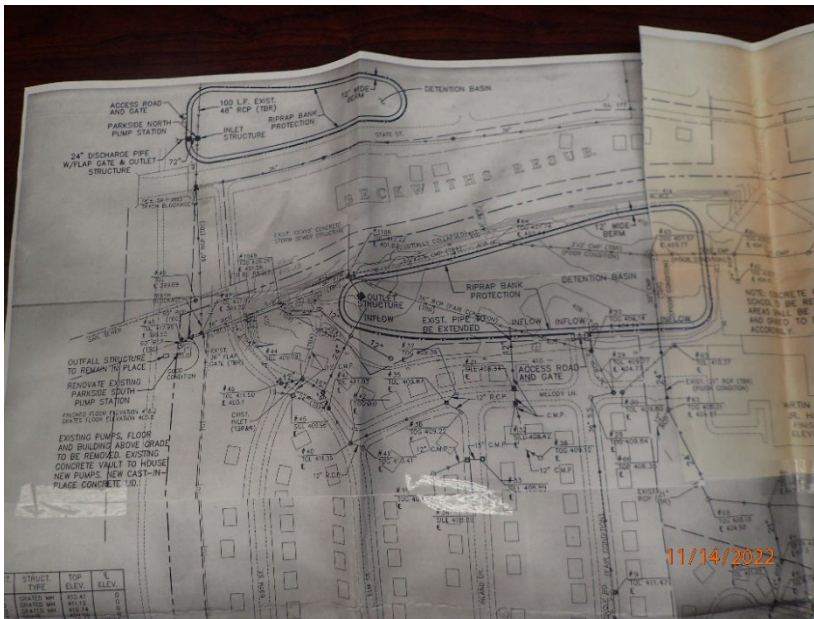
1: PB140047

At the Public Works Garage office, the EPA team observed the map of the Parkside neighborhood and Parkside and Wedgewood Pump Stations. The map, dated August 1, 1994, identified recommended improvements to the infrastructure in the area. The EPA team identified outlet structures in the detention basin across 69th Street from the lift station that it wanted to try to observe in the field.

Description: East St. Louis sewer map of the Parkside and Wedgewood Pump Stations and Parkside recommended improvements. Map date is 8/1/1994.

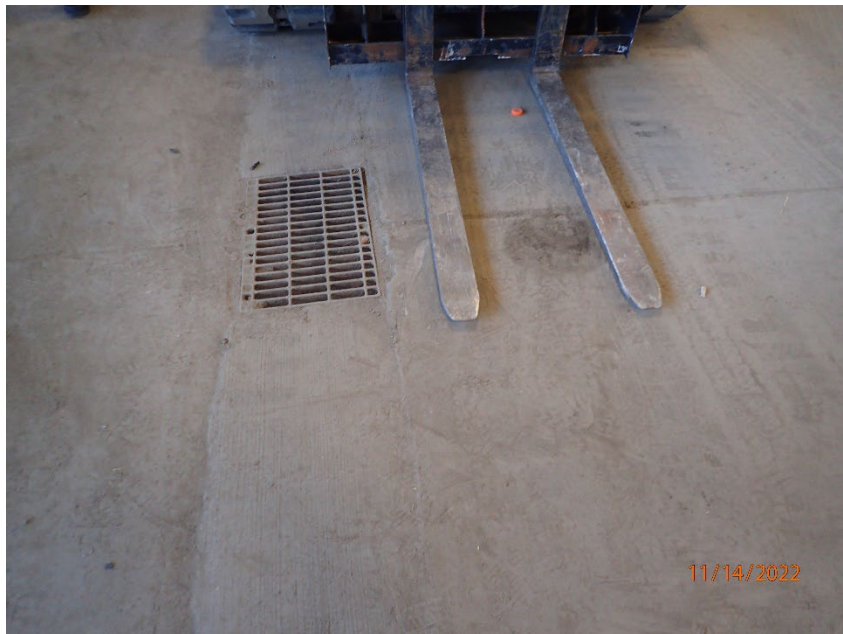
10: PB140056

Description: Trench drain in floor in the Public Works Garage has three inlets to it. The trench drain flows to a pipe that connects to the sanitary sewer in the street. The trench drain is flushed periodically and was recently flushed approximately one week before.

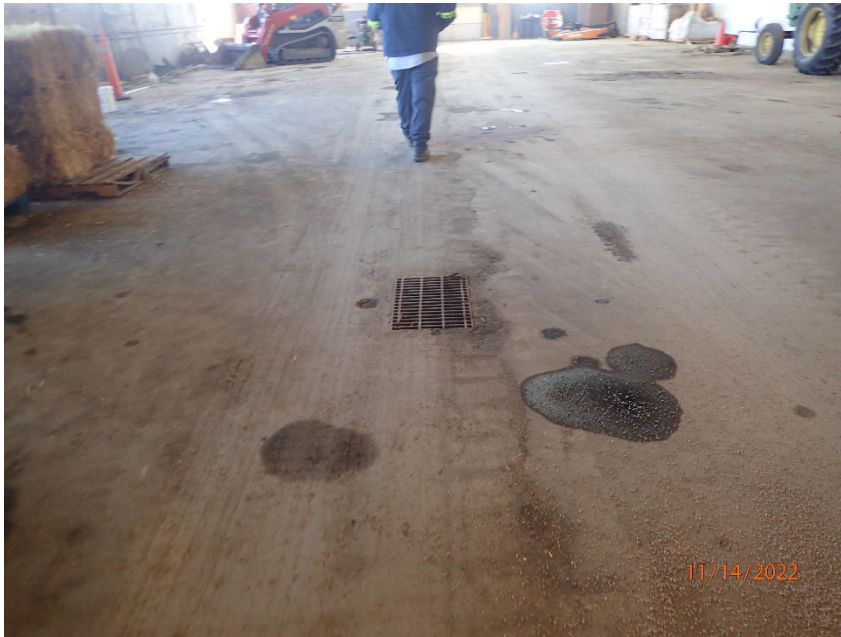
11: PB140057

Vehicles are power washed and repaired in the garage. Oil Dri Absorbant is used to absorb grease on the floor which is then swept up before the floor of the garage is washed down. The garage floor is swept and mopped daily, and power washed one to two times per week.

Description: Trench under floor drains leads out of the building and to the sanitary sewer. Trench drain receives water from rinsing off and powerwashing trucks and cars. Oil Dri Absorbant is used on spilled oil and swept up before the floor of the garage is washed down.

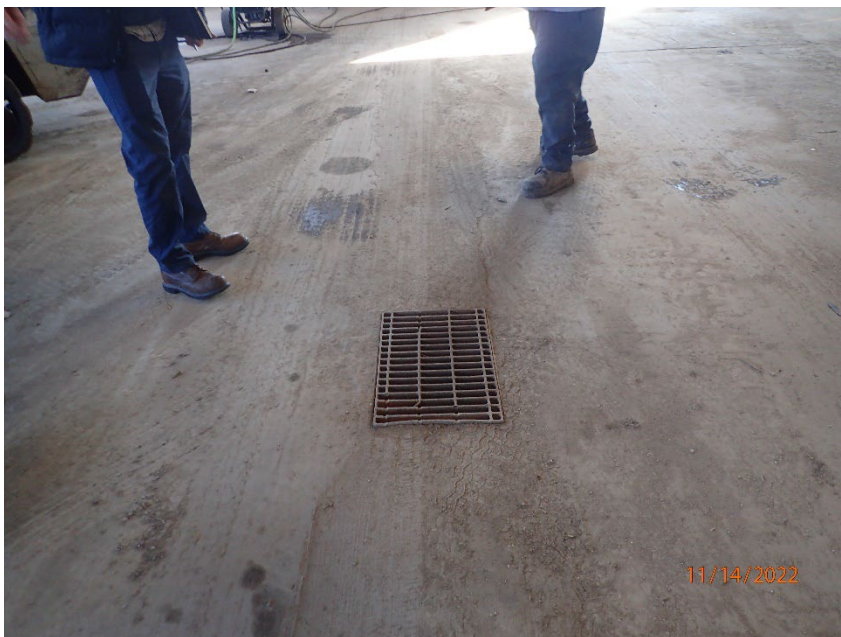
12: PB140058

Description: Third and final floor drain to the below grade trench which discharges to the sanitary sewer outside the building.

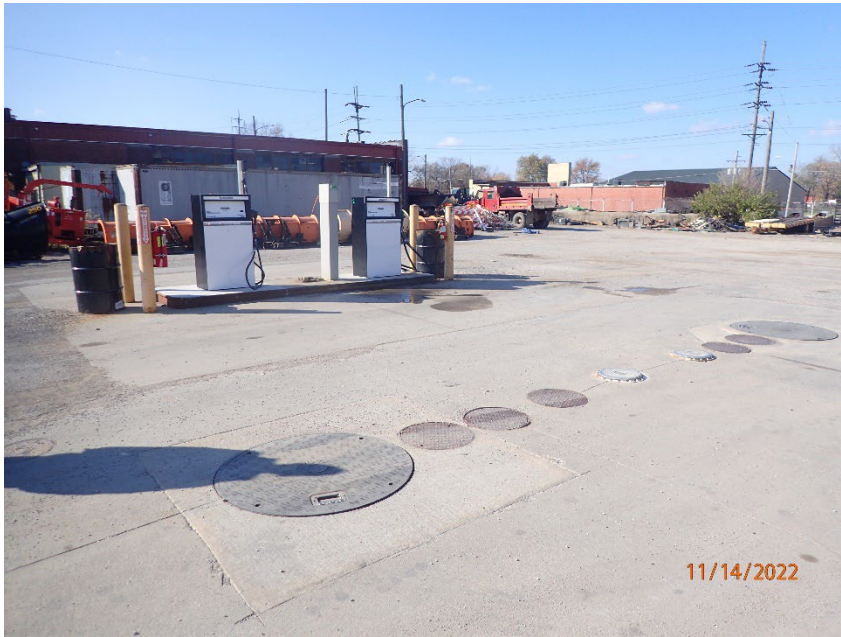
13: PB140059

Description: Two 800 gallon fuel storage tanks are underground. One is for diesel and one is for gasoline.

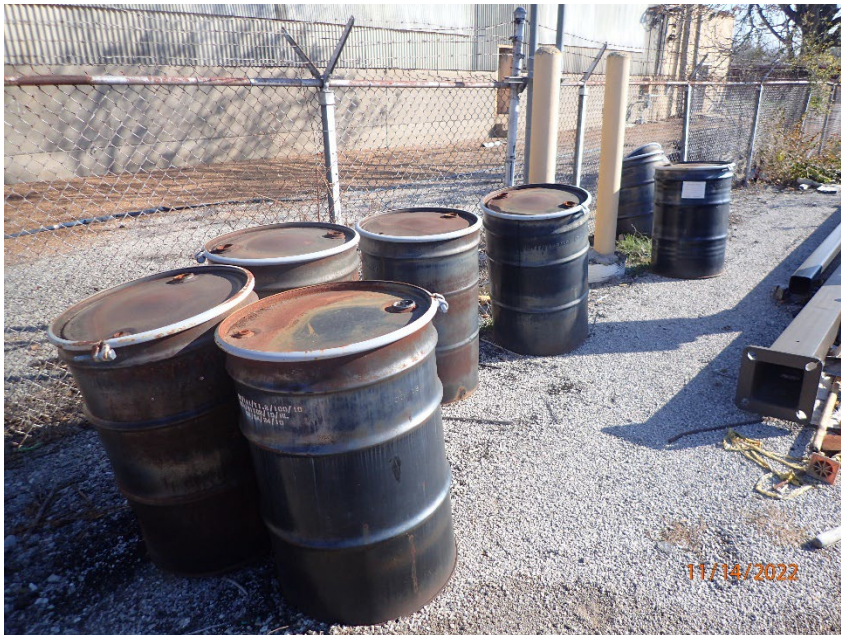
14: PB140060

Outside the garage, two 800-gallon fuel storage tanks are located underground. One holds diesel fuel, and one holds gasoline. EPA observed old drums along the fence line. Mr. White stated that they contain water and are stored there until they can be recycled. Used oil is stored on site until it can be picked up by a contractor.

Description: These drums have water in them and are stored for recycling.

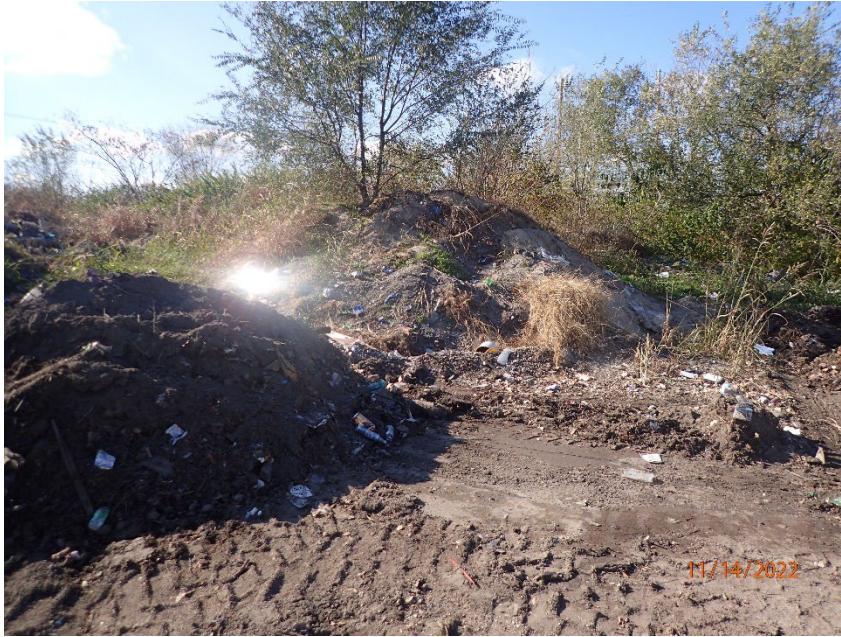
15: PB140061

Description: Piles of dirt and debris from the street sweepers are piled at the East St. Louis Storage Yard.

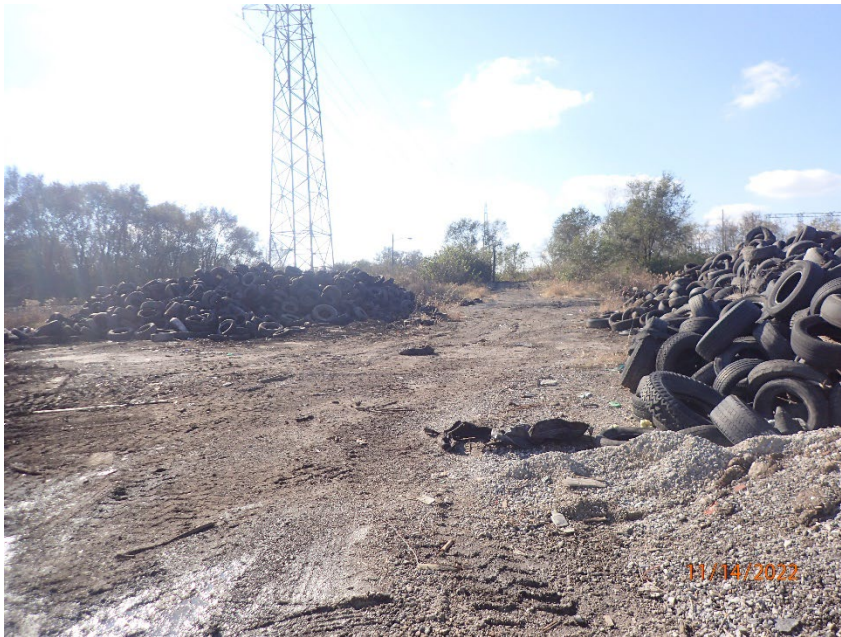
16: PB140062

Description: Used tires are piled in the East St. Louis Storage Yard down and across the street from the Public Works Garage.

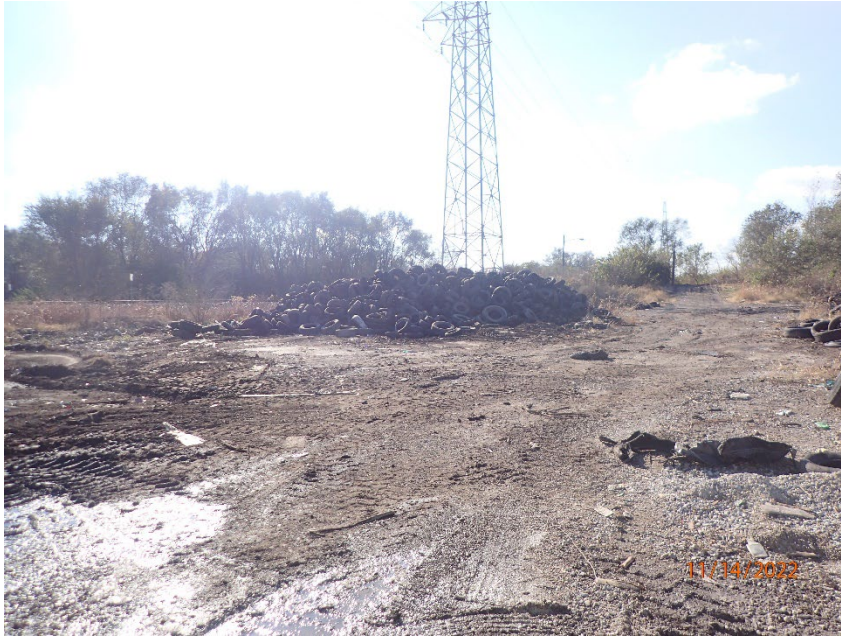
17: PB140063

On the southeast side of North 20th Street and south of the Public Works Garage is the East St. Louis Storage Yard where the City's salt dome is located. EPA observed the piles of dirt from the street sweeper which will be taken to a landfill. EPA also observed piles of used tires. Mr. Stith stated that the tires have been there for five to six months and the City is waiting for the IEPA to pick them up. The pick-up by IEPA is scheduled for December 5, 2022.

Description: Used tires in the East St. Louis Storage Yard are due to be picked up by IEPA on 12/5/22.

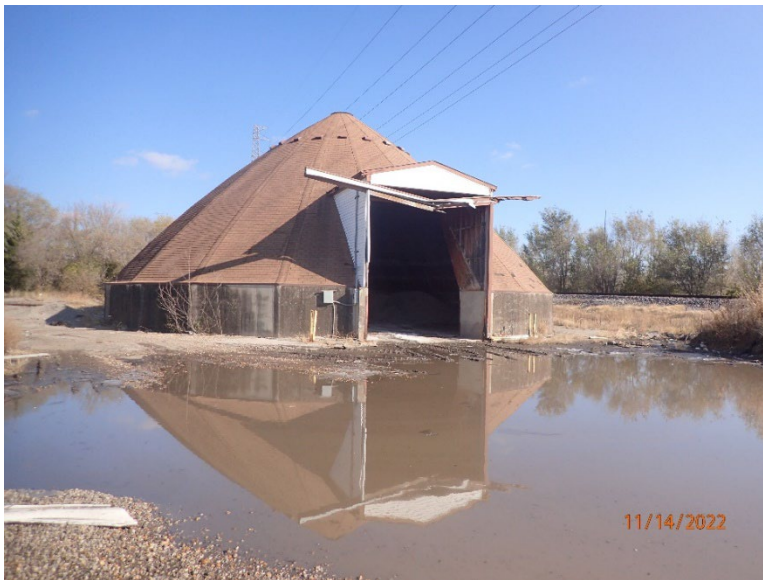
18: PB140064

EPA observed the salt dome. In a previous IEPA inspection report, the IEPA inspector recommended that the City repair the door for the salt dome. Mr. Stith stated that the salt dome never had a door. The overhang above the salt dome entrance had been damaged but was not affecting the protection of the salt. There was a large pool of water around the salt dome from poor drainage, but the water was not entering the dome. There were no storm sewer inlets on this property.

Description: Salt storage dome in the East St. Louis Storage Yard. There is no door for the salt storage dome. Facility personnel state that they keep the salt away from the entrance. There are no sewer inlets in the storage yard for storm water to drain.

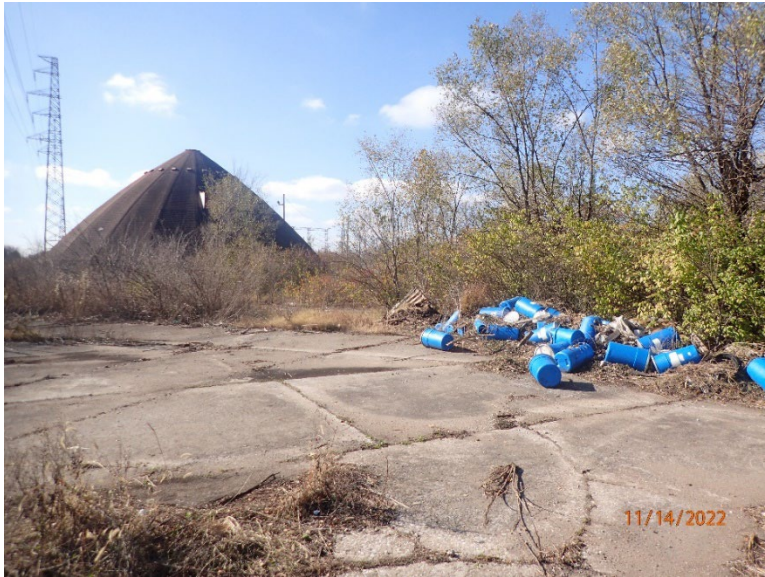
19: PB140065

EPA observed many blue drums stacked on the property next to the City's storage yard. The drums had signs on them that indicated that the contents were sodium chloride. The City did not own the property, and had never observed the blue drums before. Mr. Stith and Mr. Lockett said that they would contact the owner and have the drums removed.

Description: Barrels of sodium chloride dumped on the property next door. Investigation of the ownership shows that it is not East St. Louis property.

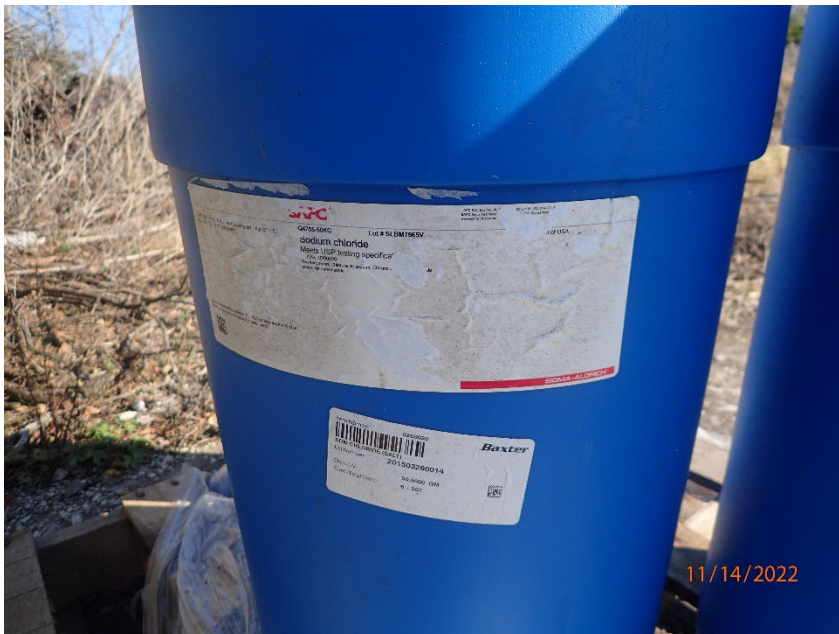
20: PB140066

Description: Labels on dumped barrels state that they are sodium chloride.

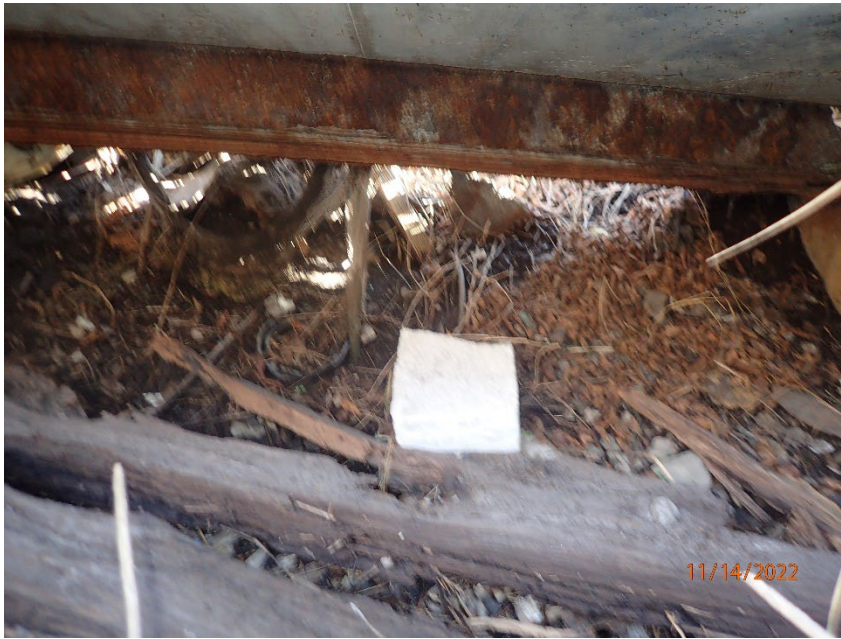
21: PB140067

Description: A culvert structure was observed at the back of the East St. Louis public works yard.

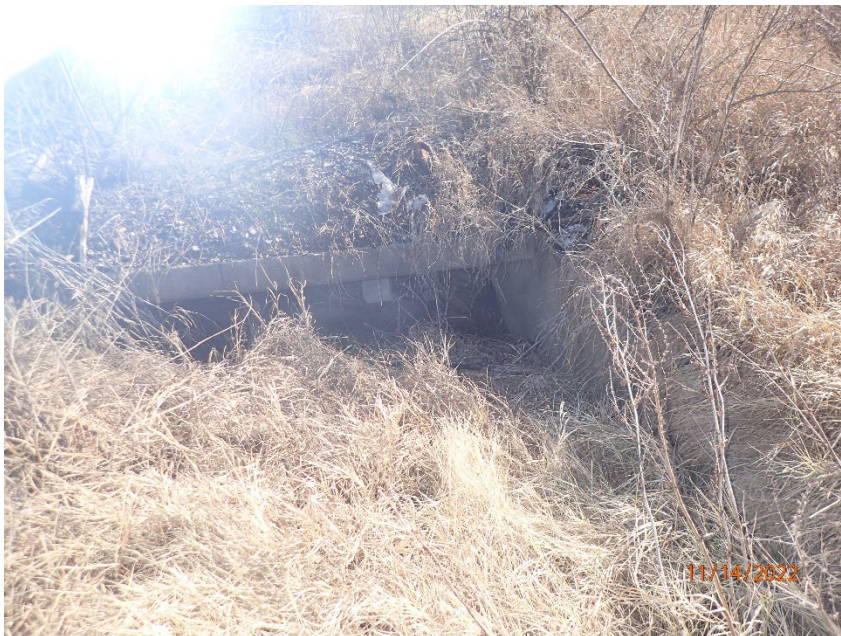
22: PB140068

EPA also observed a culvert structure in the back of the yard near the railroad tracks. EPA could not determine if this structure was an inlet to a storm sewer. EPA also observed that runoff near the entrance to the yard could flow down the driveway and to the street. There were storm sewer inlets along the curbs in the street. EPA also noted that the storm sewer inlet did not have any stenciling on it to indicate that it flows to a waterway.

Description: It is unknown if this culvert structure is an inlet to a sewer.

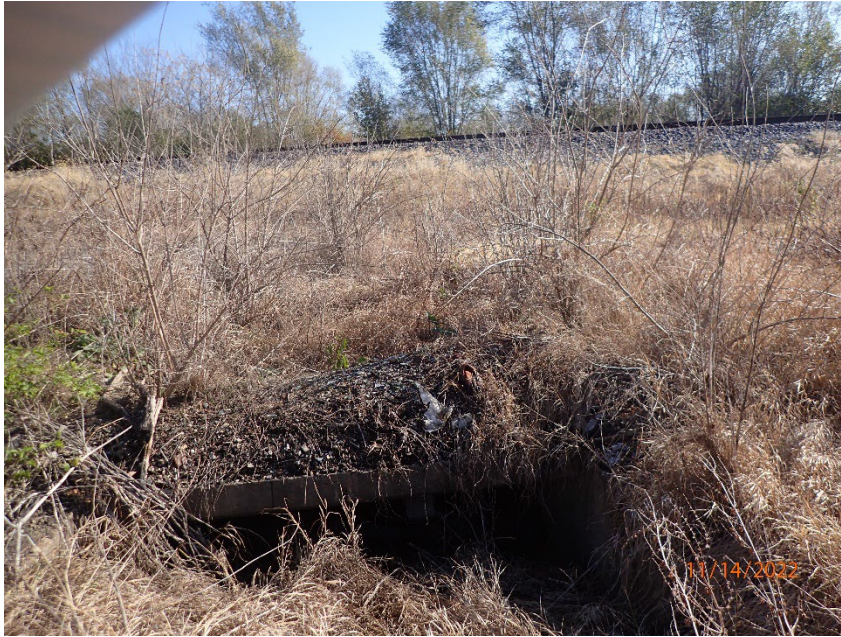
23: PB140069

Description: It is unknown if this culvert structure is an inlet to a sewer.

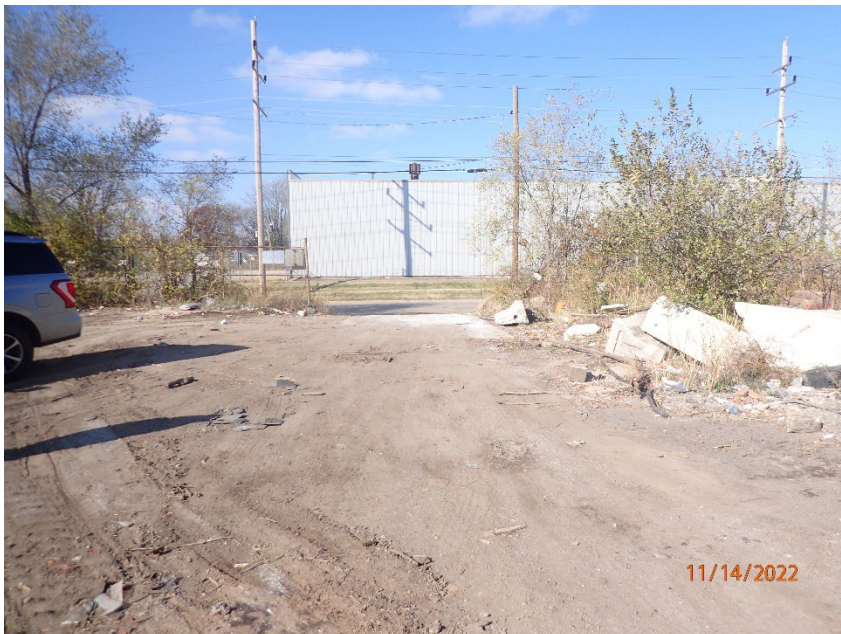
24: PB140070

Description: Although there are no storm sewer inlets on the public works yard, storm water near the entrance can leave the property via the driveway and then to storm sewer inlets along the curb of the street.

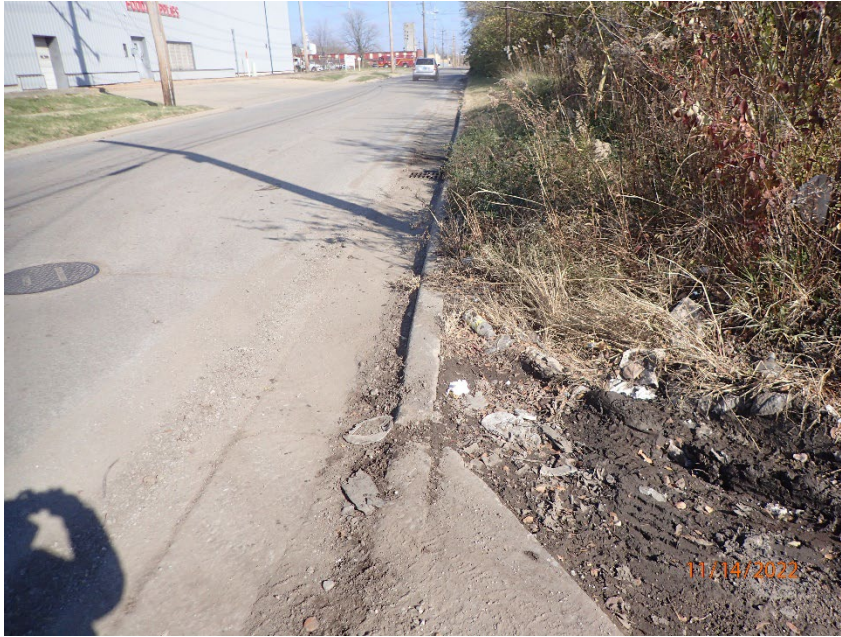
25: PB140071

Description: Some water can flow off the public works yard and to a storm sewer inlet along the curb of the street.

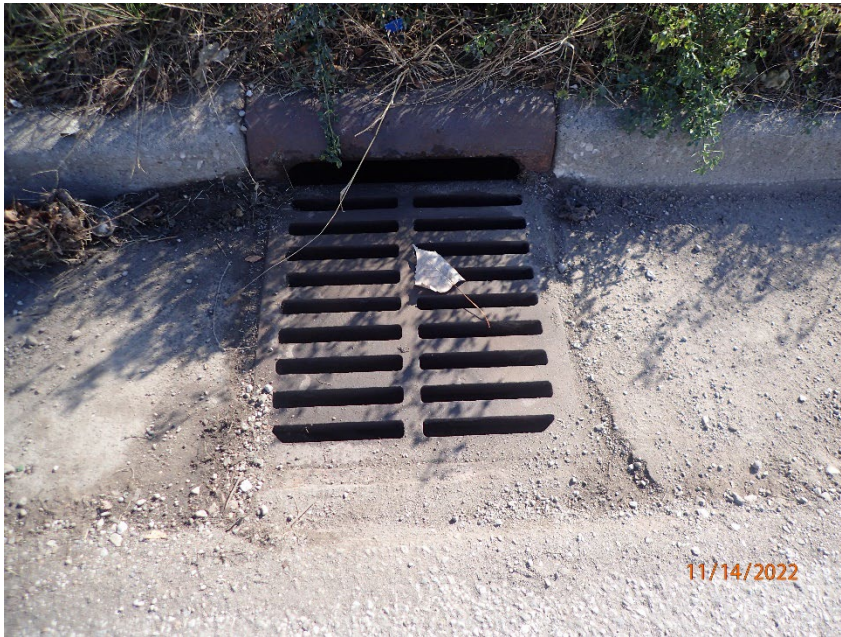
27: PB140073

Description: Storm sewer inlet along the curb near the driveway of the East St. Louis Storage Yard. Inlet does not have any stenciling on it to indicate it flows to a river.

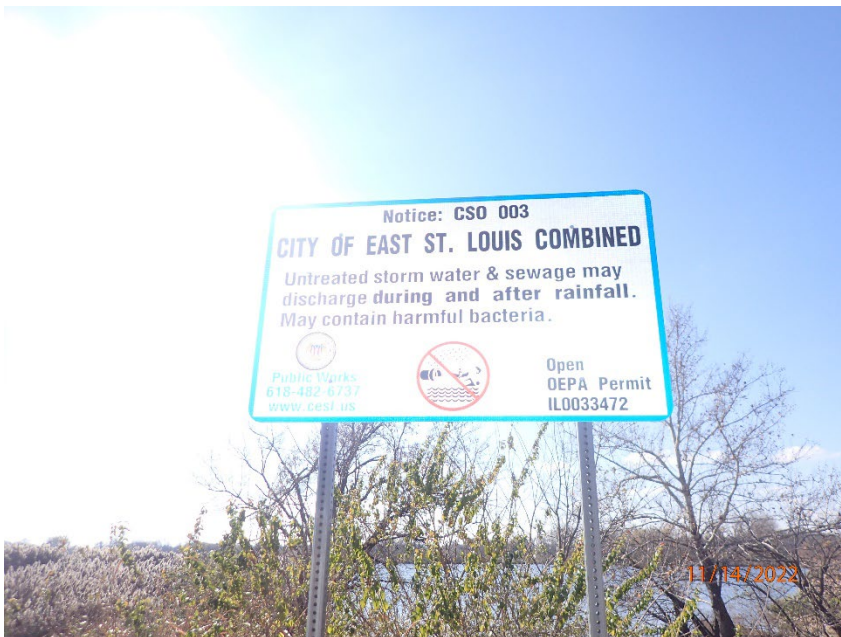
28: PB140074

Description: The new sign installed at the permitted CSO Outfall 003.

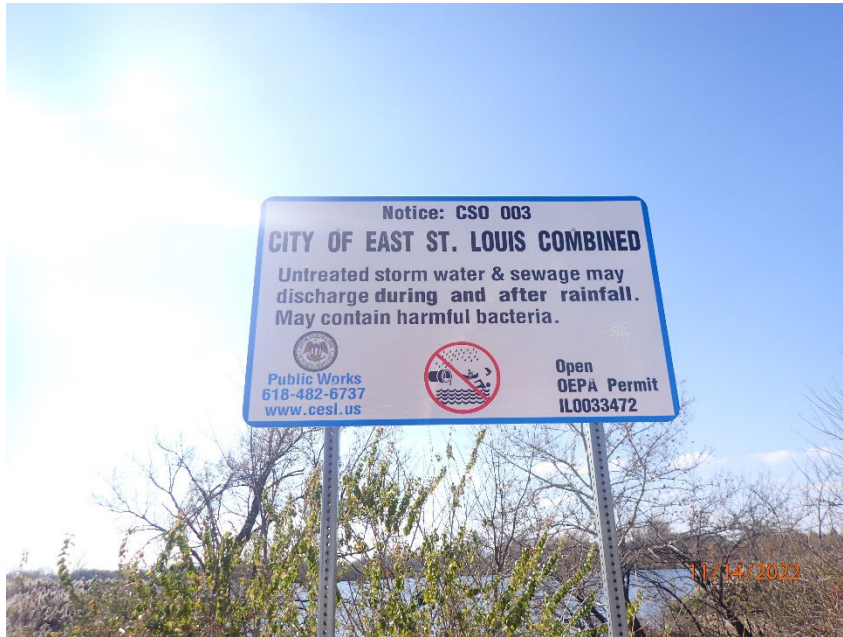
29: PB140075

Description: The new sign installed at the permitted CSO Outfall 003.

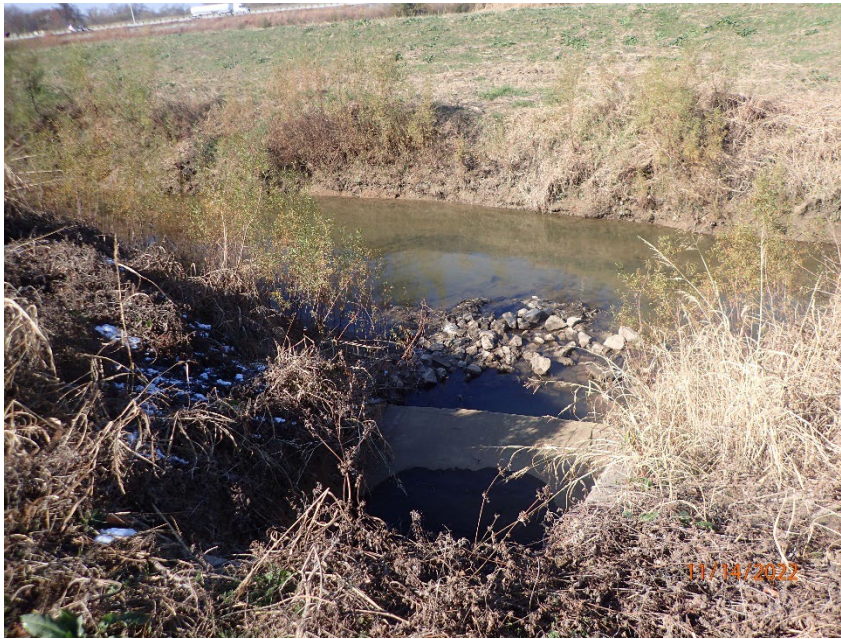
31: PB140077

The inspection team arrived at the Parkside Pump Station at 10:55 A.M. Mr. Lockett stated that the flapper gates from the station to the Harding Ditch were still in need of repair. The flapper gates prevent water from flowing back into the station when the level of water in Harding Ditch is high. The flapper gates have been broken since before April 2021 when Ms. Rogers conducted a CSO inspection in the City. EPA also observed the condition of the pump station. There was no roof in some sections of the station and equipment was rusted and inoperable. Mr. Lockett stated that only one of the three pumps were operable and the one of the pumps had been removed and was being repaired.

Description: Discharge of the Parkside Pump Station to Harding Ditch. The flapper gates to prevent water from Harding Ditch from backing up into the pump station still need to be repaired.

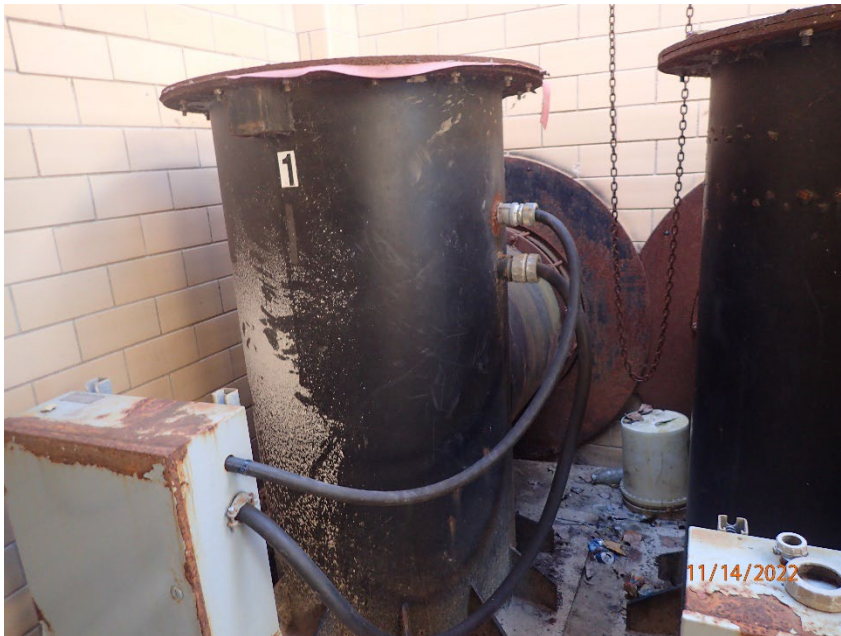
32: PB140078

3. The Parkside Pump Station is in disrepair. Part of the roof is missing, the flapper gates are not installed or working, the equipment in the station is rusted and only one of the pumps is functional.

Description: One pump is out for repair, one is not functioning, and one is functioning.

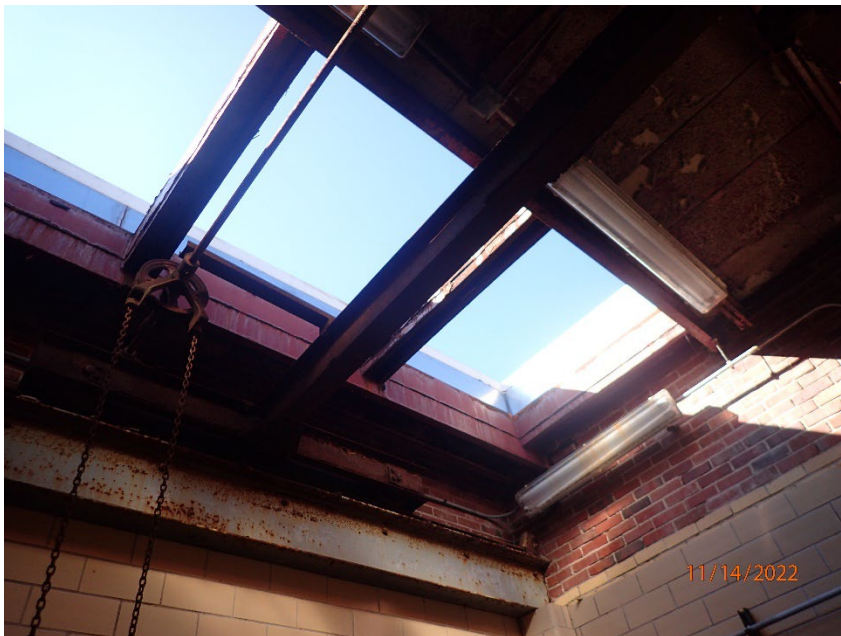
34: PB140080

Description: Parkside Pump Station does not have a roof in some sections.

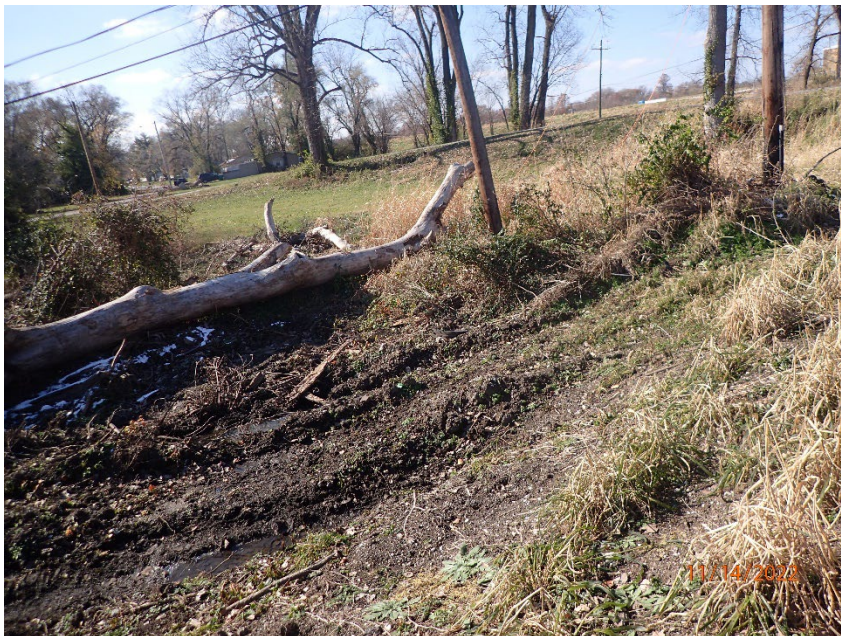
36: PB140082

Description: EPA inspectors were trying to find a pipe from the reservoir to the pump station as depicted in the map from 1994 (photo 1).

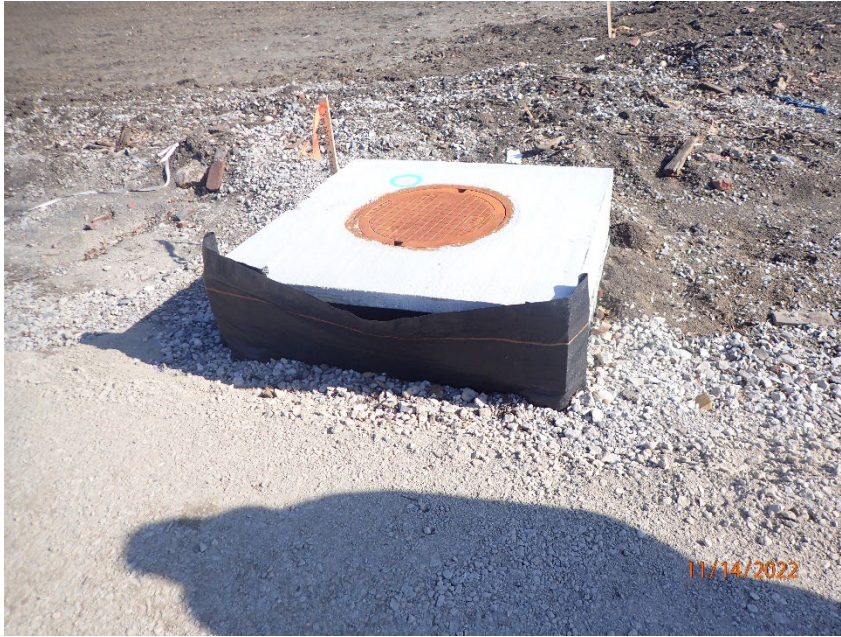
39: PB140085

At 11:23 A.M., the inspection team arrived at the new home construction site called Landsdowne UP. Twenty single-family homes are being built in the Landsdowne neighborhood by Plocher Construction. EPA requested to speak with someone from the construction company. While waiting for someone from the construction company to arrive, EPA noted that the stormwater inlets were protected by silt fences.

Description: EPA observed silt fences and inlet protections on the storm sewer inlets at the new Lansdowne Park construction site.
