Subject: July 28, 2022 Reconnaissance Inspection Report for Cleveland-Cliffs Burns Harbor, NPDES Permit Number IN0000175

**CWA COMPLIANCE EVALUATION INSPECTION REPORT  
U.S. ENVIRONMENTAL PROTECTION AGENCY, REGION 5**

Compliance Evaluation Reconnaissance Inspection

Cleveland Cliffs Burns Harbor, LLC  
250 US-12  
Burns Harbor, Indiana 46304  
Porter County  
41.625, -87.117

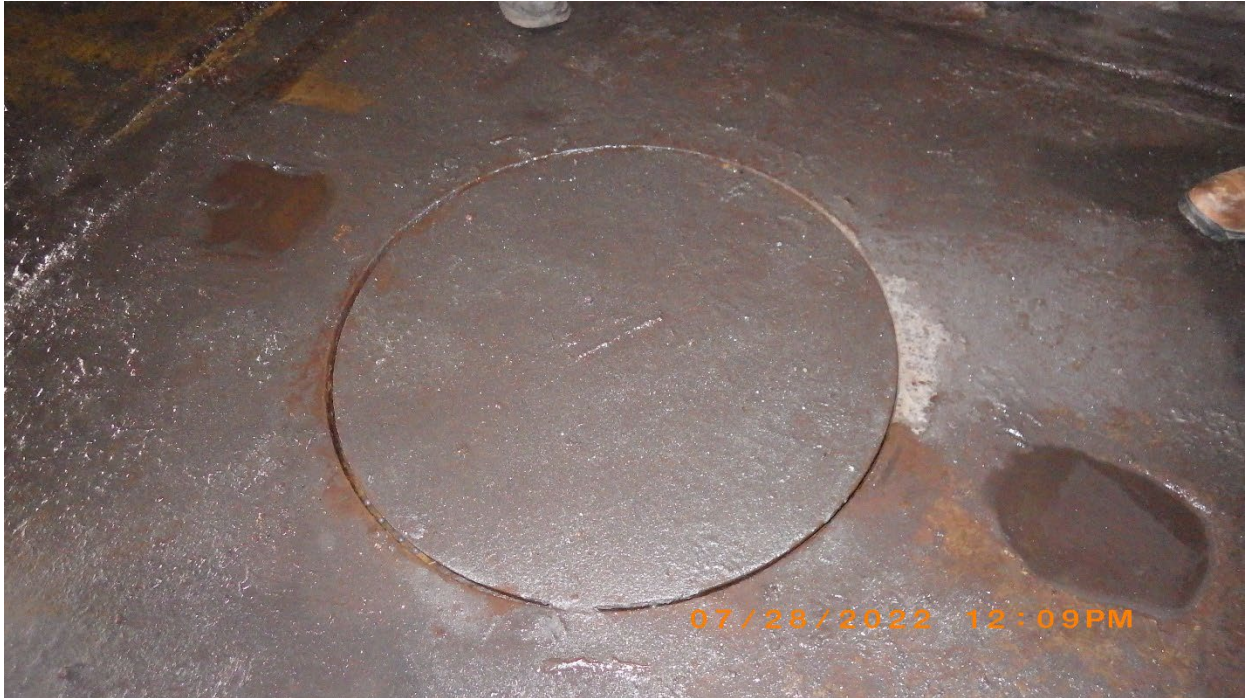
1: CHWW0057

Mr. Gorman described how the storm sewer system takes 20,000 gpm of non-contact cooling water from shell cooling to Outfall 002. The manhole plate was intact, but the weld had portions that had failed due to the force of air from the water in the pipe.

Description: Manhole storm sewer cover under Blast Furnace C. During SWPPP inspection this cover was found removed.

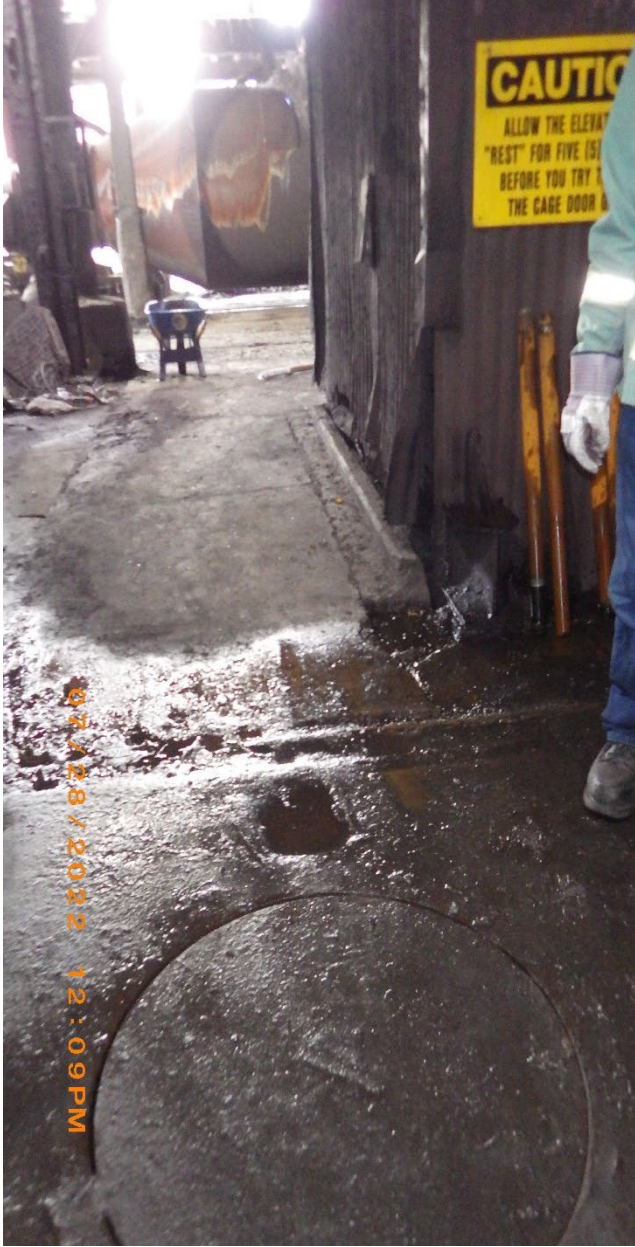
2: CHWW0058

Description: Manhole storm sewer cover under Blast Furnace C. During SWPPP inspection this cover was found removed.

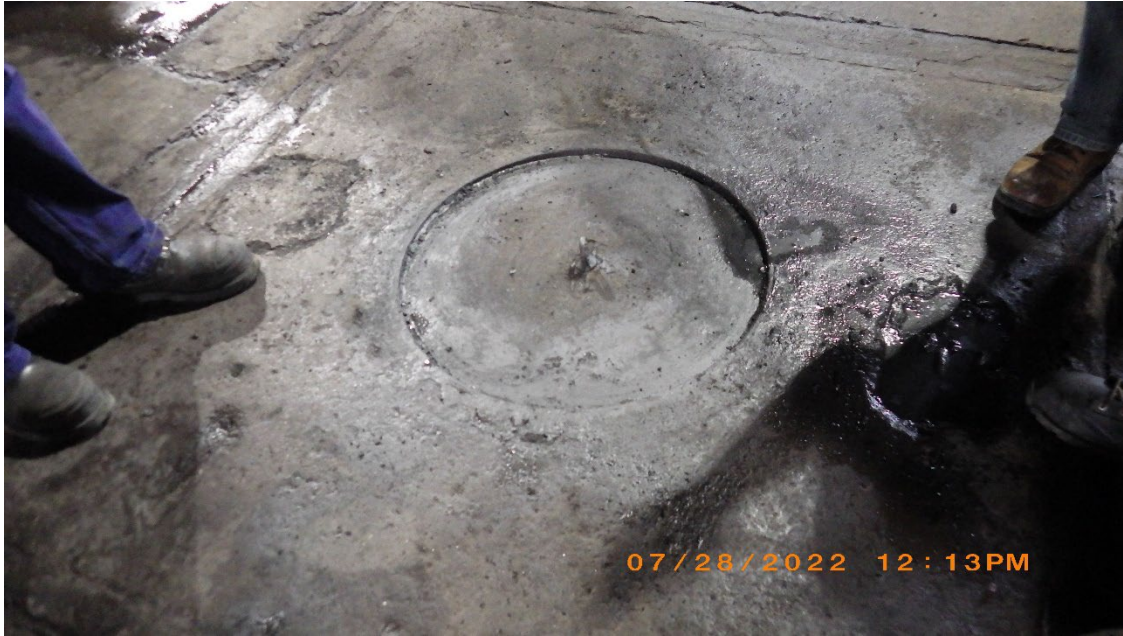
3: CHWW0059

Beneath Blast Furnace D, EPA observed the manhole cover for the storm sewer. This manhole cover had a handle on it that could cause someone to trip. Mr. Gorman stated that the handle would be removed.

Description: Manhole storm sewer cover under Blast Furnace D. During SWPPP inspection this cover was found removed. Handle in the middle of the cover is a trip hazard and will be removed.

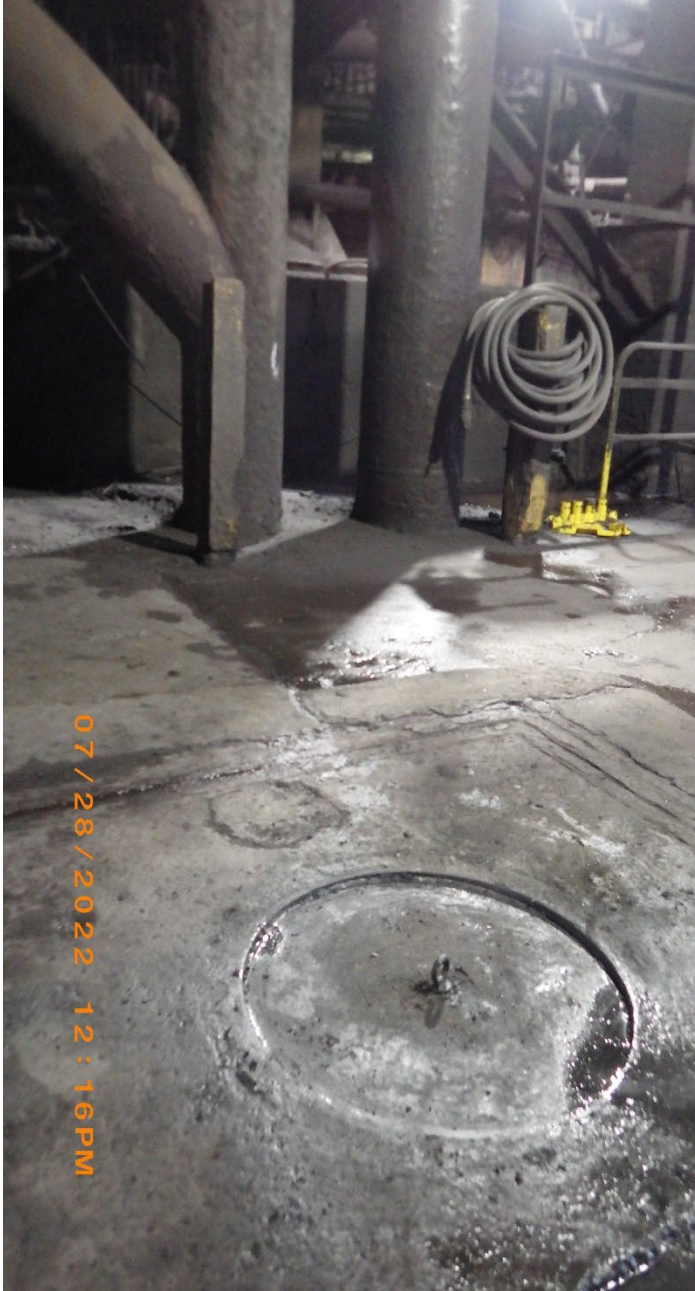
4: CHWW0060

Description: Manhole storm sewer cover under Blast Furnace D. During SWPPP inspection this cover was found removed. Handle in the middle of the cover is a trip hazard and will be removed. Two large pipes in the background are pipes for non-contact cooling water.

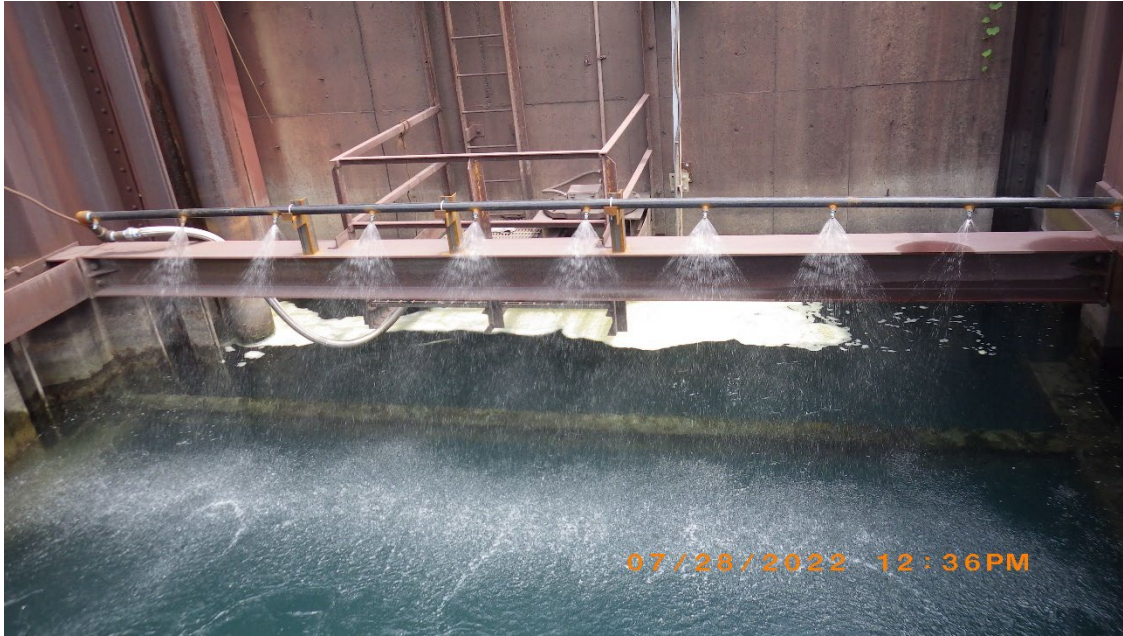
5: CHWW0061

The inspectors followed the facility personnel to Outfall 002 and arrived at 12:30 P.M. Approximately 1-2 weeks prior, Mr. Barot designed and installed a spray bar at the head of the outfall structure. The spray consisted of recirculated lake water and was intended to knock down the foam in the outfall.

Description: New spray bar at Outfall 002 to knock down foam. No chemicals are added, just recirculated lake water.

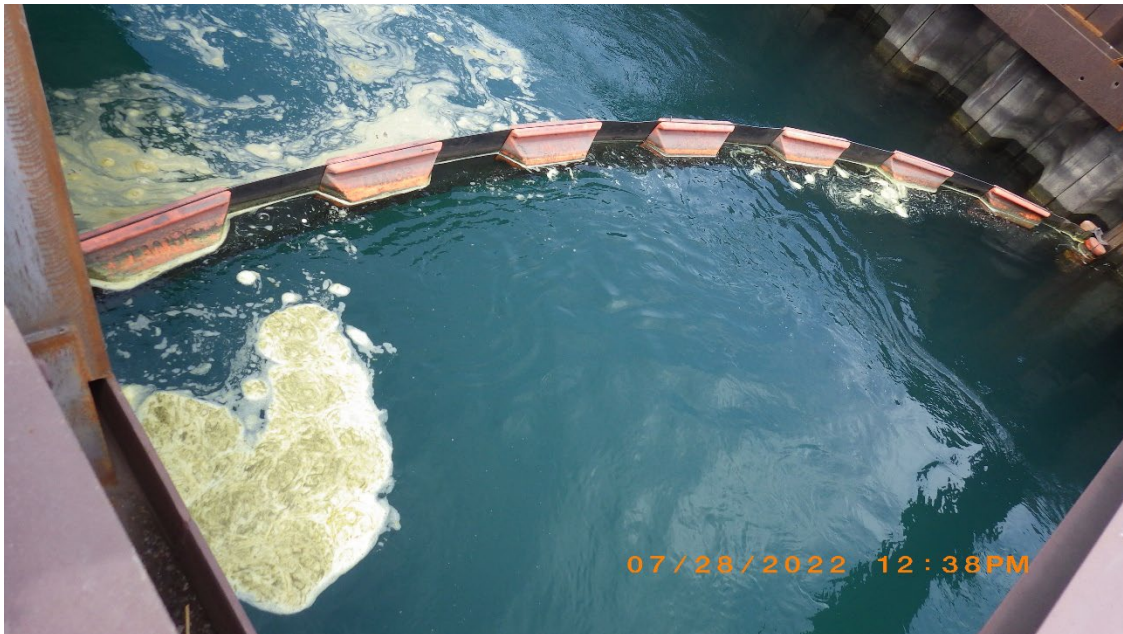
6: CHWW0062

On the day of the inspection there was foam on both sides of the permanent boom within the outfall structure. There was no foam observed at the soft boom outside the outfall structure.

- A. Foam was observed inside and outside the permanent boom of Outfall 002.
- B. The CPAR system needs to be updated with current status of some projects.
- C. The facility did not have backup power to run the pumps in WWPS 1 and thereby had a bypass event on July 23, 2022, when a lightning strike hit the electrical substation.

Description: Permanent boom in Outfall 002 has some foam on inside and outside of the boom.

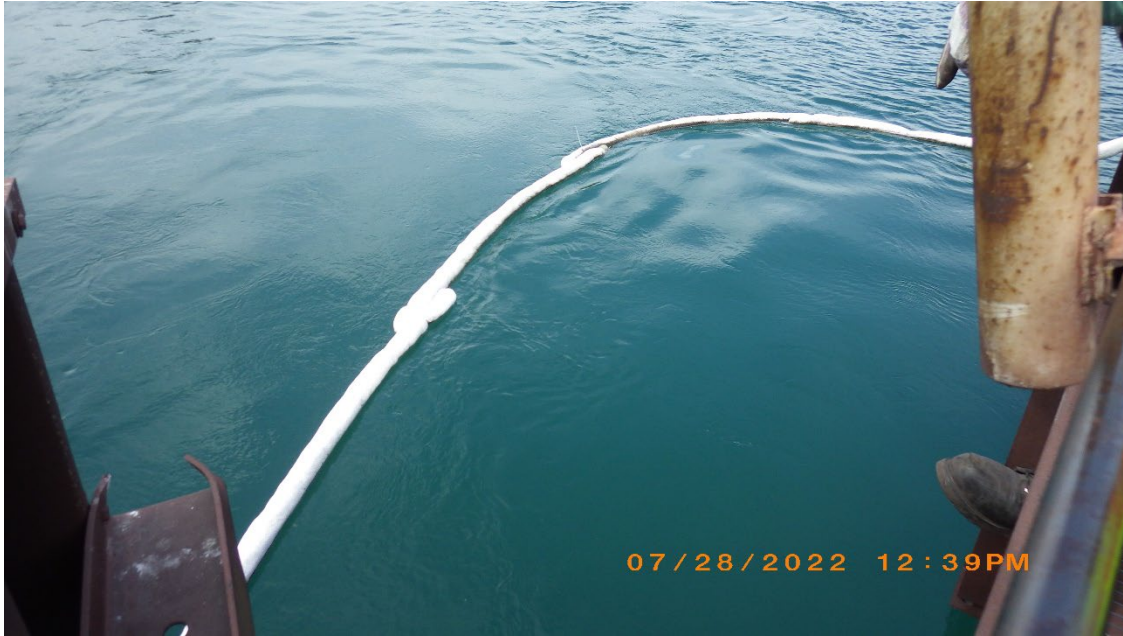
7: CHWW0063

Description: Temporary, soft boom outside of Outfall 002 will catch any remaining foam that passes the permanent boom.

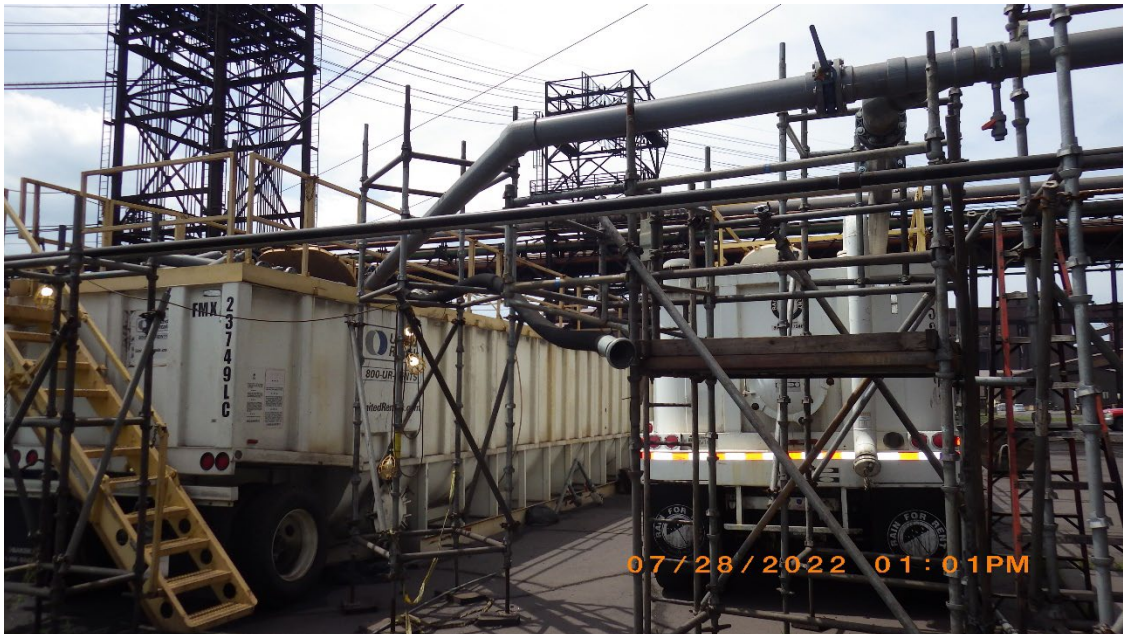
8: CHWW0064

Description: The overflow from the hydrocyclones at the Reclamation Services Building (RSB) flows to the two tanks in the photo before going to the centrifuges.

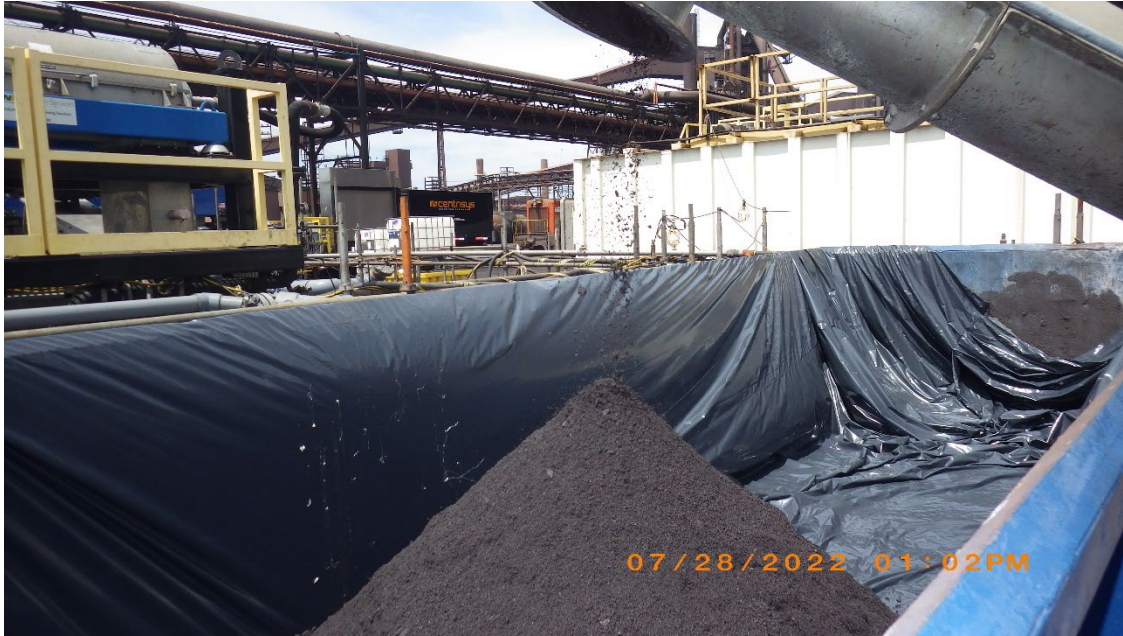
9: CHWW0065

EPA observed the solids in the dumpster and noted that it had the consistency of dry soil. EPA also observed secondary containment under the totes that contained the polymers.

Description: Solids from the centrifuges are deposited into dumpsters for disposal.

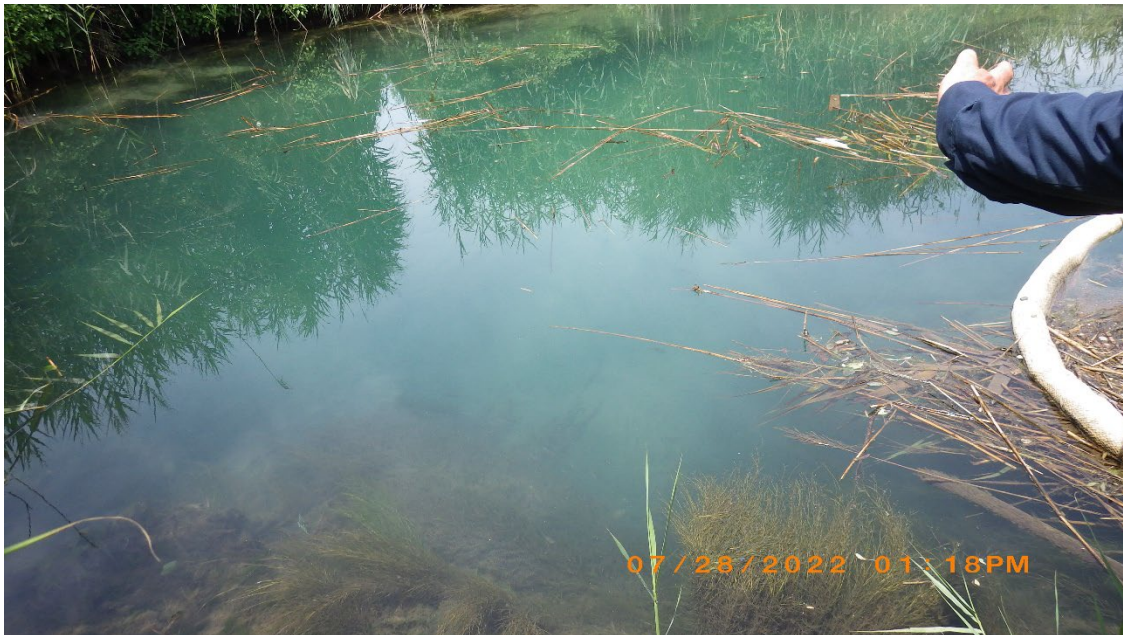
10: CHWW0066

Description: No sheen and the water was clear at Outfall 003 on the day of the inspection.

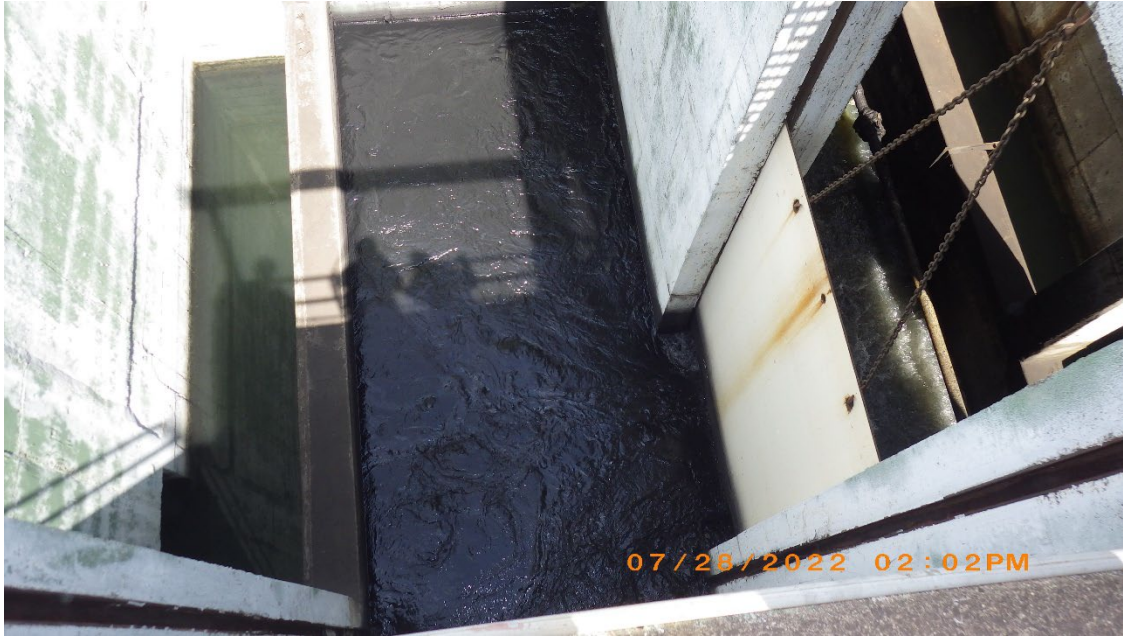
11: CHWW0067

CCBH personnel showed the inspectors a photo of a lightning strike to the substation near the WWPS 1. The lightning strike damaged the transformer which provided power to the pumps in WWPS 1. A minimum of two pumps are necessary on each side of WWPS 1 (hot mill side and cold mill side). Because of installed uninterruptable power supplies (UPSs) on the pumps, maintenance personnel were fairly quickly able to get two hot mill side pumps working but could only get one cold mill side pump working. Water overflowed from Manhole 120 to the Storm Ditch when the pumps stopped working.

During the power outage on July 23, 2022, both the Hot and Cold Mill sides overflowed to the Storm Ditch.

At WWPS 1, there are five low lift pumps for the Hot Mill side and five low lift pumps for the Cold Mill side. The process requires two functioning pumps from each side to pump all water to the SWTP. On July 23, 2022, maintenance personnel were able to quickly restart two of the pumps on the Hot Mill side but could initially only restart one pump on the Cold Mill side. The damaged surge protectors needed to be removed before more pumps could be restarted. The overflow was stopped approximately two hours after it started and approximately 600,000 gallons overflowed into the Storm Ditch.

Description: Looking down into Manhole 120. There was an overflow event from this manhole to the Storm Ditch on 7/23/22 when power was disrupted to Wastewater Pump Station I.

The facility has already ordered a generator as a backup for the pumps. It should arrive in early 2023. Additionally, all the variable frequency drive pump motors will soon have surge protectors installed.

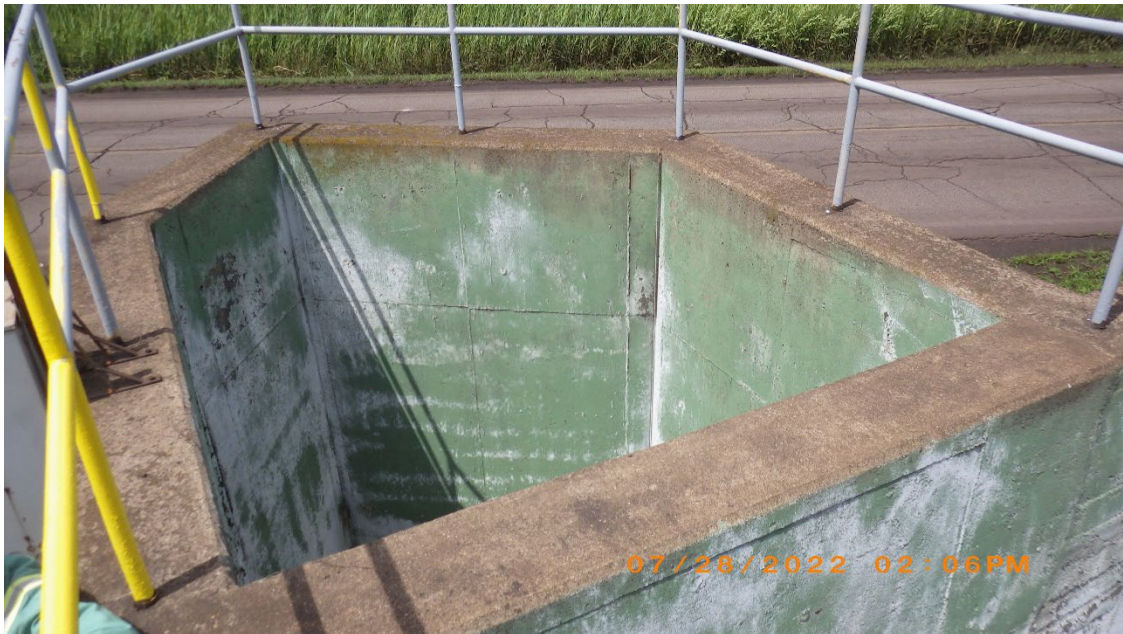
12: CHWW0068

Description: The piping from Manhole 120 to the Storm Ditch is in this structure.

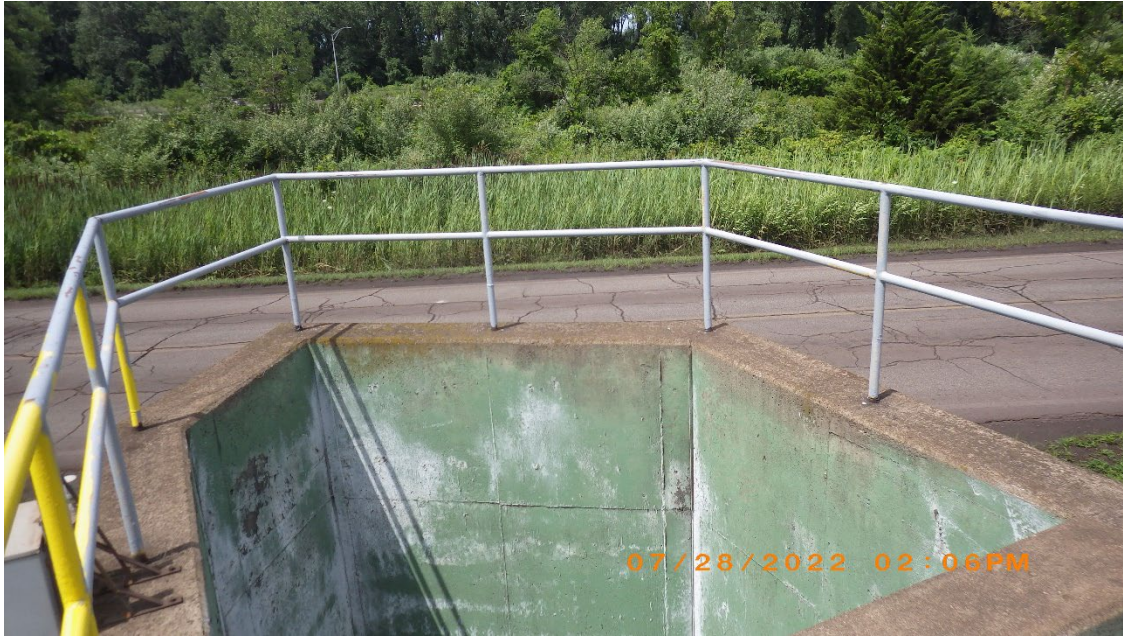
13: CHWW0069

Description: The Storm Ditch is on the other side of the road from Manhole 120.

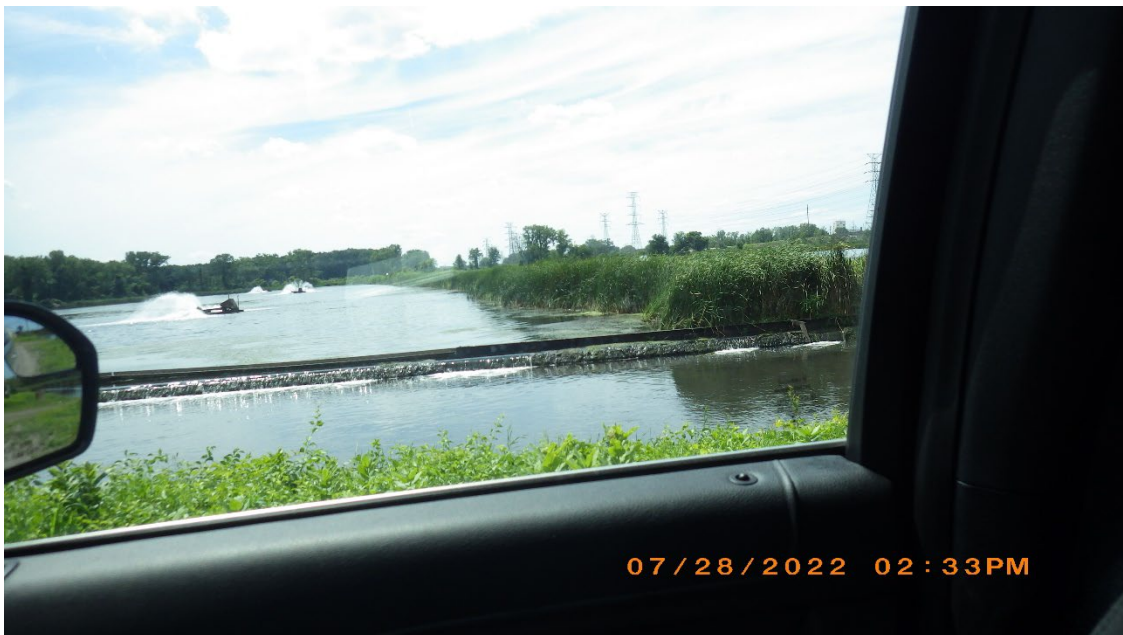
14: CHWW0070

The inspection team arrived at Outfall 011 with the facility personnel at 2:34 P.M. While passing the weirs of the lagoons, EPA observed that there was vegetation growing on the weirs.

Description: Weirs from the wastewater lagoons have vegetation on them.

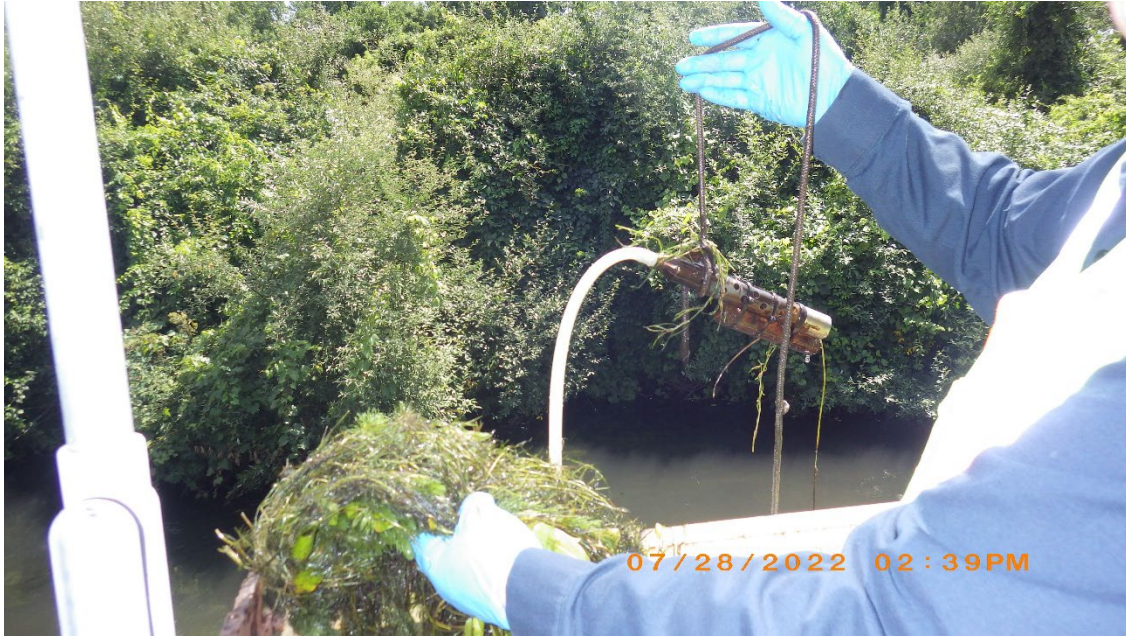
15: CHWW0071

EPA and IDEM inspectors observed the composite sampler. The temperature on the inside, as read from a thermometer in water, was 5.0°C. The tubing was last changed on July 6, 2022. The tube was not discolored on the day of the inspection, but the intake end of the tube was caught in the stream vegetation. The water by Outfall 011 was clear on the day of the inspection.

Description: Sample tube for Outfall 011 catches stream vegetation.

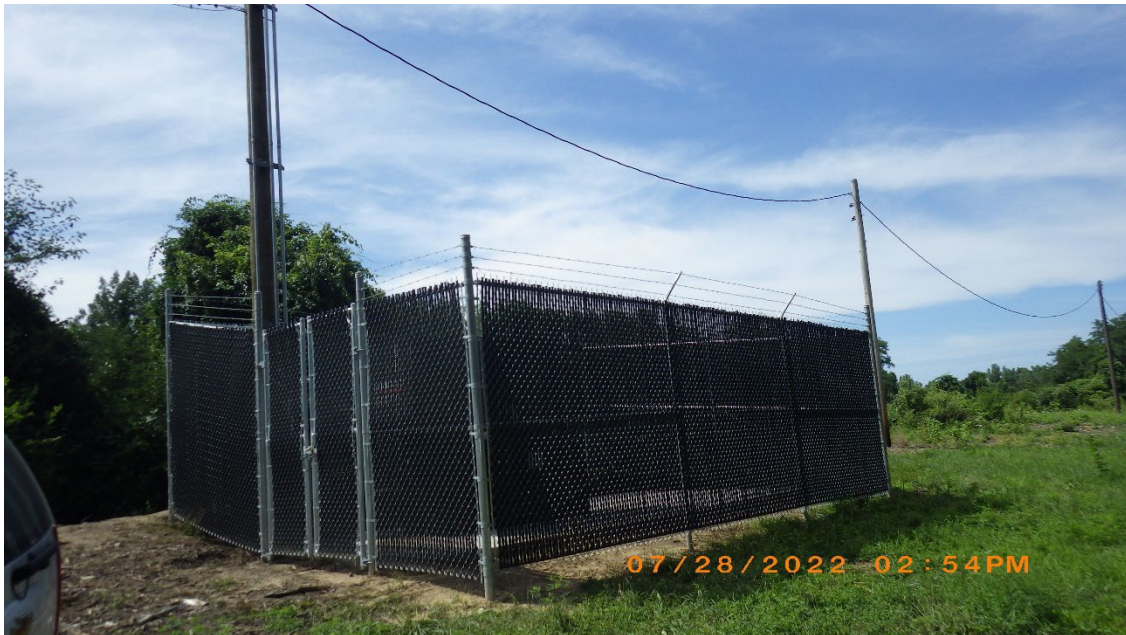
16: CHWW0072

At 2:54 P.M., the inspection team arrived at Outfall 001 and observed the new emergency generator for Outfall 001. The generator is included in the preventative maintenance program and will be tested periodically.

Description: New emergency generator for Outfall 011.
