Subject: Safe Drinking Water Act EPA Inspection Report

INSPECTION REPORT

Inspection Date(s): October 18-19, 2022

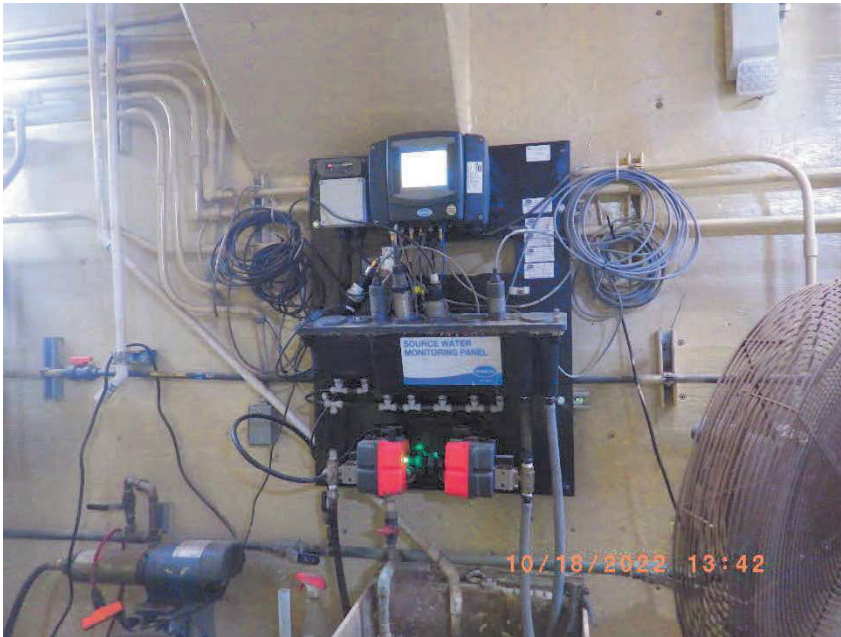
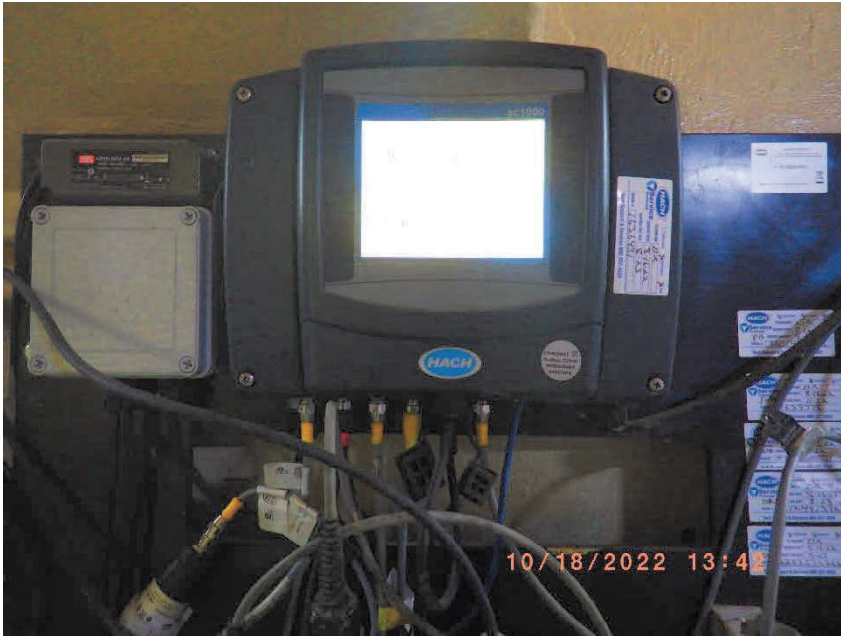
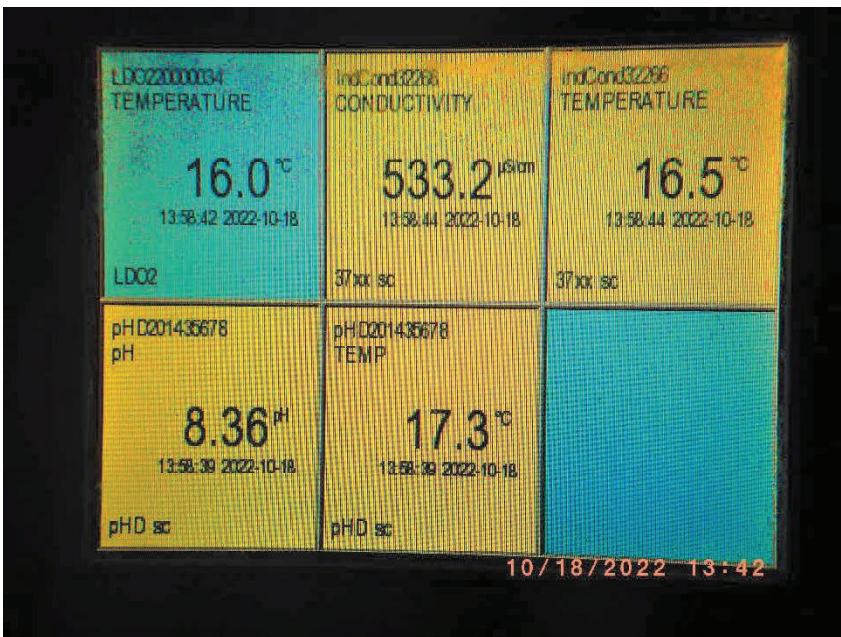
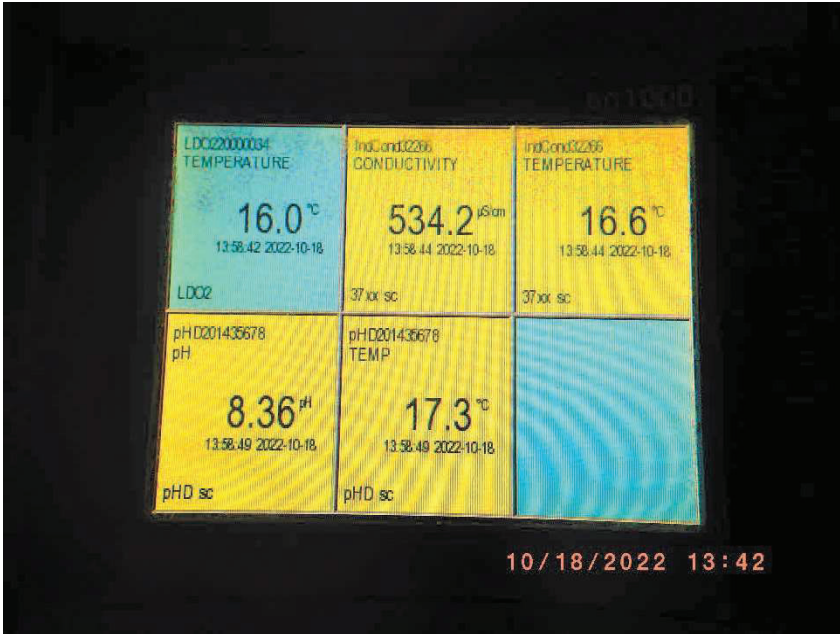
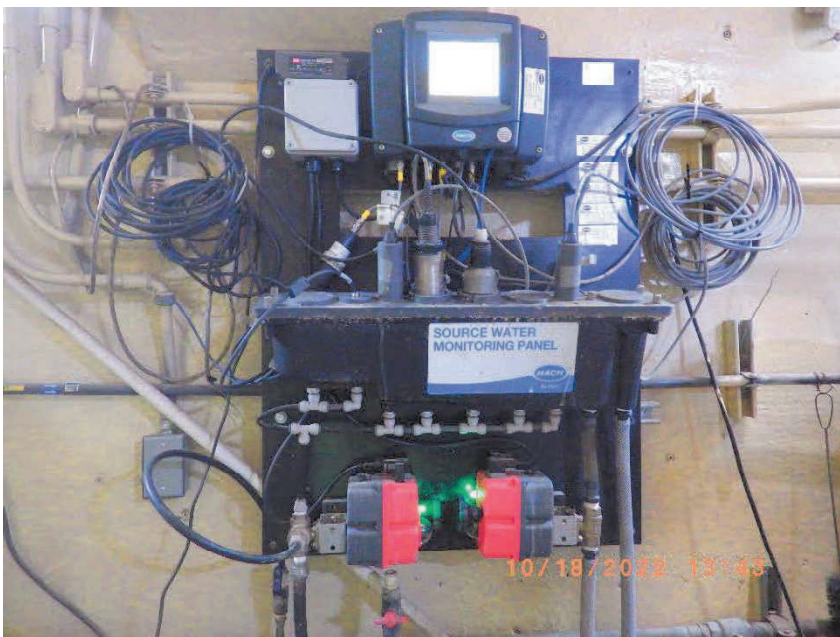
2022, and is on a regular calibration schedule from a contractor. During this inspection, EPA inspectors confirmed that the equipment was functioning and was monitoring water temperature, conductivity, and pH.	
Photo(s): Yes Appendix A Photo # 1-5

Description: Illinois American **Ex 7f (Water Infra)** Intake Monitoring Panel

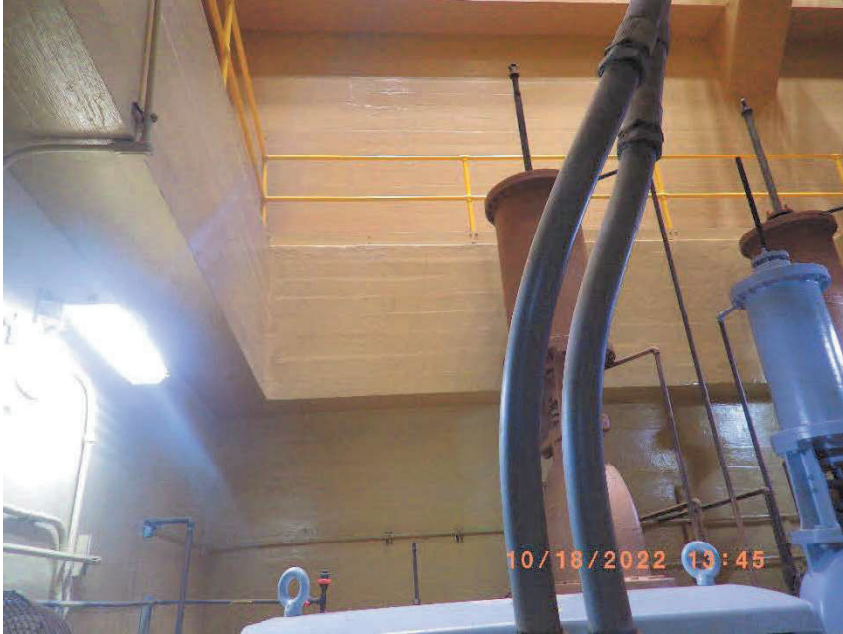
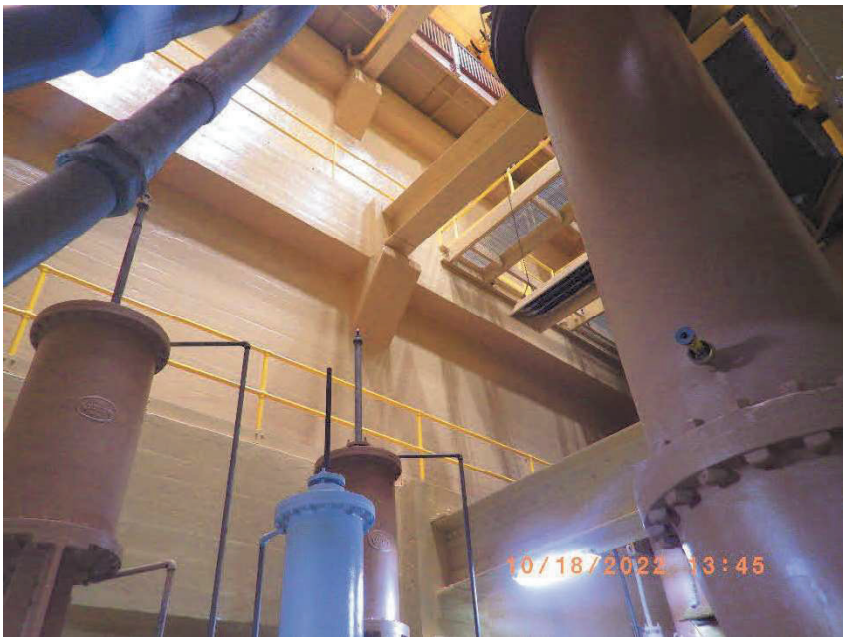
Area: Ex 7f (Water Infra) Intake	
Reference #: OB-001	AOC: No
During an April 2021 EPA inspection, it was observed that the interior of the Ex 7f (Water Infra) Intake building had areas of flaking paint that may have made system components more susceptible to corrosion. This observation was repeated in the UAO. In March 2022, this area was repainted. During this inspection, EPA inspectors confirmed that the painting project has been completed.	
Photo(s): Yes Appendix A Photos # 6-8	
Reference #: OB-002	AOC: No
During an April 2021 EPA inspection, monitoring equipment, which is used for non-regulatory water characterization, was inoperative. This observation was repeated in the UAO. In March 2022, the sample trough, conductivity probe, and pH probe was replaced. The equipment underwent a calibration on July 26,

Description: Painted Walls at Illinois American Ex 7f (Water Infra) Intake

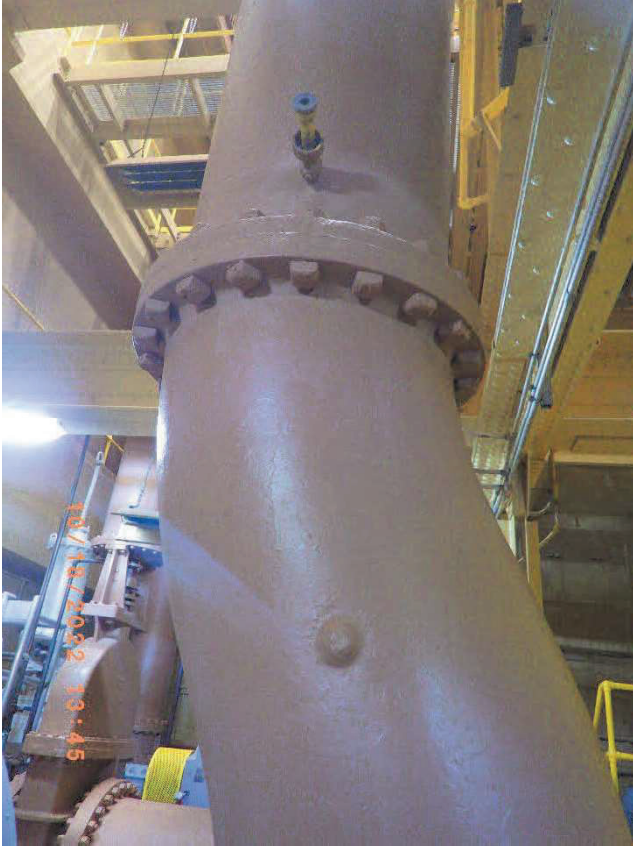
Description: Painted Pipe at Illinois American **Ex 7f (Water Infra)** Intake

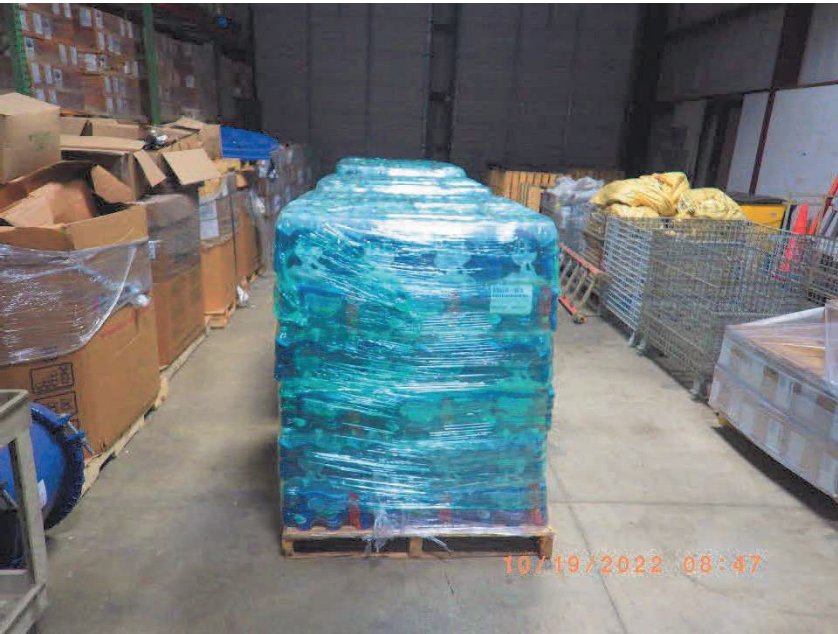
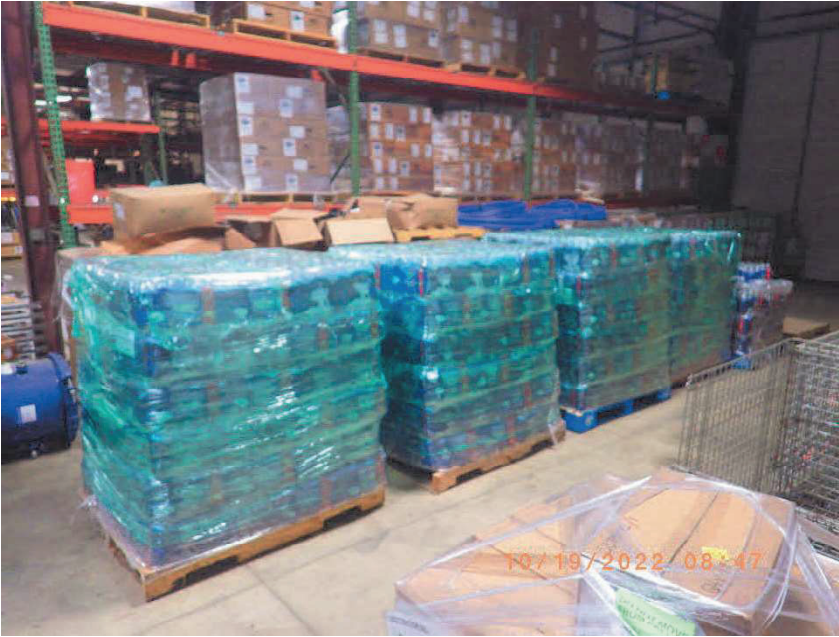
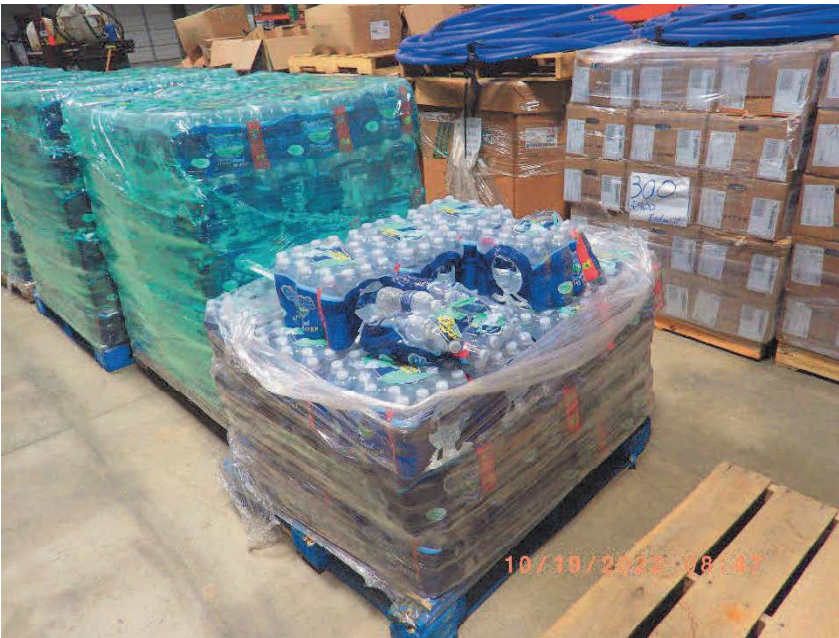
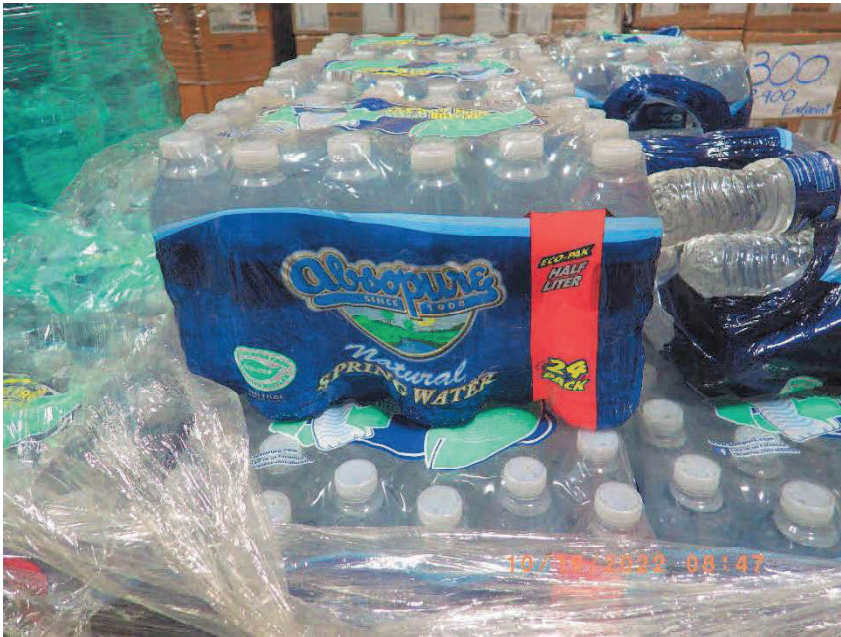
Area: Warehouse - Ex 7f (Water Infra) Belleville, IL	
Reference #: OB-003	AOC: No
This warehouse is used to store bottled water in accordance with IAW's Alternative Water Source Plan created in response to the UAO. In the event of pressure loss, a violation of the revised total coliform rule, or a water emergency, bottled water from this supply can be delivered to customers within the City of Cahokia Heights. During the inspection, there were approximately 4.5 pallets loaded with bottled water. IAW staff confirmed that additional bottled water can be ordered from a contract supplier, Absopure.	
Photo(s): Yes Appendix A Photo # 9-12	
Reference #: OB-004	AOC: No
The warehouse and nearby office building can be used to store spare parts, including, continuous pressure monitoring equipment for use on hydrants, and sandwich boards used to provide community members with contact information regarding construction in their neighborhood. During this inspection, EPA inspectors confirmed that IAW had pressure monitoring equipment and community information displays on hand.

Description: Emergency Water Supply

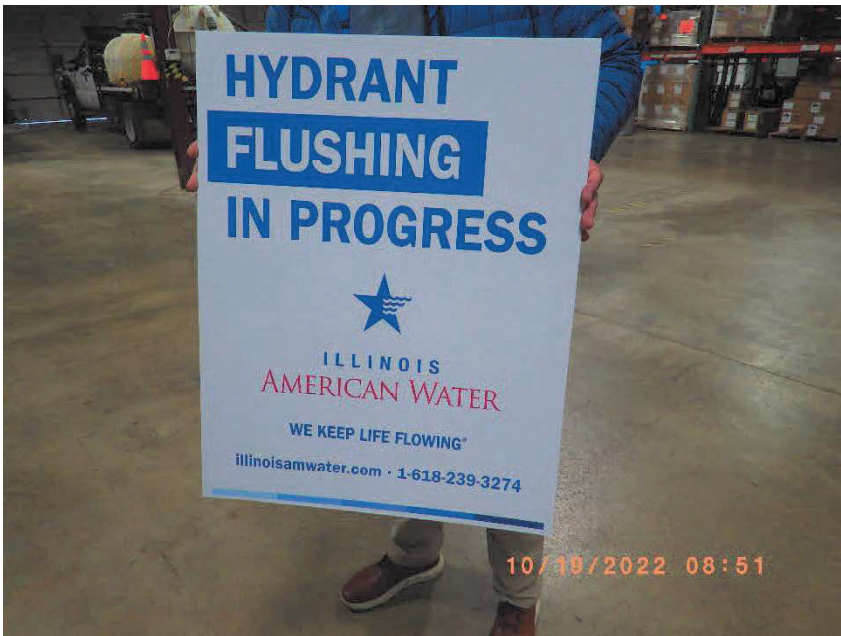
13: RIMG1613
Description: Hydrant Flushing Sign
Location: Illinois American Warehouse
Date/Time: 10-19-2022

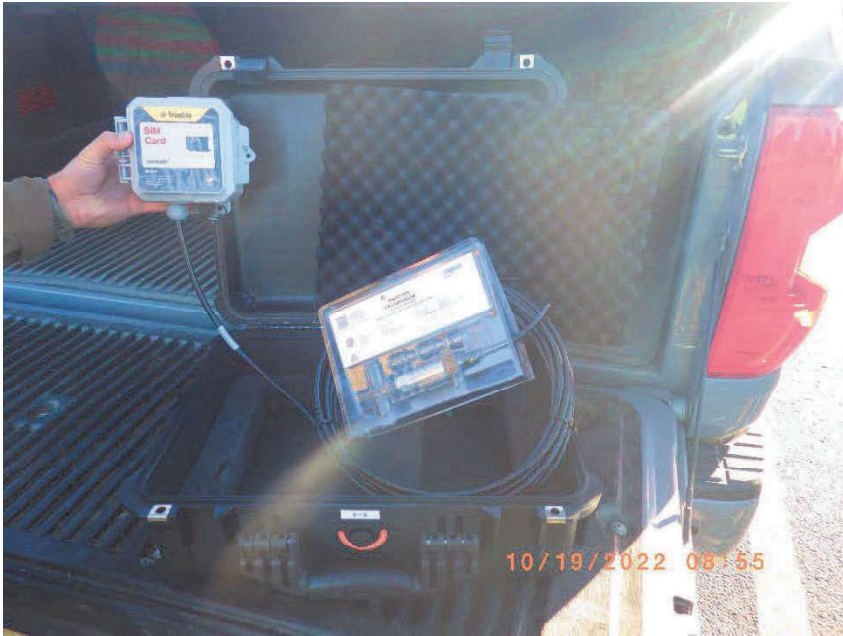
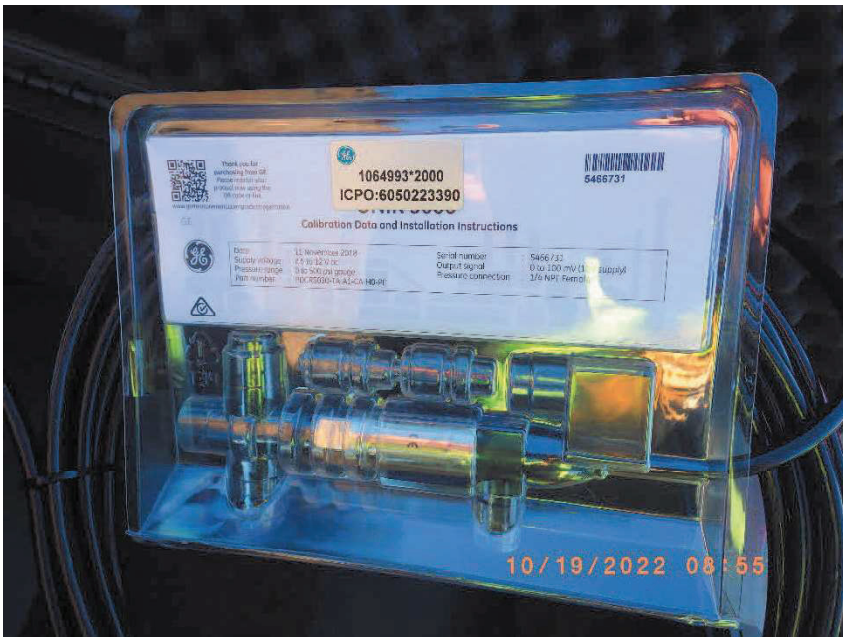
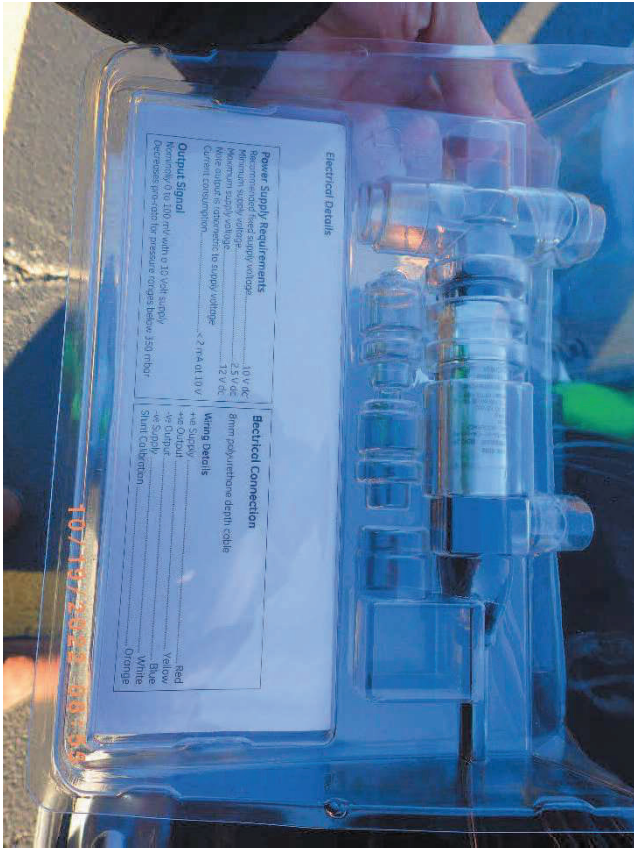
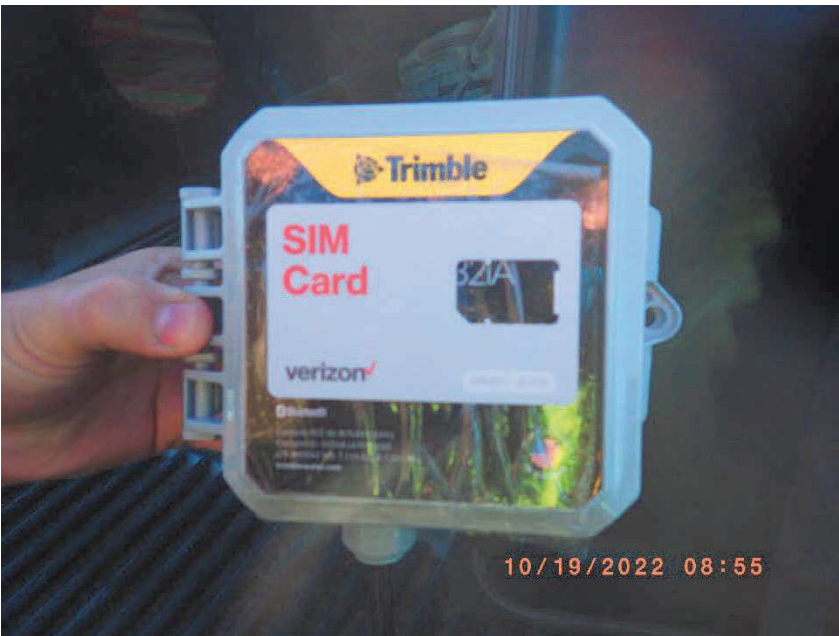
14: RIMG1614
Description: Pressure Monitoring Equipment
Location: Illinois American Warehouse
Date/Time: 10-19-2022

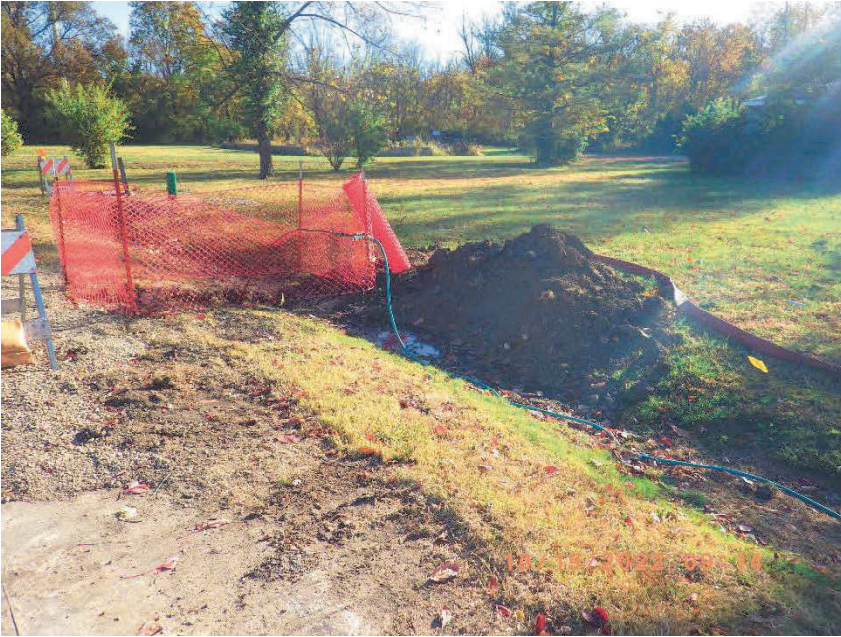
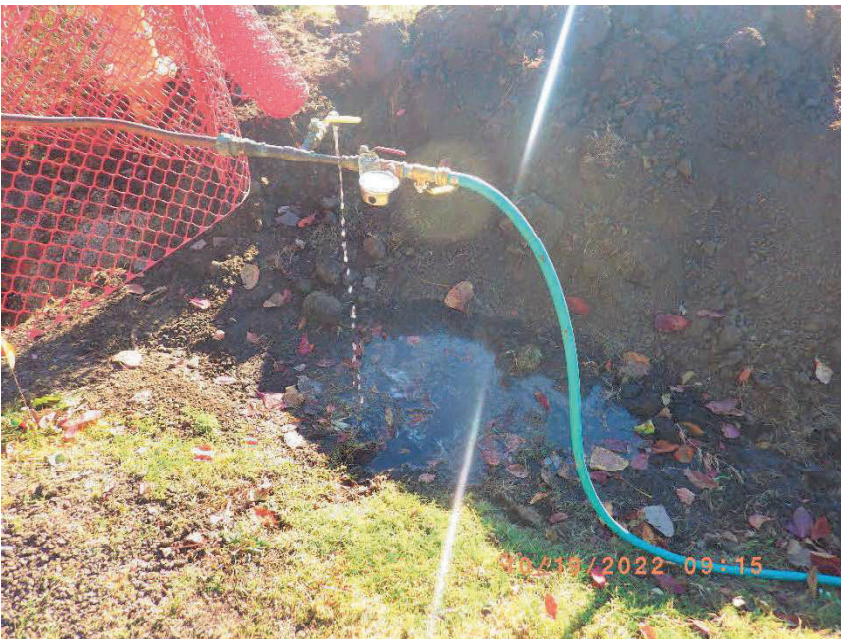
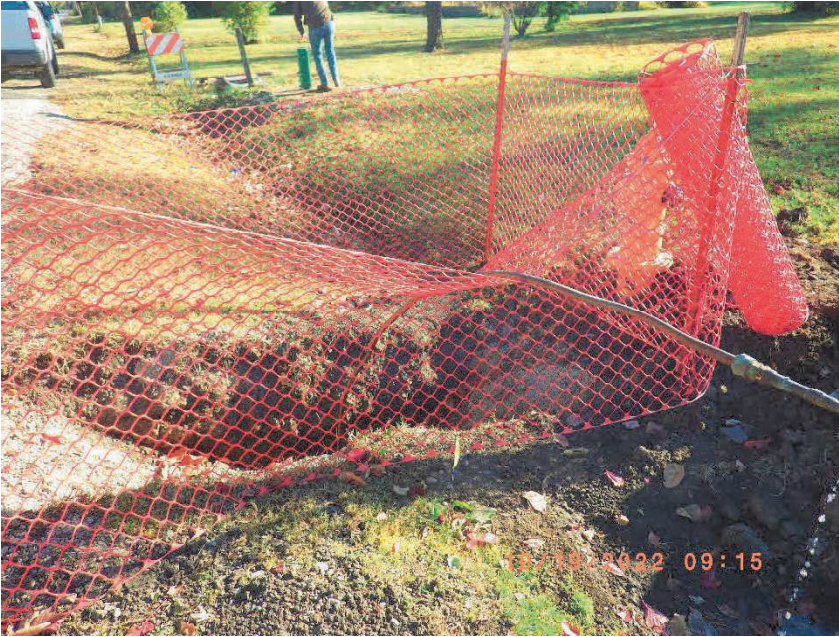
Area: Distribution System	
Reference #: OB-005	AOC: No
EPA inspectors observed some parts of IAW's service area within the City of Cahokia Heights, including areas that were located near historical occurrences of sanitary sewer overflows. The City of Cahokia Heights did not report any sanitary sewer overflows during the time EPA inspectors were onsite. EPA inspectors verified the physical location of several bacterial sampling stations and checked total chlorine levels. Sampling details are provided under Section IV: Sampling and Field Monitoring Activities.	
Photo(s): Yes Appendix A Photo # 18-24

Description: Water Main Replacement Project

This replacement project is located along N. 80th and N. 82nd streets bordered by Bluff Drive to the northeast and N. 80th Street to the south. This project will replace approximately 3,000 feet of 2-inch galvanized pipe with 4-inch water main and loop the two water mains to improve redundancy in the area.

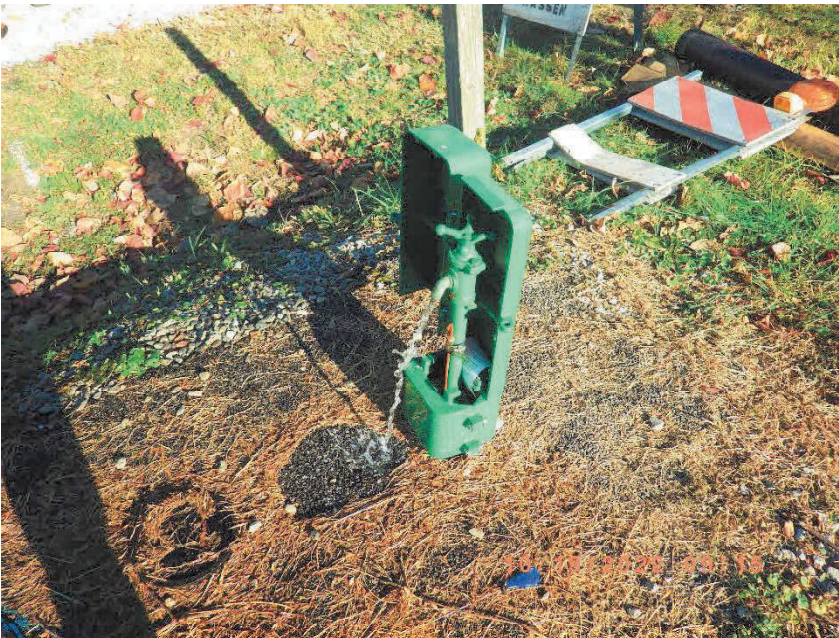
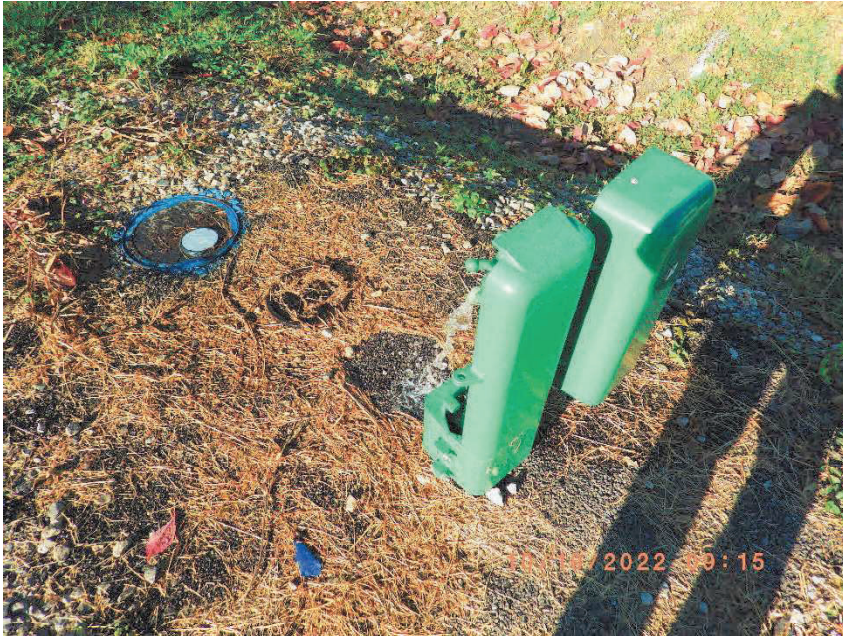
Description: Bacterial Sampling Station 1

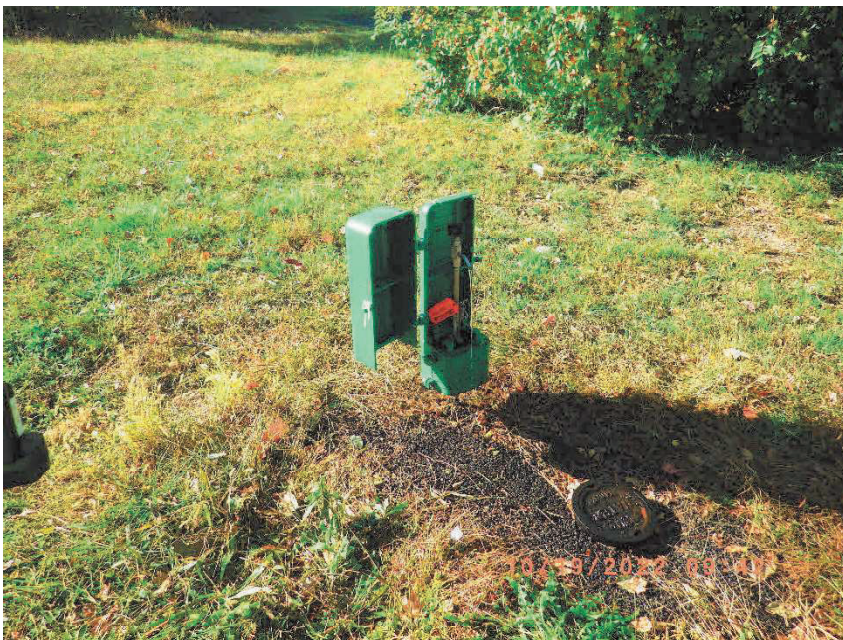
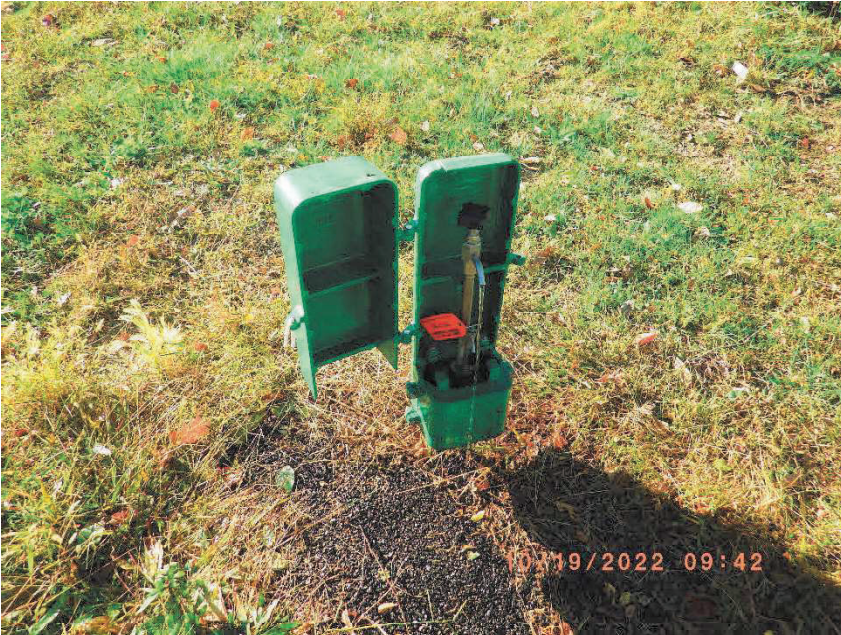
Description: Bacterial Sampling Station 2
