- SUBJECT: Long-Term Stewardship Assessment Chevron Molycorp Washington Remediation Project EPA ID: PAD030068282 300 Caldwell Avenue, Washington, PA 15301
- DATE: September 25, 2023
- TO: Alizabeth Olhasso, RCRA Corrective Action South Section Manager Long Term Stewardship File for Former Molycorp Facility RCRA Corrective Action
- FROM: Andrew Clibanoff, Remedial Project Manager

On September 14, 2023, the United States Environmental Protection Agency's (USEPA) Land, Chemicals, and Redevelopment Division (LCRD) representative, Andrew Clibanoff, conducted a long-term stewardship assessment site visit of the Chevron Molycorp Washington Remediation Project (Facility) in Washington, PA. The purpose of the LTS site visit was to assess the status of the implemented remedies at the Facility.

# September 14, 2023 Long Term Stewardship Inspection

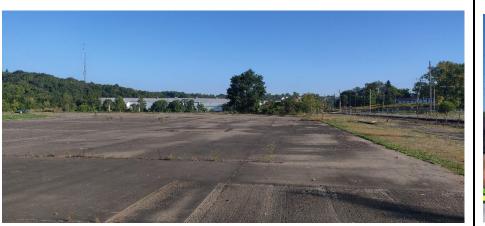
- 2. Tree growth through capped areas was observed during the site visit. While this doesn't impact the remedy, future tree growth in capped areas should be minimized.

Photo No. 1 (091305): View looking north at transshipment pad located in Area 1. Green Street is beyond the railroad tracks on the right. Note tree growth within the capped area north of the pad.

not impacting the effectiveness of the engineering and institutional controls in place in the North Process Area. It's recommended that future tree growth be prohibited on capped areas.

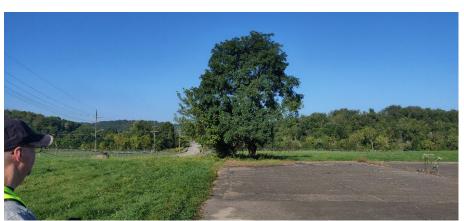
Photo No. 2 (091313): View looking west at transshipment pad located in Area 1. above Caldwell Ave. is to the left of the property fence. Note tree growth within the capped area west of the pad.

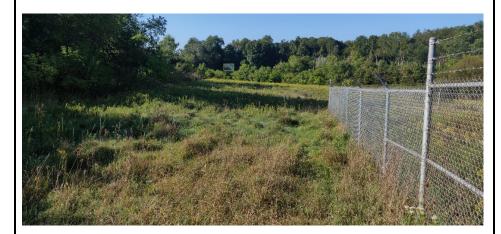
Photo No. 3 (094212): View looking southwest at former coal tar impacted Area 5. The fenced in capped former radiologically contaminated Area 3 is located to the right.

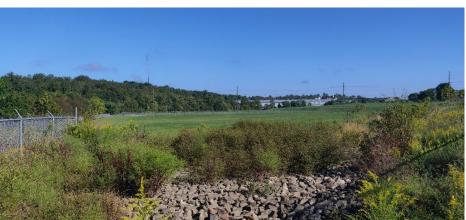
Photo No. 4 (094331): View looking northwest at Area 3 from outside the fence in Area 3's southeastern corner.

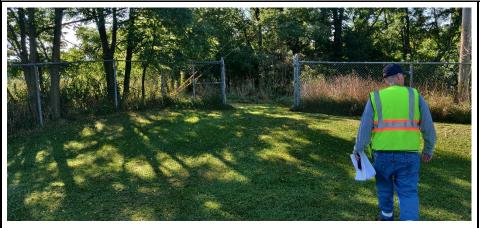
The final area visited during the LTS inspection was the portion of the property to the rear of the Canton Township Volunteer Fire Department (VFD) located on Caldwell Ave. west of Chartiers Creek. Photo No. 5 shows an as found open gate portion of the fence that separates the VFD from the Facility (Area 7B-C, an area with no known site-related impacts). Inside the fence line to the west, a tree stand was observed (see Photo No. 6) in either Area 7B-C or 7B-W, neither of which are known to have any site-related impacts. Inside the fence line to the southeast, a vertical metal pipe (See Photo No. 7) was noted in a heavily vegetated area believed to be within Area 5E. On the way back towards our vehicles, Chartiers Creek was observed from the Caldwell Avenue bridge (See Photo No. 8). No site related impacts to the creek were noted.

Photo No. 5 (095848): View looking west from rear of Canton Township VFC at gate left open onto Area 7B-C of the Molycorp Facility. Area 7B-C has no known site-related impacts but it is in close proximity to formerly coal tar impacted Areas 5E and 7B-E. Mr. Weaver from Trihydro, Inc. closed the gate upon leaving the property.

- 3. The access gate from Caldwell Avenue onto Area 10A needs to be kept locked in such a way that it prevents access onto the Facility property.
- 4. The gate located in the rear portion of the Canton Township Volunteer Fire Department that provides entrance to Area 7B-C was unlocked and wide open at the time of the site visit. It is unknown whether Chevron or the Canton Township VFD is the owner of that portion of the fence/gate. Chevron should make this determination and the responsible party should ensure the gate is locked when not in use.

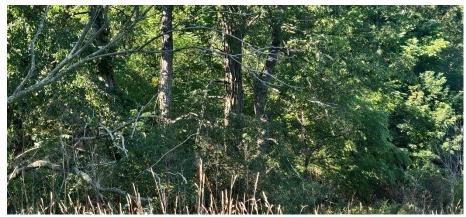
Photo No. 6 (100005): View of a tree hunting stand installed in Area 7-BW near the Canton Township VFC property line. Area 7B-W has no known site-related impacts

- 5. The presence of a hunting tree stand in Area 7B-C or 7B-W indicates that trespassers are finding their way onto the Facility Property. While this area has no known site-related impacts, once inside the fence line behind the Canton Township VFD access to impacted site area can be easily gained. More deterrence to trespassers, such as ensuring all gates remain locked and posting signage, is recommended.

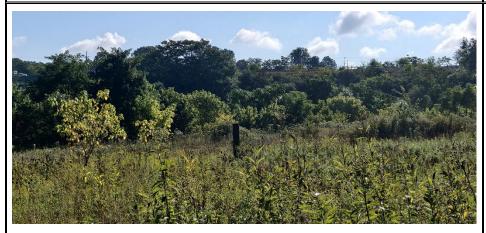
Photo No. 7 (100235): View looking at metal pipe standing vertically in Area 5E. Vegetation in the area prevented a closer inspection of the pipe. Area 5E had been historically impacted by coal tar contamination.

- 6. The presence of the vertical metal pipe observed from a distance within Area 5E should be further investigated by Chevron. If there is no reason for it to be there, it should be removed.

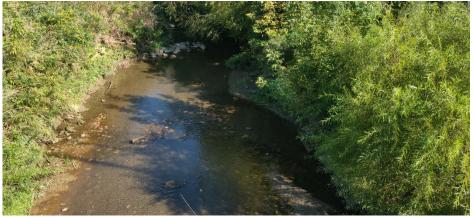
Photo No. 8 (100658): View looking north at Chartiers Creek from the Caldwell Avenue Bridge.
