# Region 9 Enforcement and Compliance Assurance Division (ECAD) INSPECTION REPORT

(0)	110.0 17.0.	<u> </u>			
Company Name:		Desert View Power Inc. (an affiliate of Greenleaf Power LLC)				
Facility or Site Name:		Desert View Power Plant				
Facility/Site Physical Location:		62-300 Gene Welmas Drive				
(city, state, zip code)		Mecca, CA 92254				
Geographic Coordinates:		33.586, -116.088				
Mailing address:		2600 Capitol Ave., Suite 430 (Corporate HQ)				
(city, state, zip code)		Sacramento, CA 95816				
Tribe/County:			Cabazon Band of Mission Indians (Riverside County)			
Facility/Site Contact and		Kevin Lawr	Kevin Lawrence, Plant Manager			
Personnel Participating in		(760) 262-1644; klawrence@greenleaf-power.com				
Inspection:			, , , , , , , , , , , , , , , , , , ,			
Facility/Site Identif	fier:	FRS 110022	FRS 110022450729			
Media Number:		ICIS-AIR CA	ICIS-AIR CA0000006065CAB27 (0900000CAB0DP1)			
NAICS:		221117, Biomass Electric Power Generation				
SIC:		4911, Electric Services

Desert View Power Plant Inspection Report Inspection Date 11/17-18/21

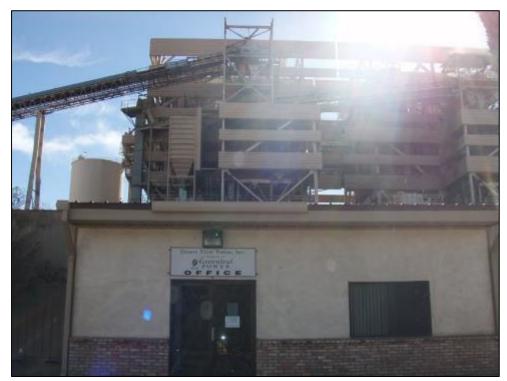
**Photograph 1:** View of front office entrance at 62-300 Gene Welmas Drive, Mecca, CA 92254, identifying Desert View Power, Inc.'s location.

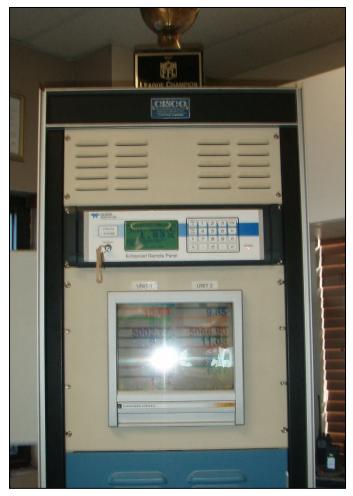
**Photograph 2:** View of visual display of CEMS real-time data in the facility's engineering control room.

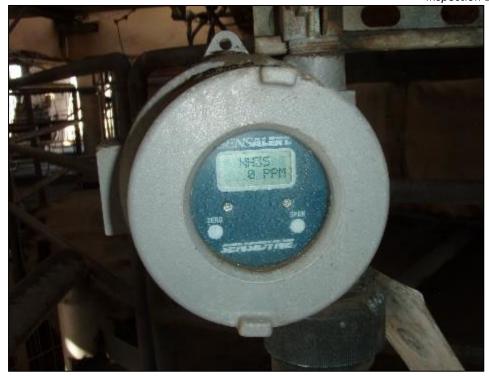
Next, the inspection team climbed at least 8 flights of stairs at the boiler unit to view the ductwork for the selective non-catalytic reduction (SNCR) system that uses ammonia to reduce nitrogen oxide emissions (NOx). Mr. LAWRENCE said that the injection valves were 7% open at Boiler units 1 and 2. Inspector LAPADA took photographs of the Sensidyne gauges that showed readings of zero ppm ammonia. Inspector CHEW asked why the readings said zero. Mr. LAWRENCE explained the next day that the Sensidyne gauges were used to measure the concentrations of ammonia outside the system for worker safety reasons. They were not used to measure the SNCR's effectiveness. A separate system controlled the SNCR's settings and parameters.

**Photograph 3:** View of Sensidyne gauge showing 0 ppm of ammonia at the SNCR unit.

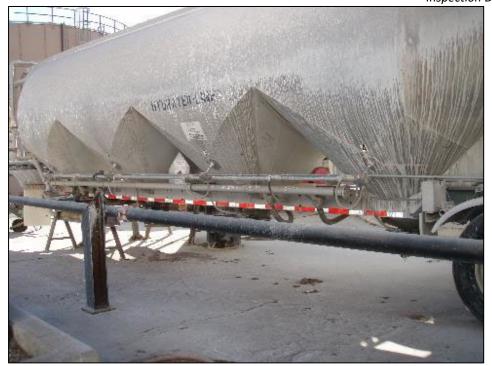
Next, the inspection team went to see the pig trailers that stored the hydrated lime used for the control of sulfur oxides (SOx) and hydrogen chloride emissions. Mr. LAWRENCE had been using a rubber mallet twice per shift per day to assess when hydrated lime needed replenishing at the pig trailers. The echoing sounds made in the pig trailer after impact with his rubber mallet would indicate to him if one of the four pods was close to being empty and a work order be made for more hydrated lime deliveries. Mr. LAWRENCE said the feed rate of the hydrated lime was set at 200 pounds per hour from the day bin to the baghouse inlet. Inspector LAPADA took photographs of the day bin. The inspection team noted that the controller for each bin was set at a range of 80 to 120 to 150 pounds per hour.

**Photograph 4:** View of pig trailer storing hydrated lime.

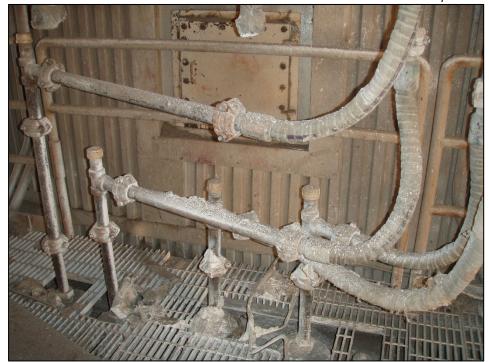
Following that, the inspection team asked Mr. LAWRENCE to take us to the delivery system where hydrated lime would be introduced into the combustion gases. Inspector CHEW asked Mr. LAWRENCE how the facility would know if the lances used to introduce hydrated lime into those gases had been clogged. He replied that an operator would inspect each of the four 6-foot long lances each shift and check for pressure suction to ensure delivery of hydrated lime. He said 60 fabric filter bags had been replaced during the last monthly inspections during an outage. The operators would clean the baghouse every 90 days using puffed air. There were 250 bags per module and eight modules in the baghouse. Their system reading was 1.8% opacity earlier today. Inspector CHEW asked to see the facility's recent work orders for bag replacement.

**Photograph 5:** View of 6-foot lances that deliver hydrated lime to the combustion gases.

As to the lances delivering hydrated lime for use at the boilers, Mr. LAWRENCE told us that alarm screens would alert a technician if a lance had been clogged. This was a measure taken in addition to physical checks during every shift and round sheets to check for working pressure suction at the lances at both boiler units.

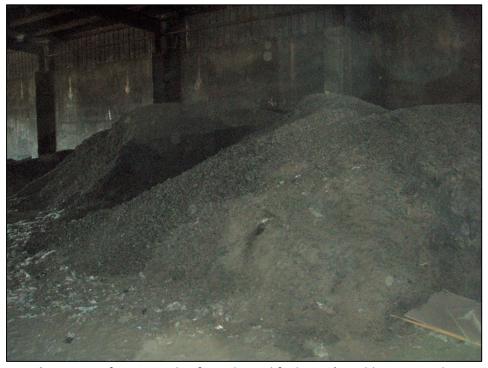
Next, the inspection team went to the pet coke barn. Mr. LAWRENCE said there were 2.1 tons of TDF sample burned earlier this year. Inspector CHEW asked him to give us a rough estimate of TDF that was in the barn. He said 40 tons.

**Photograph 6:** View of storage pile of tire-derived fuel, TDF (roughly estimated at 40 tons).

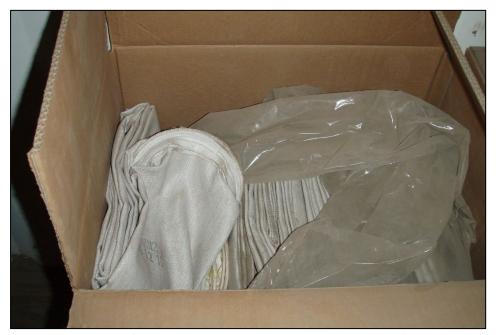
At around 10:45 am the next morning, the inspection team entered a shipping container where the surplus bags to be used in the baghouse had been stored. Inspector LAPADA took photographs of fabric filter bags stored inside. Mr. LAWRENCE said there were close to 80 bags and the facility was purchasing 75 more. Mr. LAWRENCE said the purchases for bags typically take place twice a year - in the spring and fall. The facility would inventory the bags every 90 days, such as shorter outages when inspection took place as recently as two weeks ago.

**Photograph 7:** View of box inside storage trailer containing surplus fabric filter bags.

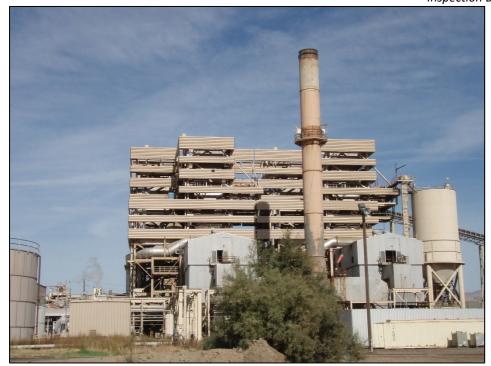
Mr. LAWRENCE explained that if opacity increased, the facility would need to isolate modules one at a time to perform more thorough inspections to look for bags with holes or tears inside the baghouse. He said the facility performed thorough bag inspections around four years ago in 2017. That was when the facility transferred to a new system, he said. As to visible emissions readings, Mr. LAWRENCE said the facility had a certified E and I technician performing their Method 9 readings. Inspector DUDASH said he was certified for Method 9 visible emissions reading. As the inspection team evaluated the proper circumstances for such readings, the inspection team stated that it could not properly perform visible emission readings at the main stack due to the time of the day, sun's position at the reader's back, and the lack of a proper contrasting background behind the smoke plume when facing the southern direction. Despite those circumstances, the inspection team made a preliminary attempt and Inspector DUDASH did not come up with any 15-second interval readings that exceeded 5% opacity. Upon checking against the opacity reading of 1.91% in the engineering control room about 20 minutes later, the inspection team said that the preliminary readings would appear to be consistent with the instrumentation's reading.

**Photograph 8:** View of main stack on which preliminary attempts were made to perform proper Method 9 visible emissions readings.

team stated that follow-up on opacity recordings was needed as the team had not been able to perform in-person Method 9 visible emission field readings properly.

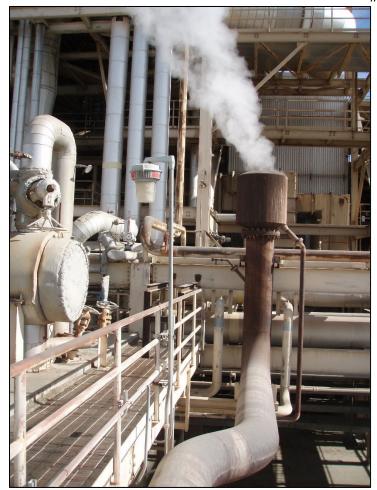
Inspectors CHEW and DUDASH asked Mr. LAWRENCE about the venting that was taking place to the left side of the main stack when facing the southern direction. Mr. LAWRENCE said that would be the blowdown vent before the sump and the cooling tower. Inspector CHEW asked Mr. LAWRENCE to lead the team there. At the blowdown drum, Inspector LAPADA took photographs of the blowdown vent and drain before the sump and cooling tower. The inspection team did not note any particulate fallout on nearby equipment surfaces.

**Photograph 9:** View of blowdown vent and nearby equipment surfaces.

Inspector CHEW asked for a water chemistry analysis at the blowdown equipment.
