**Top Deck Intermediate Cover**

**January 23, 2024**

MUNICIPALITY OF TOA ALTA JANUARY 2024  
MONTHLY REPORT  
Civ. No. 3:21-01087-DRD

NIVIA I. AYALA, PE  
TERRATEK ENGINEERING GROUP, PSC  
P.O. Box 367445 San Juan, PR 00936

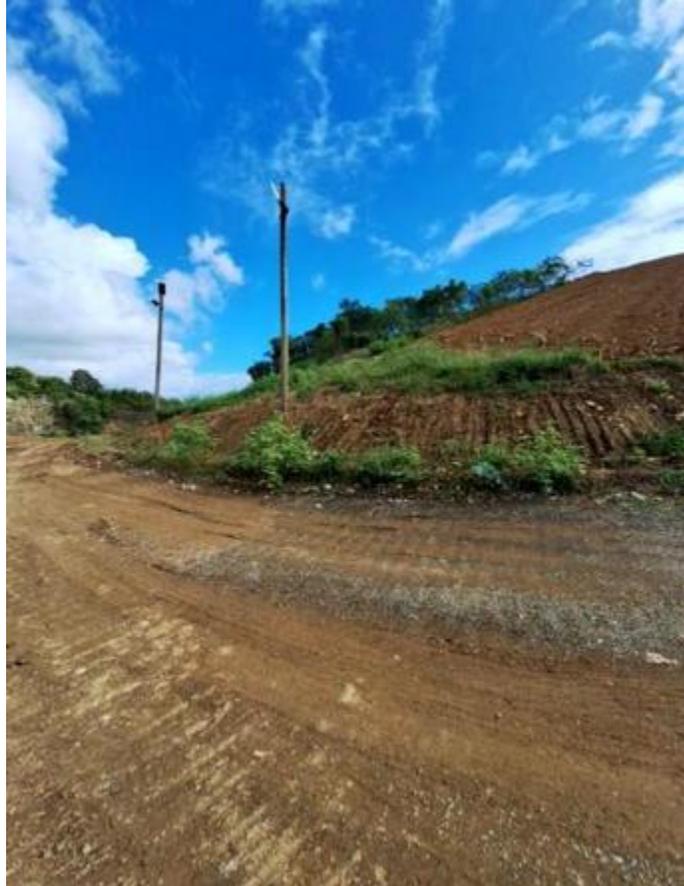
**Daily Cover:**

Daily Cover at the facility was completed on April 30, 2022. Daily Cover covered all areas of exposed waste.

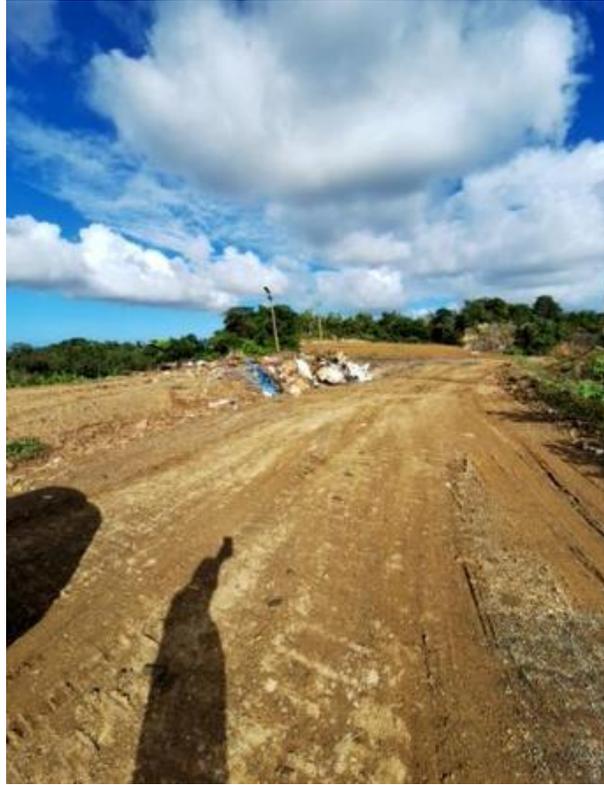
**Cessation of Waste Disposal:**

The cessation of waste disposal at the facility was completed by March 30, 2022. However, as agreed in the Stipulation, the temporary storage of construction and demolition (C&D) waste, bulk household waste (durable goods such as mattresses, furniture, and appliances), or yard waste (vegetation waste generated by land maintenance) for final disposal at a different landfill is active and been performed daily.

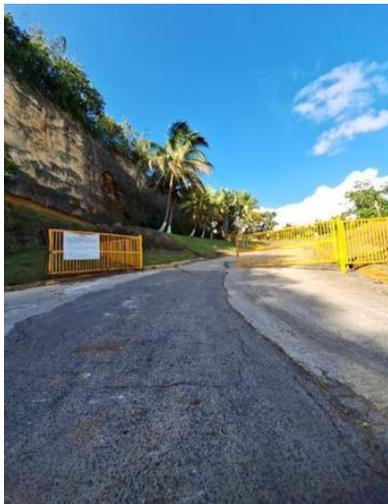
**Posting of Signs:**

A sign size of four feet by five feet was installed at the landfill entrance. See the attached pictures.

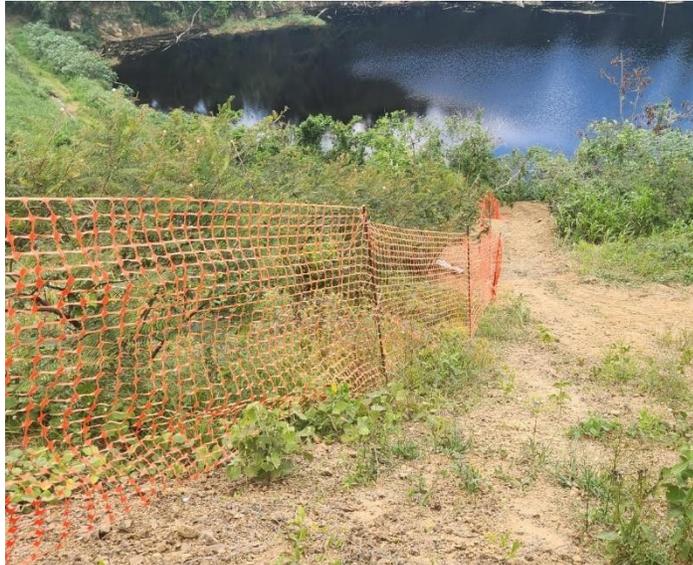
## Safety Barrier Fencing

Completed on April 28, 2023. Picture taken on November 03, 2023

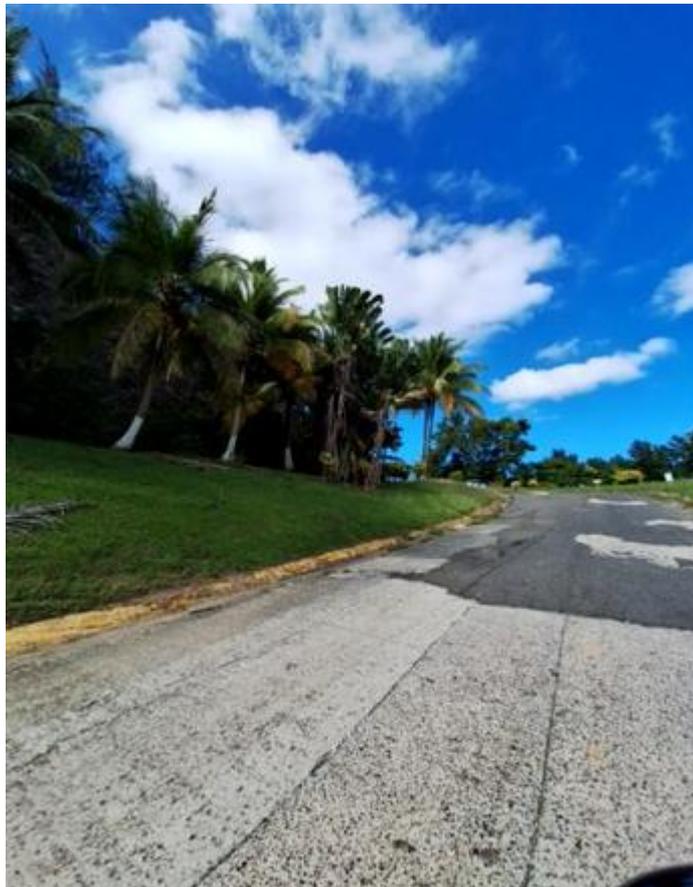
Foto Entrada

Esta la entrada limpia y libre de basura? Si

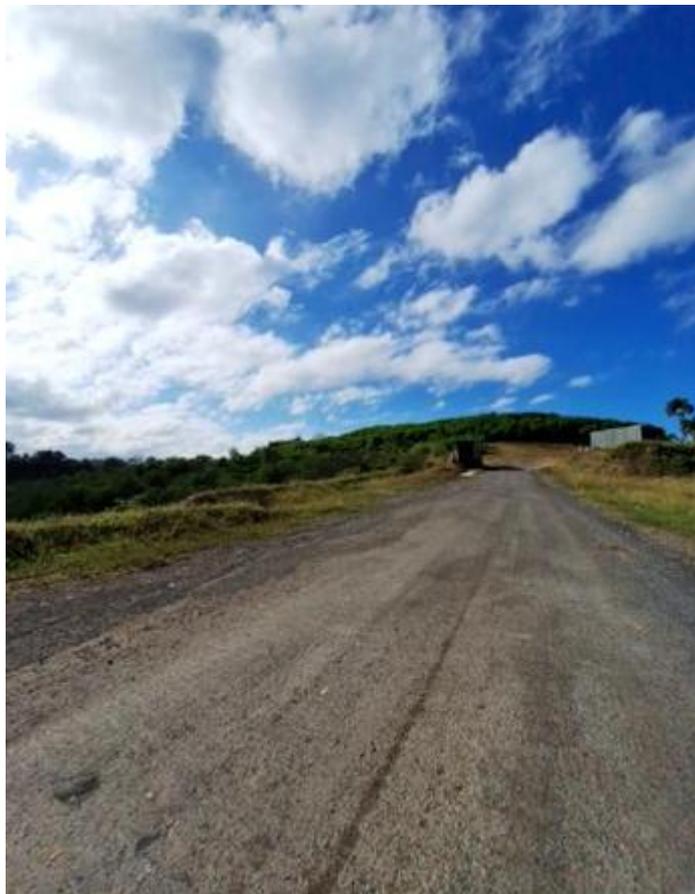
Estan las areas verdes limpias y se ha realizado mantenimiento? **SI**

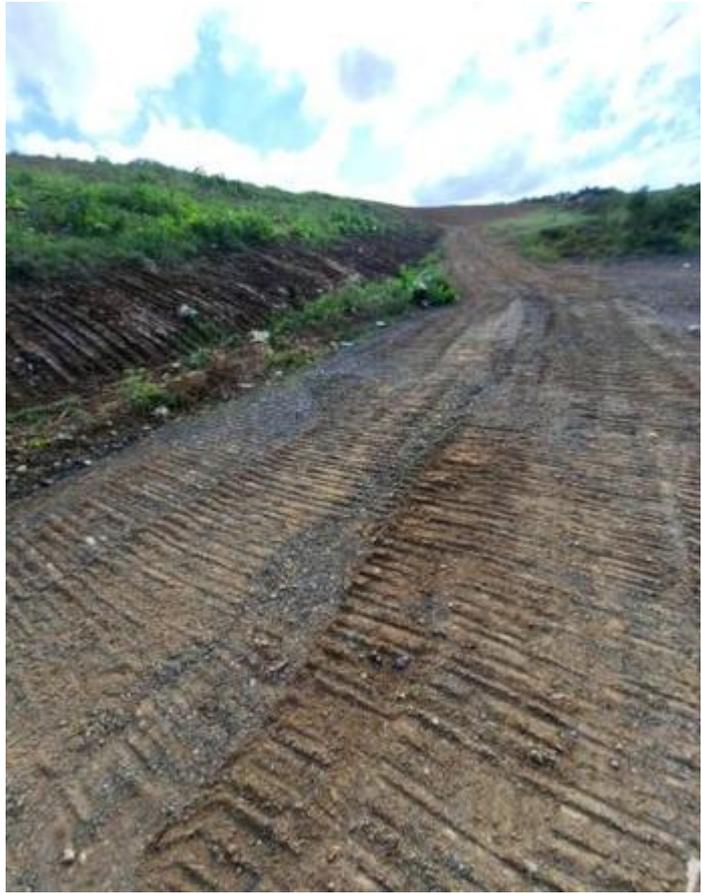
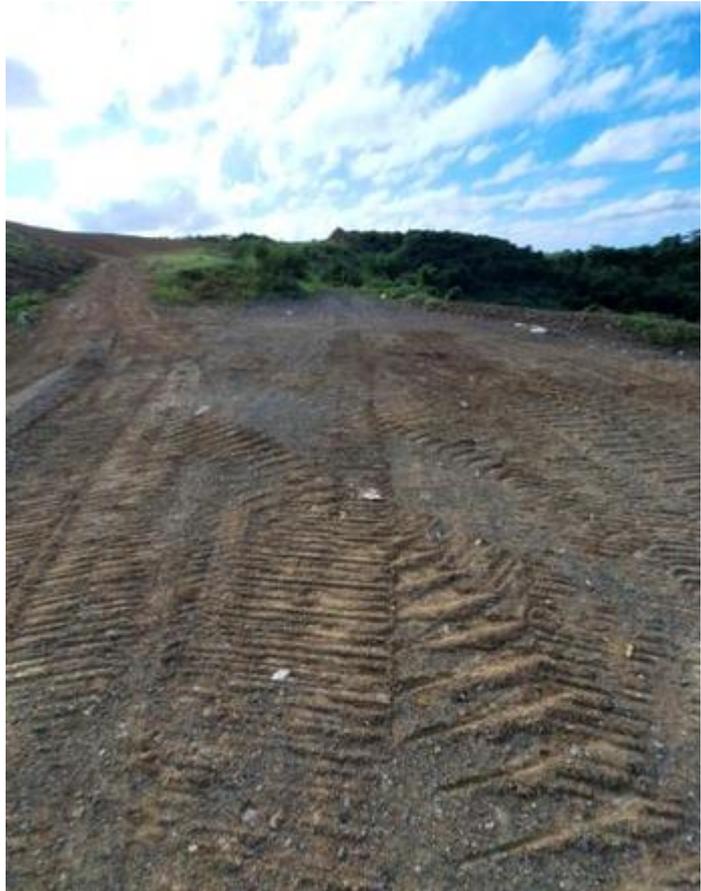
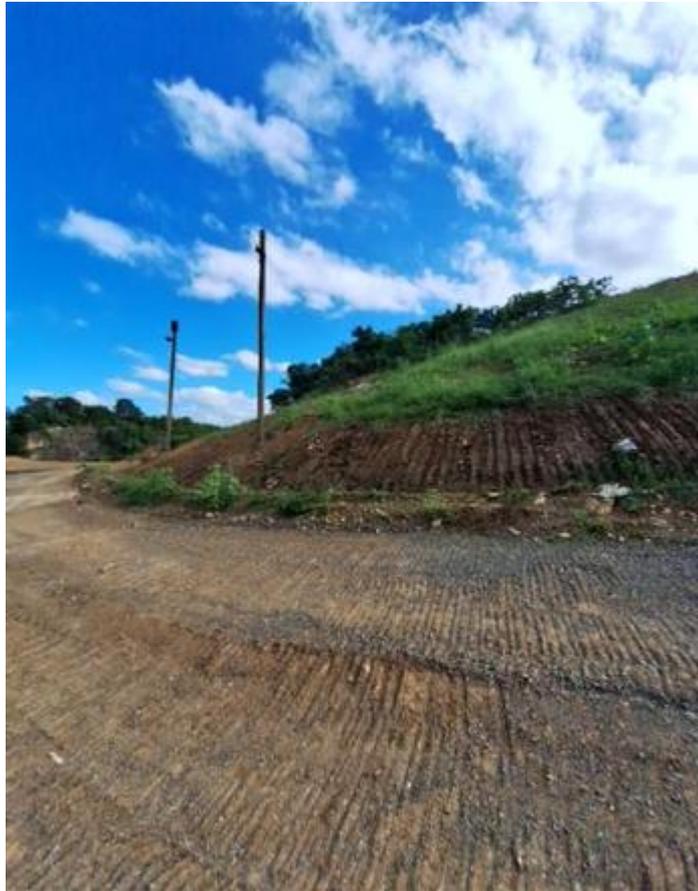
Condicion de Cubierta Talud Norte **Excelentes condiciones**

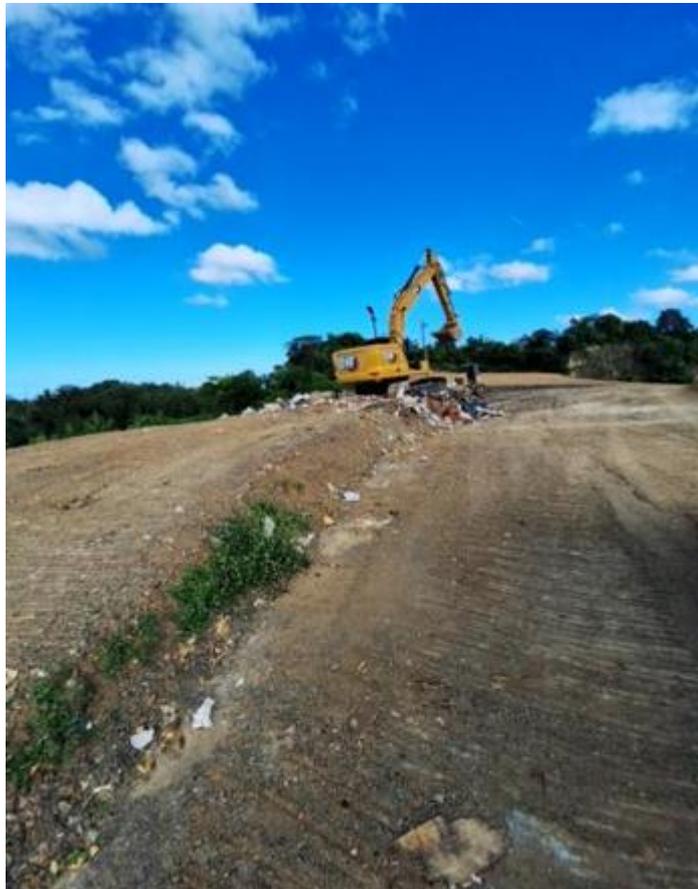
Condicion Operacion Recibo de Escombros

Necesita Limpieza

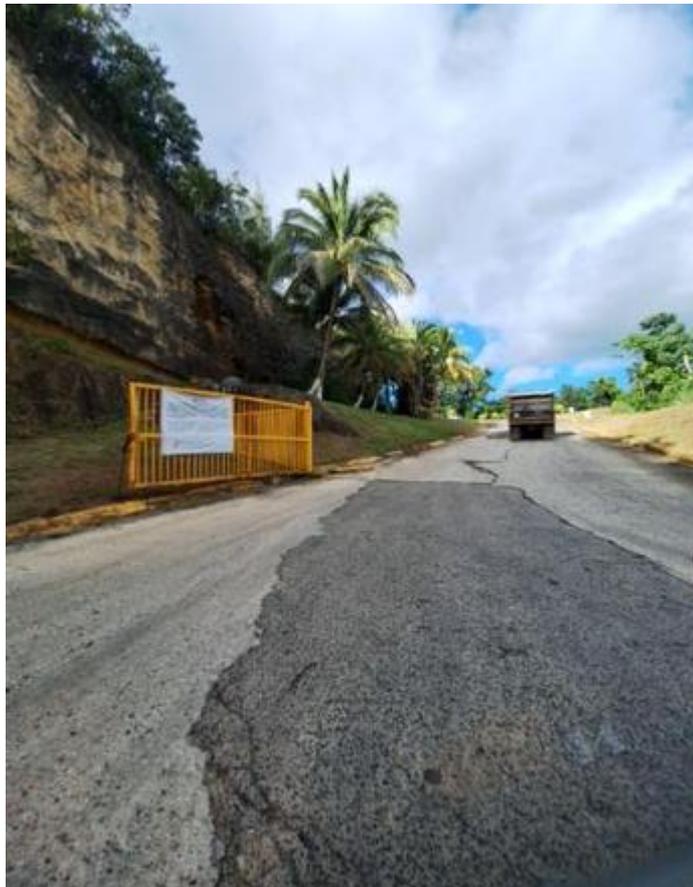
Foto Entrada

Esta la entrada limpia y libre de basura? Si

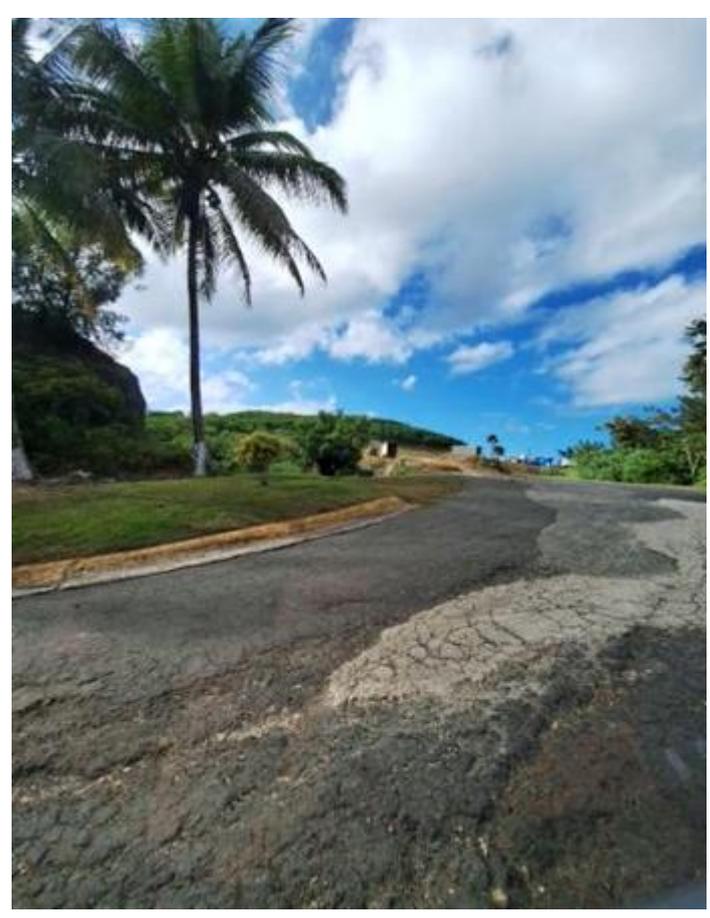
Estan las areas verdes limpias y se ha realizado mantenimiento? **SI**

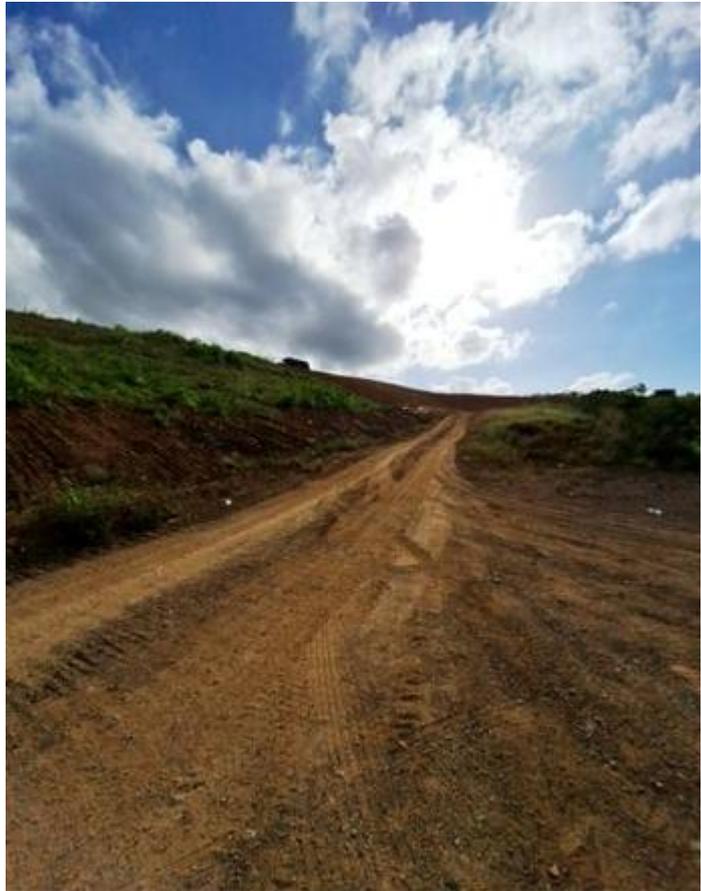
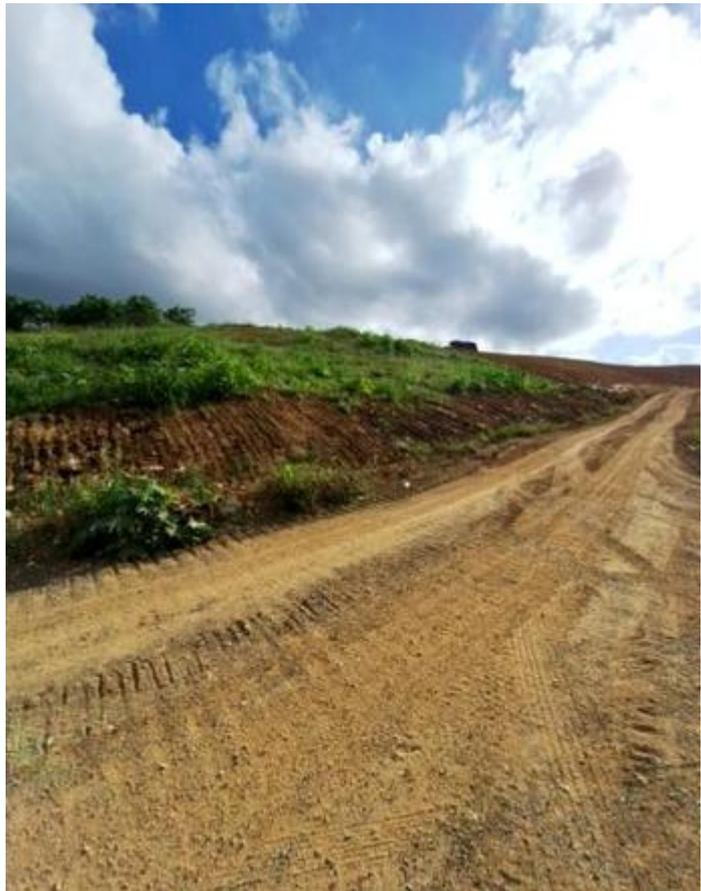
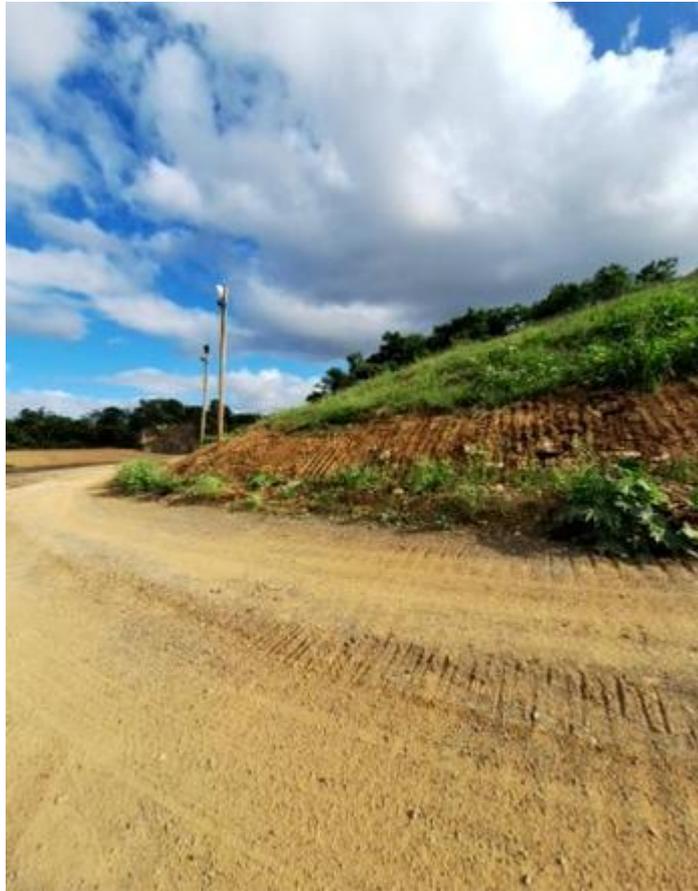
Condicion de Cubierta Talud Norte **Excelentes condiciones**

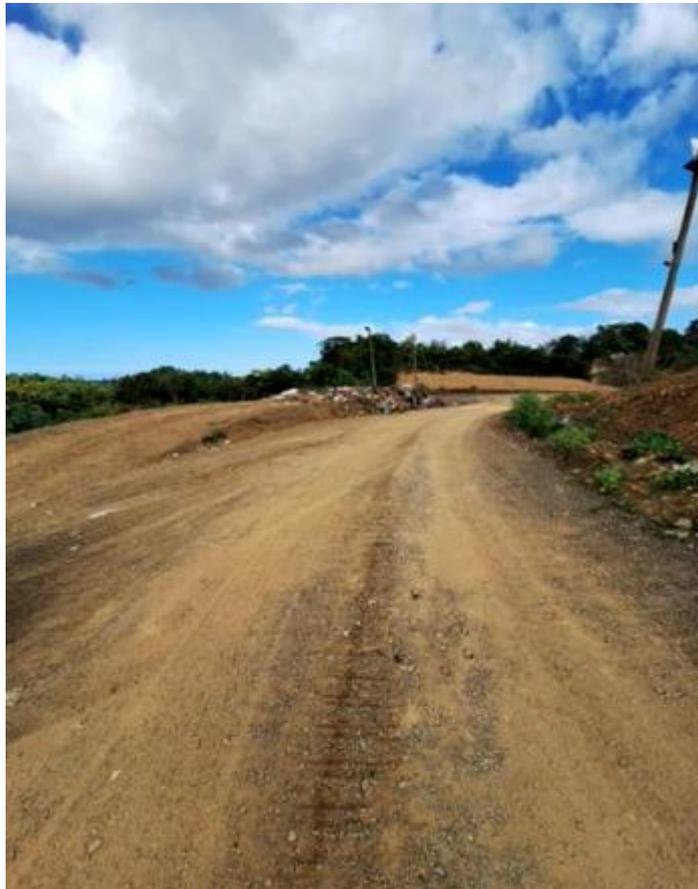
Condicion Operacion Recibo de Escombros

Buena

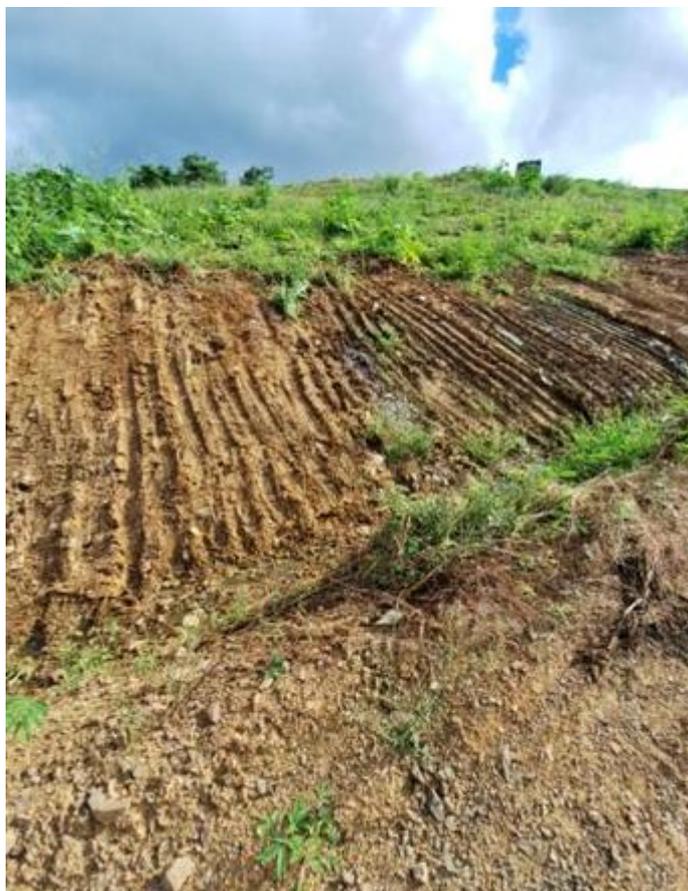
Añadir fotos deal area de brotes visibles

Se pueden notar brotes de lixiviado?

SI

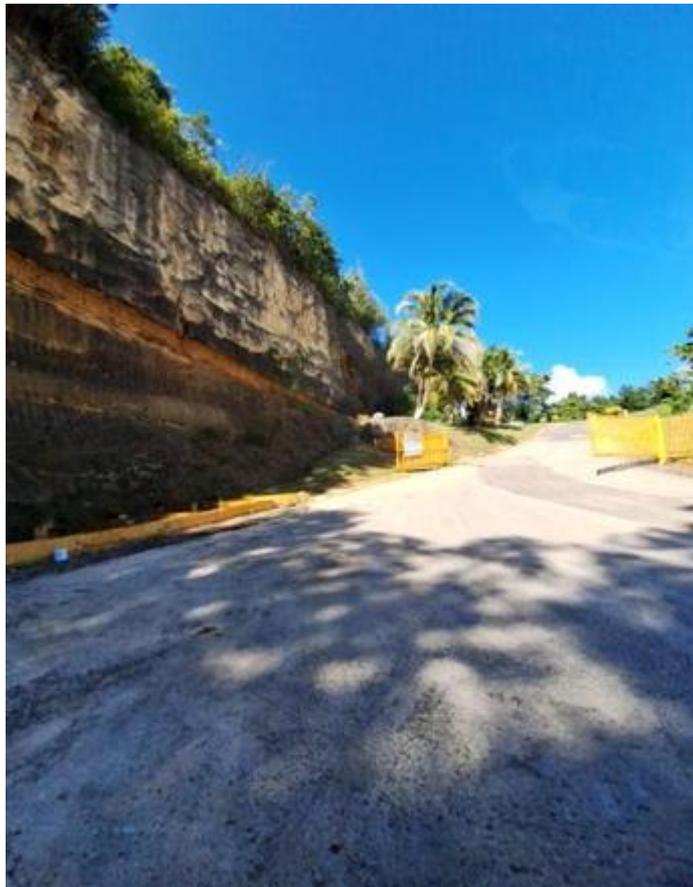
Foto Entrada

Esta la entrada limpia y libre de basura? Si

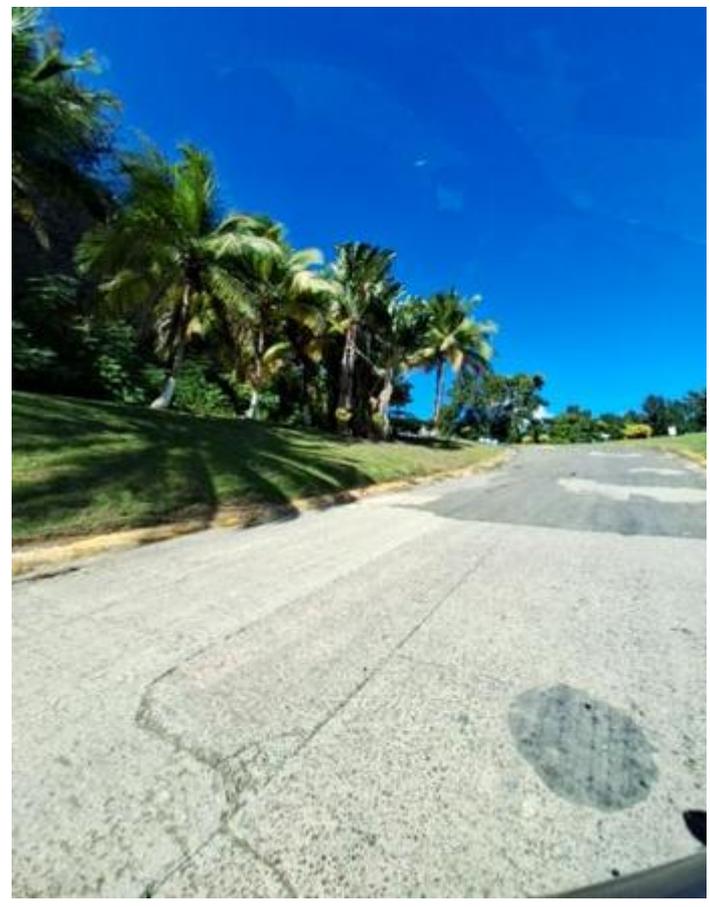
Estan las areas verdes limpias y se ha realizado mantenimiento? **SI**

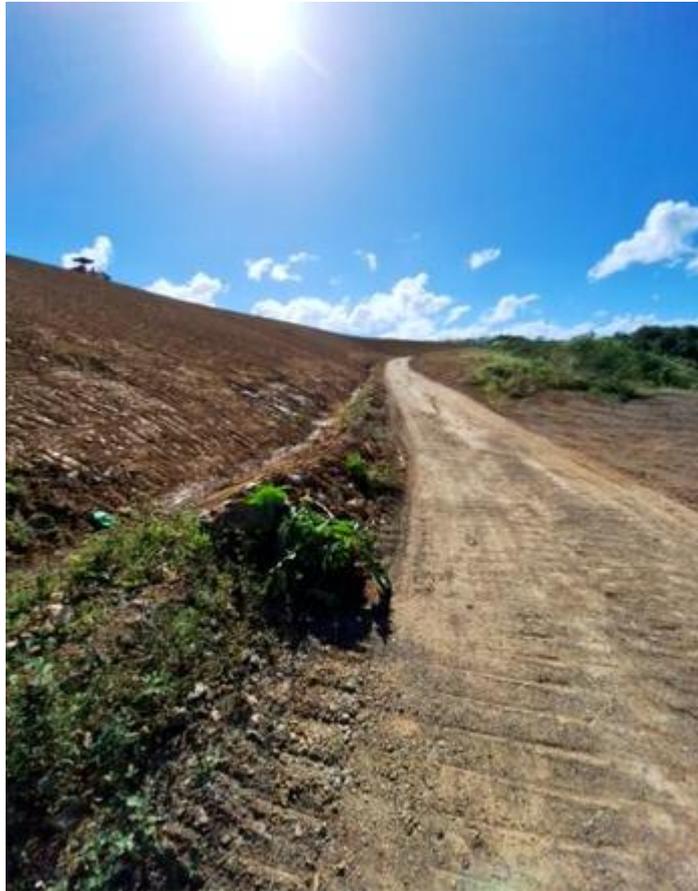
Condicion de Cubierta Talud Norte **Excelentes condiciones**

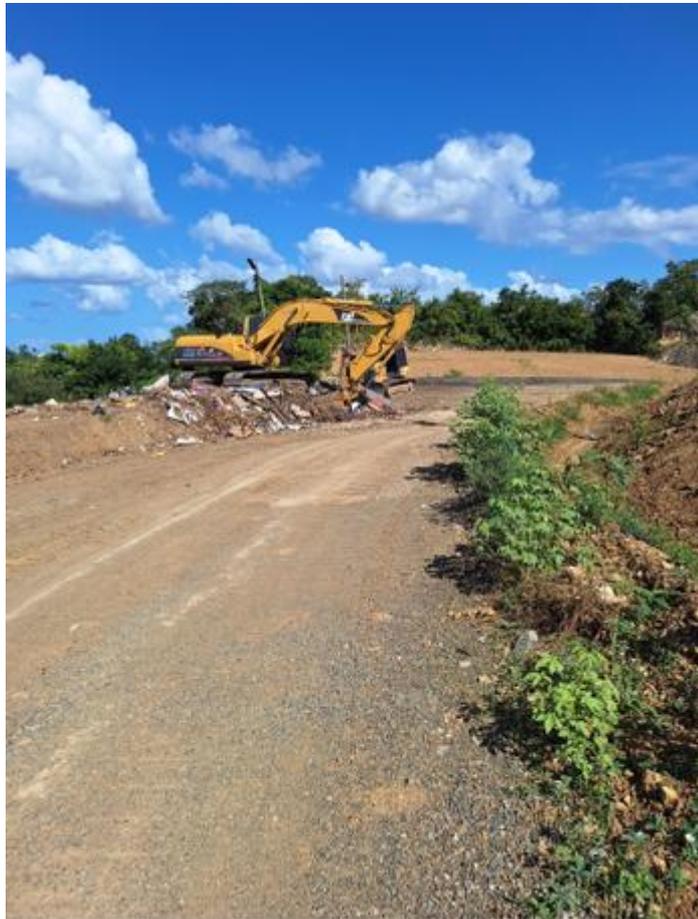
Condicion Operacion Recibo de Escombros

Necesita Limpieza

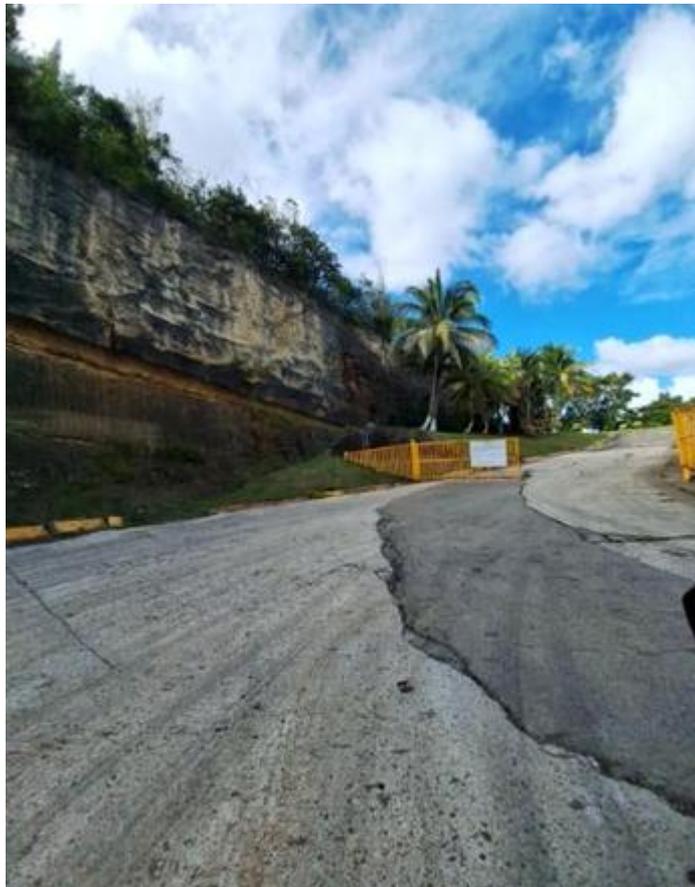
Foto Entrada

Esta la entrada limpia y libre de basura? Si

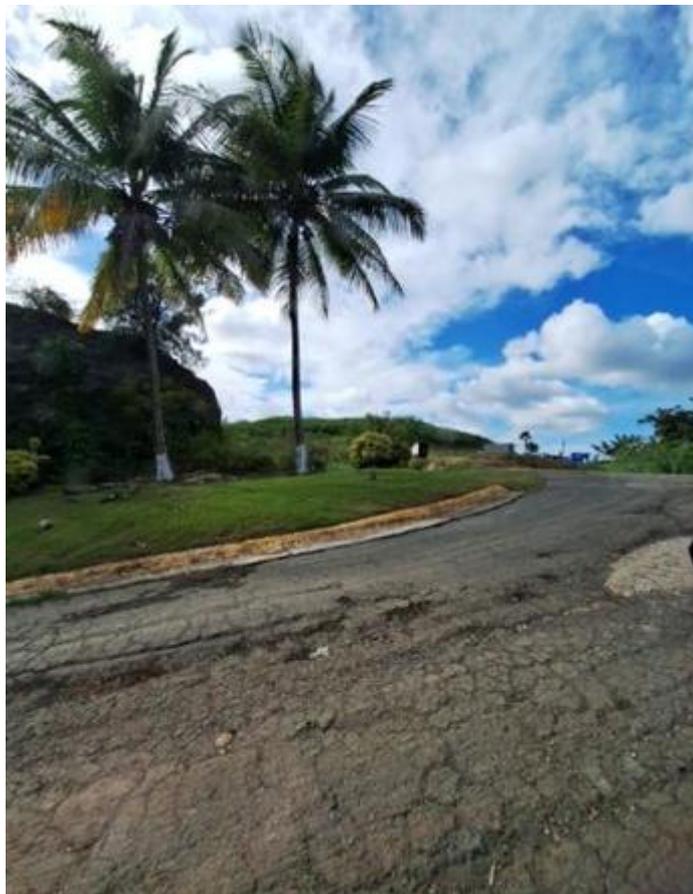
Estan las areas verdes limpias y se ha realizado mantenimiento? **SI**

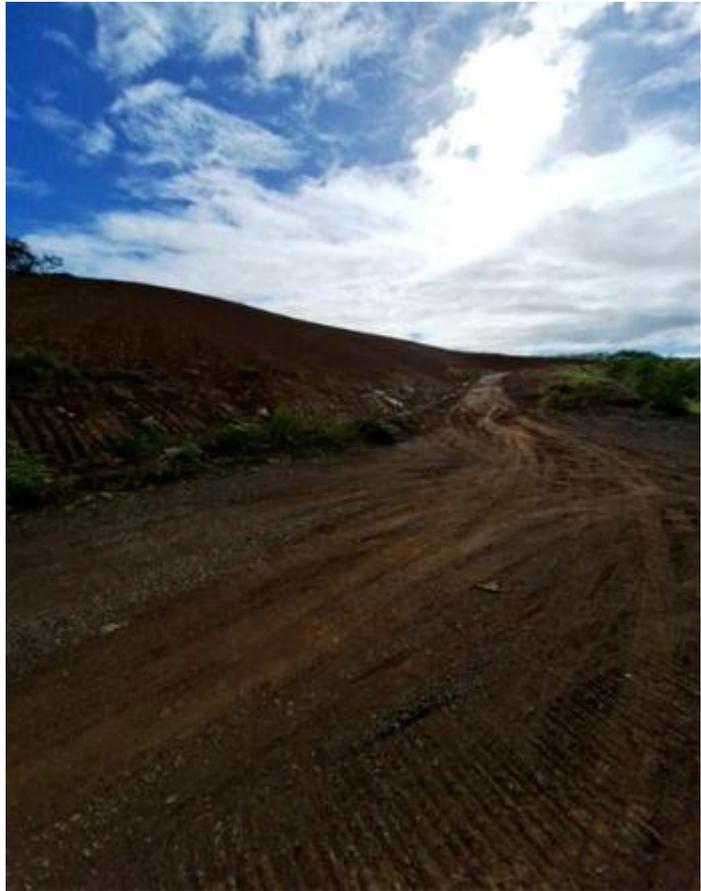
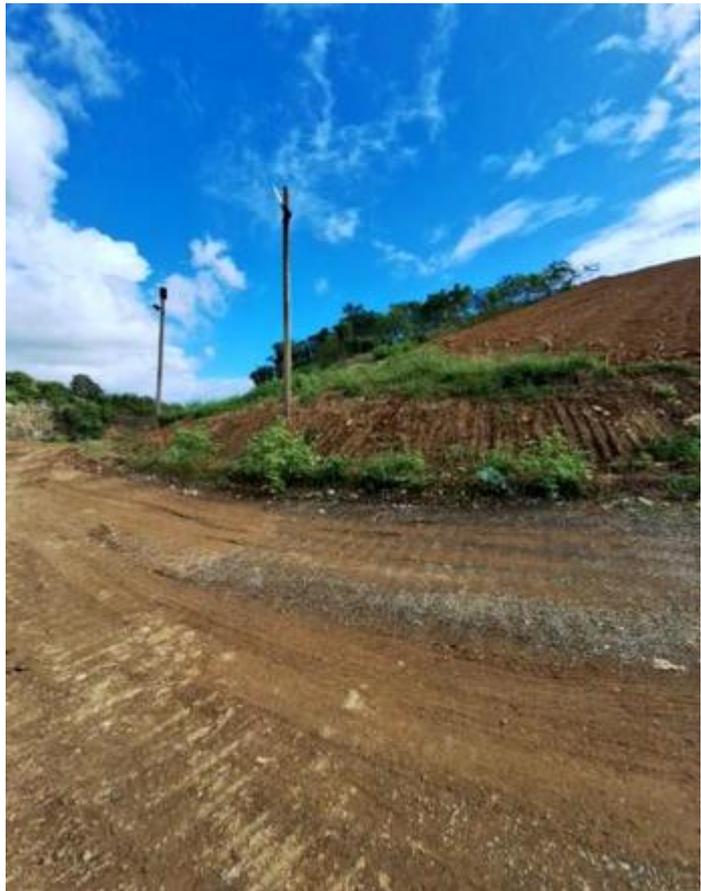
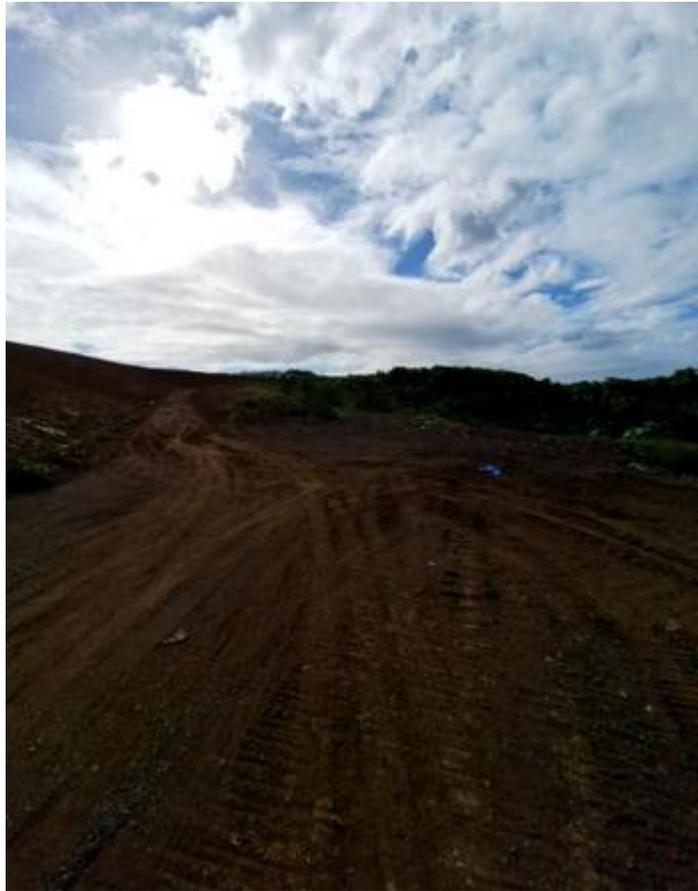
Condicion de Cubierta Talud Norte **Excelentes condiciones**

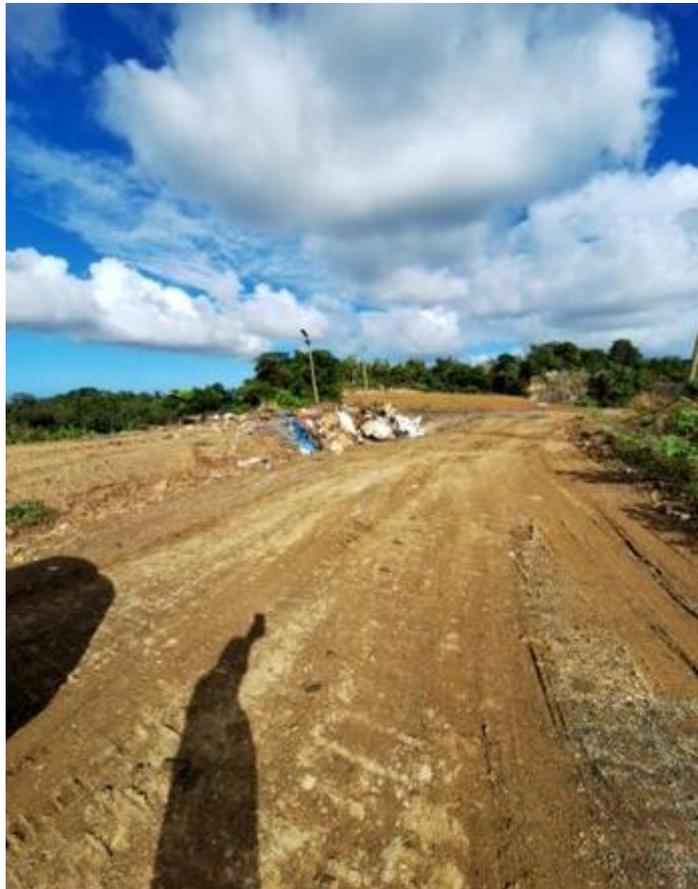
Condicion Operacion Recibo de Escombros

Necesita Limpieza

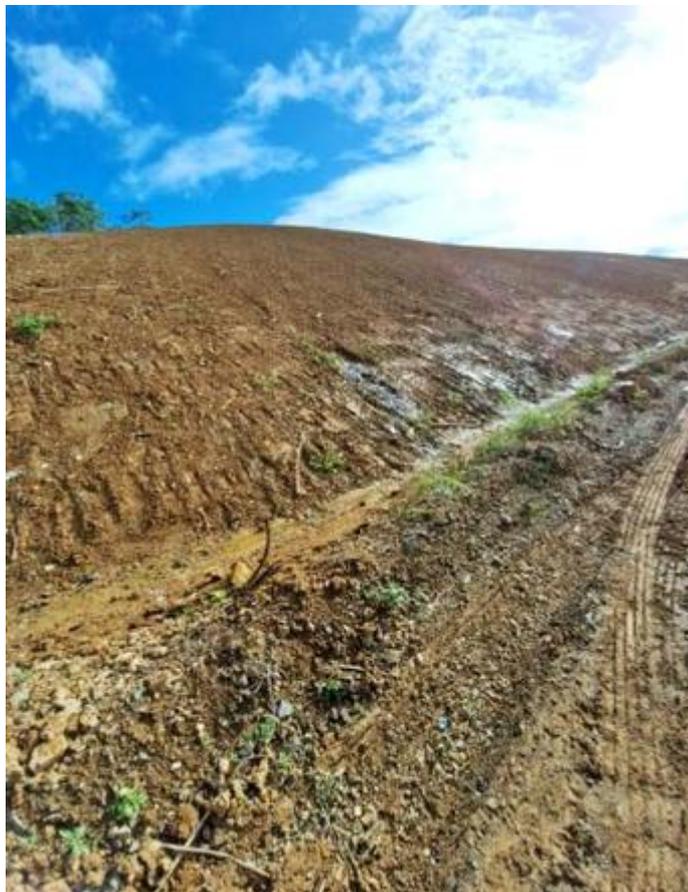
Añadir fotos deal area de brotes visibles

Se pueden notar brotes de lixiviado?

SI
