MUNICIPALITY OF TOA ALTA NOVEMBER 2022 MONTHLY REPORT  
Civ. No. 3:21-01087-DRD

N. AYALA  
TERRATEK ENGINEERING GROUP, PSC  
P.O. Box 367445 San Juan, PR 00936

Municipality of Toa Alta Civ. No. 3:21-01087-DRD		
Reporting Period:	November 1 to November 30, 2022	
Reporting Number:	04	
Reporting Official:	Nivia Ayala, PE/TerraTek	
Reporting Date:	12/15/2022	
Description of Compliance with each requirement of the Order		
ID	Requirement	Compliance Status
1	Daily Cover	Daily cover was completed prior to April 30, 2022.
2	Cessation of Waste Disposal	In-Compliance
3	Posting of Signs	In Compliance
4	Intermediate Cover	Intermediate cover was scheduled to start by October 1, 2022. However, MTA is still waiting for DNER funds to acquire specified cover material and contract an independent contractor to perform the required task. After DNER approves, or approves with modifications or conditions, any MTA revised permanent closure plan, and if the approved plan includes a schedule for completion of Intermediate Cover, that schedule shall control. Please see Additional comment for ID 4 item.

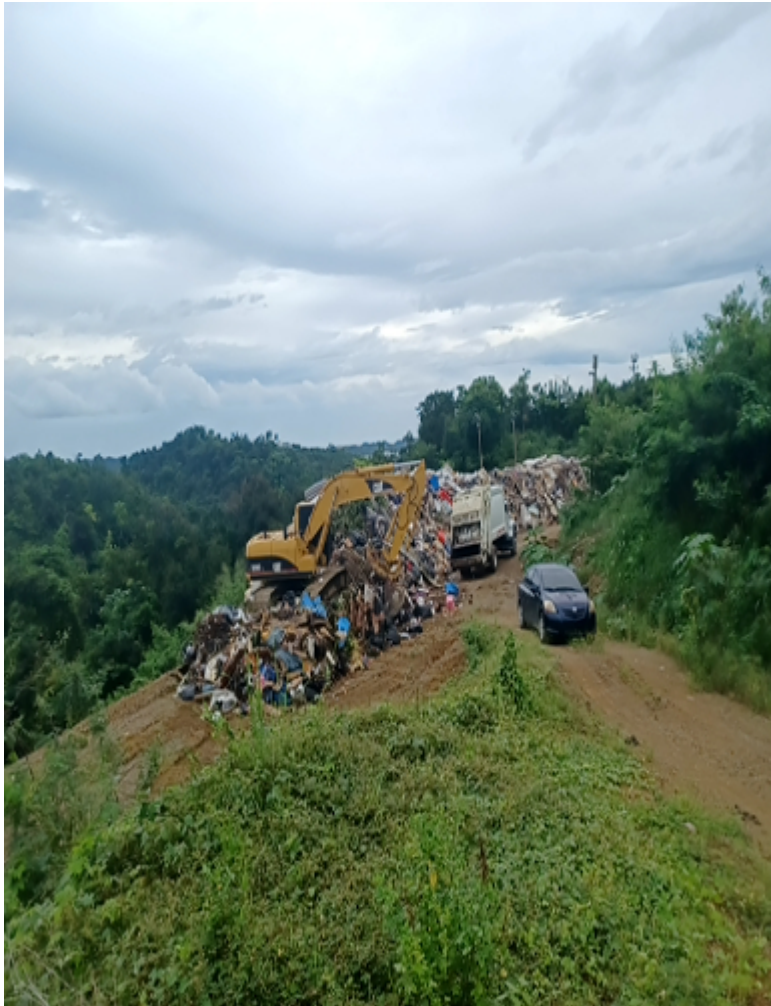
Condicion Operacion Recibo  
de Escombros

Mucho material acumulado

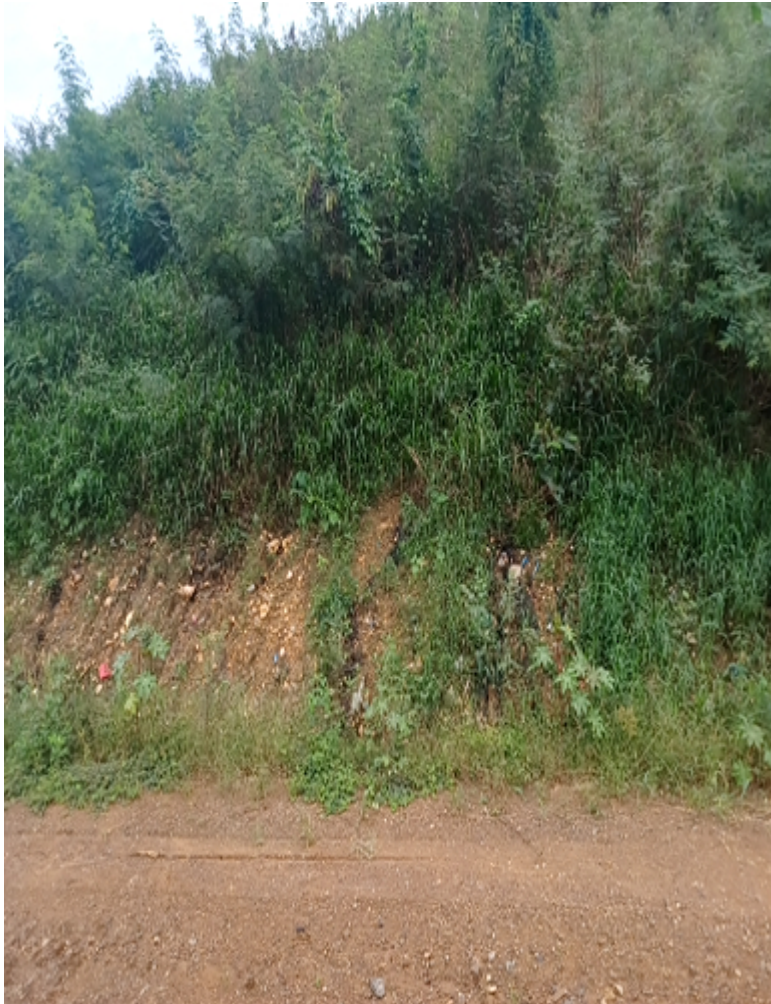
Se pueden notar brotes de lixiviado?

SI

Añadir fotos deal area de brotes visibles

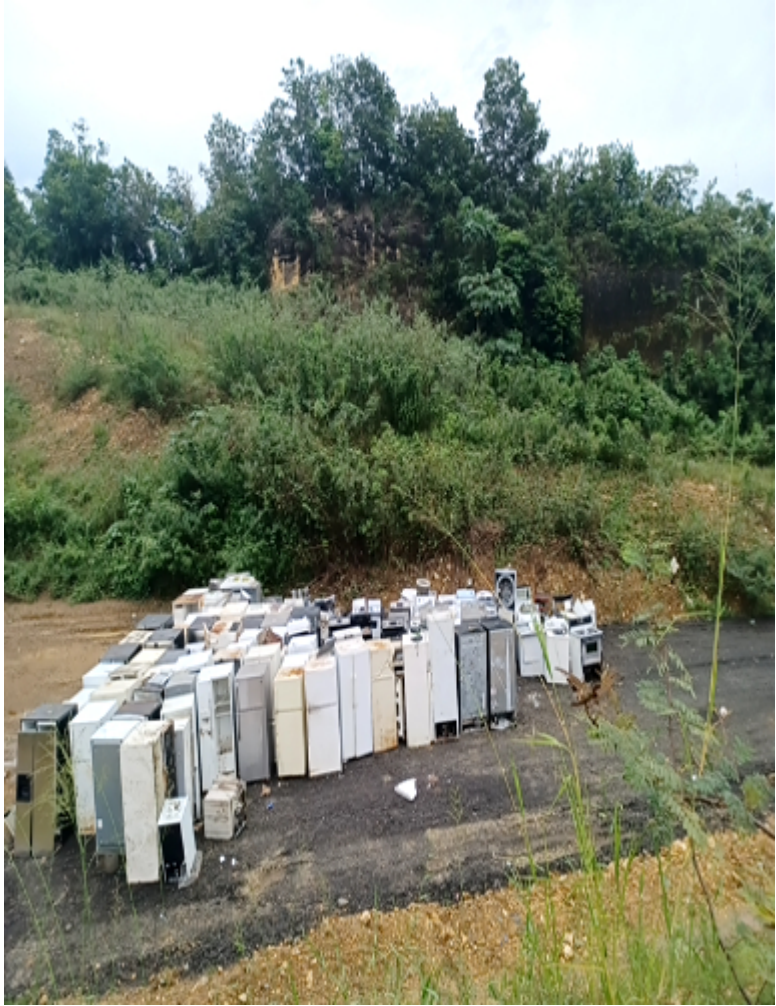
Condicion de areas de desvio  
de materiales

**Está llenA esta area de White Goods!**

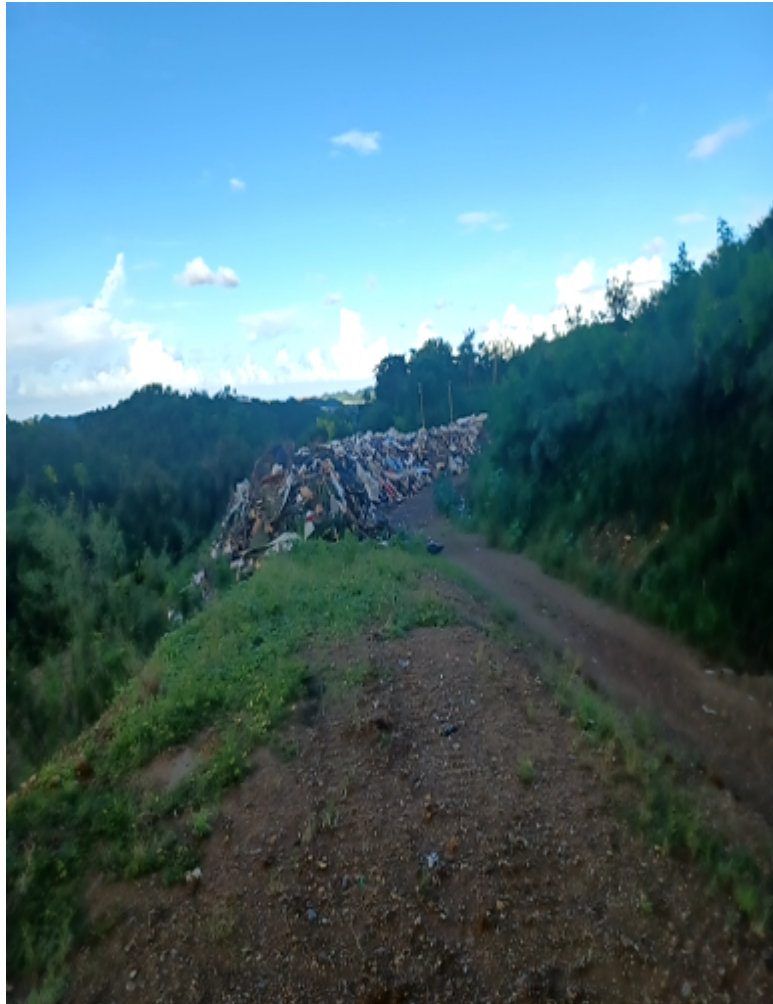
Condicion Operacion Recibo  
de Escombros

Mucho material acumulado

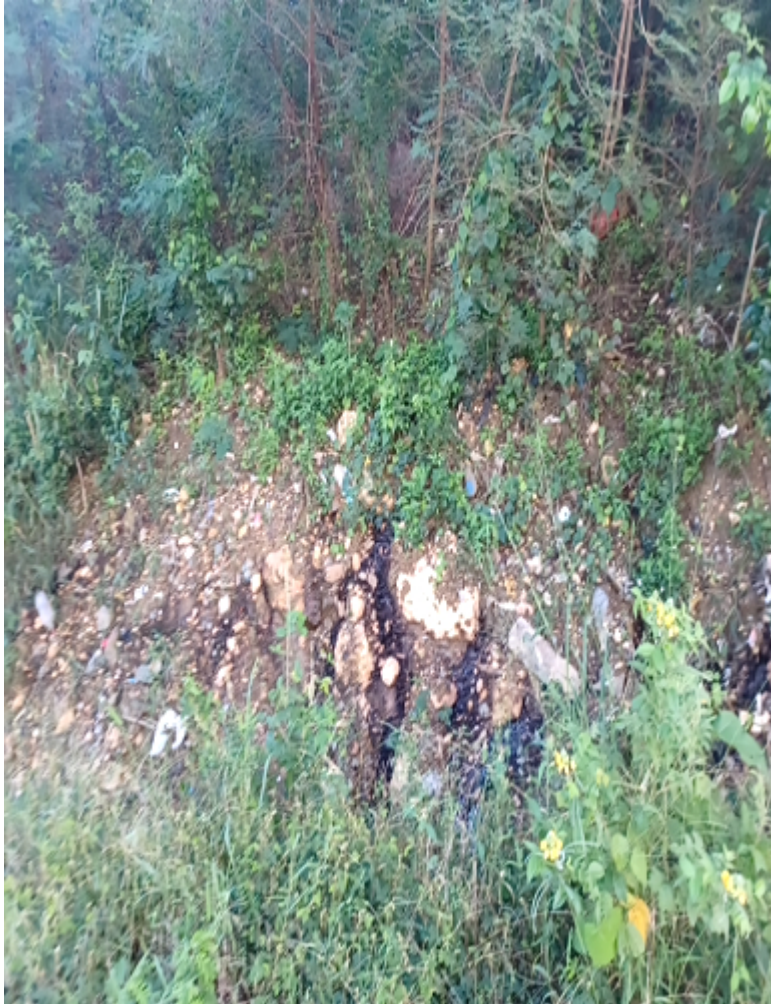
Se pueden notar brotes de lixiviado?

SI

Añadir fotos deal area de brotes visibles

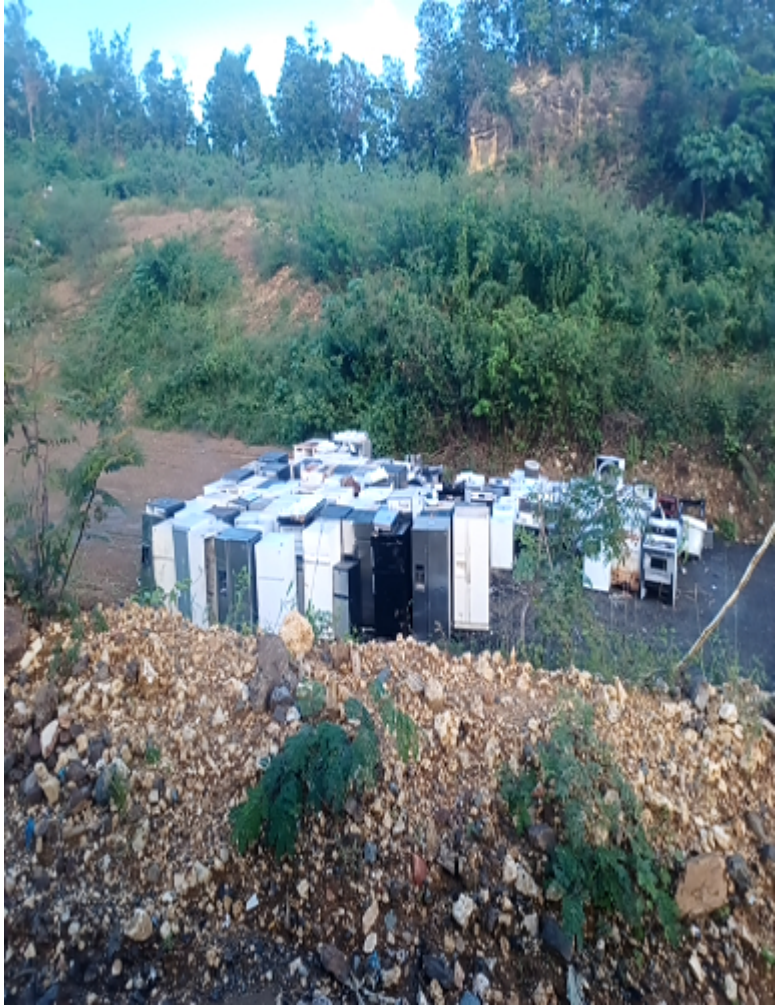
Condicion de areas de desvio  
de materiales

**Está llenA esta area de White Goods!**

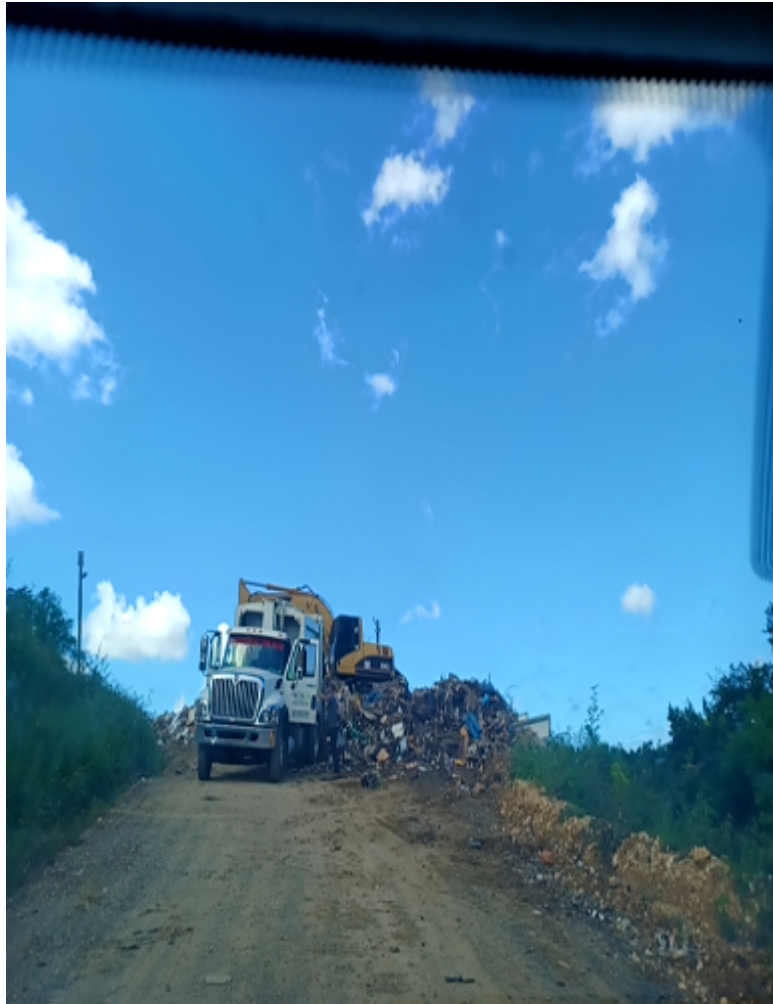
Condicion Operacion Recibo  
de Escombros

Mucho material acumulado

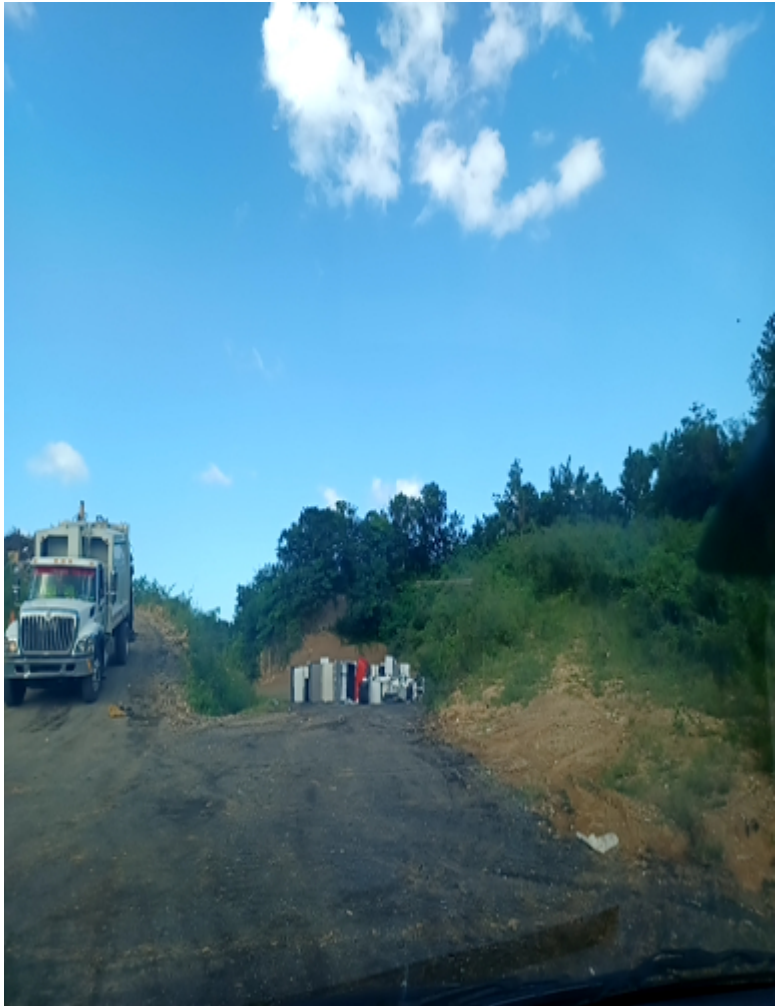
Condicion de areas de desvio de materiales

Esta area esta llena de White Goods!

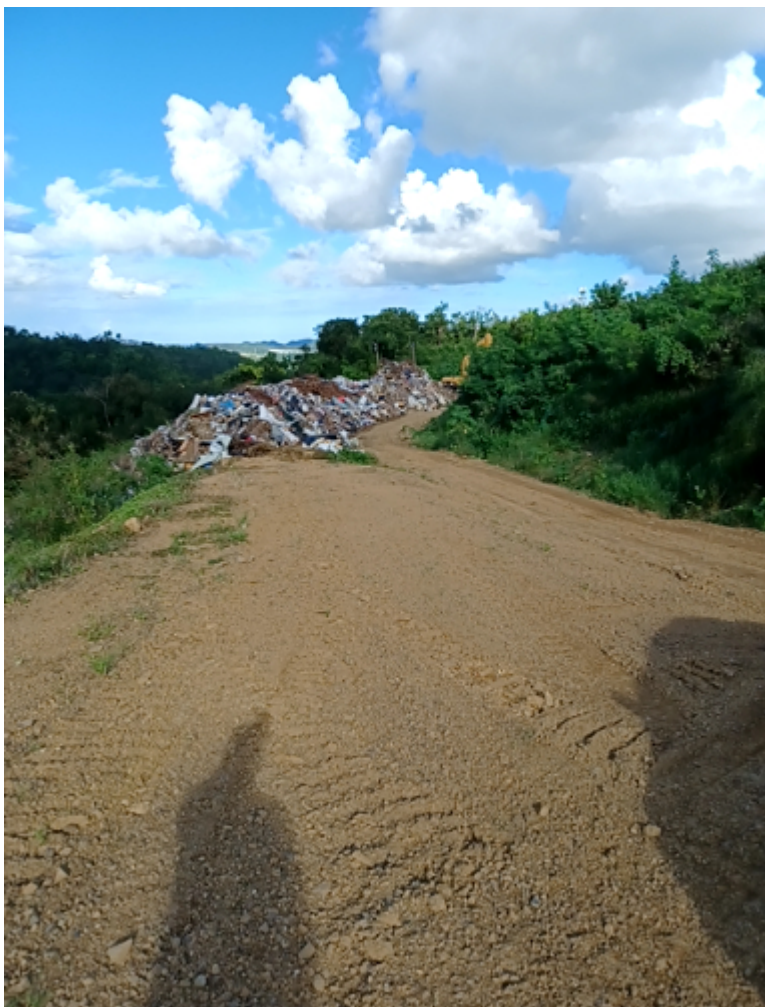
Condicion Operacion Recibo  
de Escombros

Mucho material acumulado

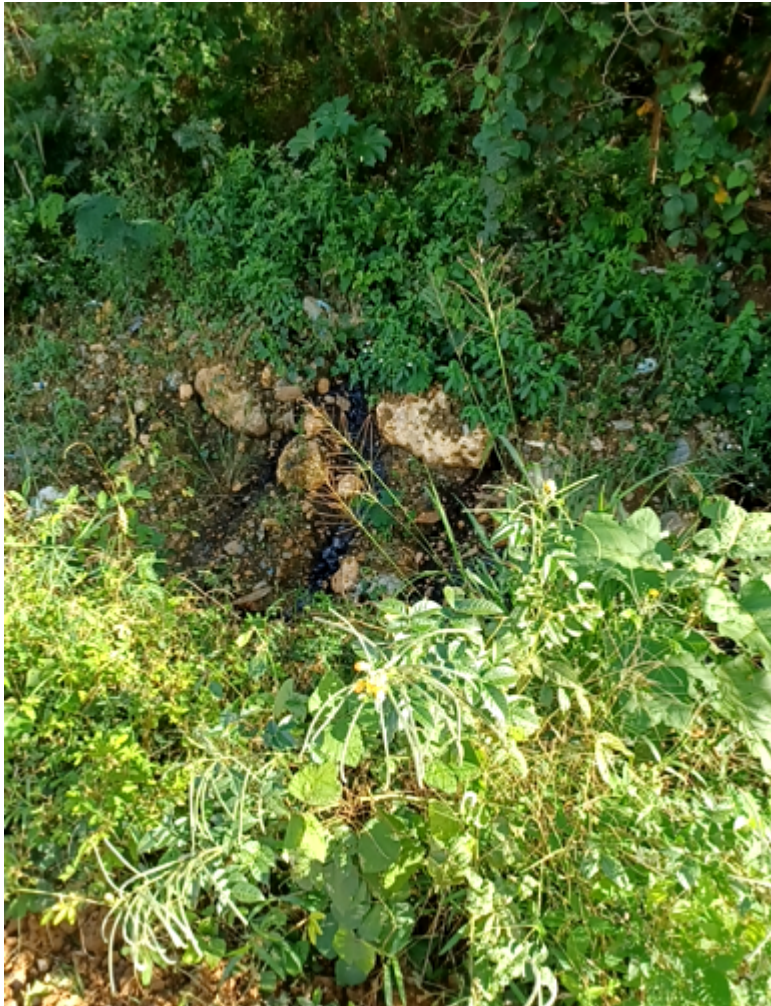
Se pueden notar brotes de lixiviado?

SI

Añadir fotos deal area de brotes visibles

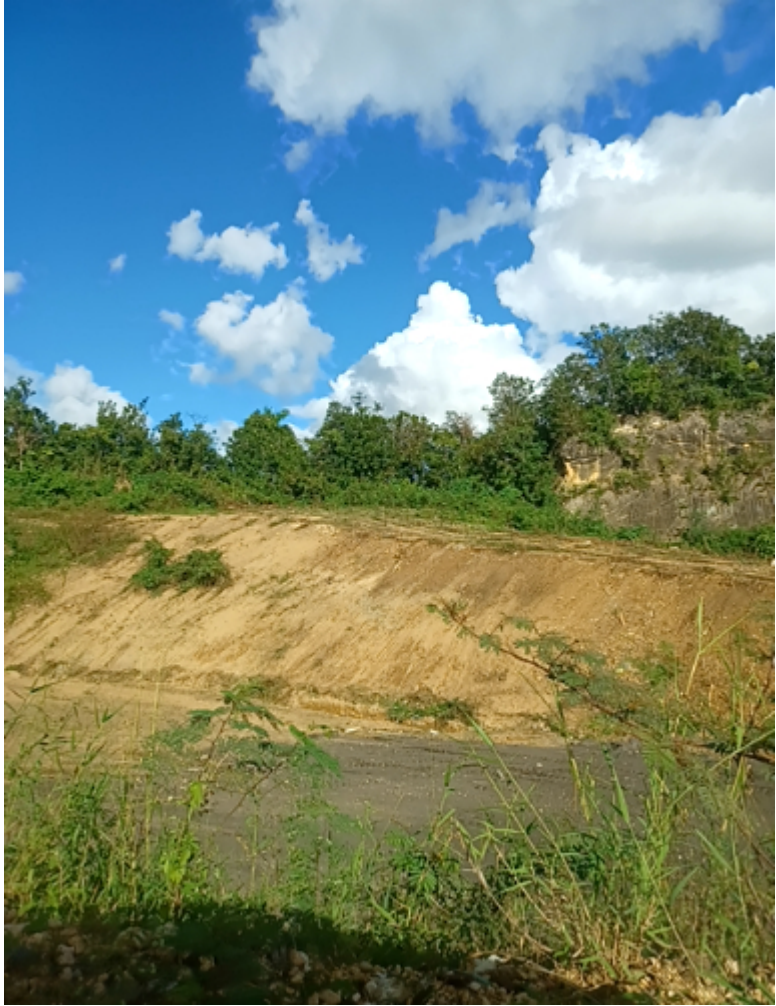
Condicion de areas de desvio  
de materiales

**Esta area estaba llena de White Goods! y se limpió.**
