APRIL 17, 2023

MUNICIPALITY OF TOA ALTA MARCH 2023 MONTHLY REPORT
Civ. No. 3:21-01087-DRD

N. AYALA
TERRATEK ENGINEERING GROUP, PSC
P.O. Box 367445 San Juan, PR 00936

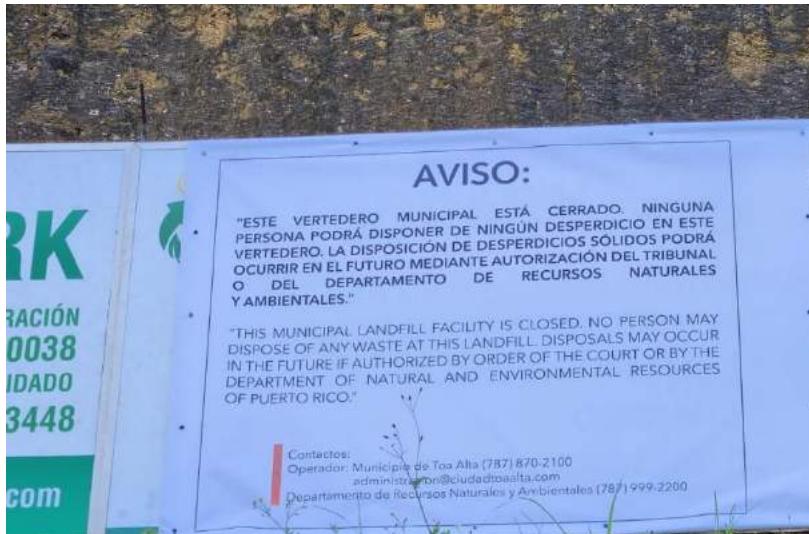
A sign with a size of four feet by five feet was installed at the landfill entrance. See the attached picture.

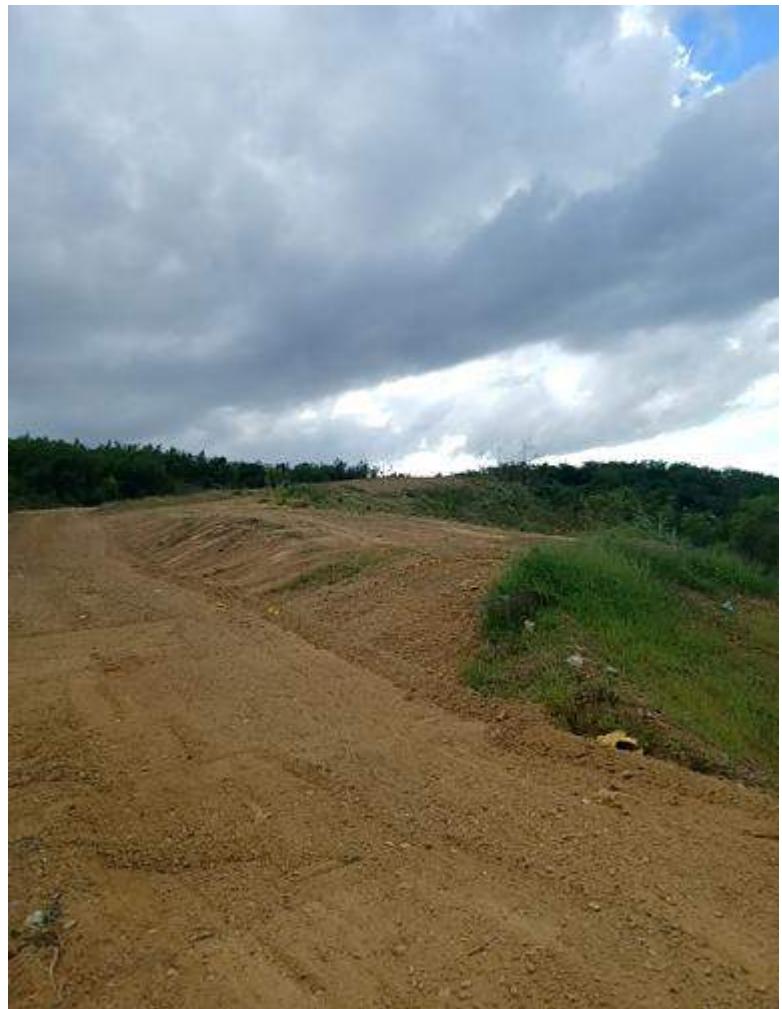
Incluir foto

Condicion de Cubierta Talud Norte

Excelentes condiciones

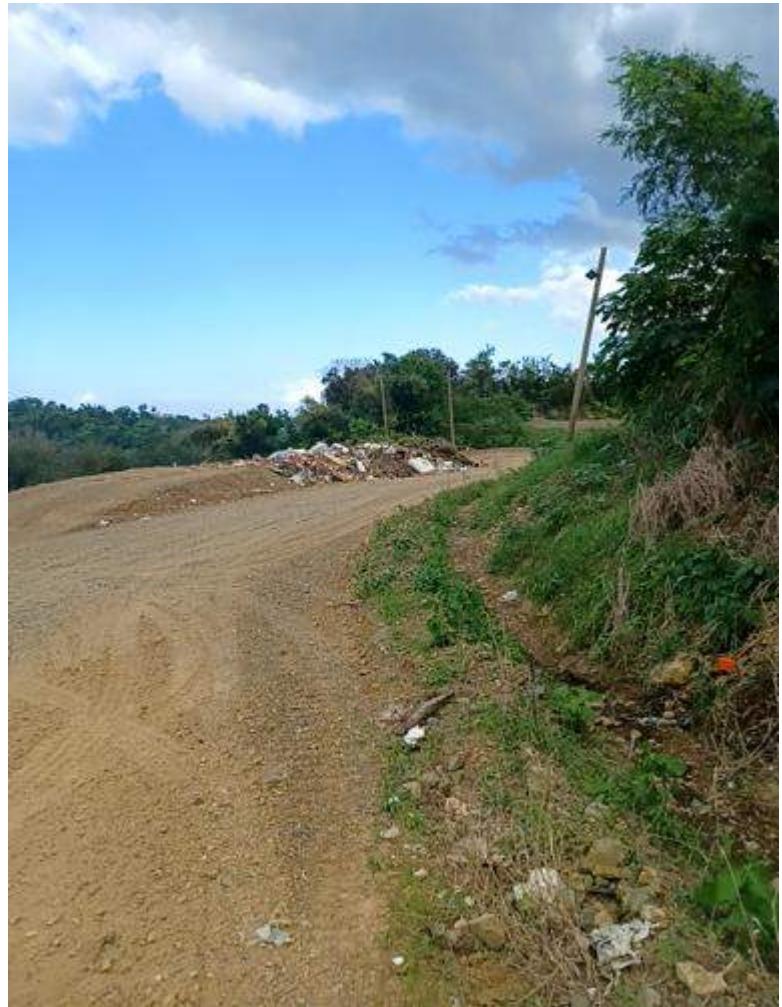
Tomar foto

**Condicion Operacion Recibo de
Escombros**

Necesita Limpieza

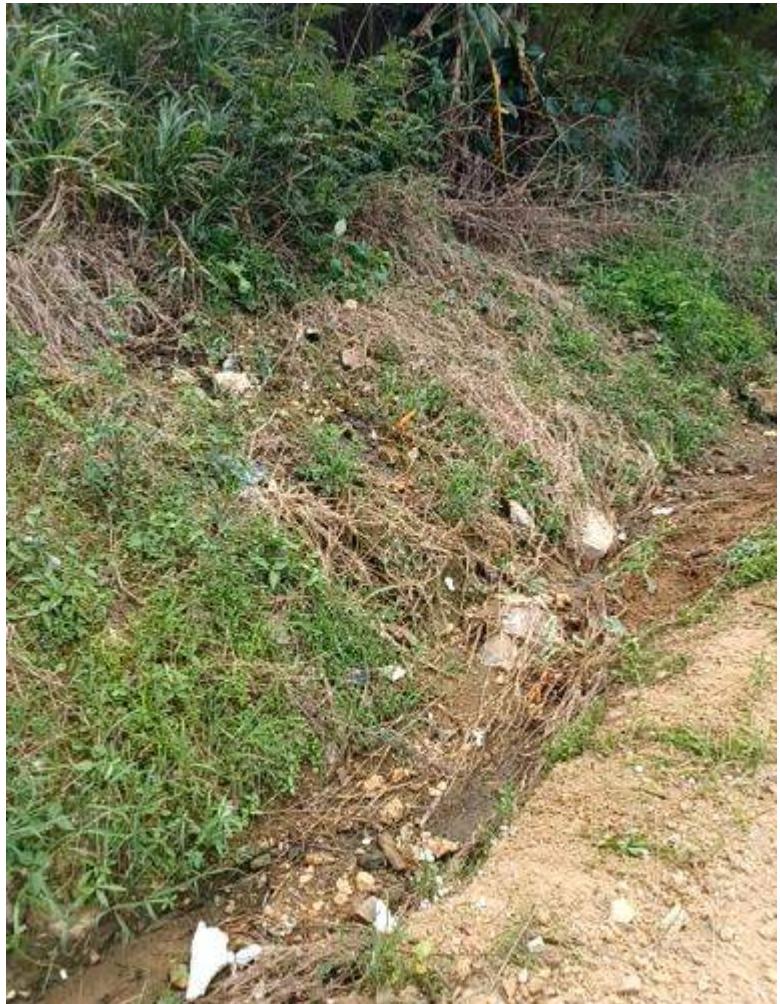
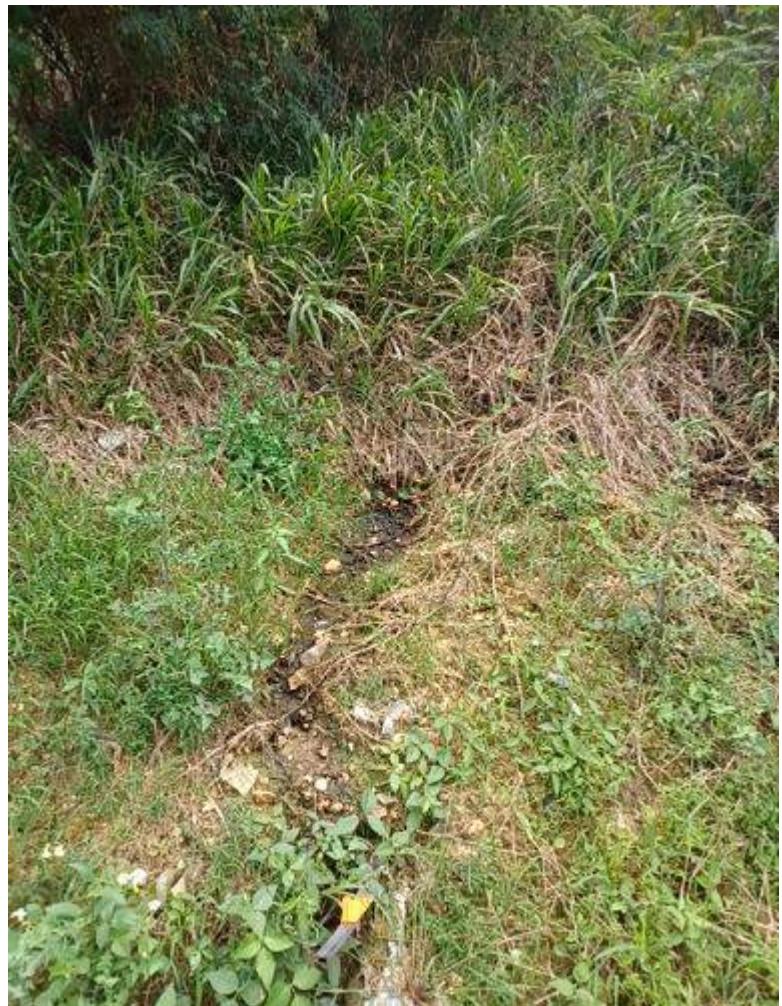
**Añadir fotos deal area de brotes
visibles**

Se pueden notar brotes de lixiviado?

SI

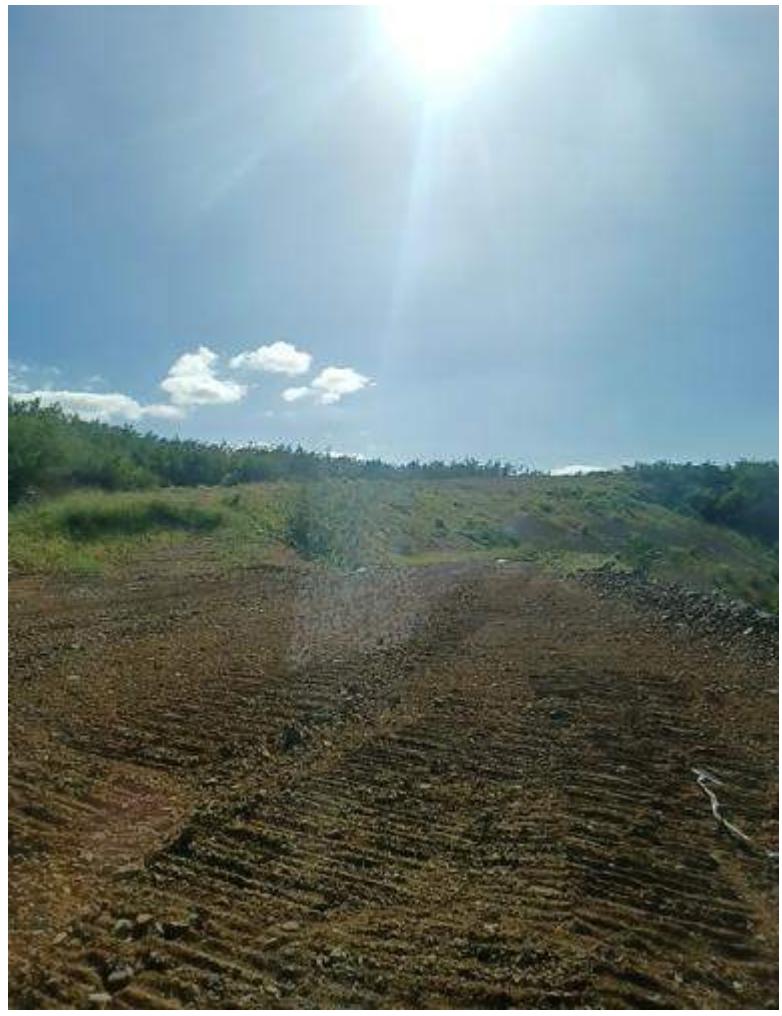
Incluir foto

Condicion de Cubierta Talud Norte

Excelentes condiciones

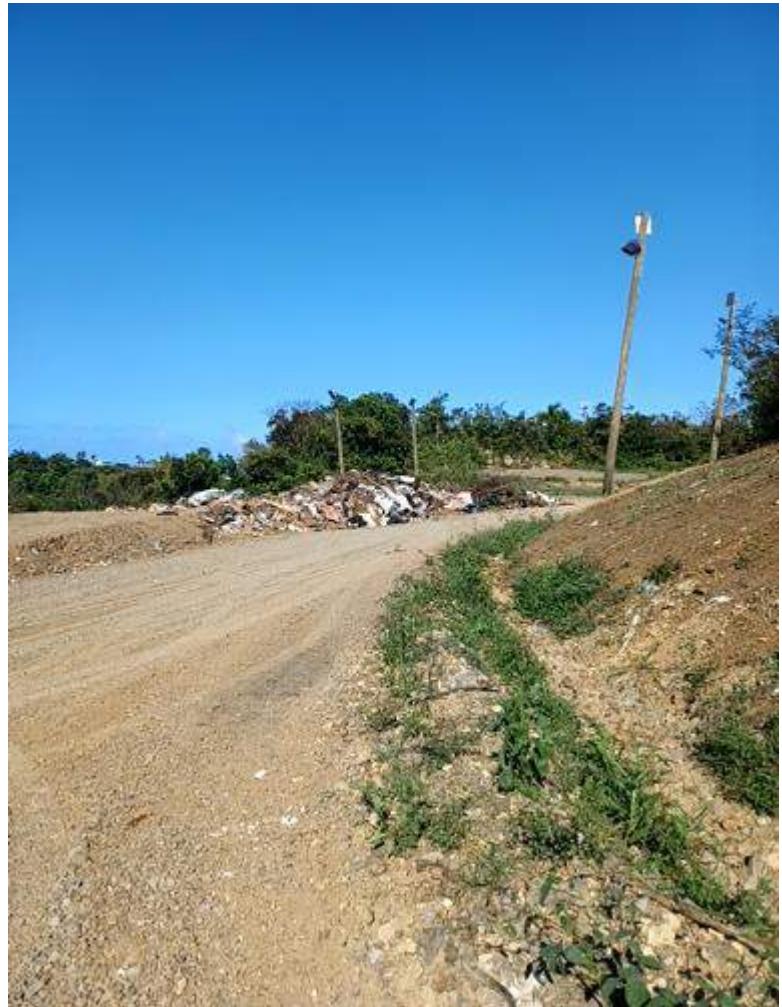
Tomar foto

**Condicion Operacion Recibo de
Escombros**

Necesita Limpieza

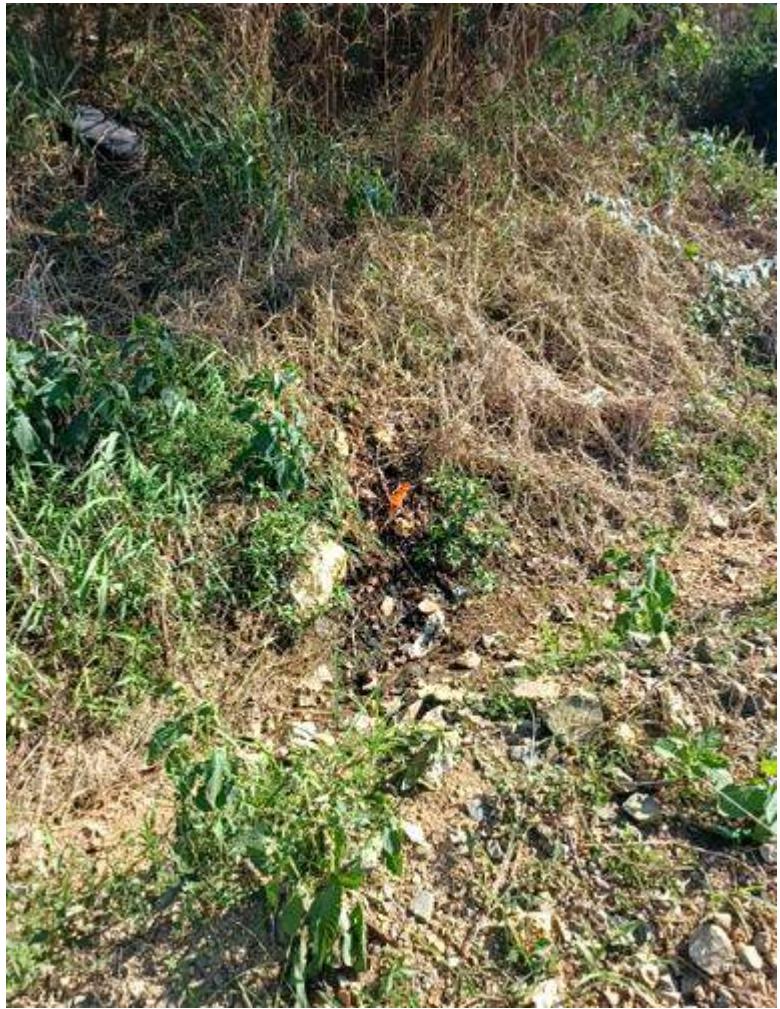
Añadir fotos deal area de brotes visibles

Se pueden notar brotes de lixiviado?

SI

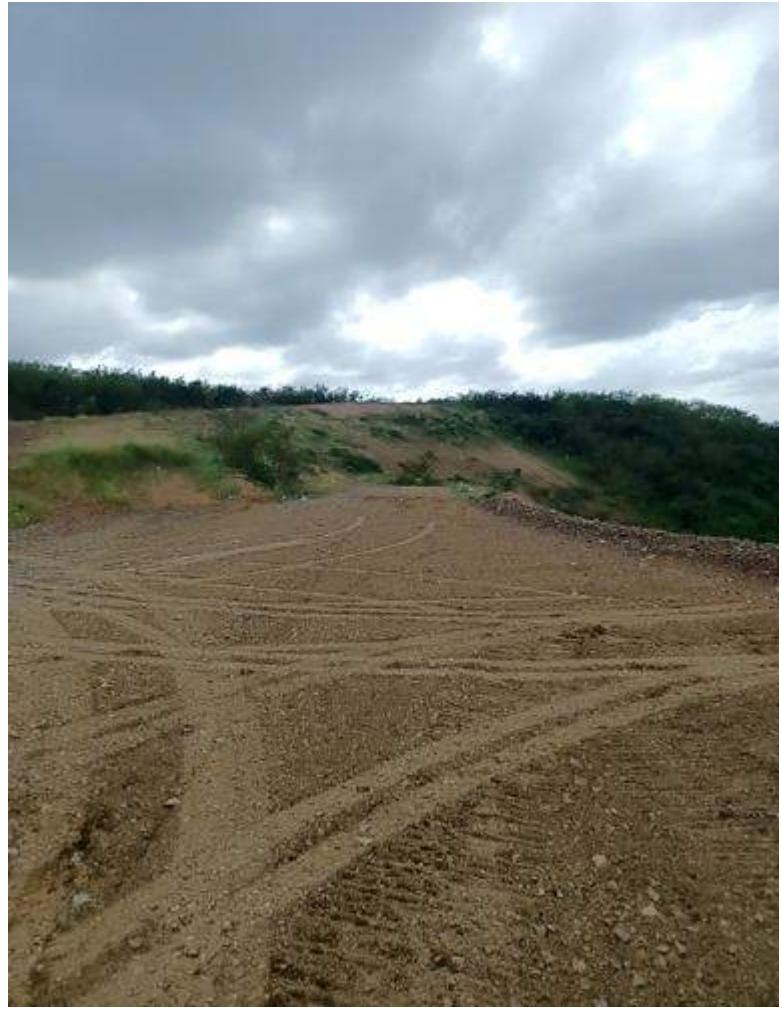
Incluir foto

Condicion de Cubierta Talud Norte

Excelentes condiciones

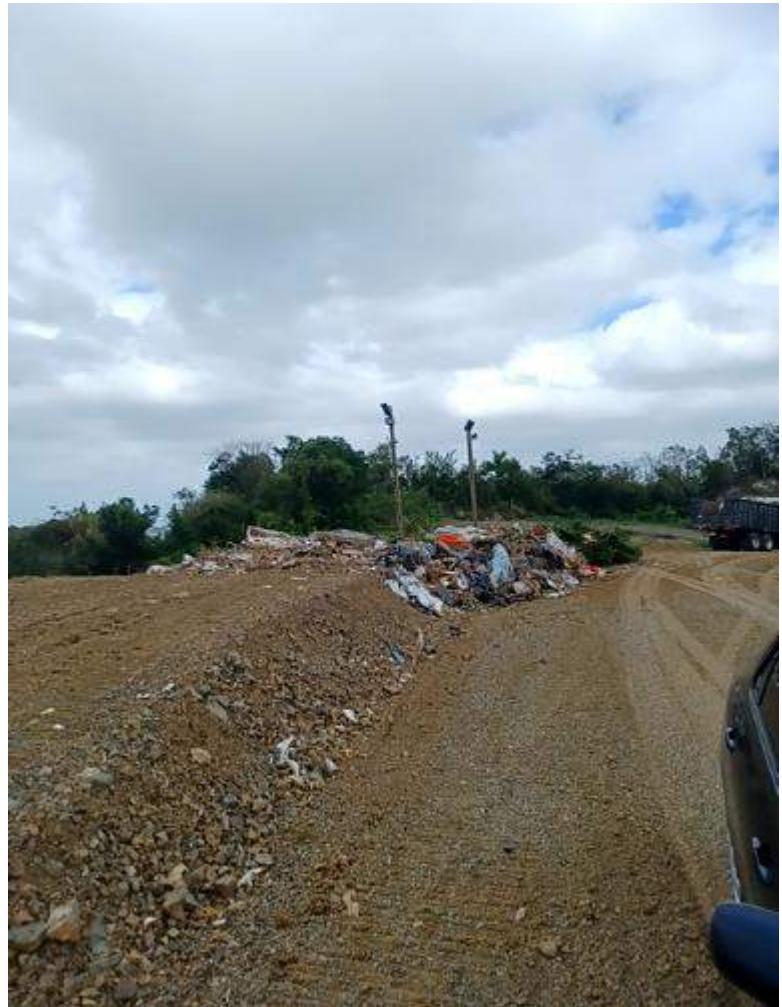
Tomar foto

**Condicion Operacion Recibo de
Escombros**

Necesita Limpieza

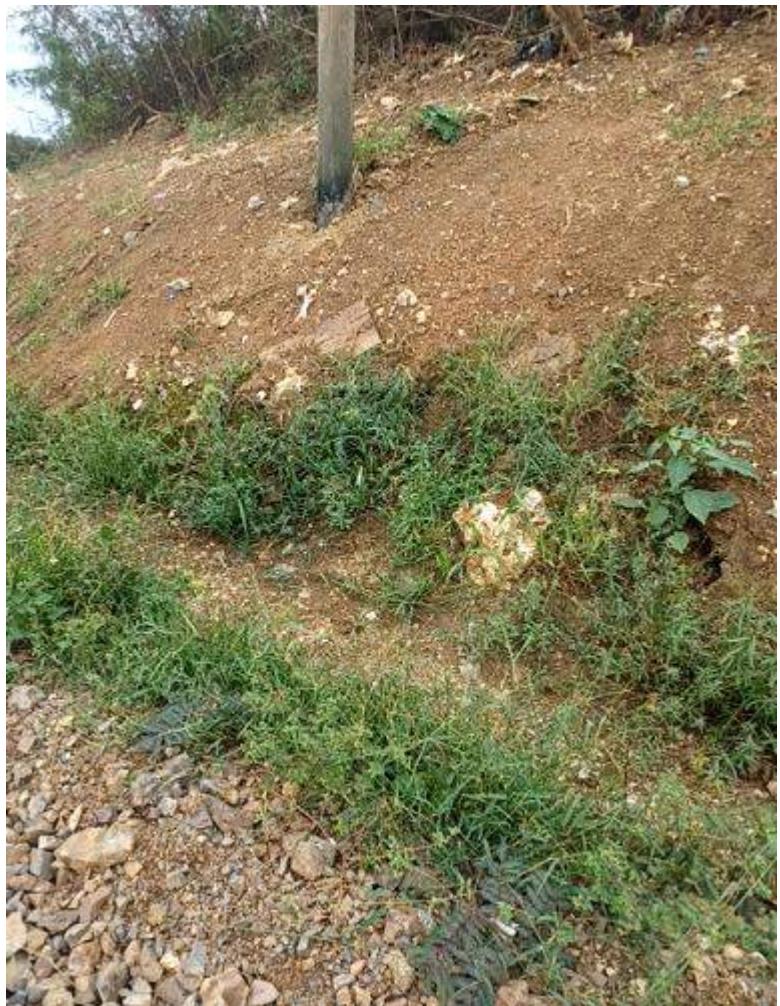
Añadir fotos de la área de brotes visibles

Se pueden notar brotes de lixiviado?

SI

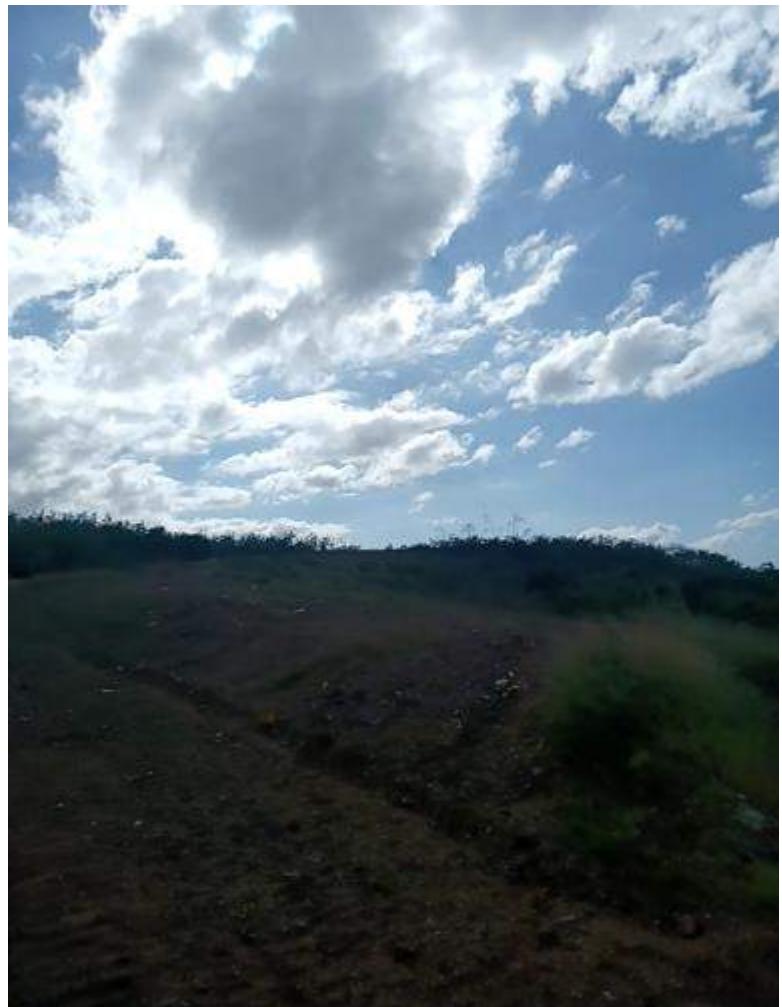
Incluir foto

Condicion de Cubierta Talud Norte

Excelentes condiciones

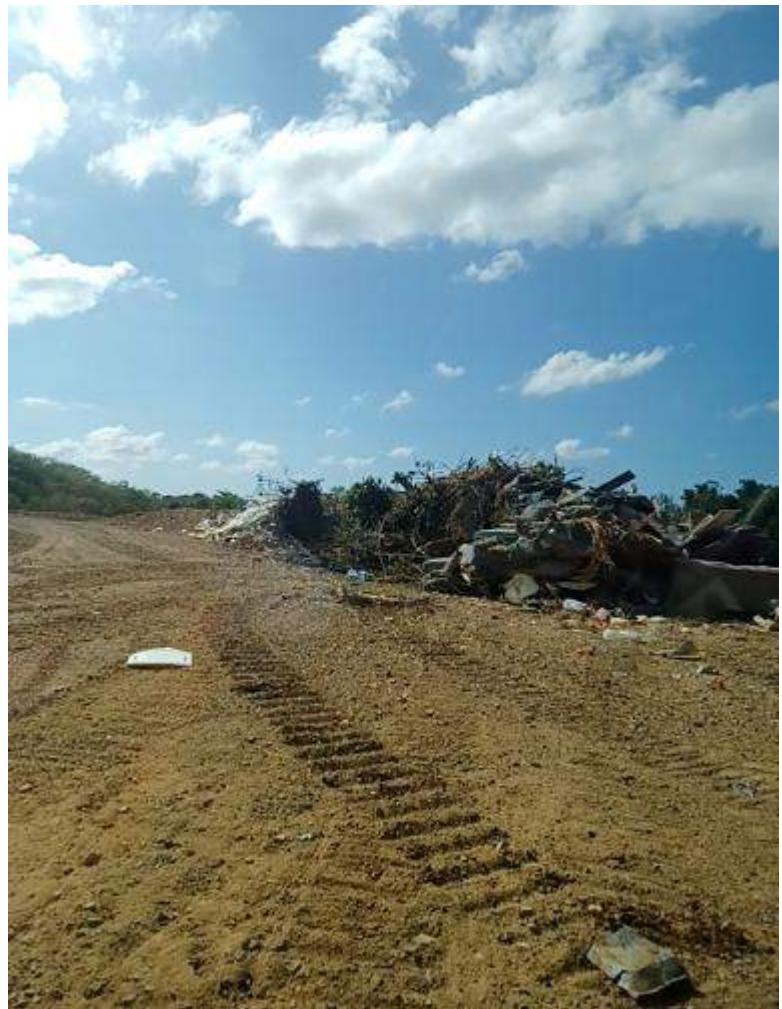
Tomar foto

**Condicion Operacion Recibo de
Escombros**

Necesita Limpieza

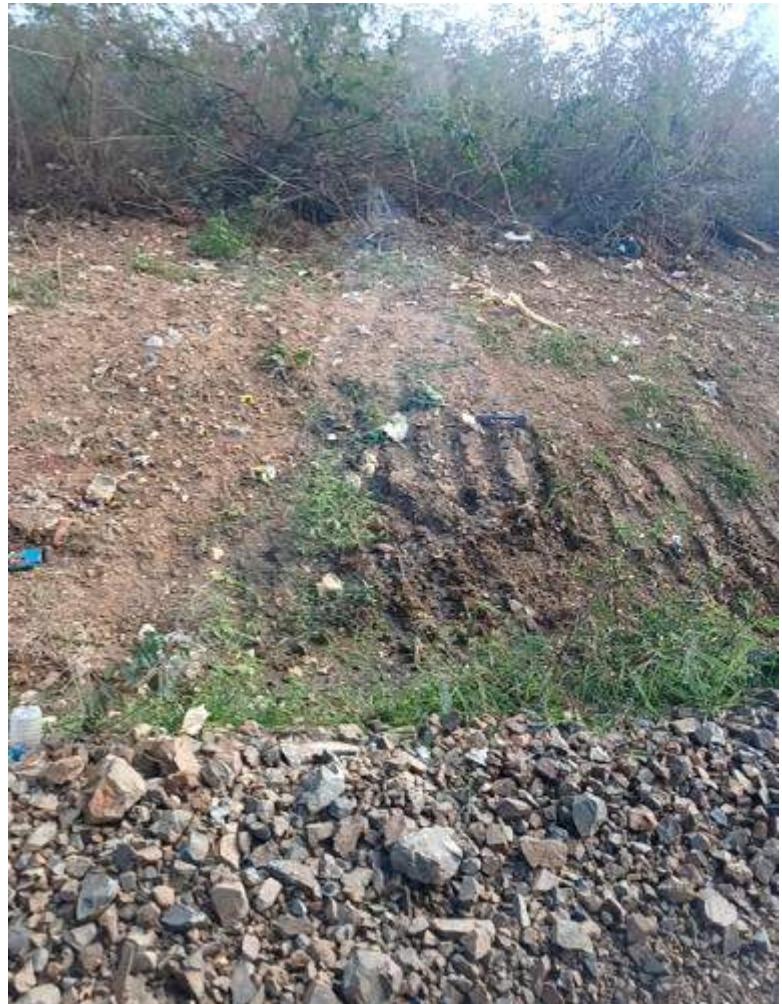
Añadir fotos deal area de brotes visibles

Se pueden notar brotes de lixiviado?

SI
