APPENDIX 6

FIVE-YEAR REVIEW SITE INSPECTION CHECKLIST

FIVE-YEAR REVIEW SITE INSPECTION CHECKLIST OU1

FIVE-YEAR REVIEW SITE INSPECTION CHECKLIST OU2

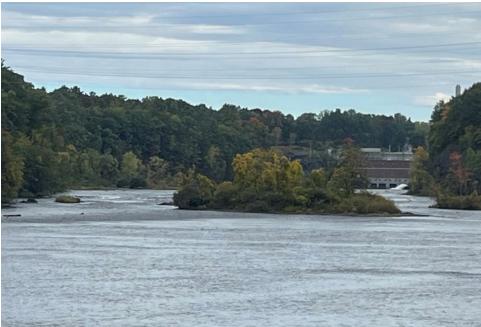
Photo 1. Remnant Deposit 1 (island and nearby shallows).

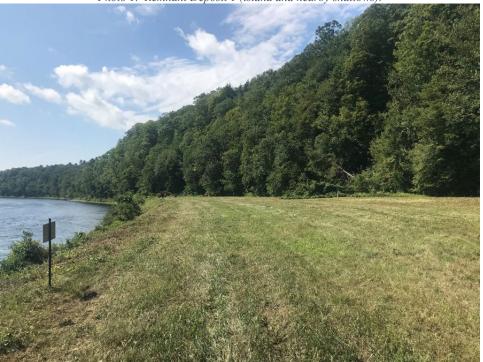
Remarks: <u>A downed tree from a landslide was observed on the land-side edge of the cap for Remnant</u> <u>Deposit 2.</u> The tree was subsequently removed, and GE reported no significant damage to the cap.

Photo 2. Remnant Deposit 2 with a fallen tree in the background.

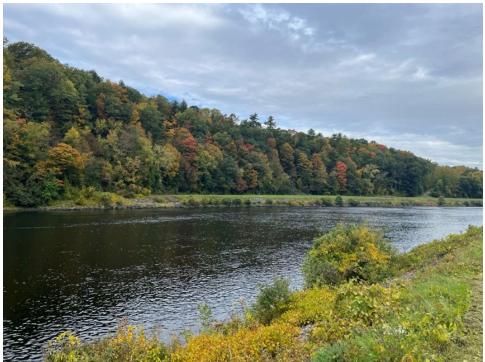
Photo 3. Remnant Deposit 2 (facing northwest from Remnant Deposit 3).

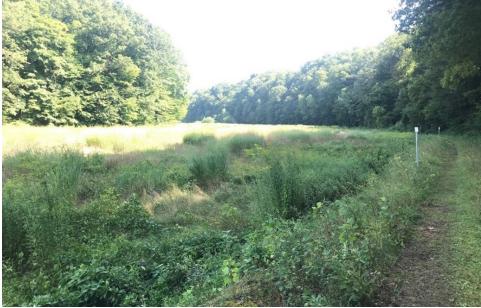
Photo 4. Remnant Deposit 3 (facing north).

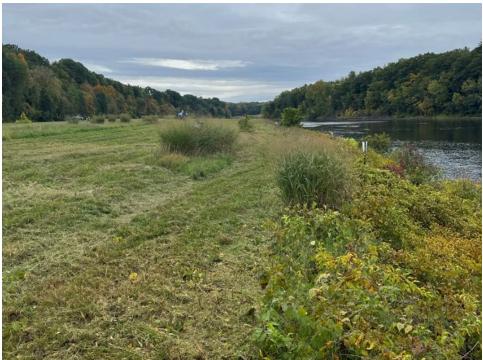
Photo 5. Remnant Deposit 3 (facing south).

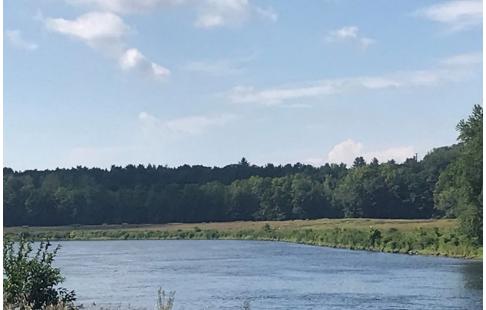
Photo 6. Remnant Deposit 4 (facing southwest from Remnant Deposit 3).

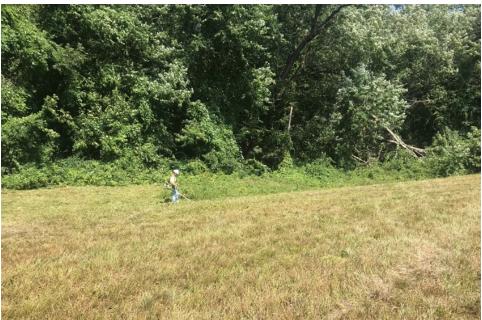
Photo 7. Remnant Deposit 4.

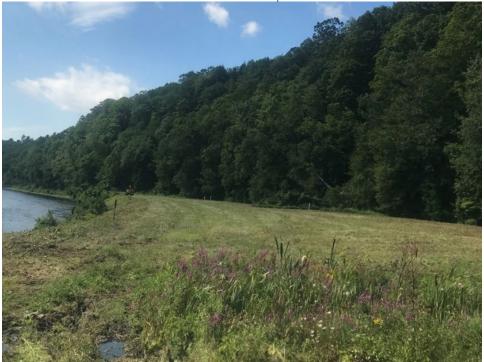
Photo 8. Remnant Deposit 4 (facing south).

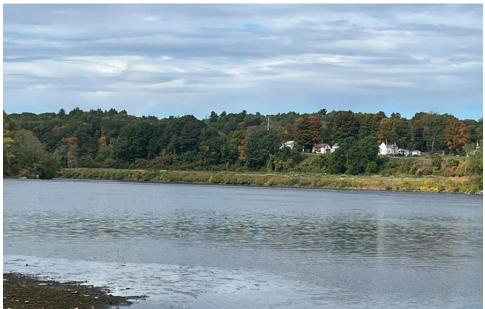
Photo 9. Remnant Deposit 5 (facing northeast from Rogers Island).

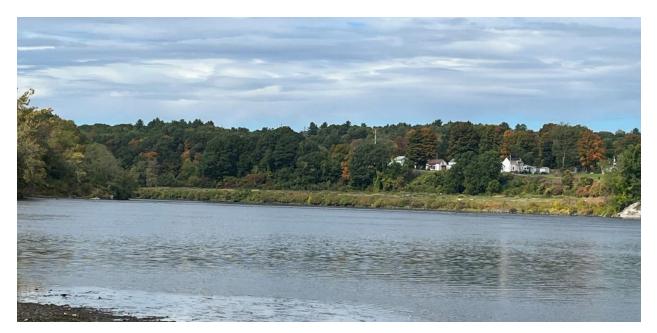
Photo 1. Water column sampling location north of Rogers Island. Remnant Deposit 5 is visible in the background.

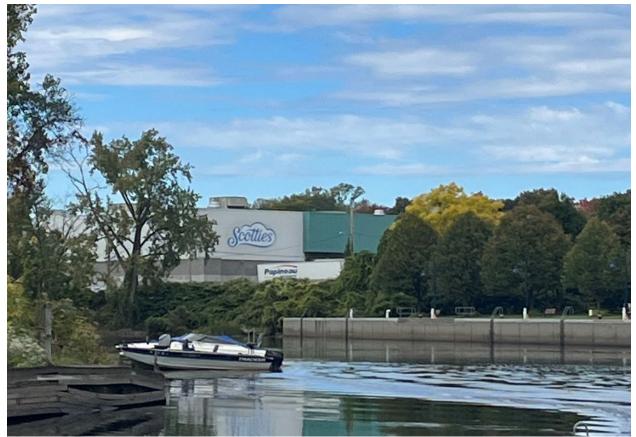
Photo 2. Location of CUs 0 and CU 1, where silting in after dredging was observed.

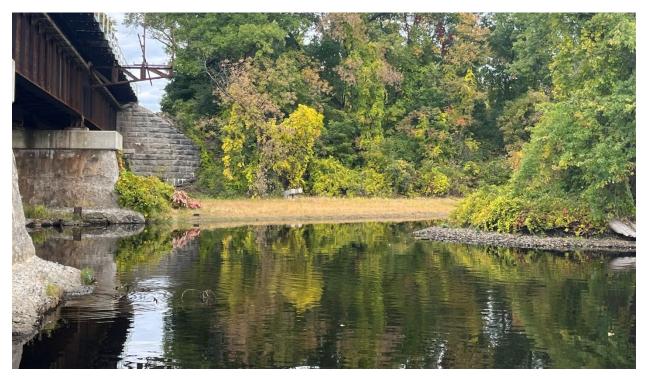
Photo 3. Cove in CU8 that is included in the TD1 fish sampling area.

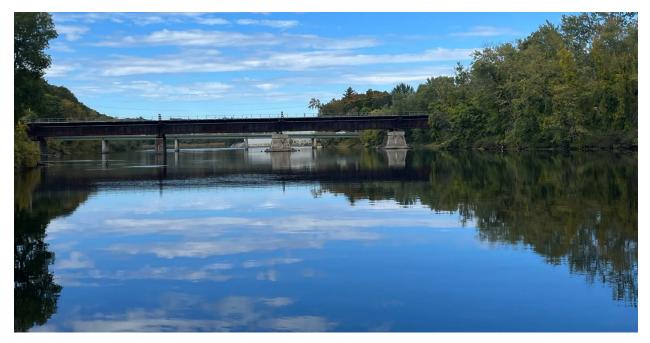
Photo 4. TD1 fish sampling location and CU6 (looking south).

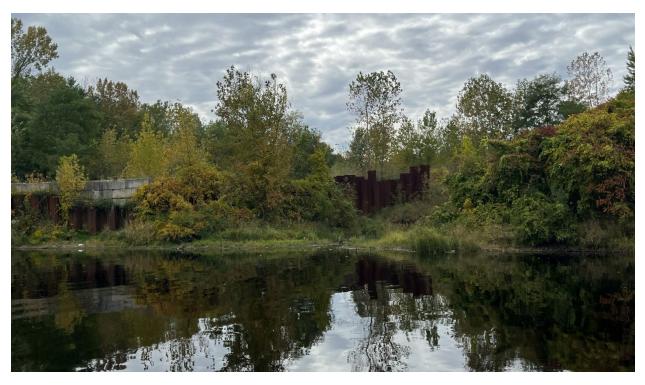
Photo 5. NYSDEC Moreau launch and loading area during dredging (Reach 8).

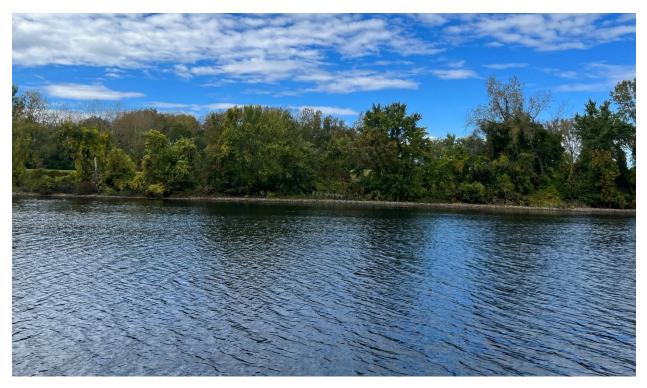
Photo 6. TD2 fish sampling area. A short-term response action (shoreline stone placement) is visible along the shoreline in the background as part of the Hudson River floodplain program.

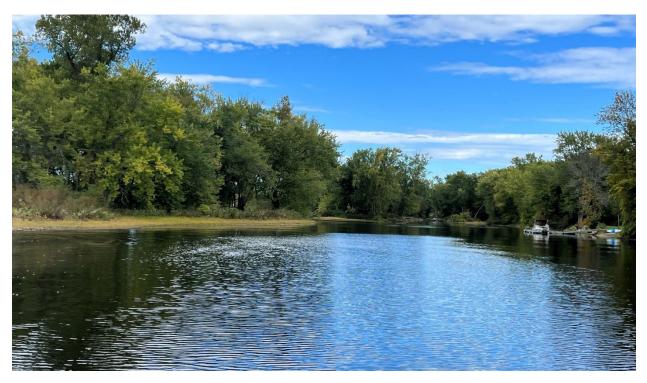
Photo 7. TD3 fish sampling location near the confluence with Snook Kill.

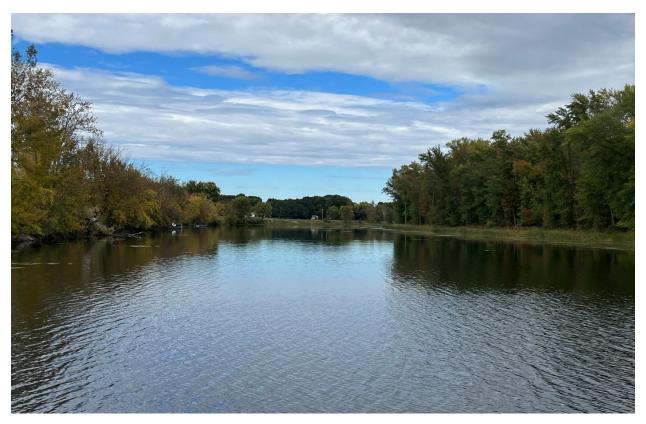
Photo 8. Fish sampling location TD4.

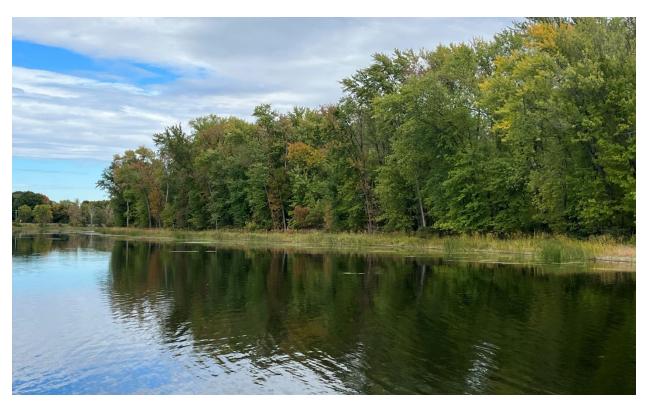
Photo 9. Fish sampling location TD5 along West Griffin Island.

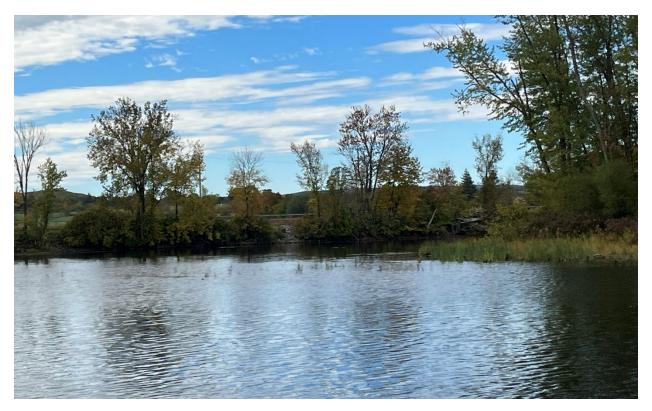
Photo 10. Reconstructed wetland at the southern tip of Griffin Island.

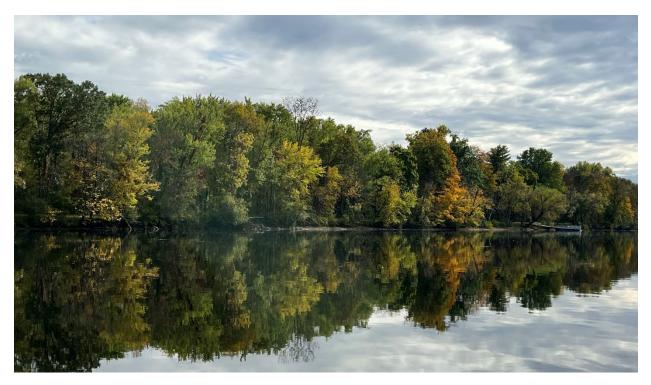
Photo 11. Fish sampling location ND3.

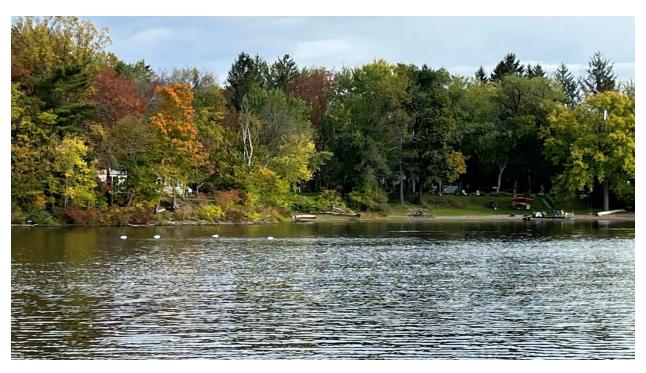
Photo 12. NYSDEC Hotspot 28, which was identified as a high-priority dredging area. A monitored habitat construction area was established on top of the fill.

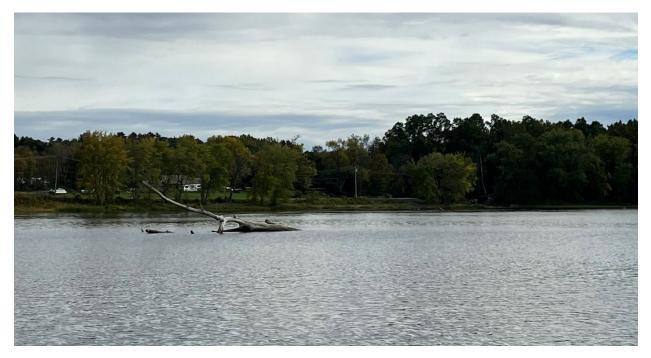
Photo 13. The southern extent of NYSDEC Hotspot 28.

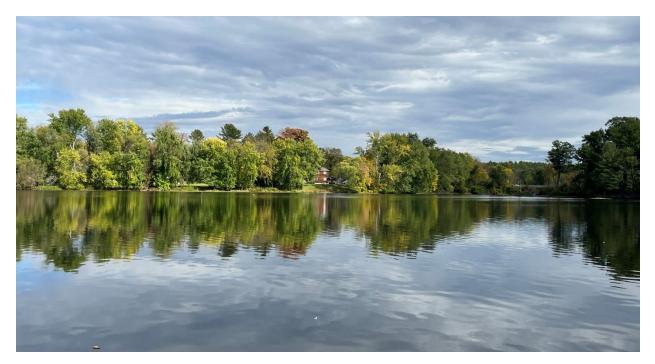
Photo 14. Fish sampling location ND4.

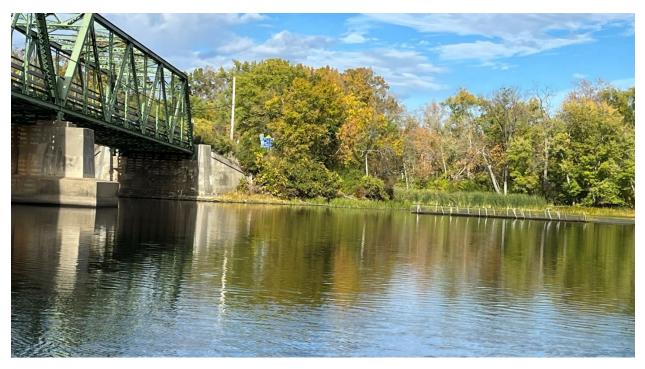
Photo 15. Fish sampling location ND5 with a wetland reconstruction area in the background.

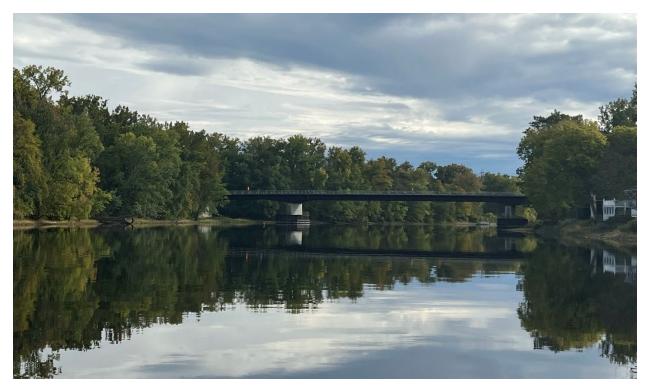
Photo 16. The Schuylerville Dix Bridge water column sampling location.

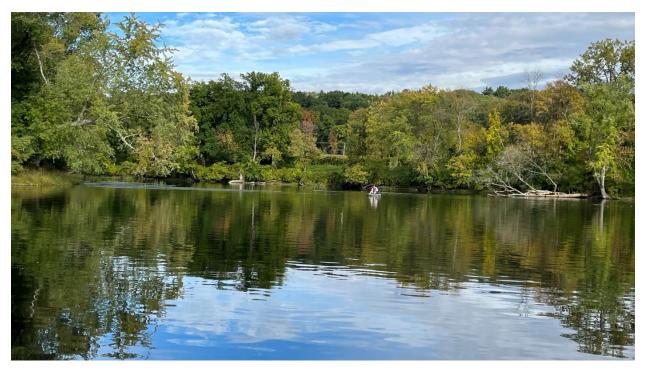
Photo 17. Fish sampling location SW1.

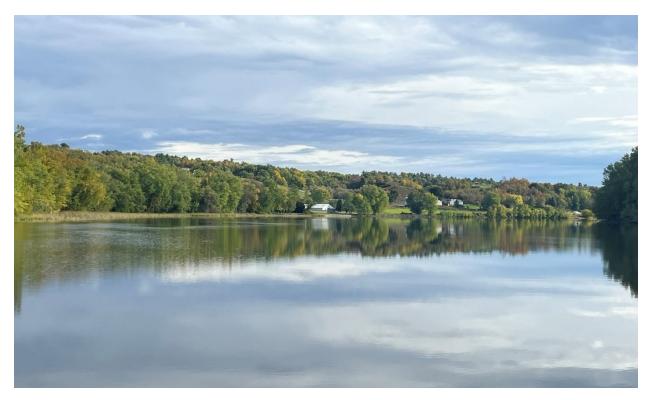
Photo 18. Fish sampling location SW2.

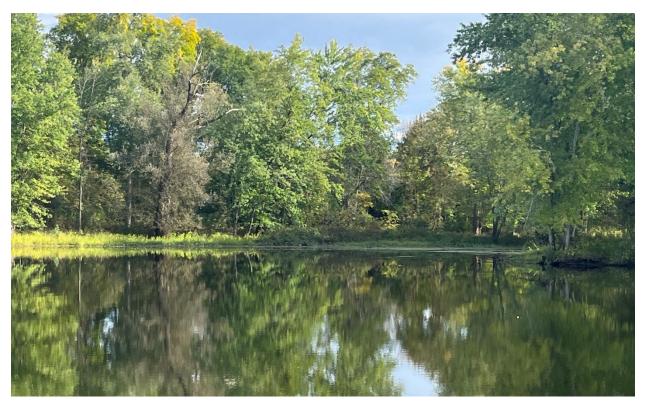
Photo 19. Fish sampling location SW3.
