**Air Branch Inspection Report
Unannounced Partial Compliance Evaluation**

Elantas PDG, Inc.
5200 N Second Street
St. Louis, MO 63147
FRS# 110000441889

Inspection Date(s):
September 07, 2023

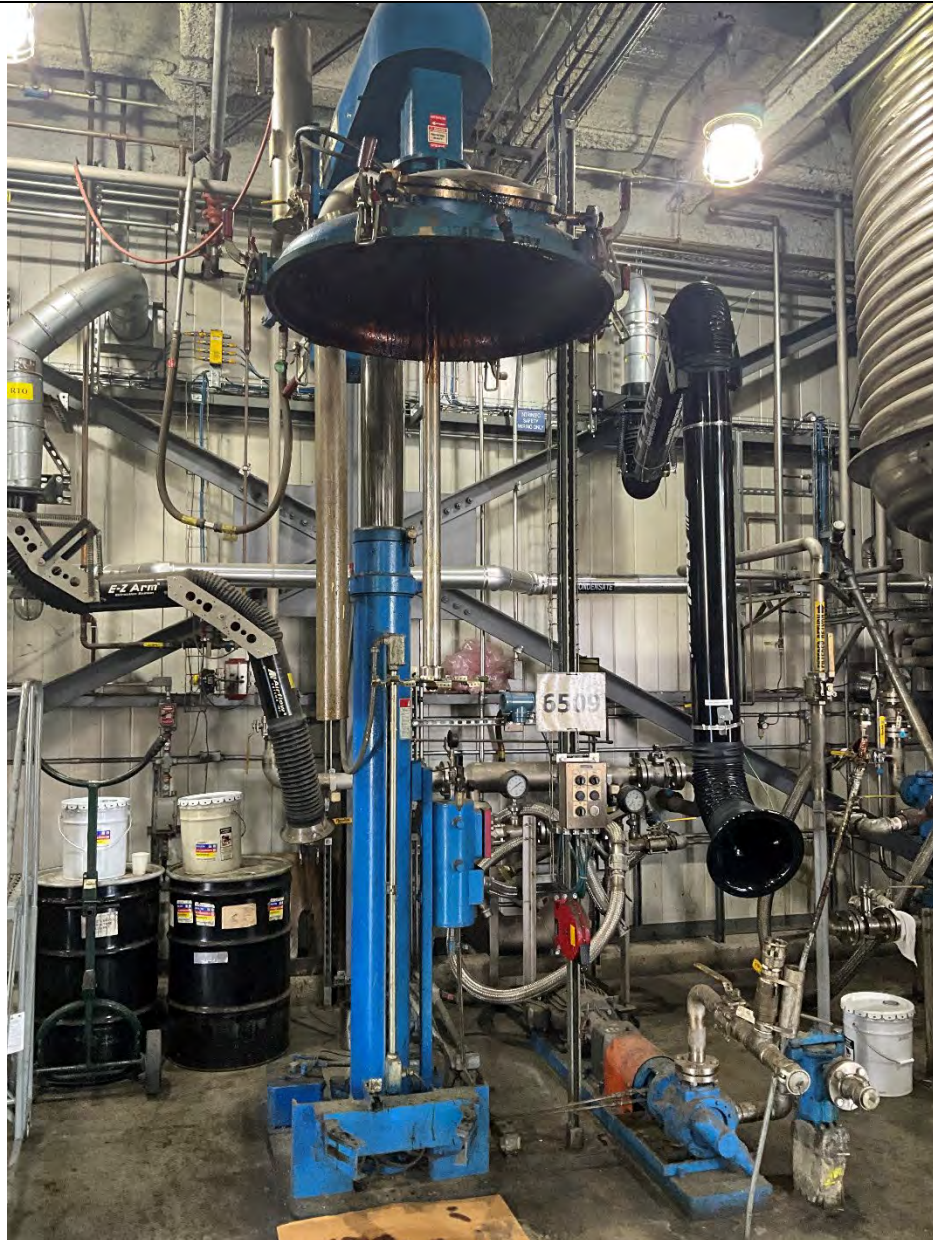
2

T6509 Mixer and cover (facing East)

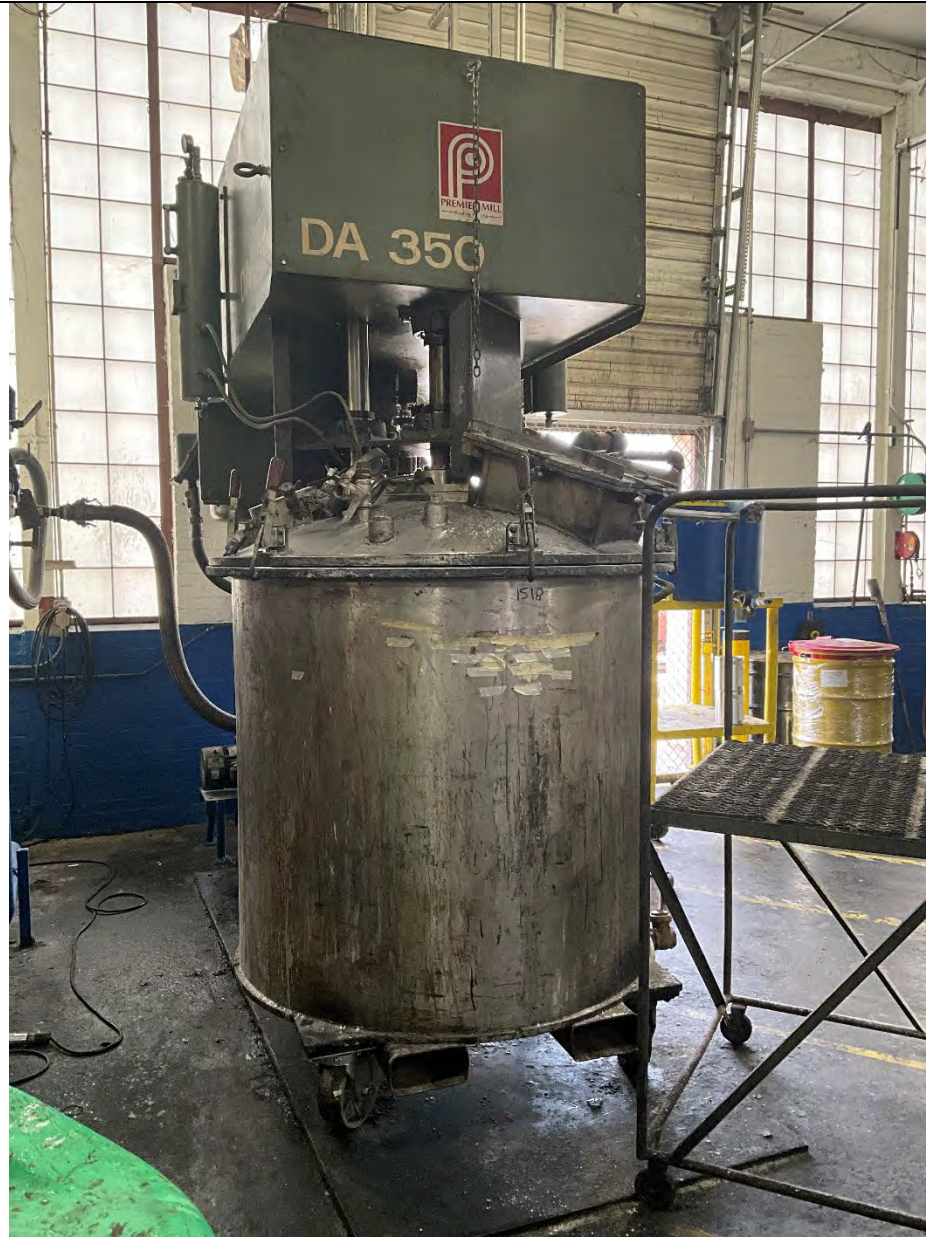
DA-350 de-aerating mixer with the cover on (facing West)

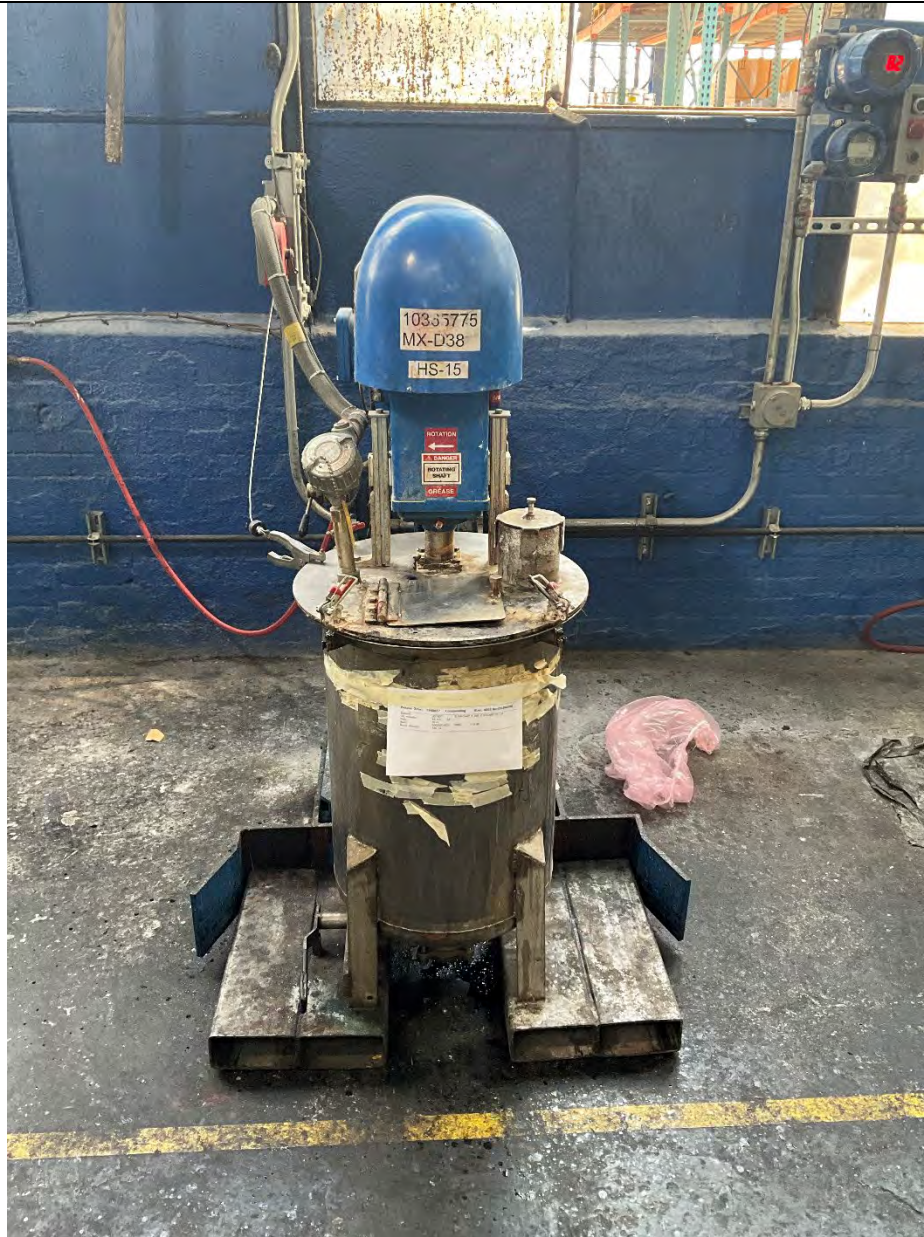
4

DA-15 de-aerating mixer with the cover on (facing Northeast)

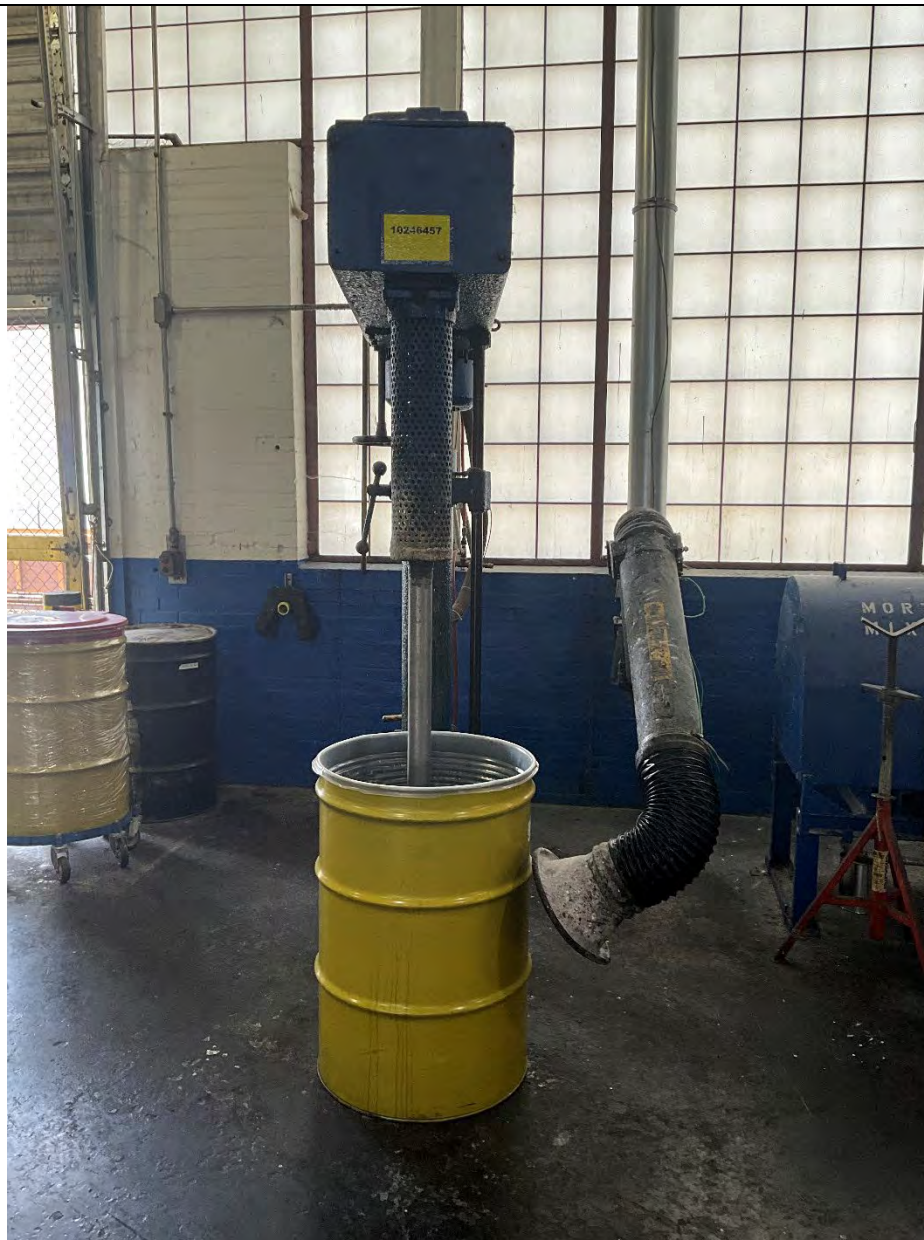
5

45-1 mixer, which was empty and its associated emission collection system (facing Southwest)

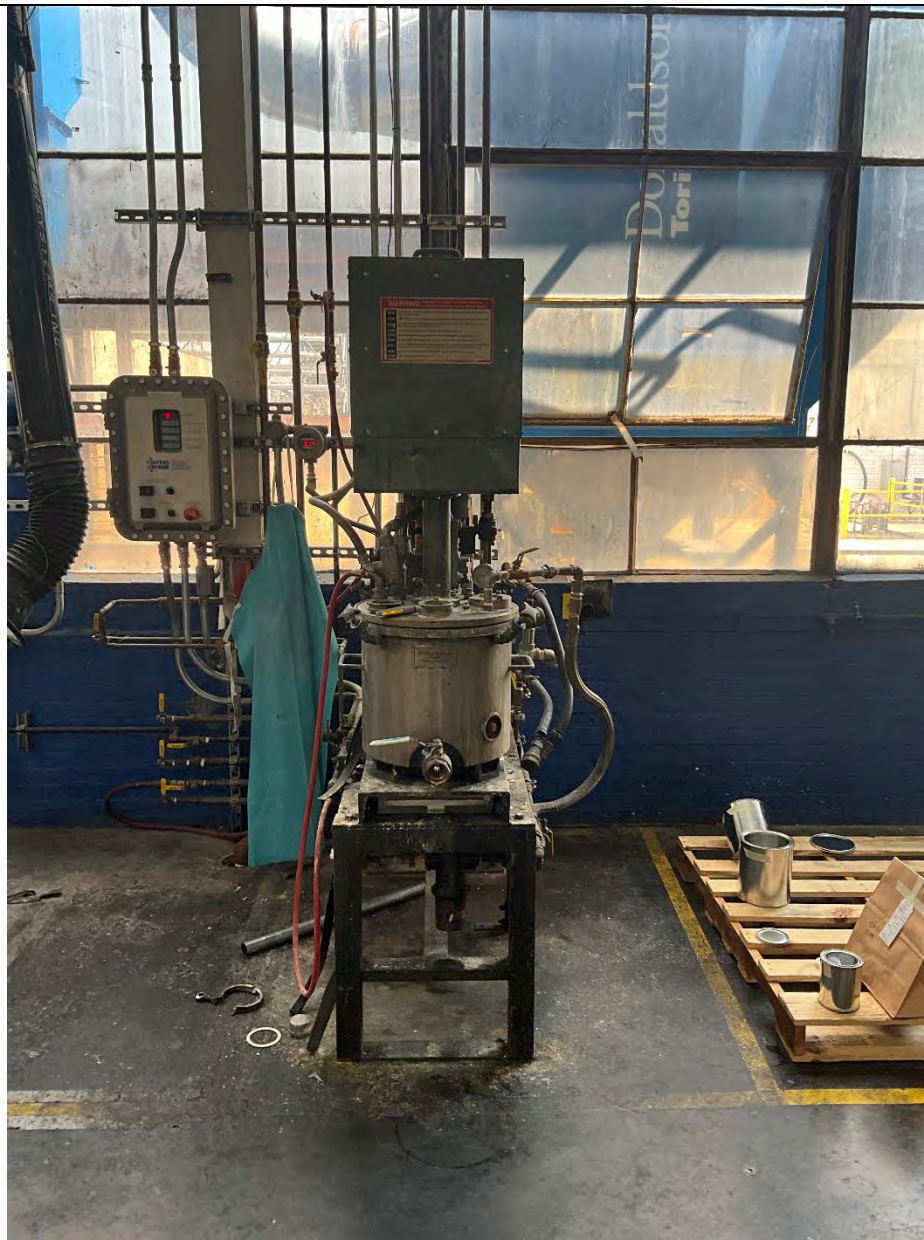
6

DA-5 de-aerating mixer with the cover on (facing Northeast)

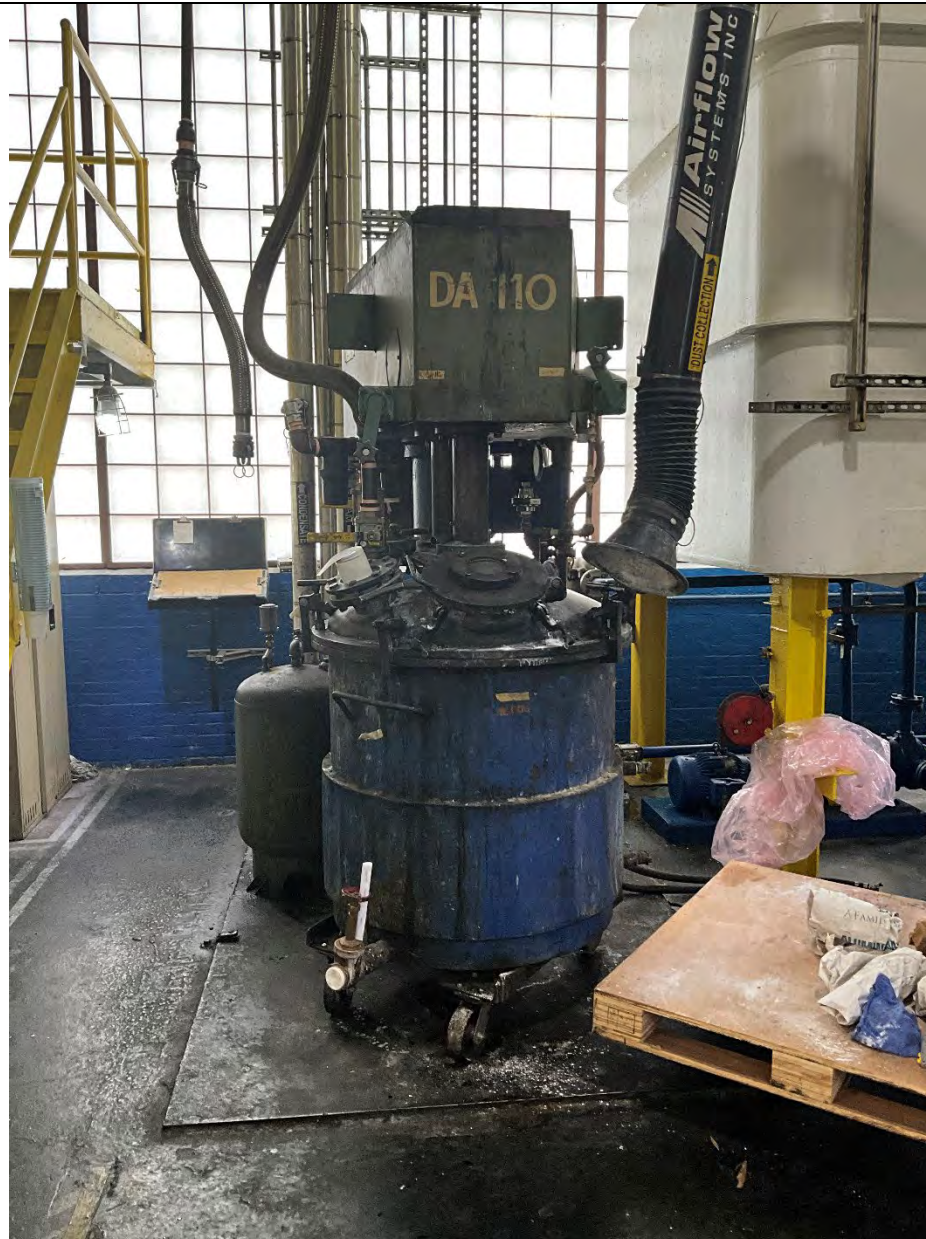
7

DA-110 de-aerating mixer with the cover on (facing West)

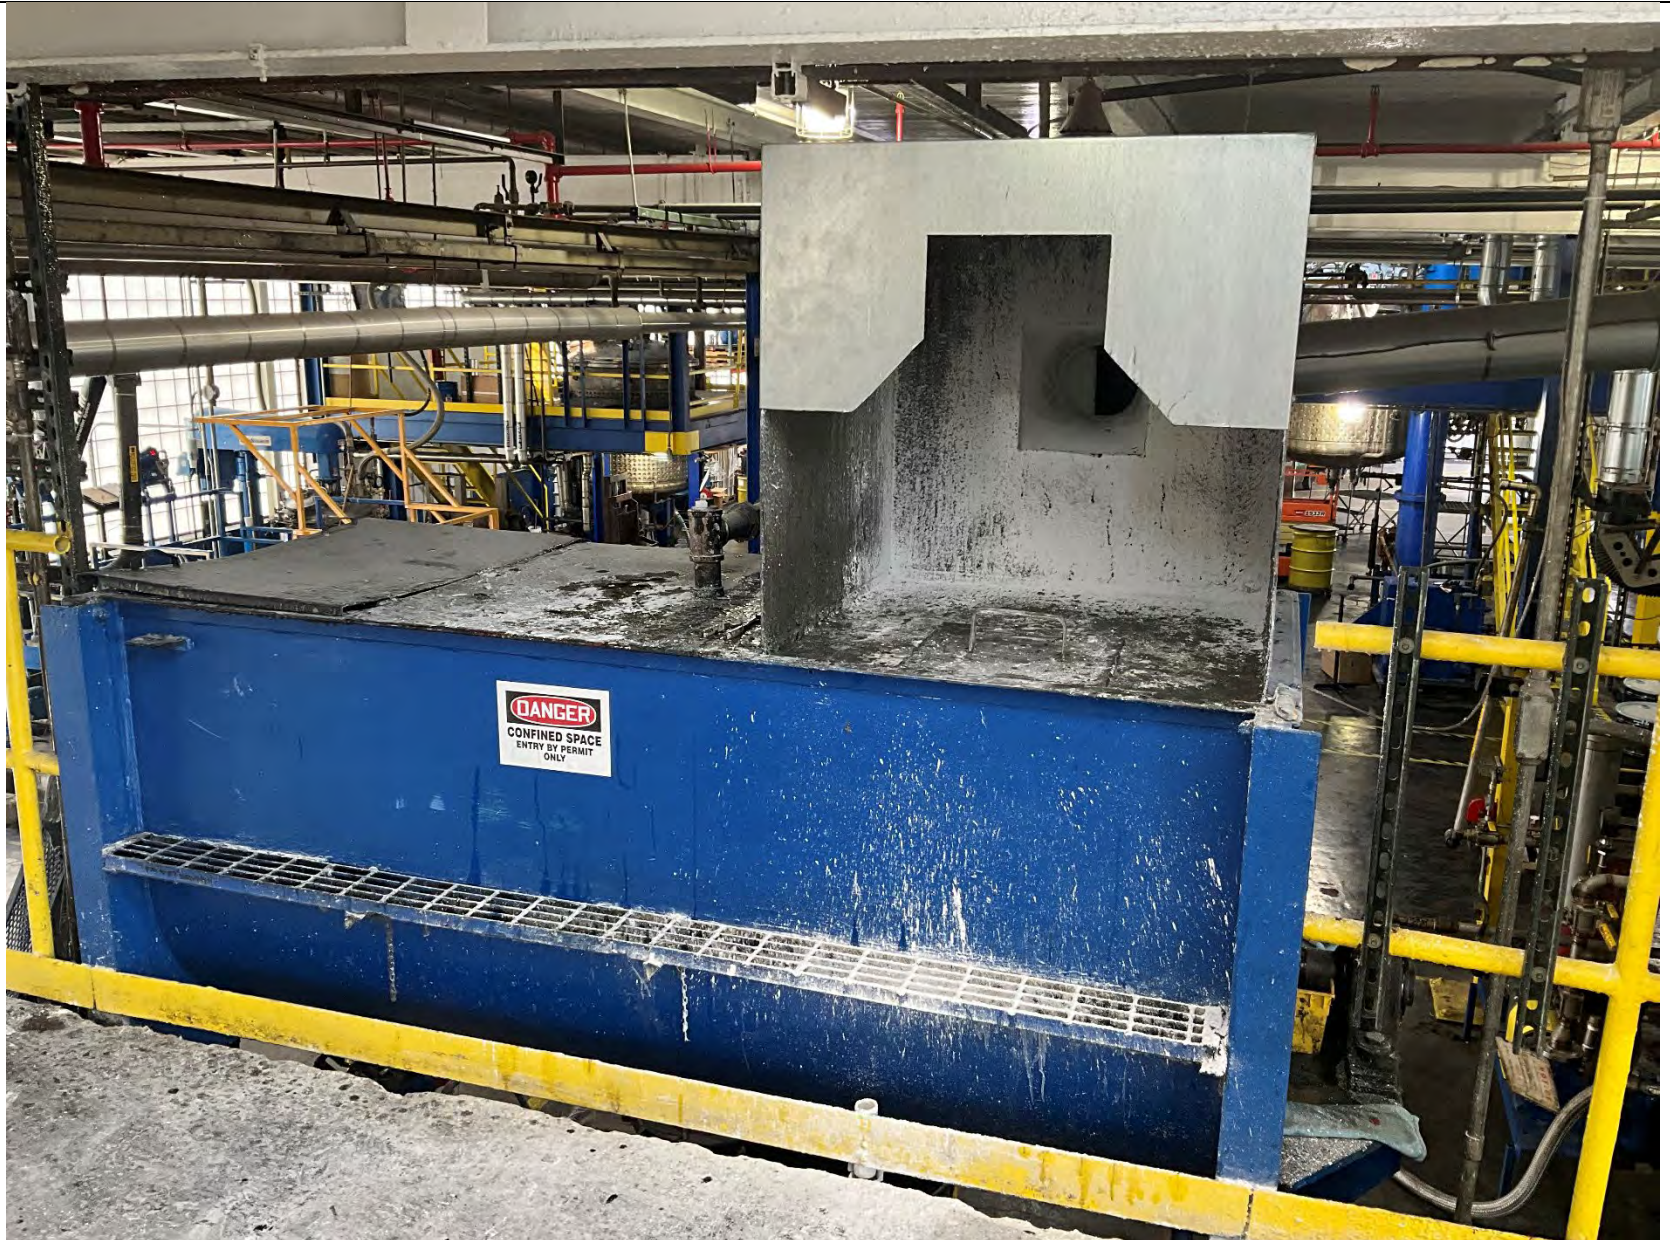
Ribbon mixer with the cover on (facing Northwest)

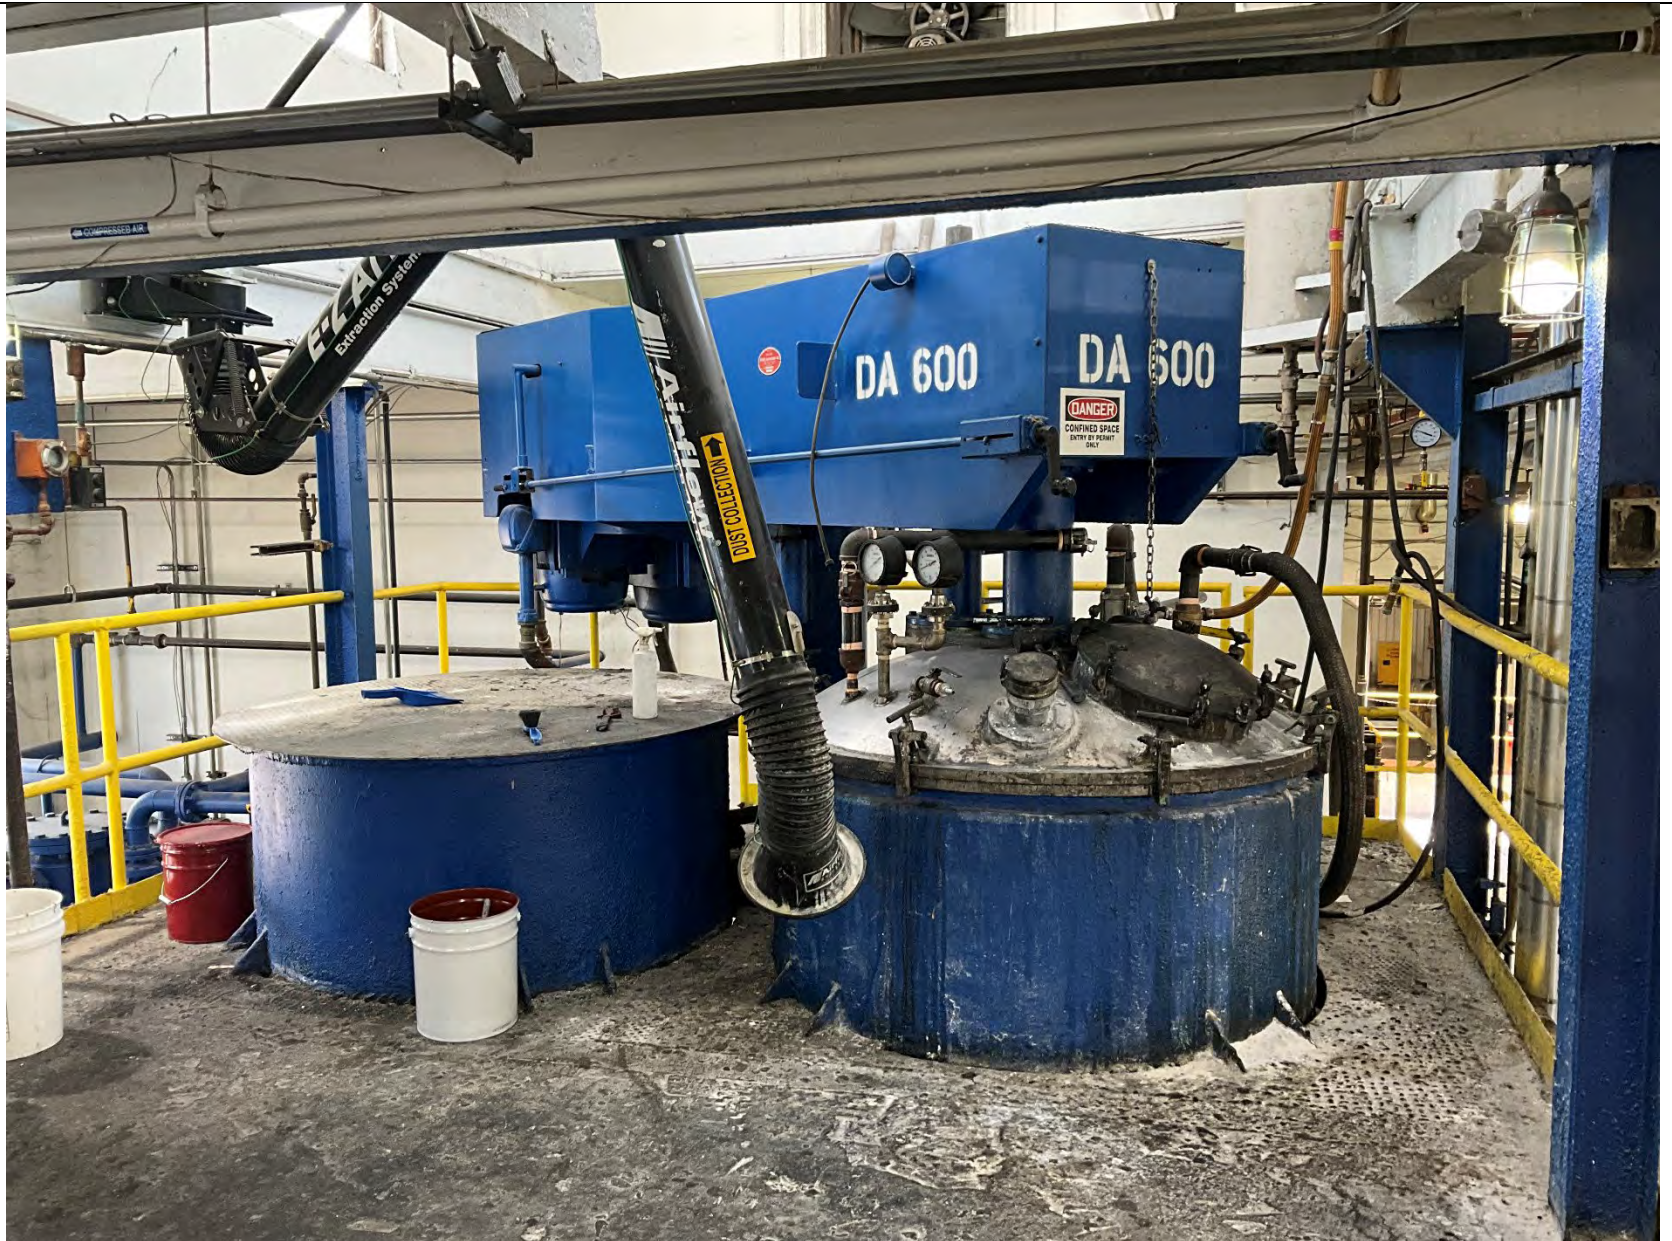
DA-600 de-aerating mixer with the cover on (facing Southeast)

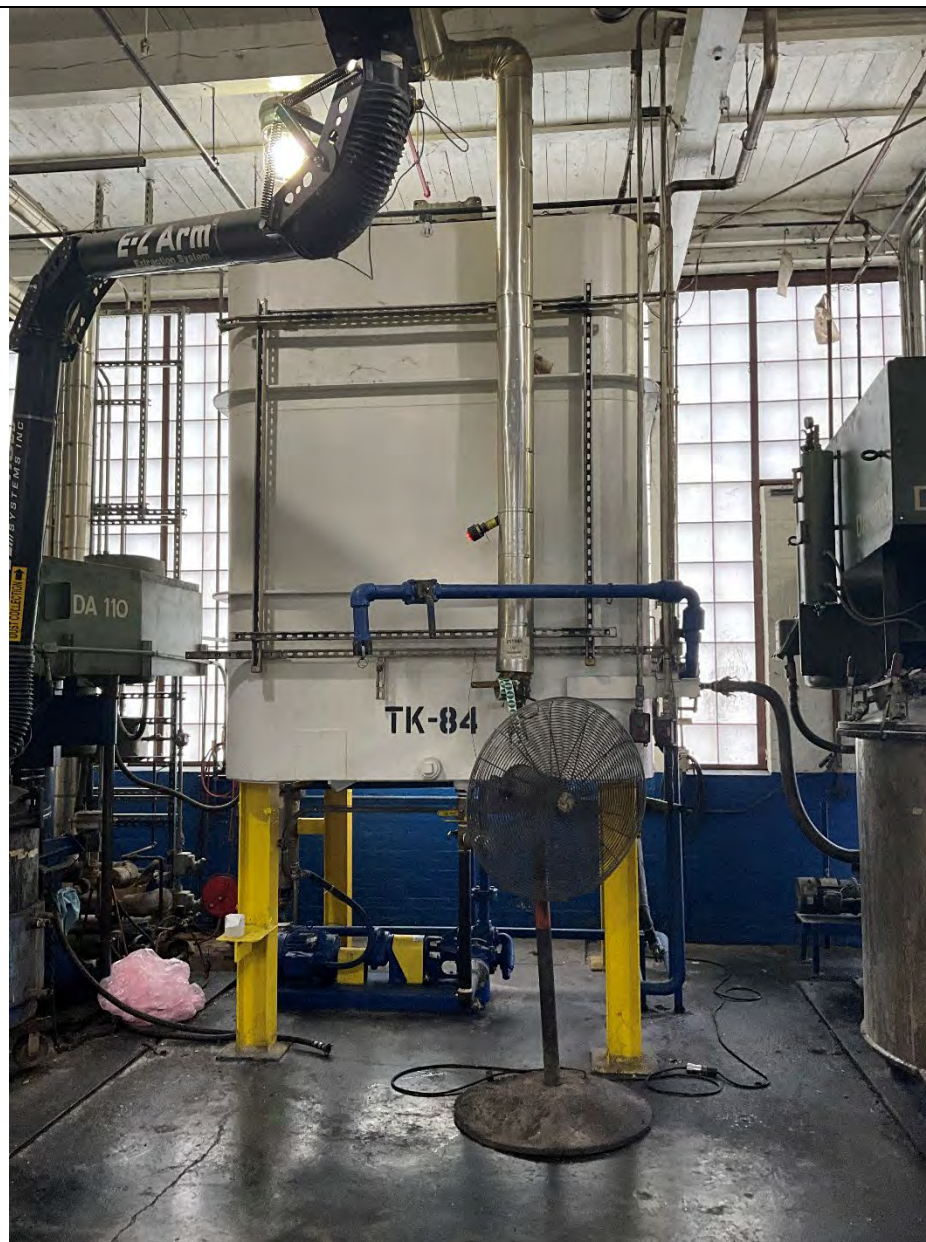
10

T484 mixer (facing Southwest)

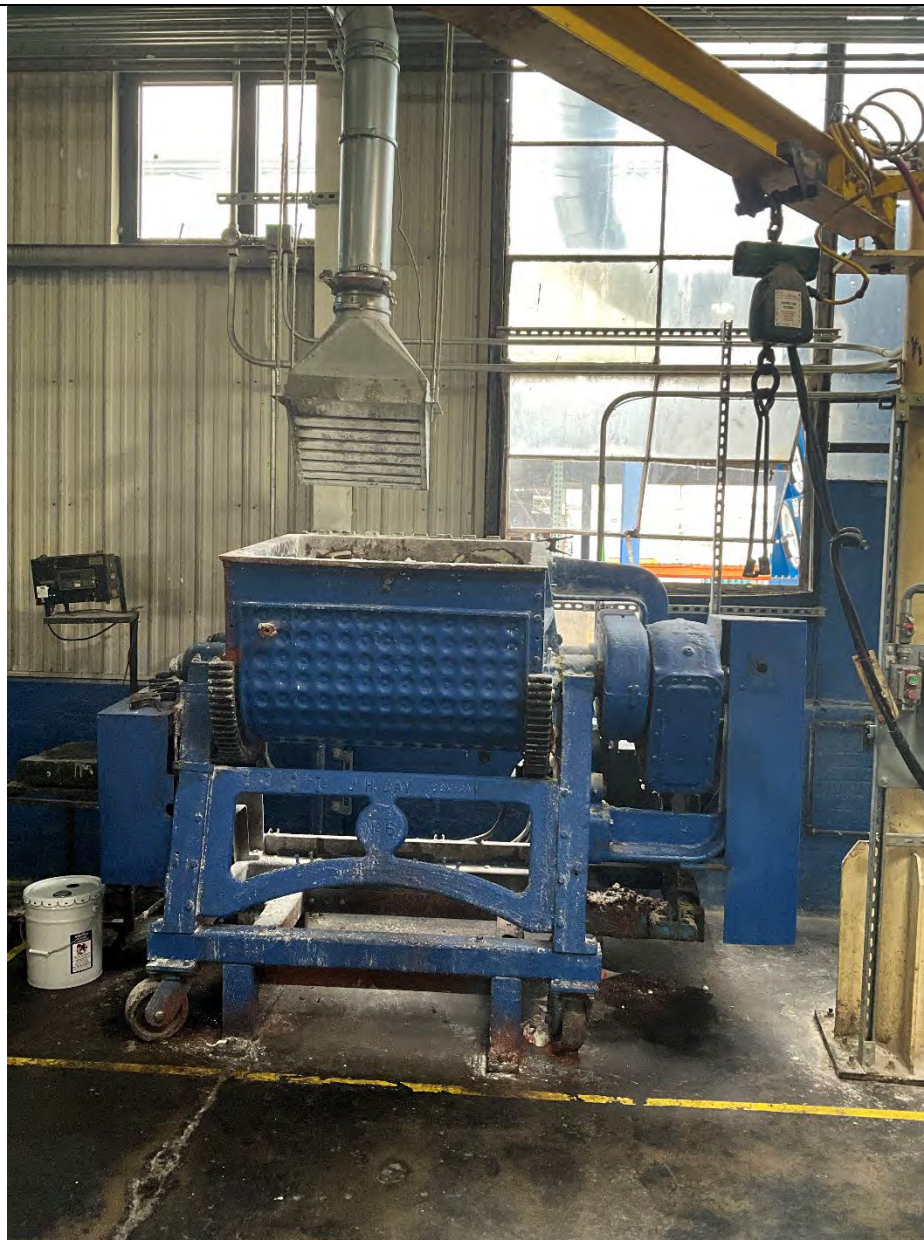
Dough mixer, which was empty and the associated emission collection system (facing Northeast)

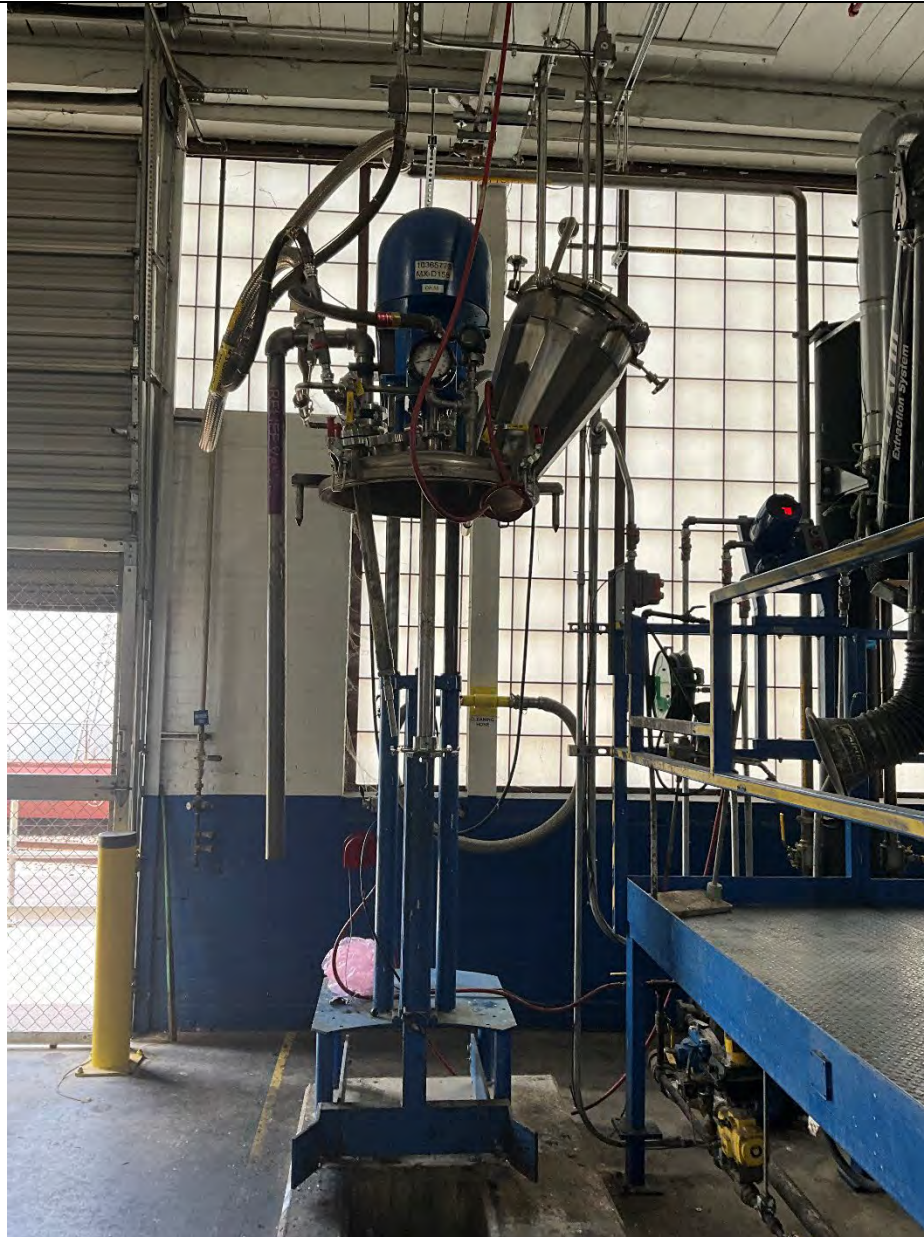
12

DA-55 de-aerating mixer not in use (facing West)

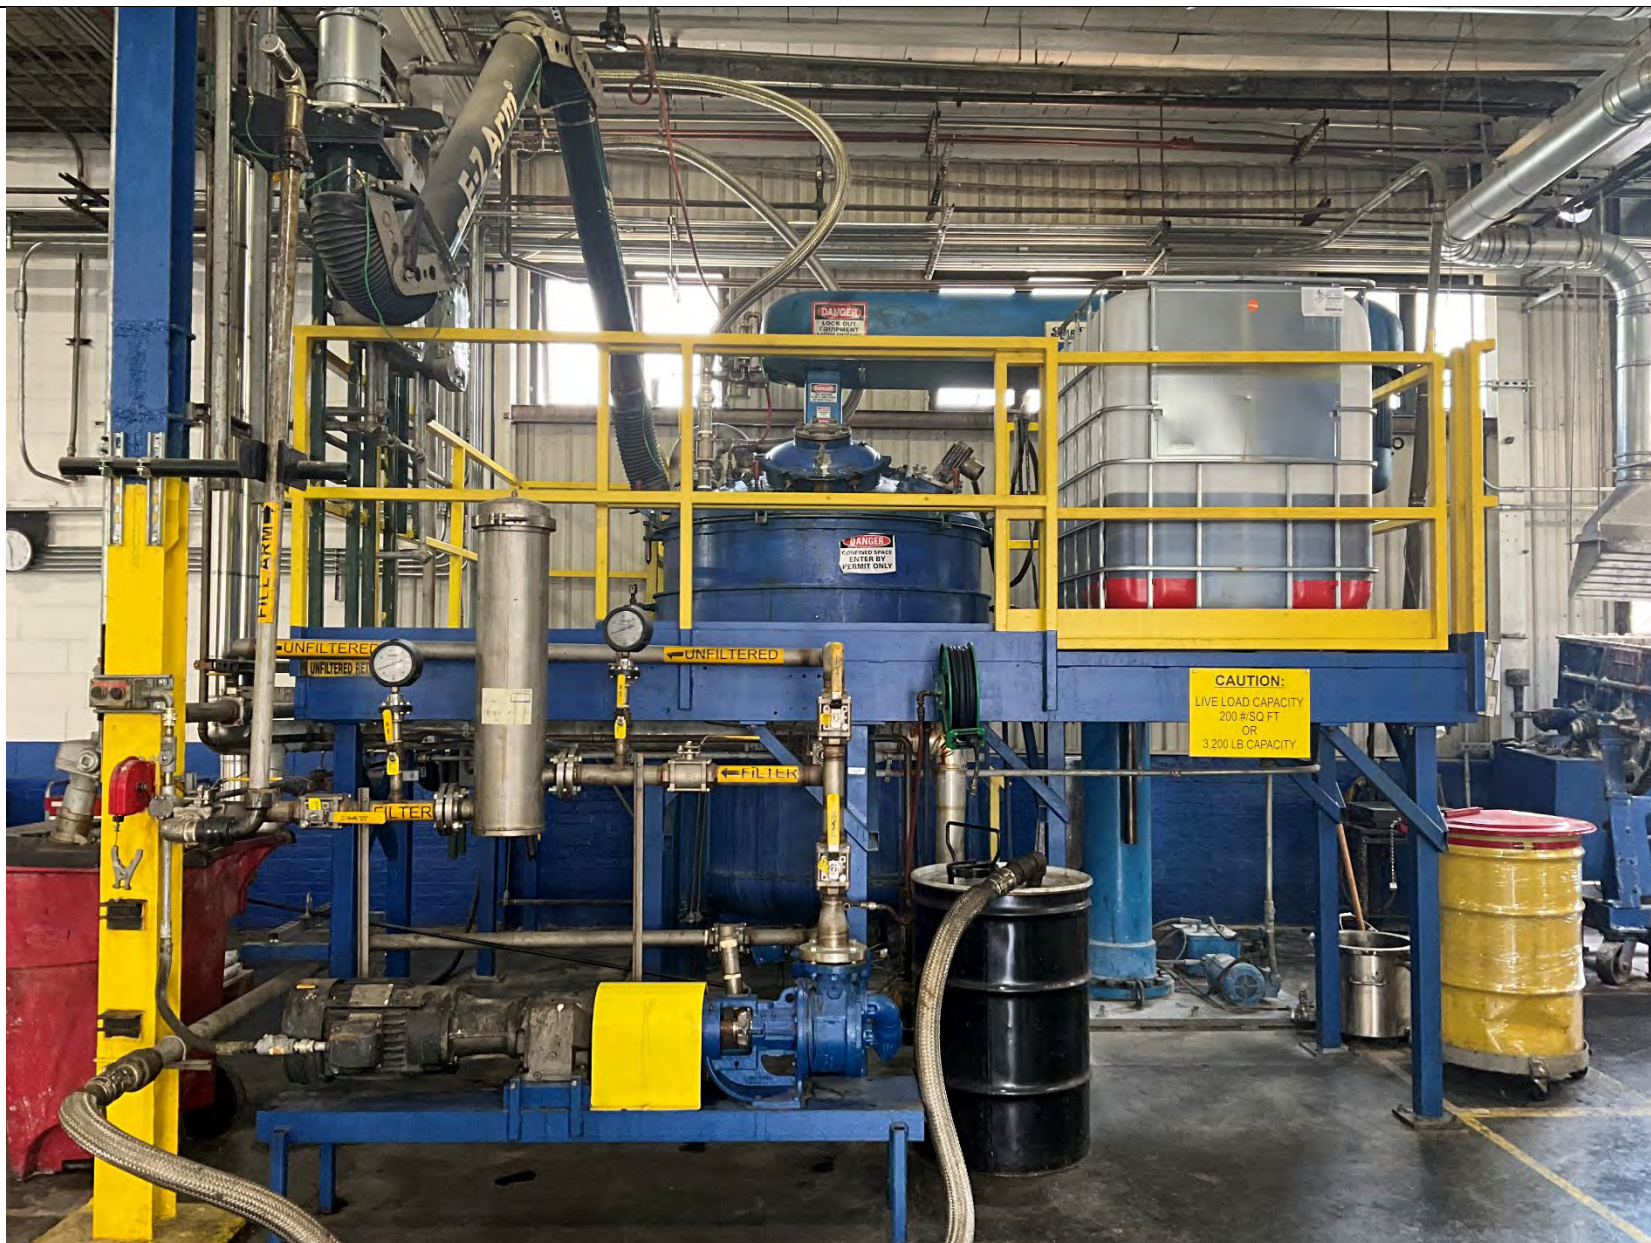
13

QS-800 mixer with the cover on (facing Northeast)

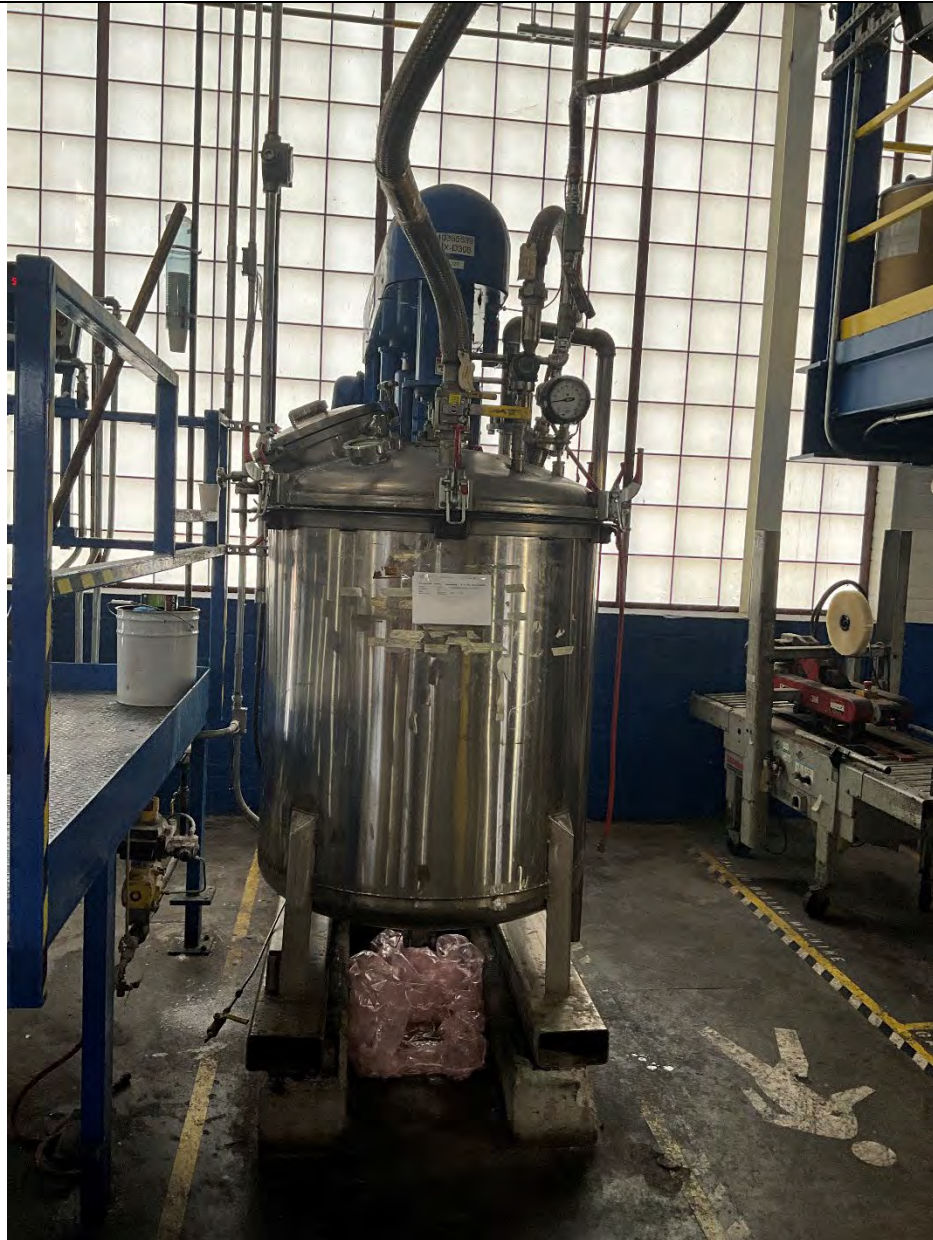
14

DA-220 de-aerating mixer with the cover on (facing West)

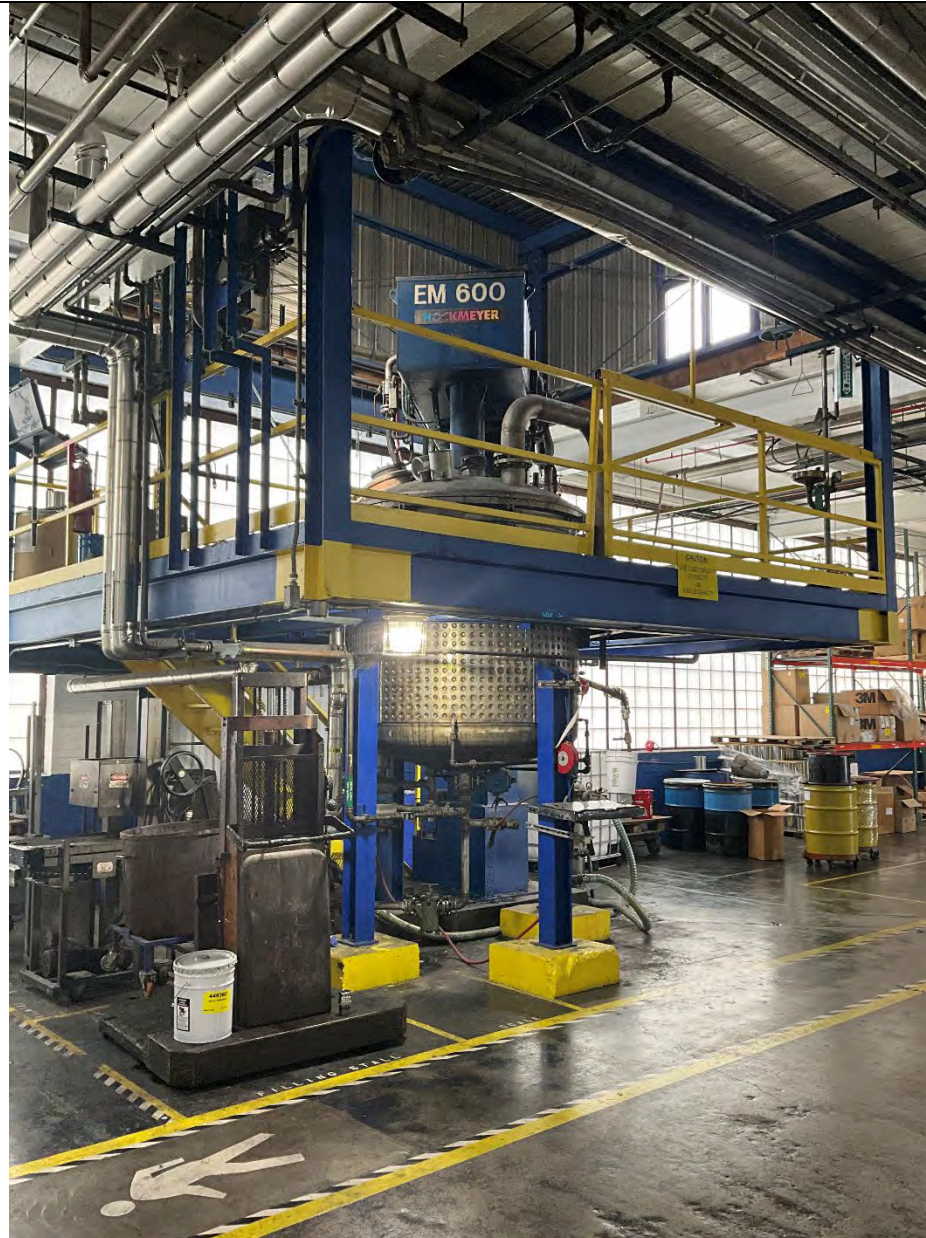
15

EM-600 mixer with the cover on (facing Northwest)

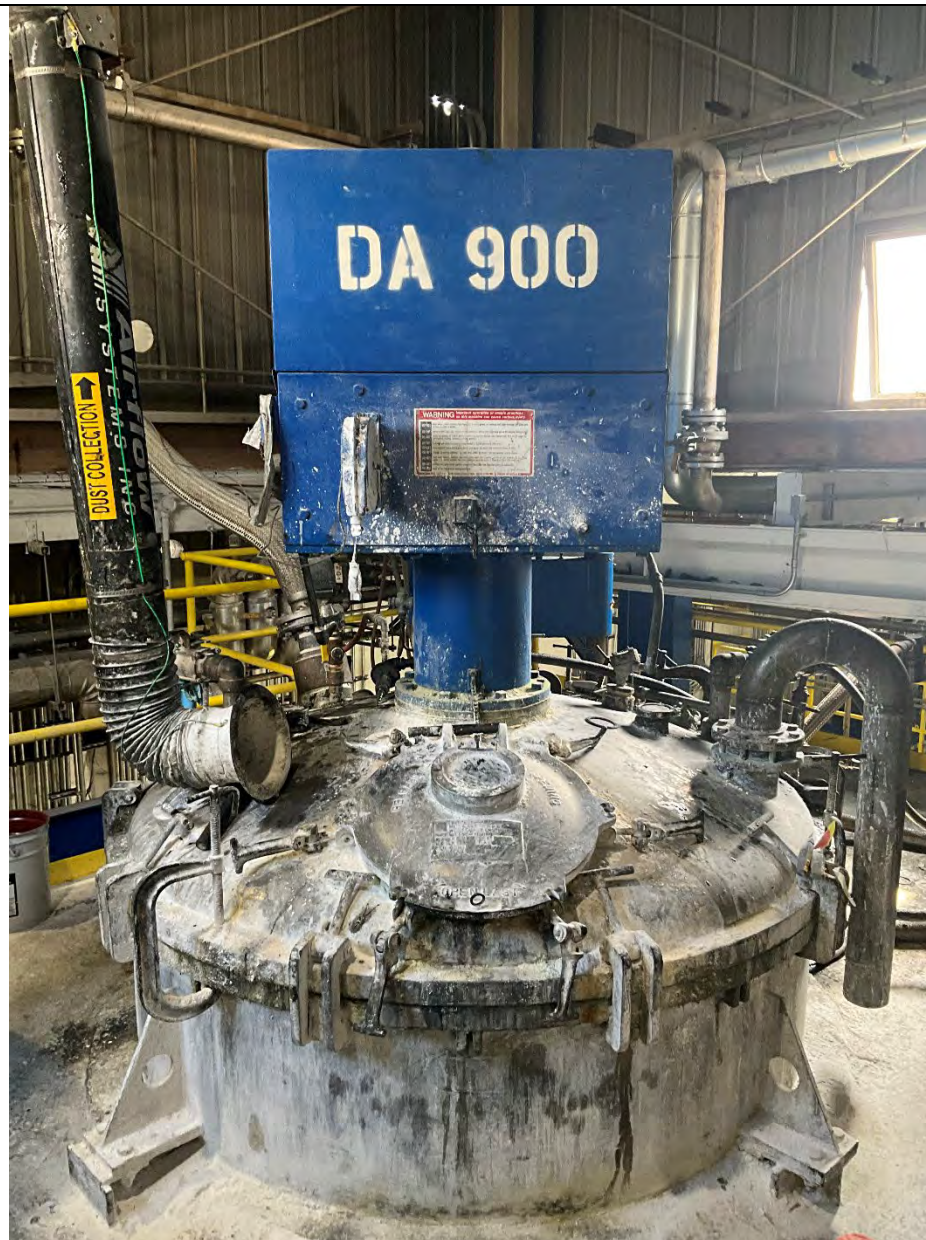
16

DA-900 de-aerating mixer with the cover on (facing North)
