SEPTEMBER 16, 2024

MUNICIPALITY OF TOA ALTA AUGUST 2024  
MONTHLY REPORT  
Civ. No. 3:21-01087-DRD

NIVIA I. AYALA, PE  
TERRATEK ENGINEERING GROUP, PSC  
P.O. Box 367445 San Juan, PR 00936

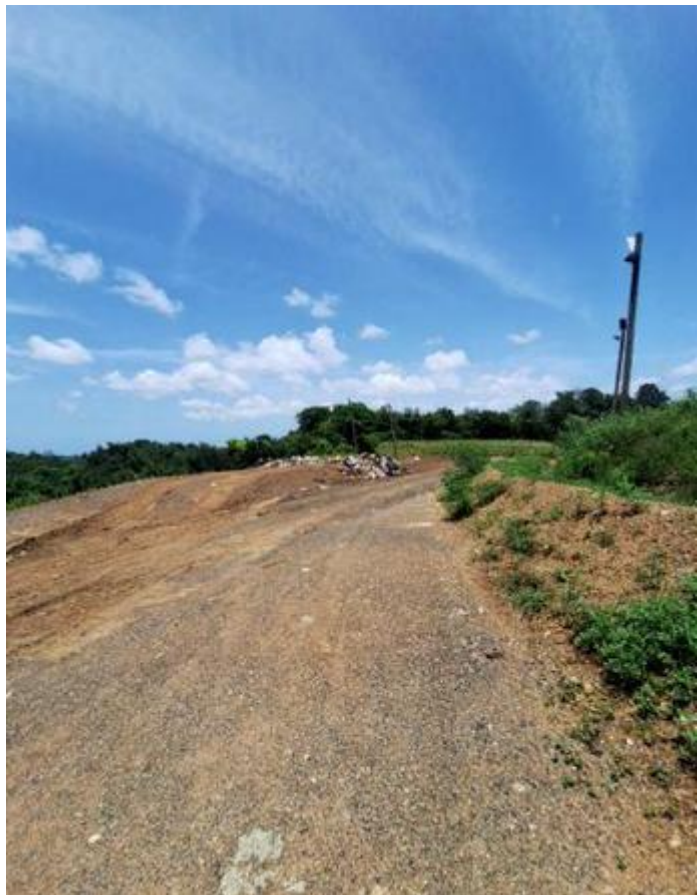
Condicion Operacion Recibo de Escombros

Necesita Limpieza

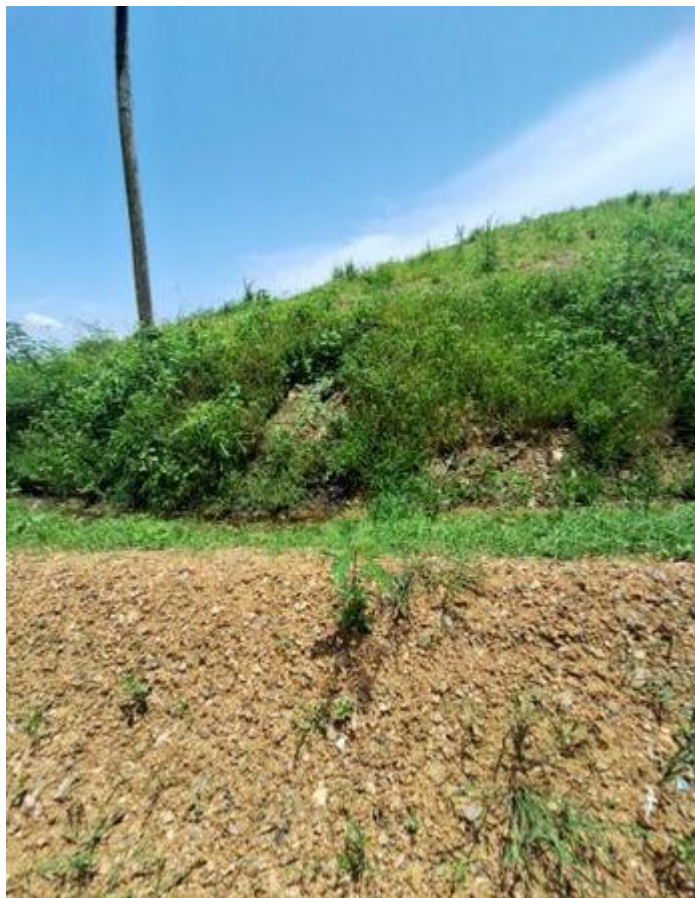
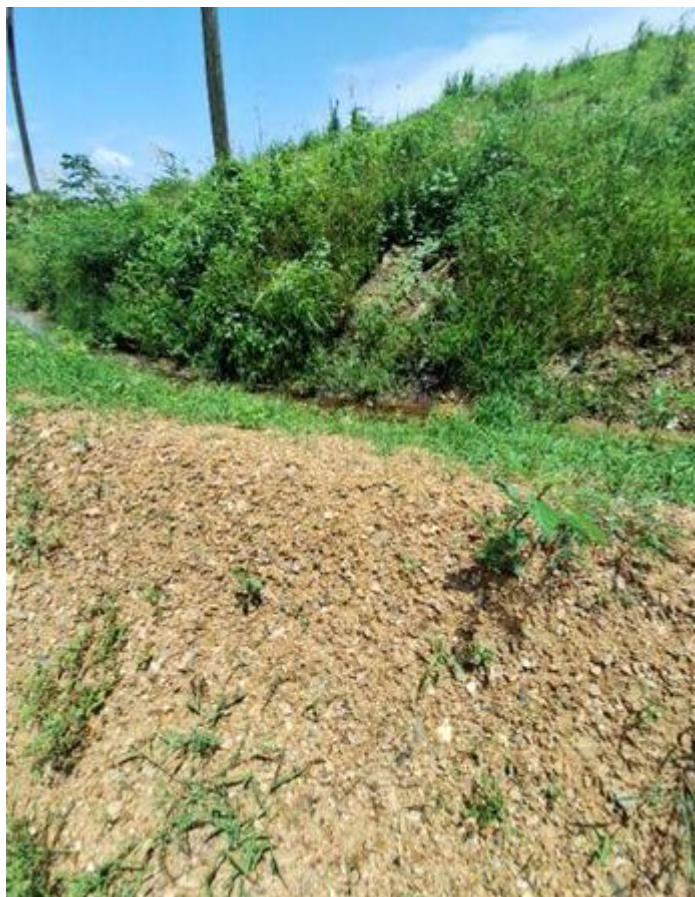
Se pueden notar brotes de  
lixiviado?

SI

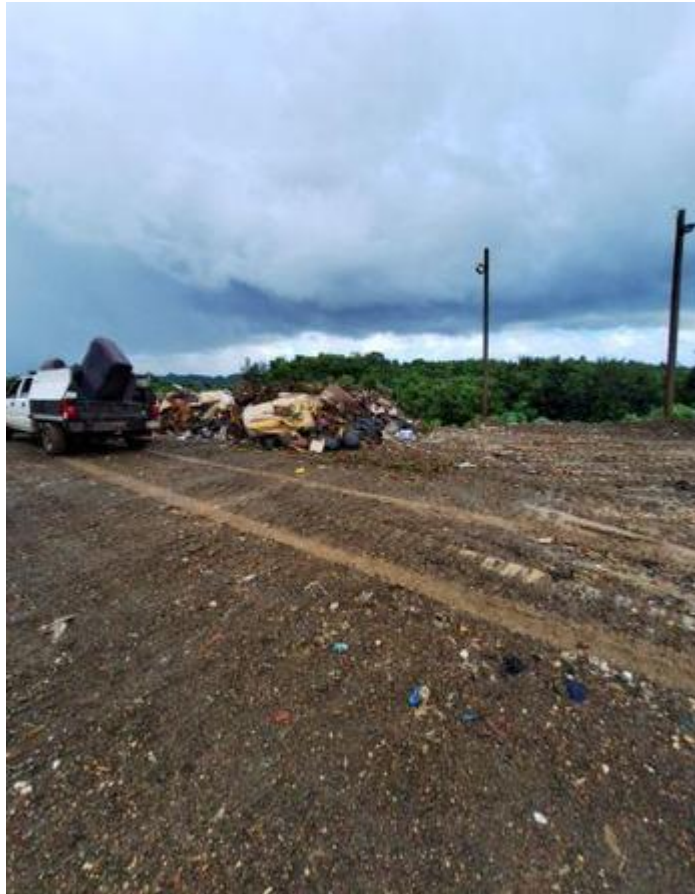
Condicion Operacion Recibo de Escombros

Necesita Limpieza

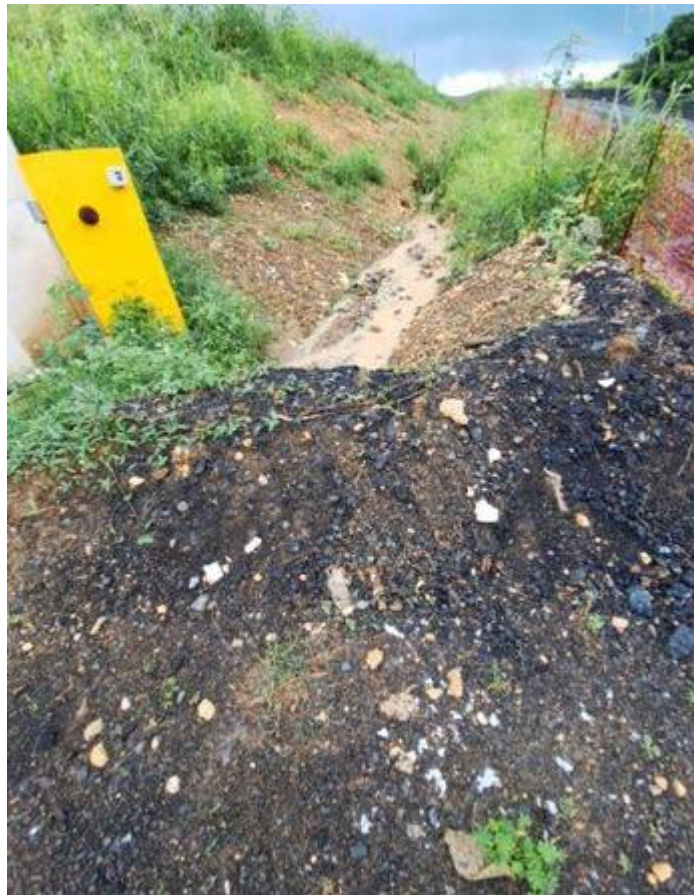
sedimentacion

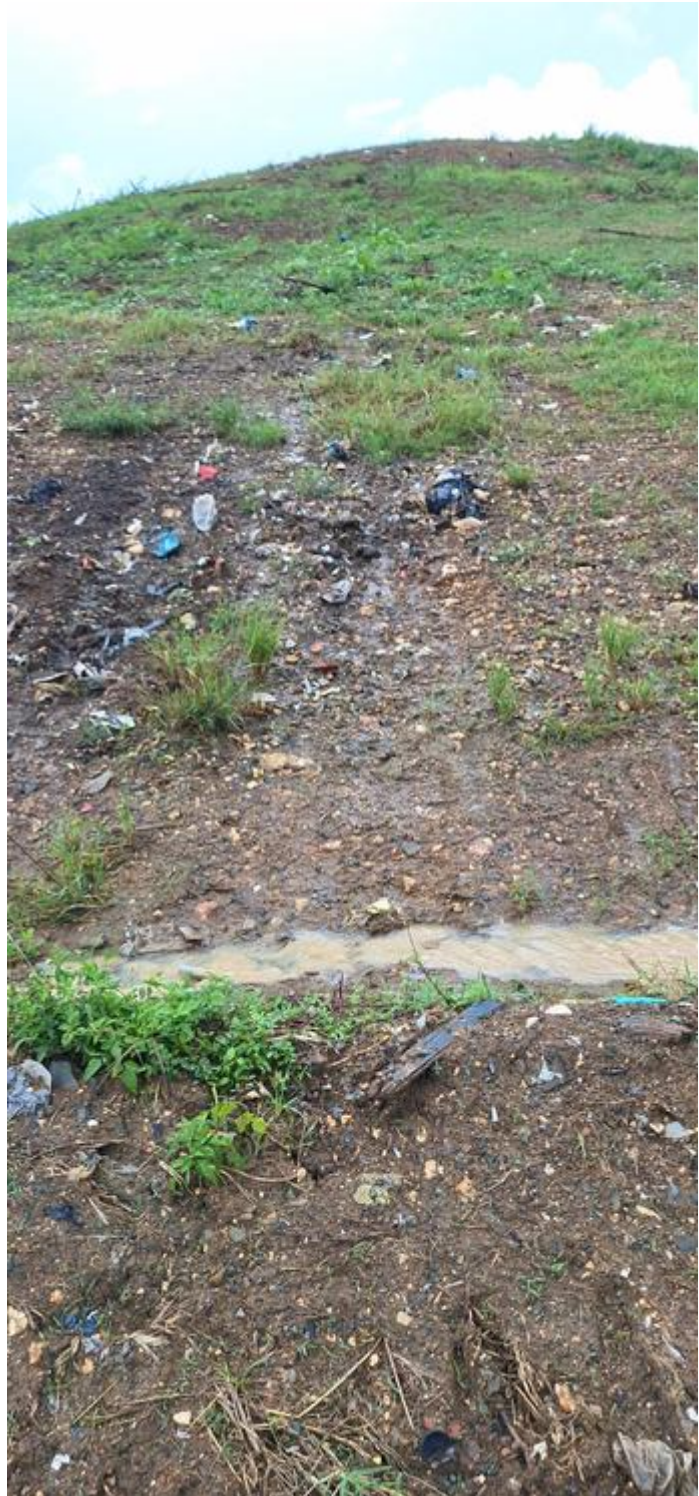
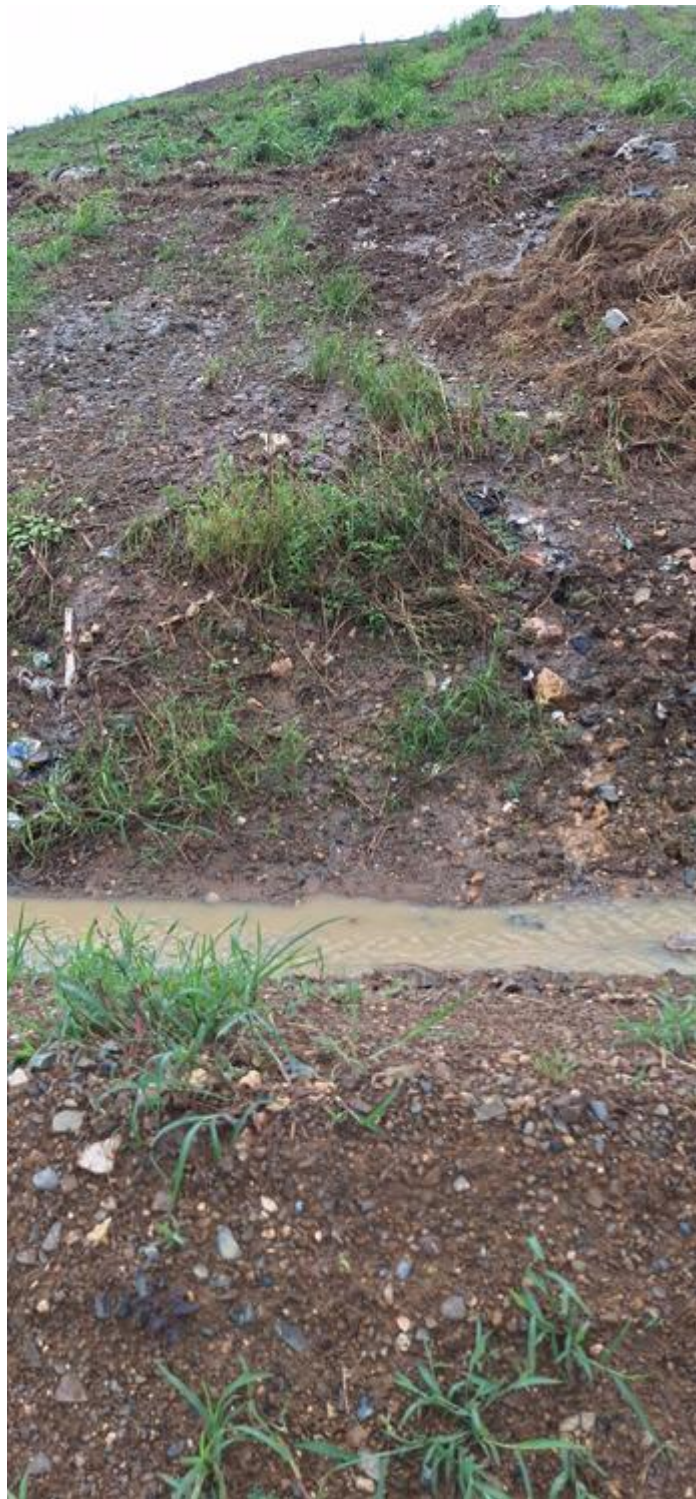
Se pueden notar brotes de  
lixiviado?

SI

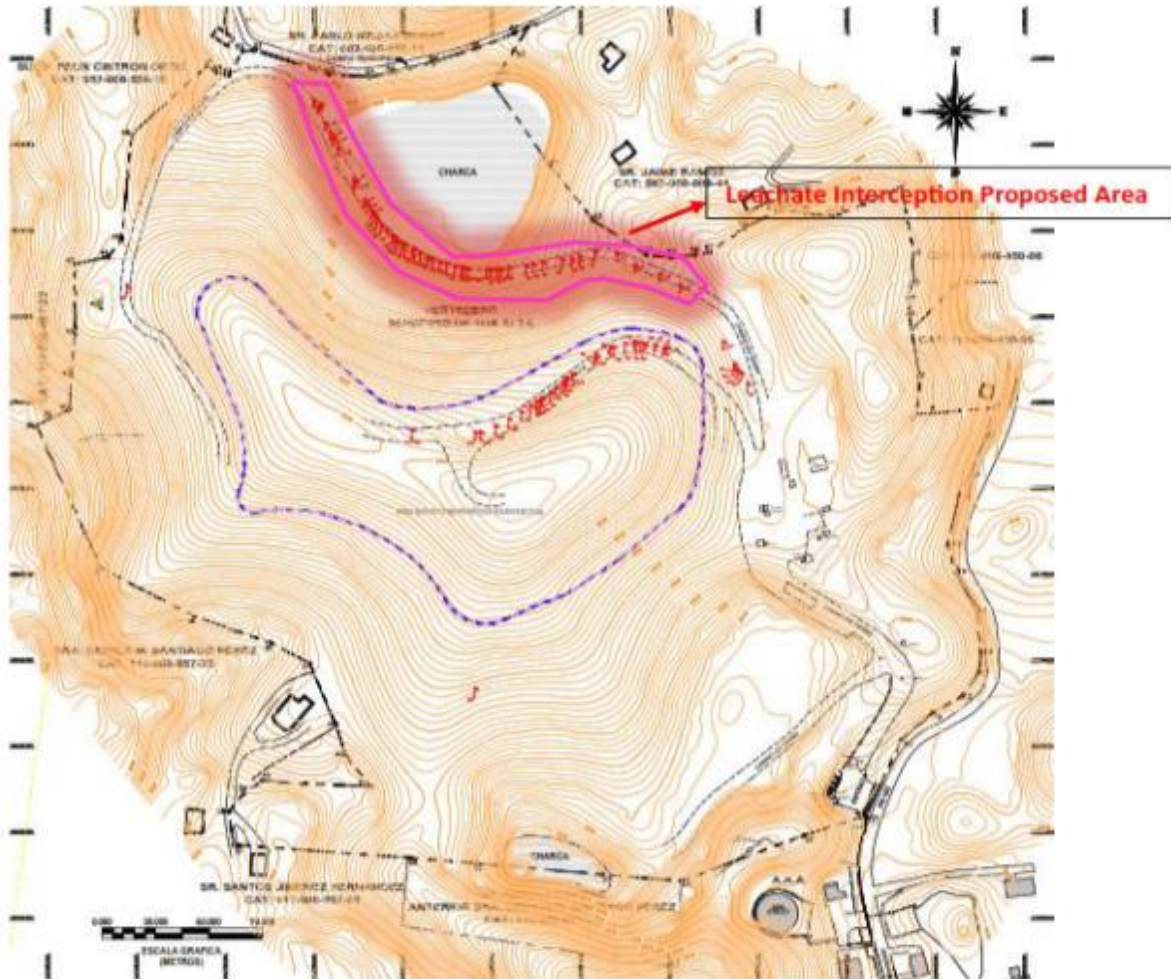
Figure 4 Leachate Seepage Inventory

February monthly report included the final Leachate Seepage Inventory Report. As expected, all visually identifiable leachate seepages were found at the toe of the site slopes, terraces, and interior pathways (marked on this drawing as small red flags).

In the above graphic, the area depicted in Magenta is the proposed area for installing a Leachate Interception System. As we can infer from the seepage locations, the Leachate Management Plan to be part of the Final Closure Design should include Leachate interception Systems along the Site to collect leachate and provide for safe and environmentally responsible treatment and disposition.

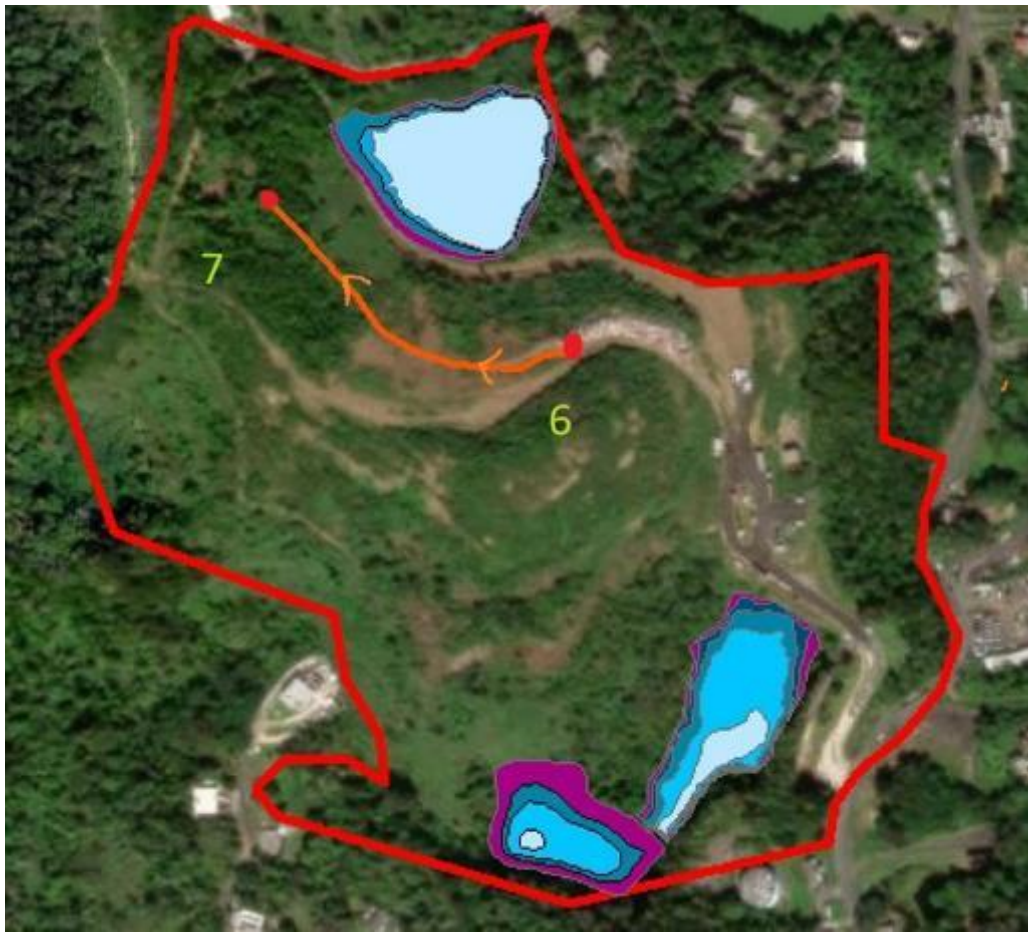
### Channel North MID

| Channel ID | Length (ft) | Slope S (%) | BASE b (ft) | z | Angle (°) | Flow depth (ft) | TOP WIDTH T (ft) | Flow Q (cfs) | Velocity (ft/s) | Froude Number |
|---|---|---|---|---|---|---|---|---|---|---|
| 6-7 | 941.0 | 6.85 | 1 | 0.6 | 60 | 1.2 | 2.44 | 25 | 12.96 | 2.08 |

All channels will be covered with erosion control mats. We recommend the Curlex erosion control blankets, which are designed to provide extended protection for grass seed and topsoil from wind and water erosion for approximately 36+ months while simultaneously promoting ideal growing conditions on steep, long slopes and/or in channel applications.

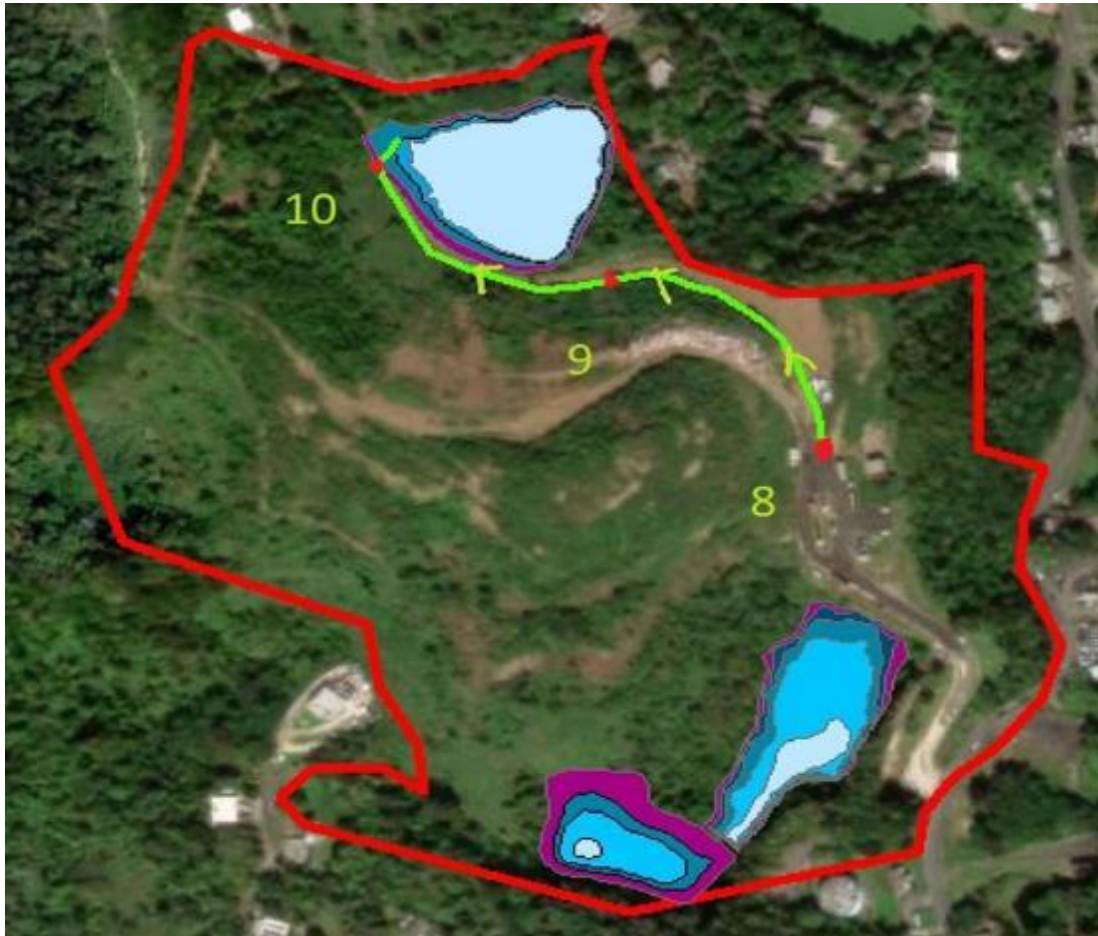
### Channel North Down

| Channel ID | Length (ft) | Slope S (%) | Base b (ft) | z | Angle (°) | Flow depth (ft) | Top Width T (ft) | Flow Q (cfs) | Velocity (ft/s) | Froude Number |
|---|---|---|---|---|---|---|---|---|---|---|
| 8-9 | 596.4 | 9.90 | 1 | 0.6 | 60 | 1.55 | 2.86 | 52.5 | 17.53 | 2.48 |

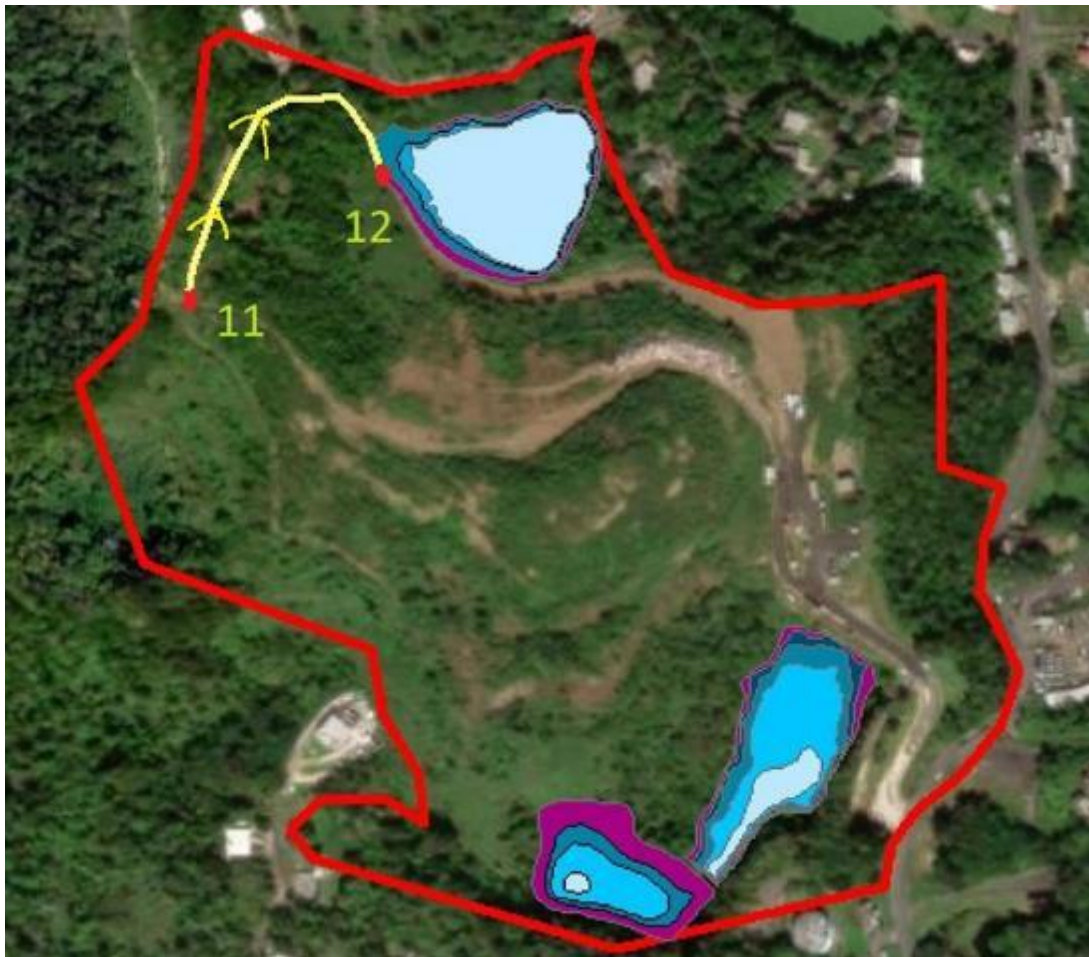
### Channel Trap West

| Channel ID | Length (ft) | Slope S (%) | BASE b (ft) | z | Angle (°) | Flow depth (ft) | Top Width T (ft) | Flow Q (cfs) | Velocity (ft/s) | Froude Number |
|---|---|---|---|---|---|---|---|---|---|---|
| 11-12 | 740.9 | 18.30 | 1 | 0.6 | 60 | 1.00 | 2.20 | 20 | 11.9 | 2.10 |

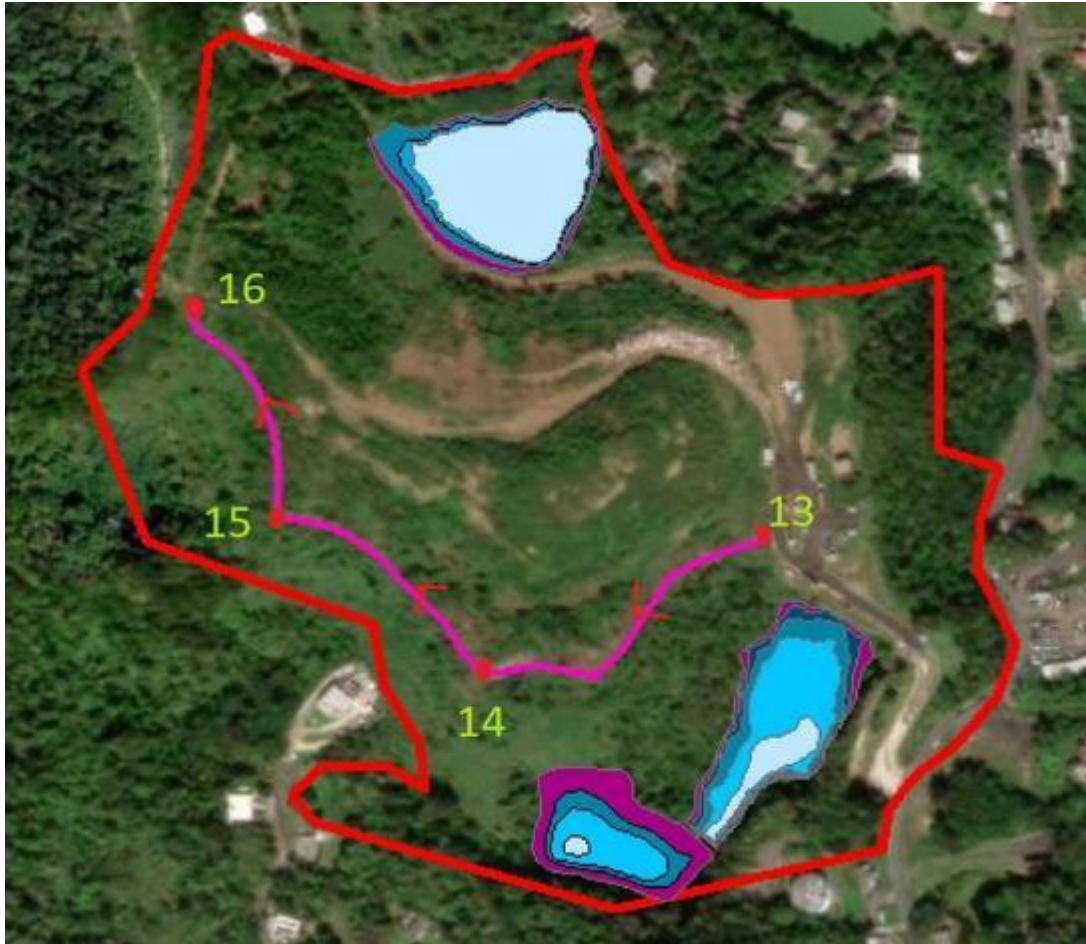
### Channel Trap South Up

| Channel ID | Length (ft) | Slope S (%) | BASE b (ft) | z | Angle (°) | Flow depth (ft) | Top Width T (ft) | Flow Q (cfs) | Velocity (ft/s) | Froude Number |
|---|---|---|---|---|---|---|---|---|---|---|
| 13-14 | 709.9 | 5 | 1 | 0.6 | 60 | 1.10 | 2.32 | 18.0 | 10.6 | 1,79 |
