**Maier Inspection Report, July 14, 2022**

Re: Inspection Report for Maher Cattle LLC, Unpermitted Site

## NPDES Inspection Report – Concentrated Animal Feeding Operations

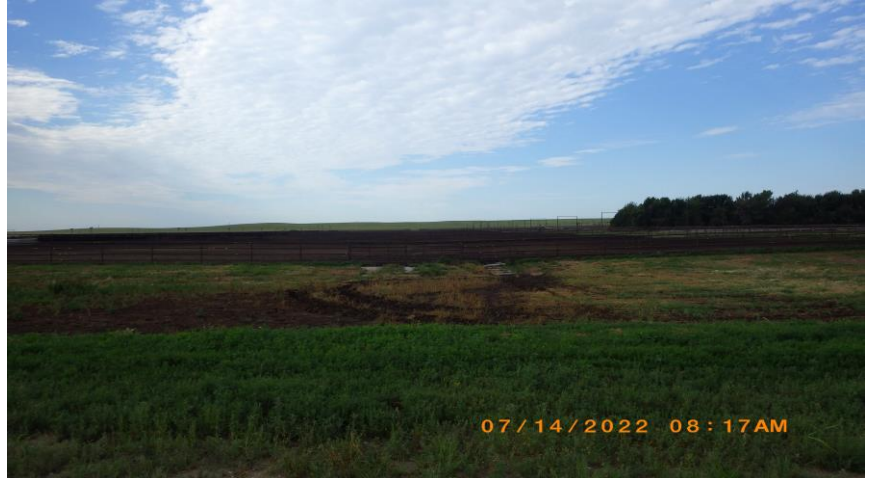
Photo number 126 taken by Stephanie Meyers on 7/14/2022.

A facility representative indicated that solid manure from the settling basins (photos 126 and 127) was land applied to crops in 2020 and 2021. At the time of the inspection, there were no agronomic rate calculations records for the application of the manure. It appears the appropriate agronomic rate at which manure is being land applied is not being calculated.

Overview of cattle pens in the background and Settling Basin 3 in the foreground. The water flows to the north towards the settling basin. Solids settle out in the settling basin and the water flows to Settling Basin 4, which then flows into Settling Basin 5, which flows to Holding Pond 2.

Ensure manure is land applied in accordance with site-specific nutrient management practices and documentation of land application of manure is maintained. Provide the EPA and the Tribe with a description of the corrective actions taken to address this finding.

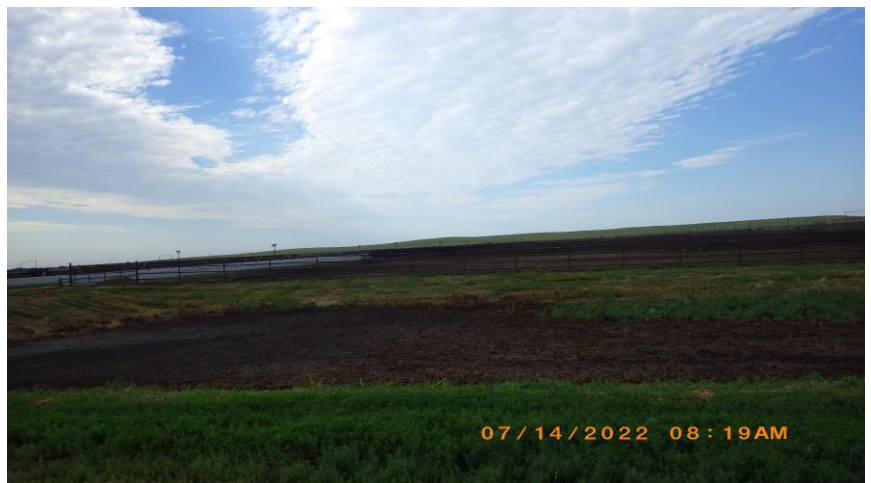
Photo number 127 taken by Stephanie Meyers on 7/14/2022.

Overview of cattle pens in the background and Settling Basin 3 in the foreground. The water flows to the north towards the settling basin. Solids settle out in the settling basin and the water flows to Settling Basin 4, which then flows into Settling Basin 5, which flows to Holding Pond 2.

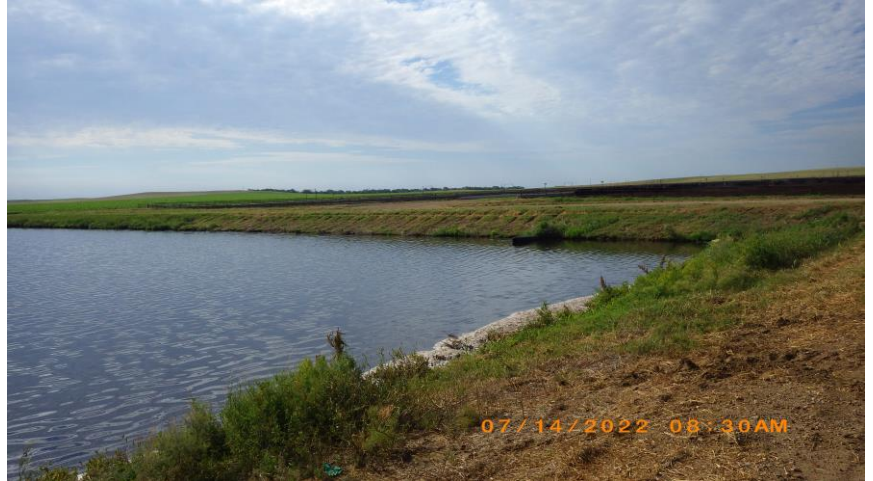
Photo number 128 taken by Stephanie Meyers on 7/14/2022.

Overview of Holding Pond 2 showing the inlet pipes coming from Settling Basin 5 and Settling Basin 6.

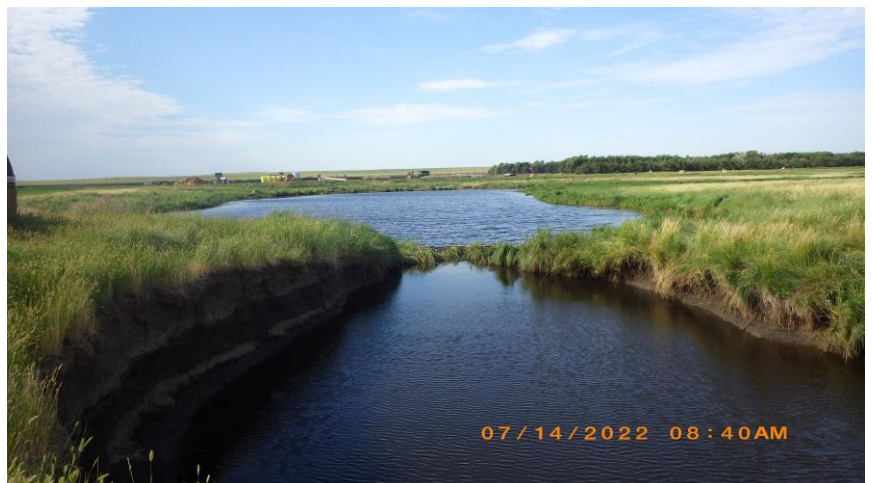
Photo number 129 taken by Stephanie Meyers on 7/14/2022.

Overview of High Bank Creek near a dam on the north side of the feed pad area. The water flows to the north towards the foreground of the photo. Note erosion of the banks.

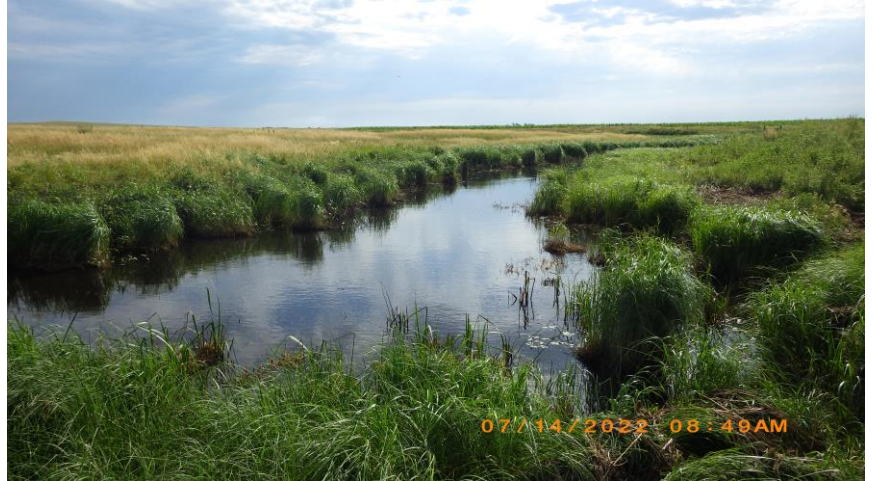
Photo number 130 taken by Stephanie Meyers on 7/14/2022.

Overview of High Bank Creek north of Holding Pond 2. The water flows to the east towards the background of the photo.

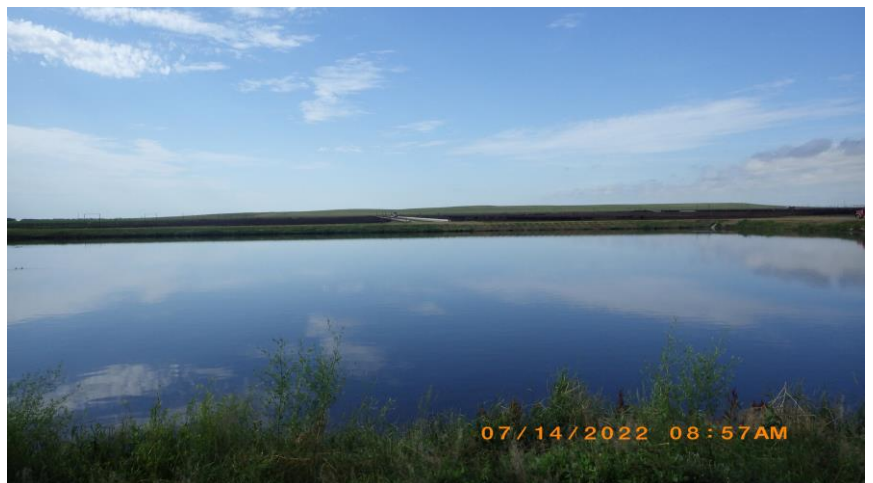
Photo number 131 taken by Stephanie Meyers on 7/14/2022.

Overview of Holding Pond 2 with cattle pens and settling basins in the background.

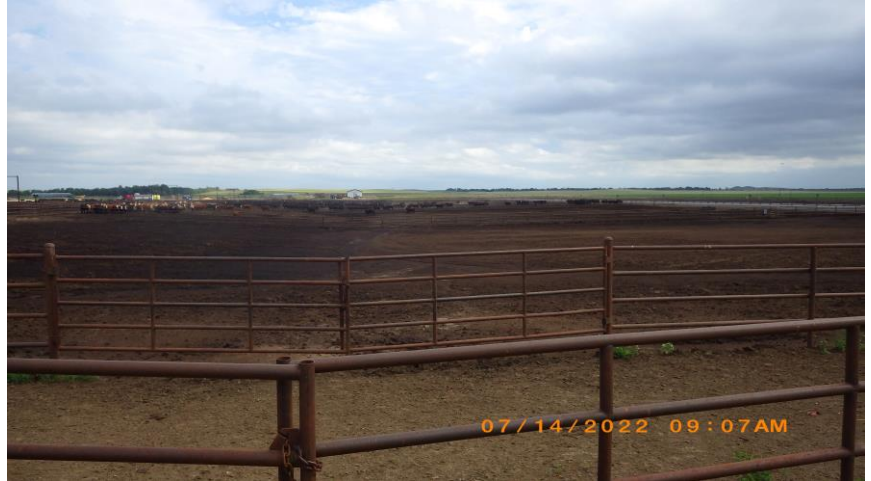
Photo number 132 taken by Stephanie Meyers on 7/14/2022.

Overview of drainage from cattle pens to the north towards Holding Pond 2.

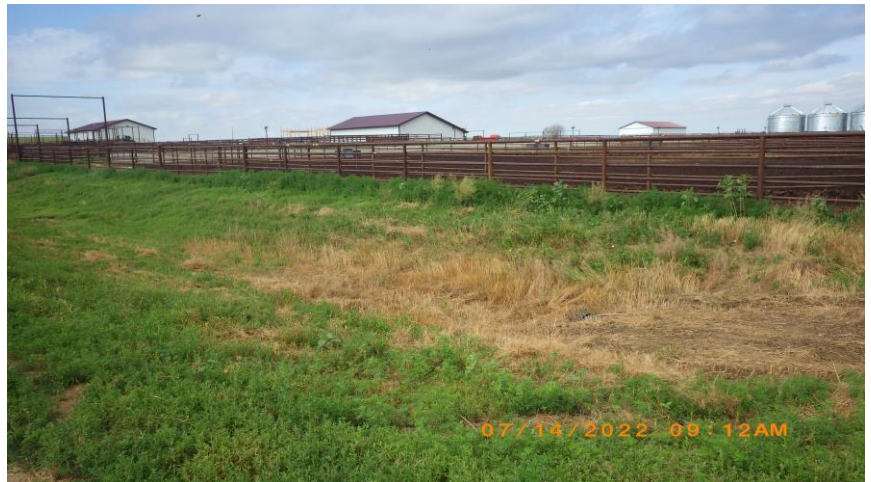
Photo number 133 taken by Stephanie Meyers on 7/14/2022.

Overview of settling basin for the receiving pens.  
Solids accumulate in the settling basin and the water goes to Holding Pond 1.

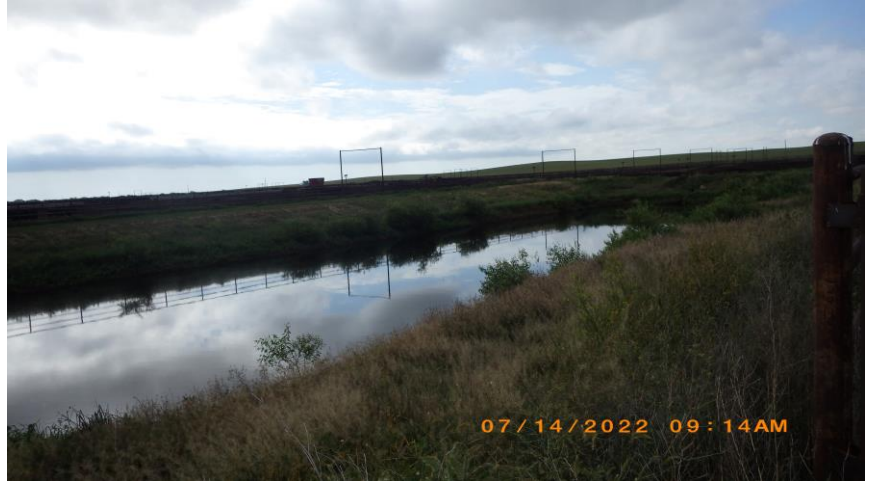
Photo number 134 taken by Stephanie Meyers on 7/14/2022.

Overview of Holding Pond 1 that receives water from Settling Basin 1 and 2 for the receiving pens.

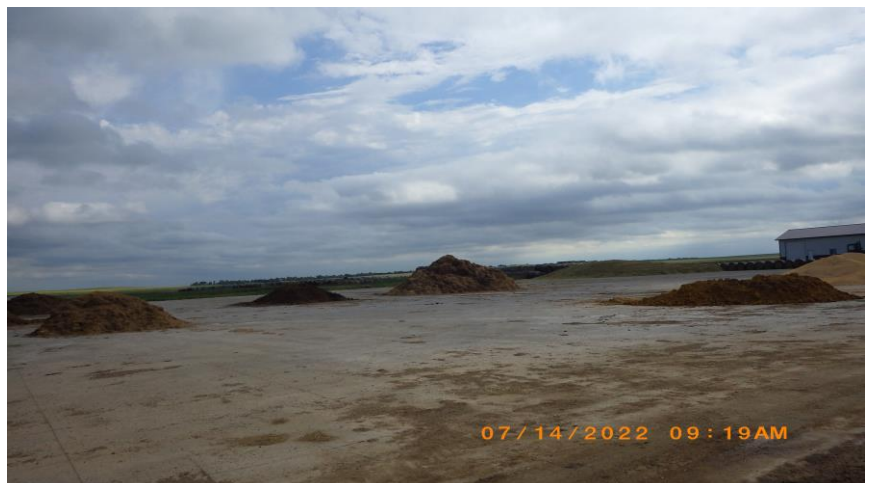
Photo number 135 taken by Stephanie Meyers on 7/14/2022.

**Finding #4: Feed was stored uncovered on the concrete feed pad.**

Feed, including oatlage, is stored on a concrete pad uncovered and susceptible to being transported by wind and coming into contact with storm runoff (photo 135). High Bank Creek is in close proximity to the north of the feed concrete pad. On July 25, 2022, facility representatives had sent EPA inspectors a photo showing the pile of oatlage has since been covered.

Overview of feed pad. Note the feed was not covered at the time of the inspection.

Ensure runoff from the concrete feed pad is contained within the production area and not discharged to High Bank Creek. Provide the EPA and the Tribe with a description of the corrective actions taken to address this finding.

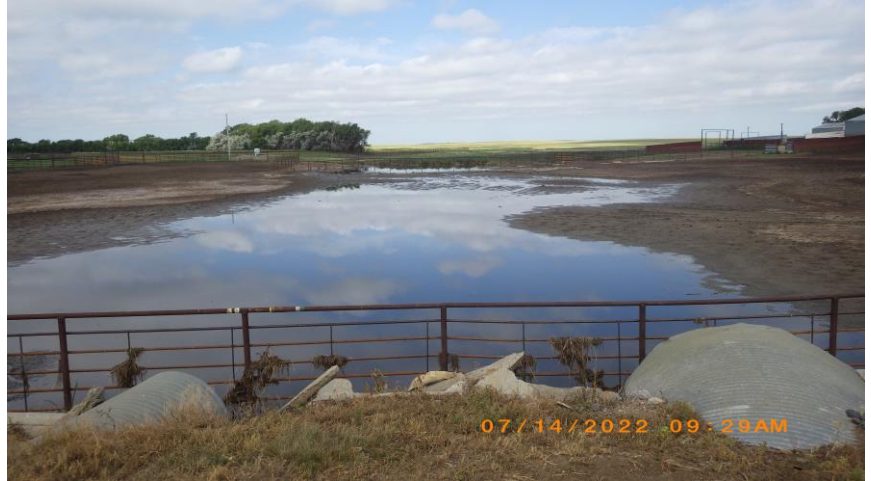
Photo number 136 taken by Stephanie Meyers on 7/14/2022.

**Finding #2: There were unauthorized discharges of wastewater to High Bank Creek.**

There were unauthorized discharges of wastewater from the yearling pens to High Bank Creek due to the location of the yearling pens in close proximity to High Bank Creek, the slope of the yearling pens towards High Bank Creek and the rainfall in the area. The yearling pens are located around and inside of High Bank Creek and contain manure (photos 136-138).

Overview of High Bank Creek with yearling pens on both sides of the creek. The GPS coordinates were 45.50857 N, -101.16221 W. Note this was on the west side of 248th Avenue. High Bank Creek flows to the east.

Ensure that wastewater from the yearling pens is not discharged to High Bank Creek. Provide the EPA and the Tribe with a description of the corrective actions taken to address this finding.

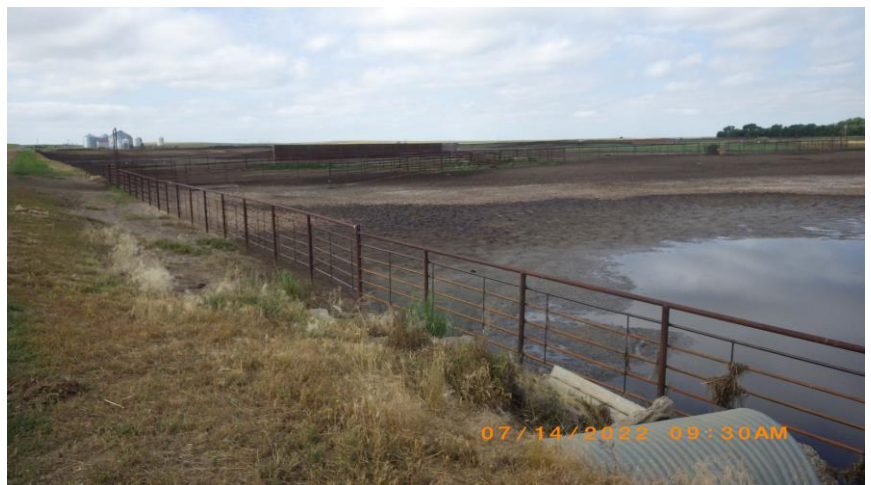
Photo number 137 taken by Stephanie Meyers on 7/14/2022.

Overview of High Bank Creek with yearling pens on the south side of the creek. Note this was on the west side of 248th Avenue. High Bank Creek flows to the east.

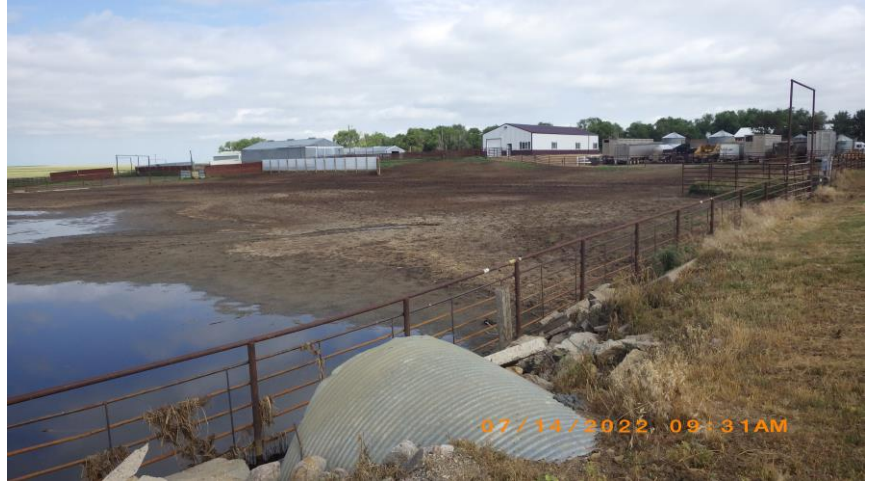
Photo number 138 taken by Stephanie Meyers on 7/14/2022.

Overview of High Bank Creek with yearling pens on the north side of the creek. Note this was on the west side of 248th Avenue. High Bank Creek flows to the east.

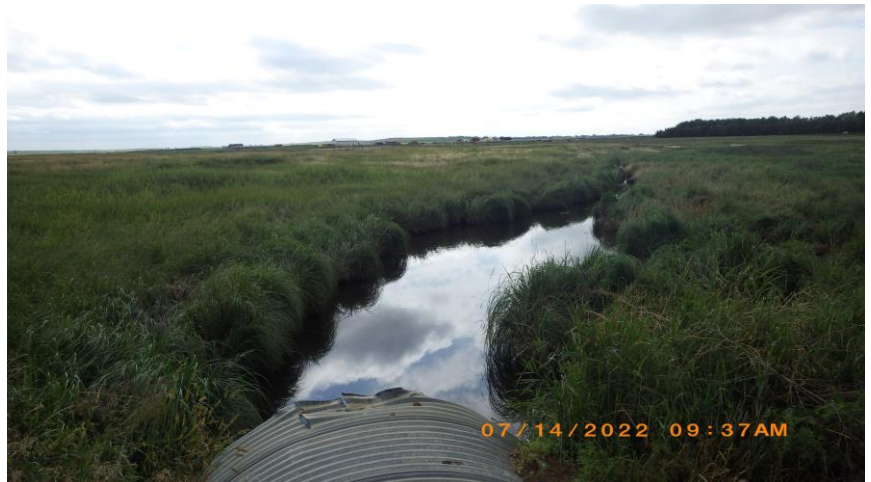
Photo number 139 taken by Stephanie Meyers on 7/14/2022.

Overview of High Bank Creek. Note this was on the east side of 248th Avenue. High Bank Creek flows to the east.
