**Municipality/Organization:** City of Malden  
**EPA NPDES Permit Number:** MA041046  
**MADEP Transmittal Number:** 041088  
**Annual Report Number  
& Reporting Period:** No. 1: April 1, 2010-March 31, 2011

## NPDES PII Small MS4 General Permit Annual Report

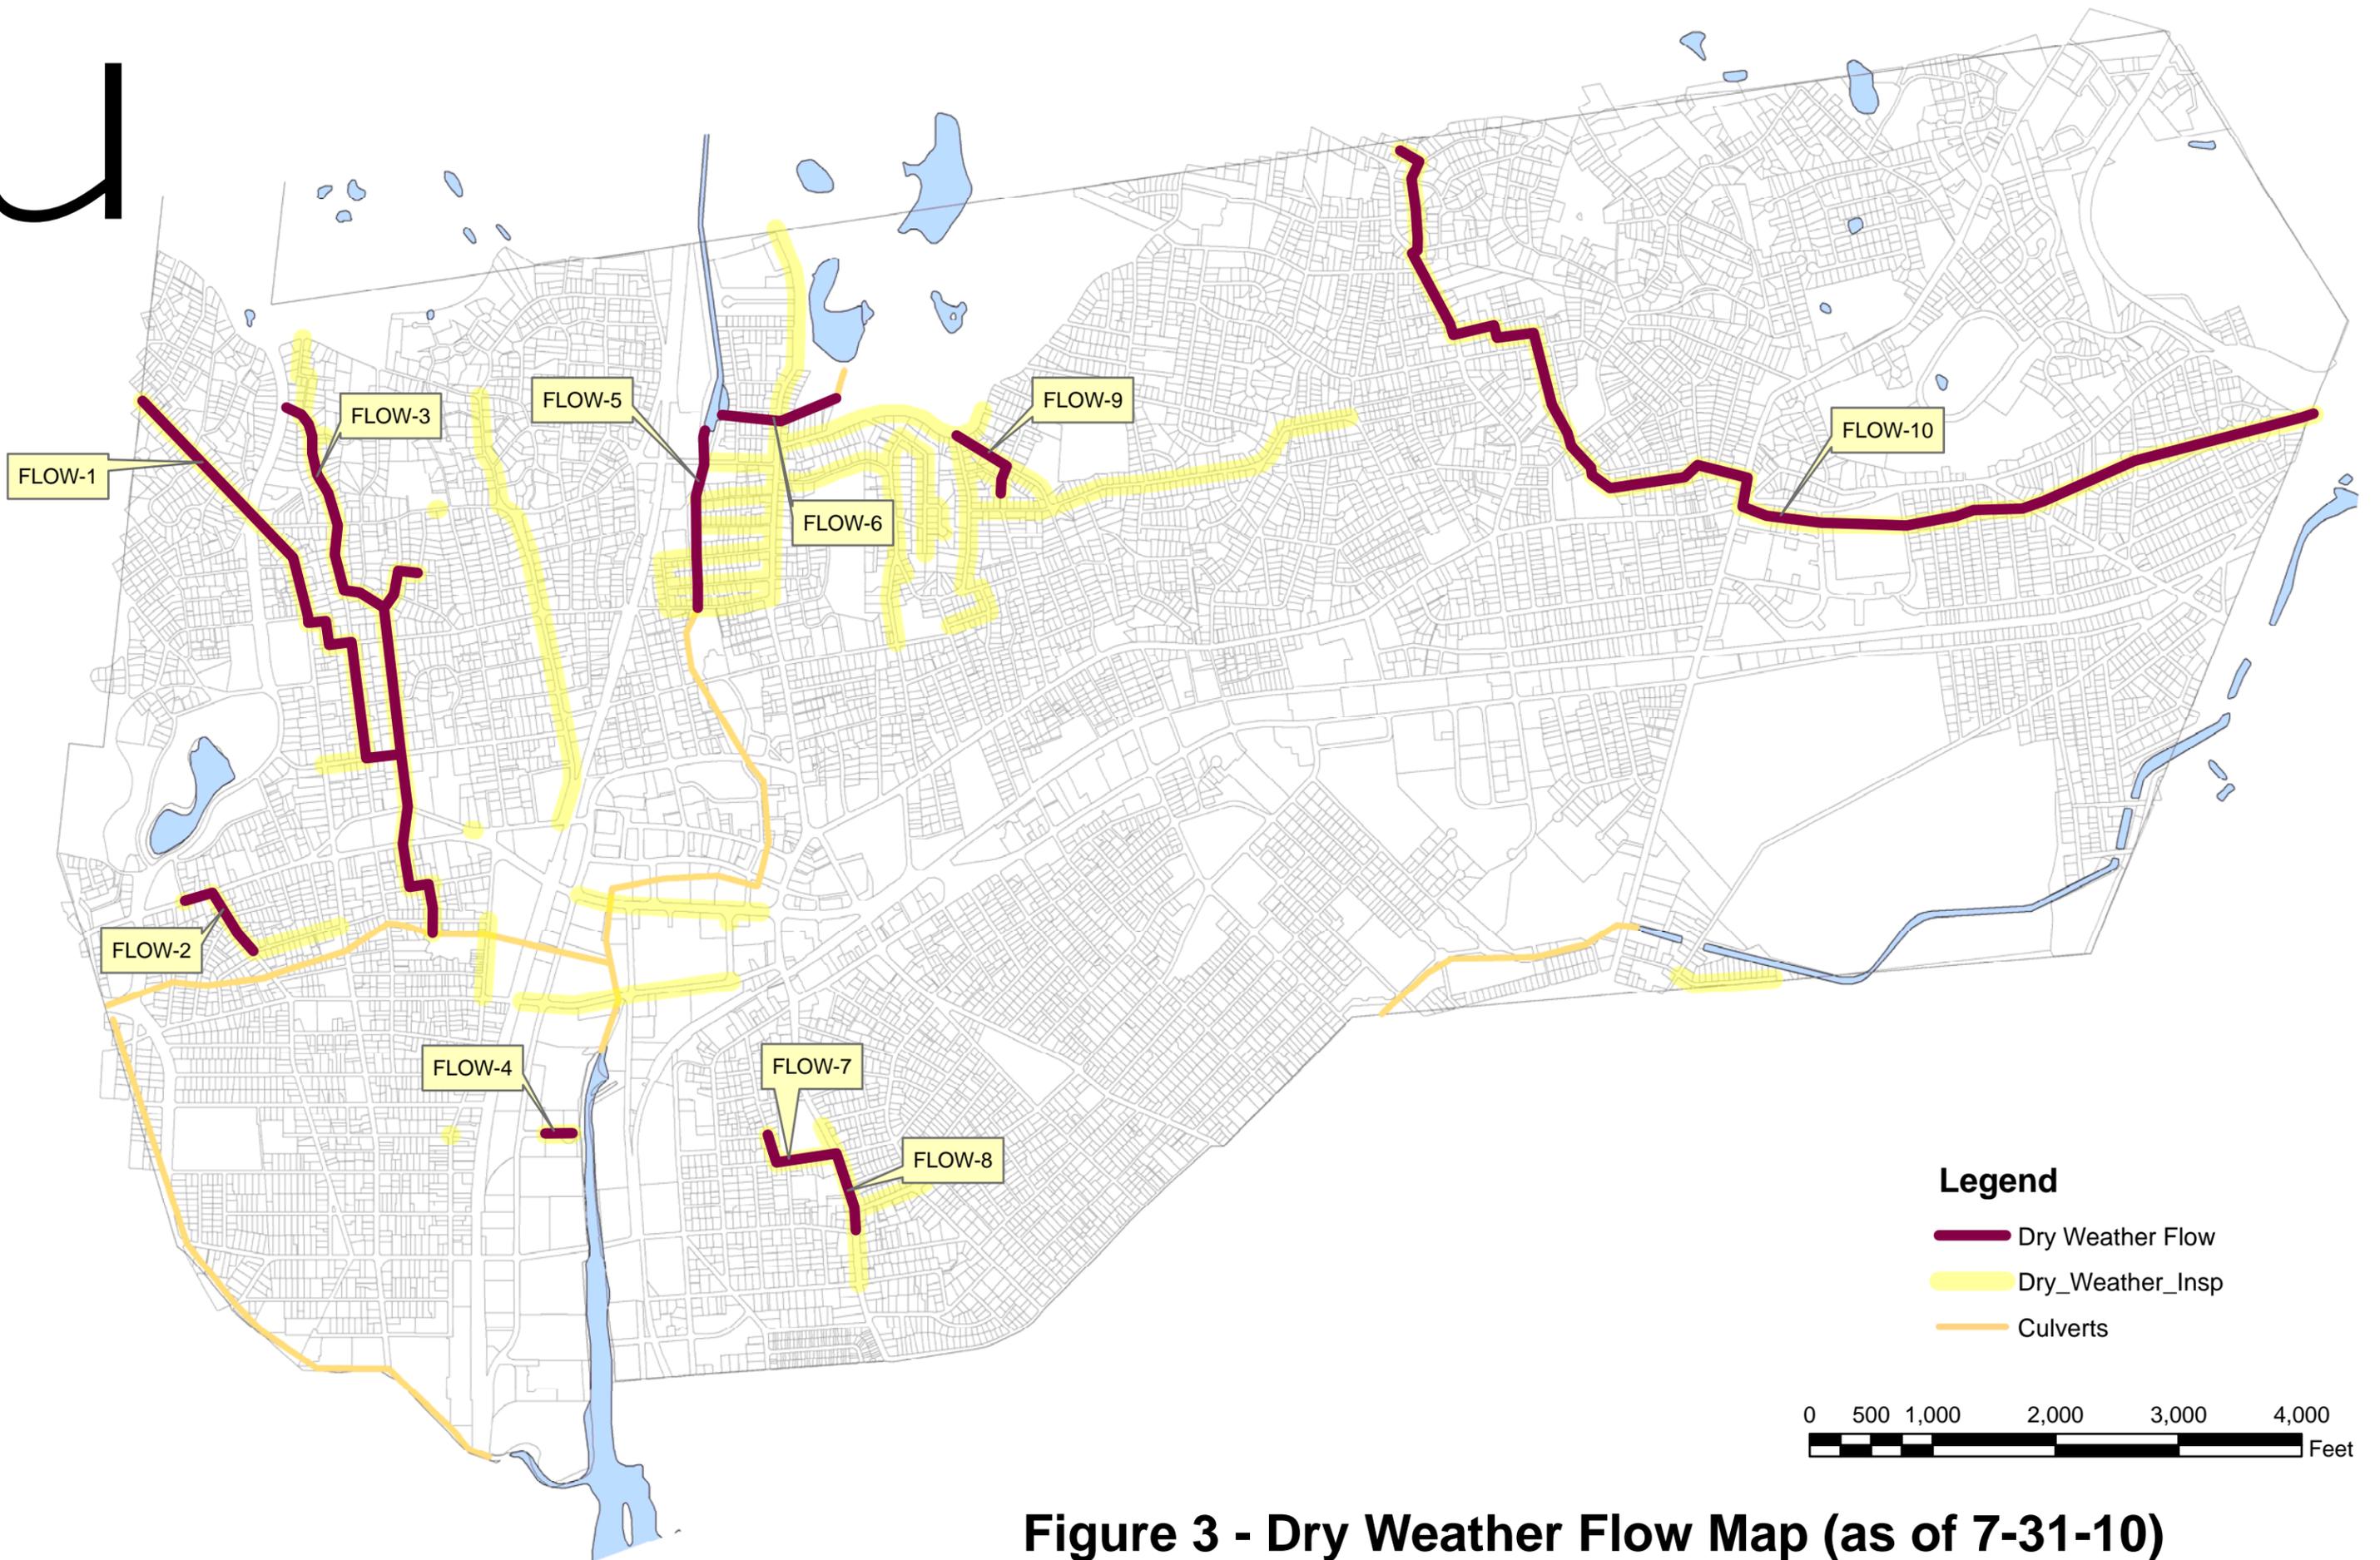
Figure 3 - Dry Weather Flow Map (as of 7-31-10)

weather flows, consisting primarily of waterline leaks and culverted surface waters have been identified. A summary of these dry weather flows within the municipal system that have been identified to date is provided on Figure 3, and are described as follows.

- Flow 1 – City of Medford water line leak (removed).
- Flow 2 – Groundwater breakout near St. Mary’s Street
- Flow 3 – Fellsmere Reservation base flow
- Flow 4 – Malden River surcharge (submerged invert)
- Flow 5 – DCR Spot Pond Brook base flow
- Flow 6 – Base flow, Forestdale-Pine Banks Park
- Flow 7 – Groundwater breakout, illicit discharge (removed 8/09), Flow 8
- Flow 8 – Waterline Leak (under investigation)
- Flow 9 – Groundwater breakout
- Flow 10 – Linden Brook base flow

As shown, with the exception of water line leaks (Flow 1, Flow 8) and the illicit discharge that contributed to Flow 7, the remaining dry weather flows have been determined to be either base flow from culverted surface waters, or groundwater breakout from higher elevations. No illicit discharges were identified within this portion study area during this reporting period during either the targeted or routine (Section 3.2) inspection program.

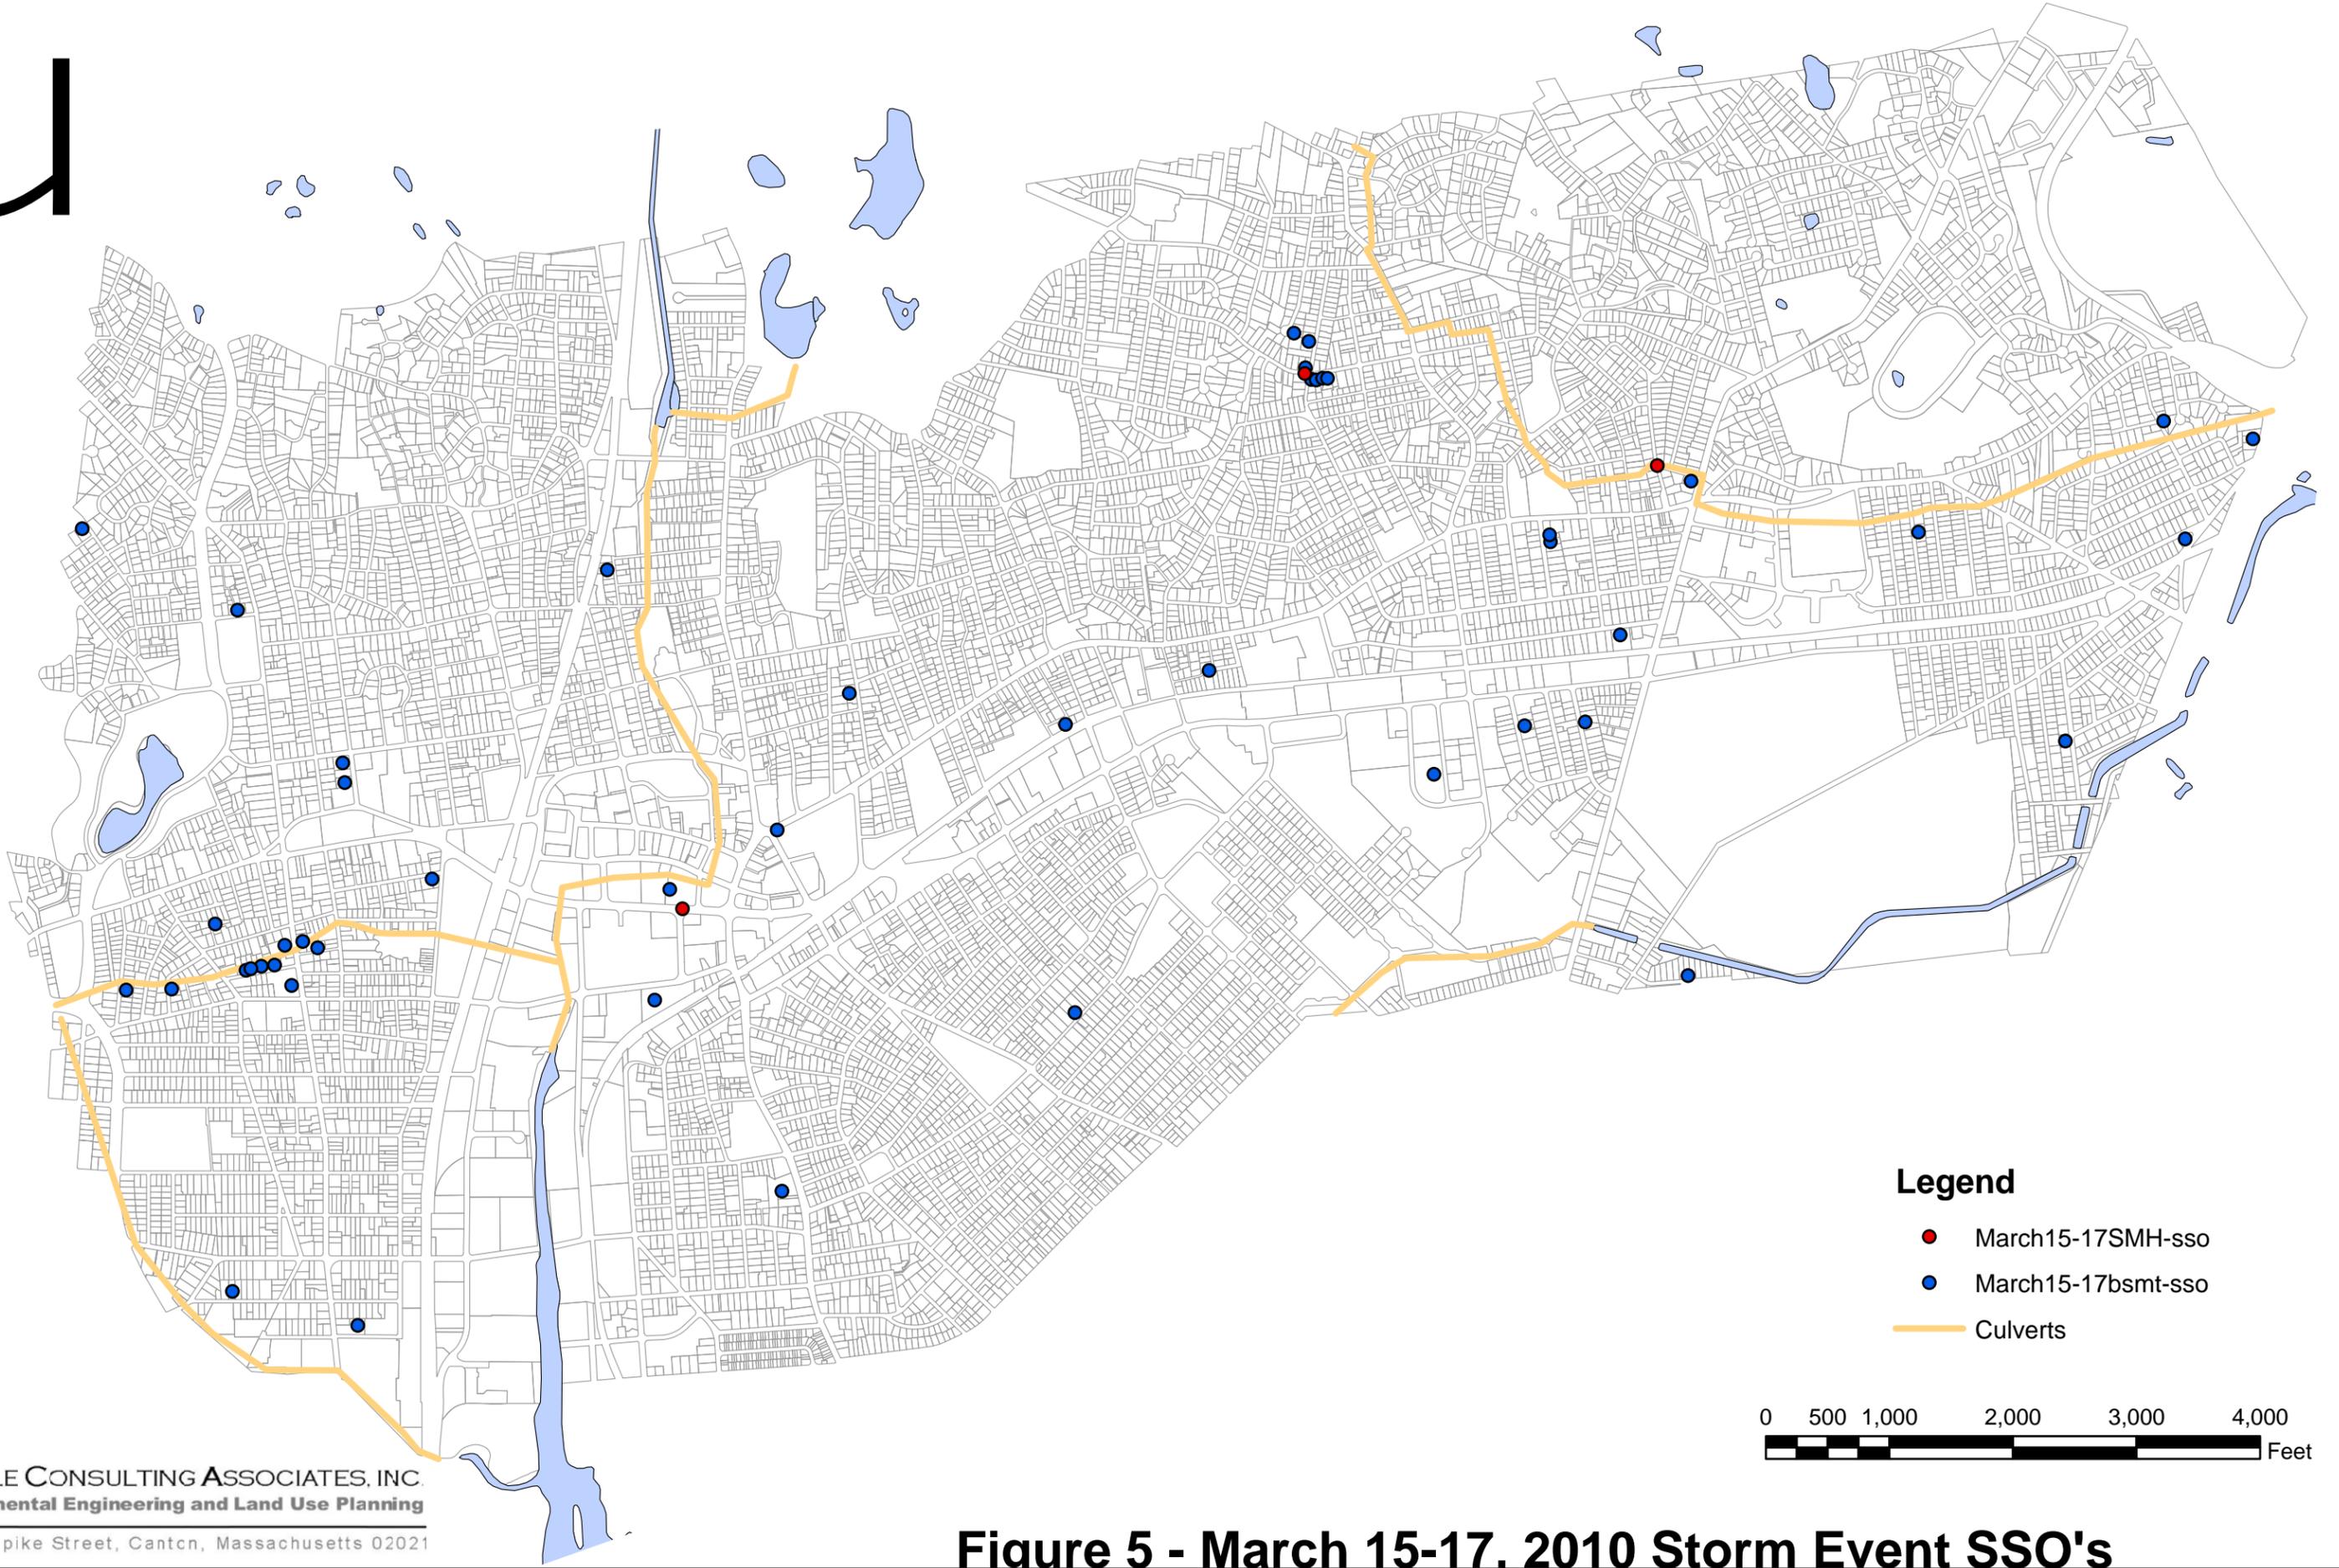
**Figure 5 - March 15-17, 2010 Storm Event SSO's**

approximate location of basement and sewer manholes where SSO's occurred during the initial storm event that began in mid-March is presented as Figure 5. As shown, numerous SSO's occurred throughout the City, with the highest density of SSO's occurring in central western portions of the City proximate to the West End/Edgeworth Culvert. Previous inspections in this area have revealed that portions of this culvert have exposed earthen walls and pervious wooden bottoms. Accordingly, it is expected that significant exfiltration of culverted flows contributed to the basement flooding/SSO condition. Conversely, the infiltration of bacteria laden groundwater was likely discharged to the Malden during wet weather conditions. Easterly portions of the culvert have been replaced and the results of the inspection program serve to support CIP recommendations to be considered during the next fiscal planning process.

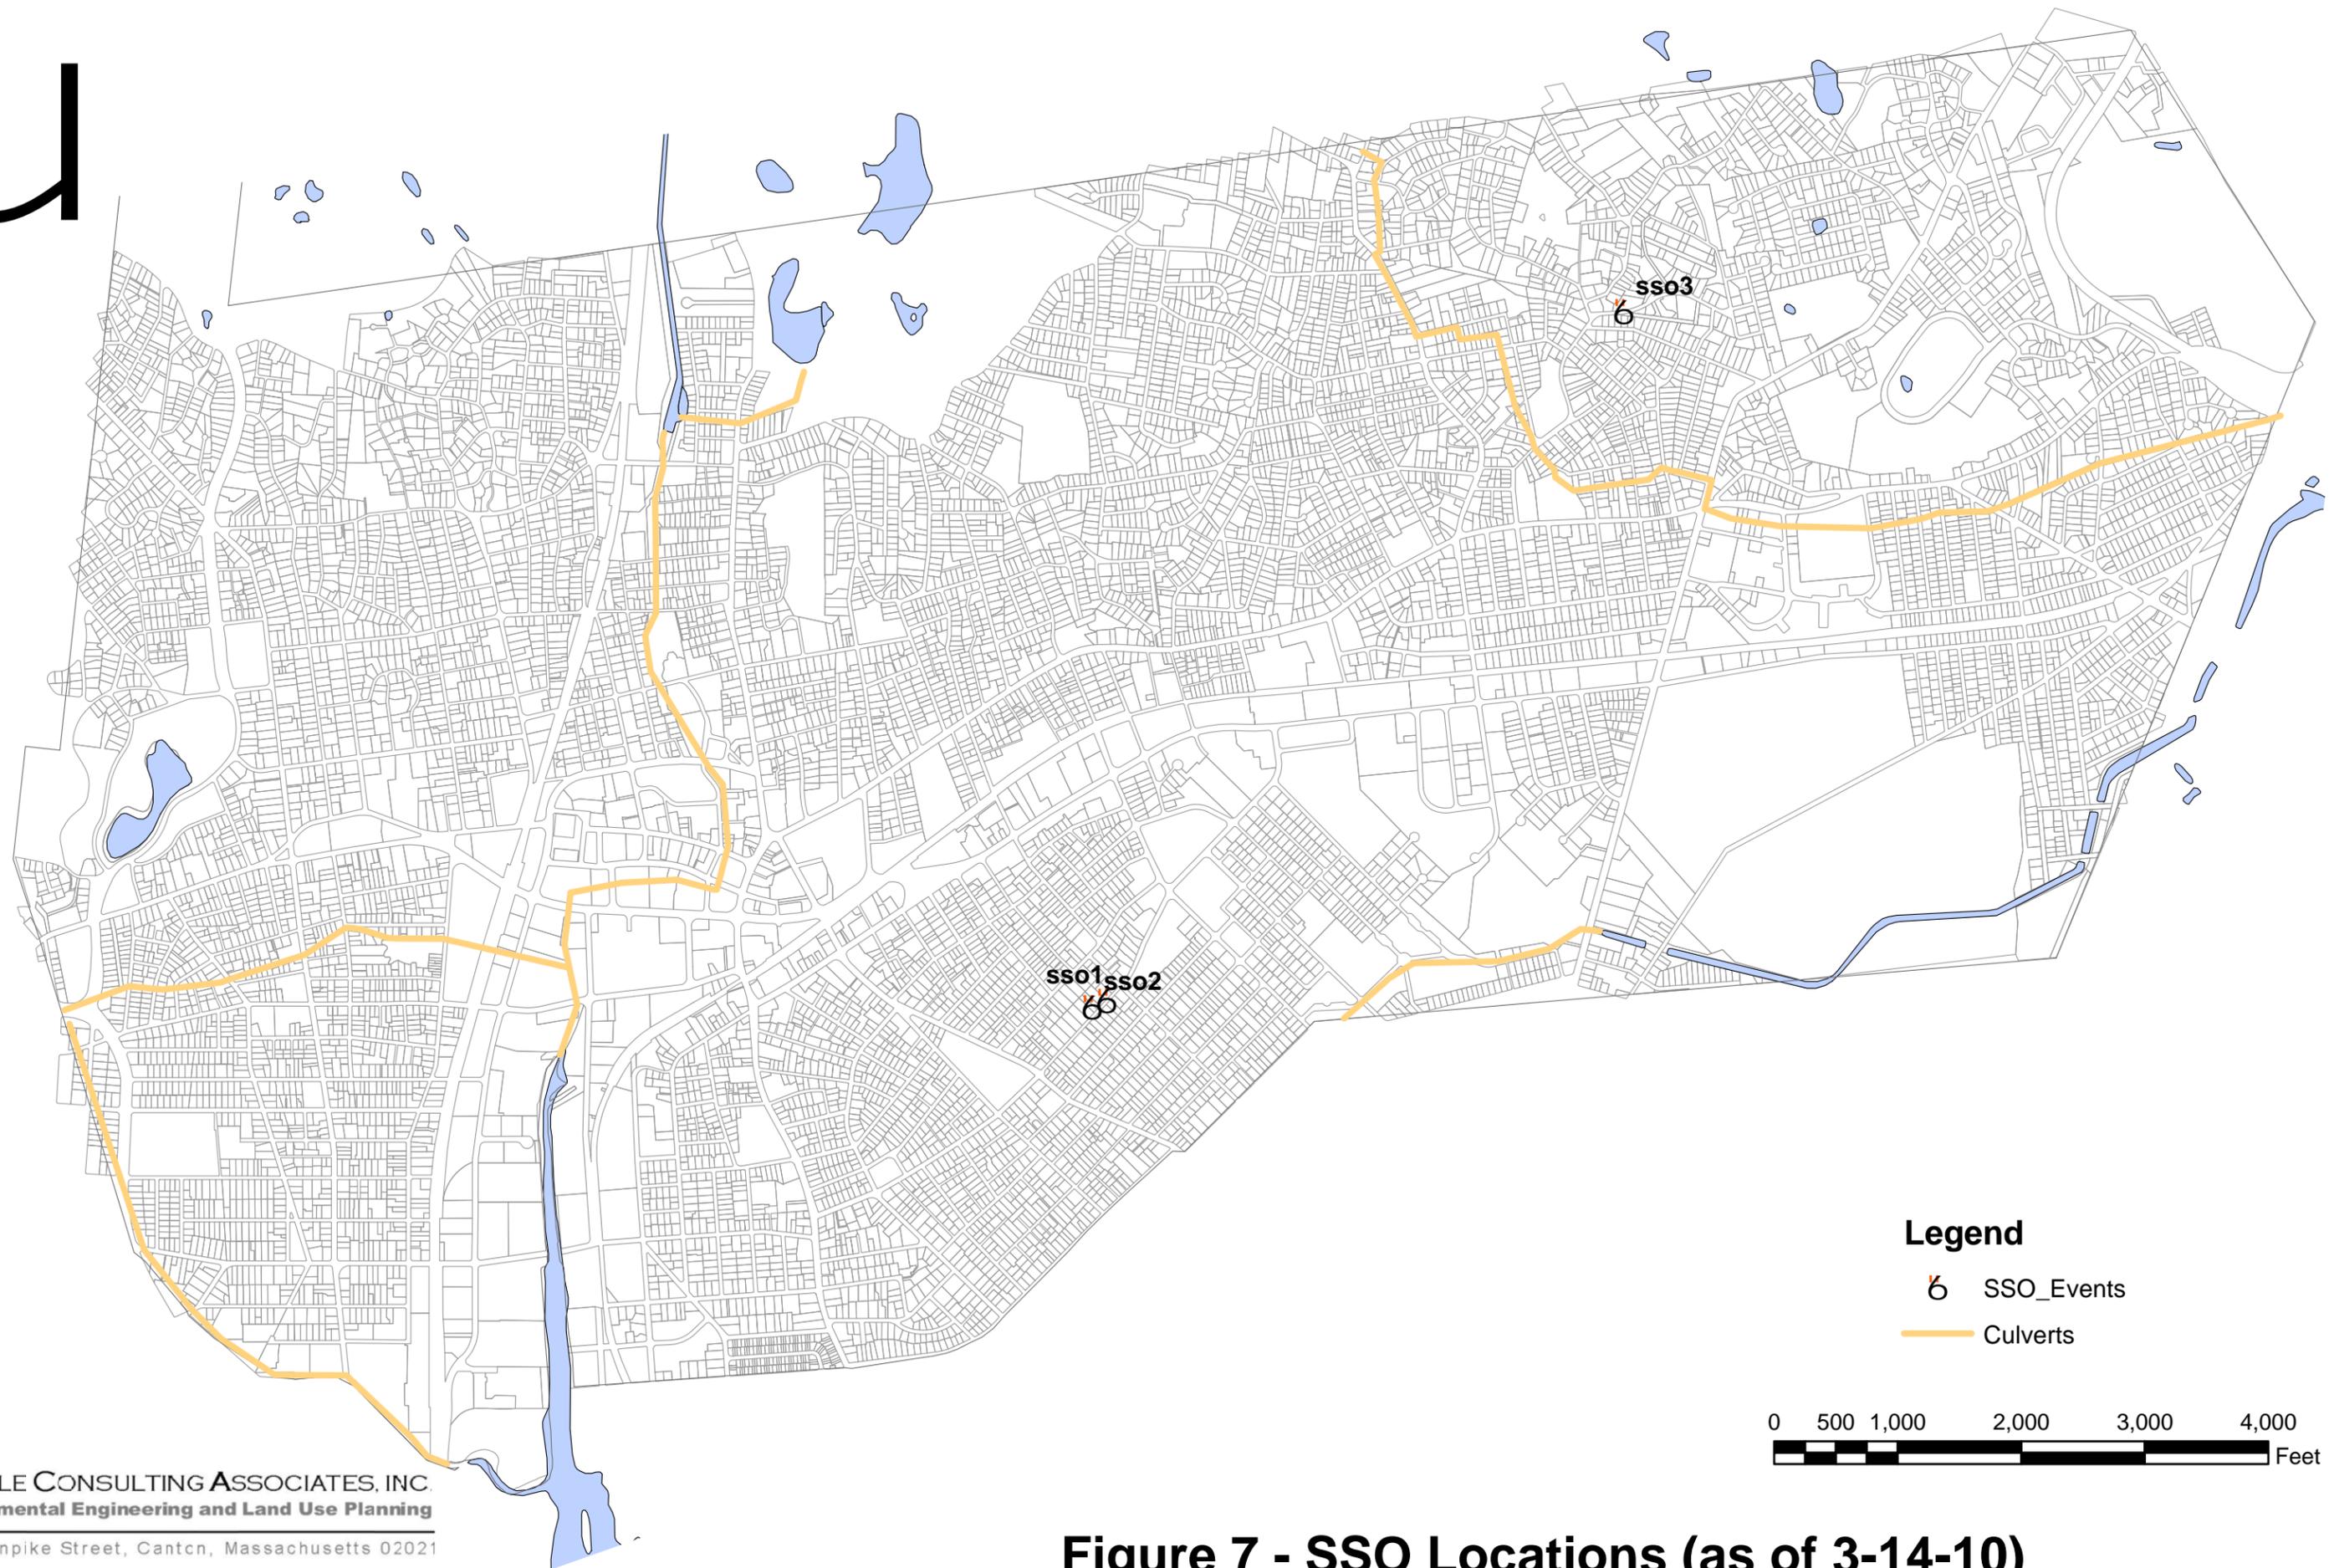
**Figure 7 - SSO Locations (as of 3-14-10)**

A second storm event began on 29 March 2010 and the City was notified by the MWRA that previously sealed bypass structures to the Malden River would be opened to mitigate the potential for surcharging within the City. Significant volumes (5-10 million gallons) of waste water were also discharged by the MWRA during this storm event within downstream portions of the system to prevent treatment system damage and mitigate up stream SSO's. As evidence from a review of Figure 6 as compared to Figure 5, a significantly less number of occurrences were reported following the second storm event, which may be due in part to the relief in downstream flow due to emergency measures taken by the MWRA. A listing of all of the SSO locations that was included within the City's notification to USEPA is included within Appendix B of this report. Other than the two storm events described above, no additional SSO's have been identified during this reporting period. A map depicting the location of all prior SSO's that have been identified to date is presented as Figure 7.

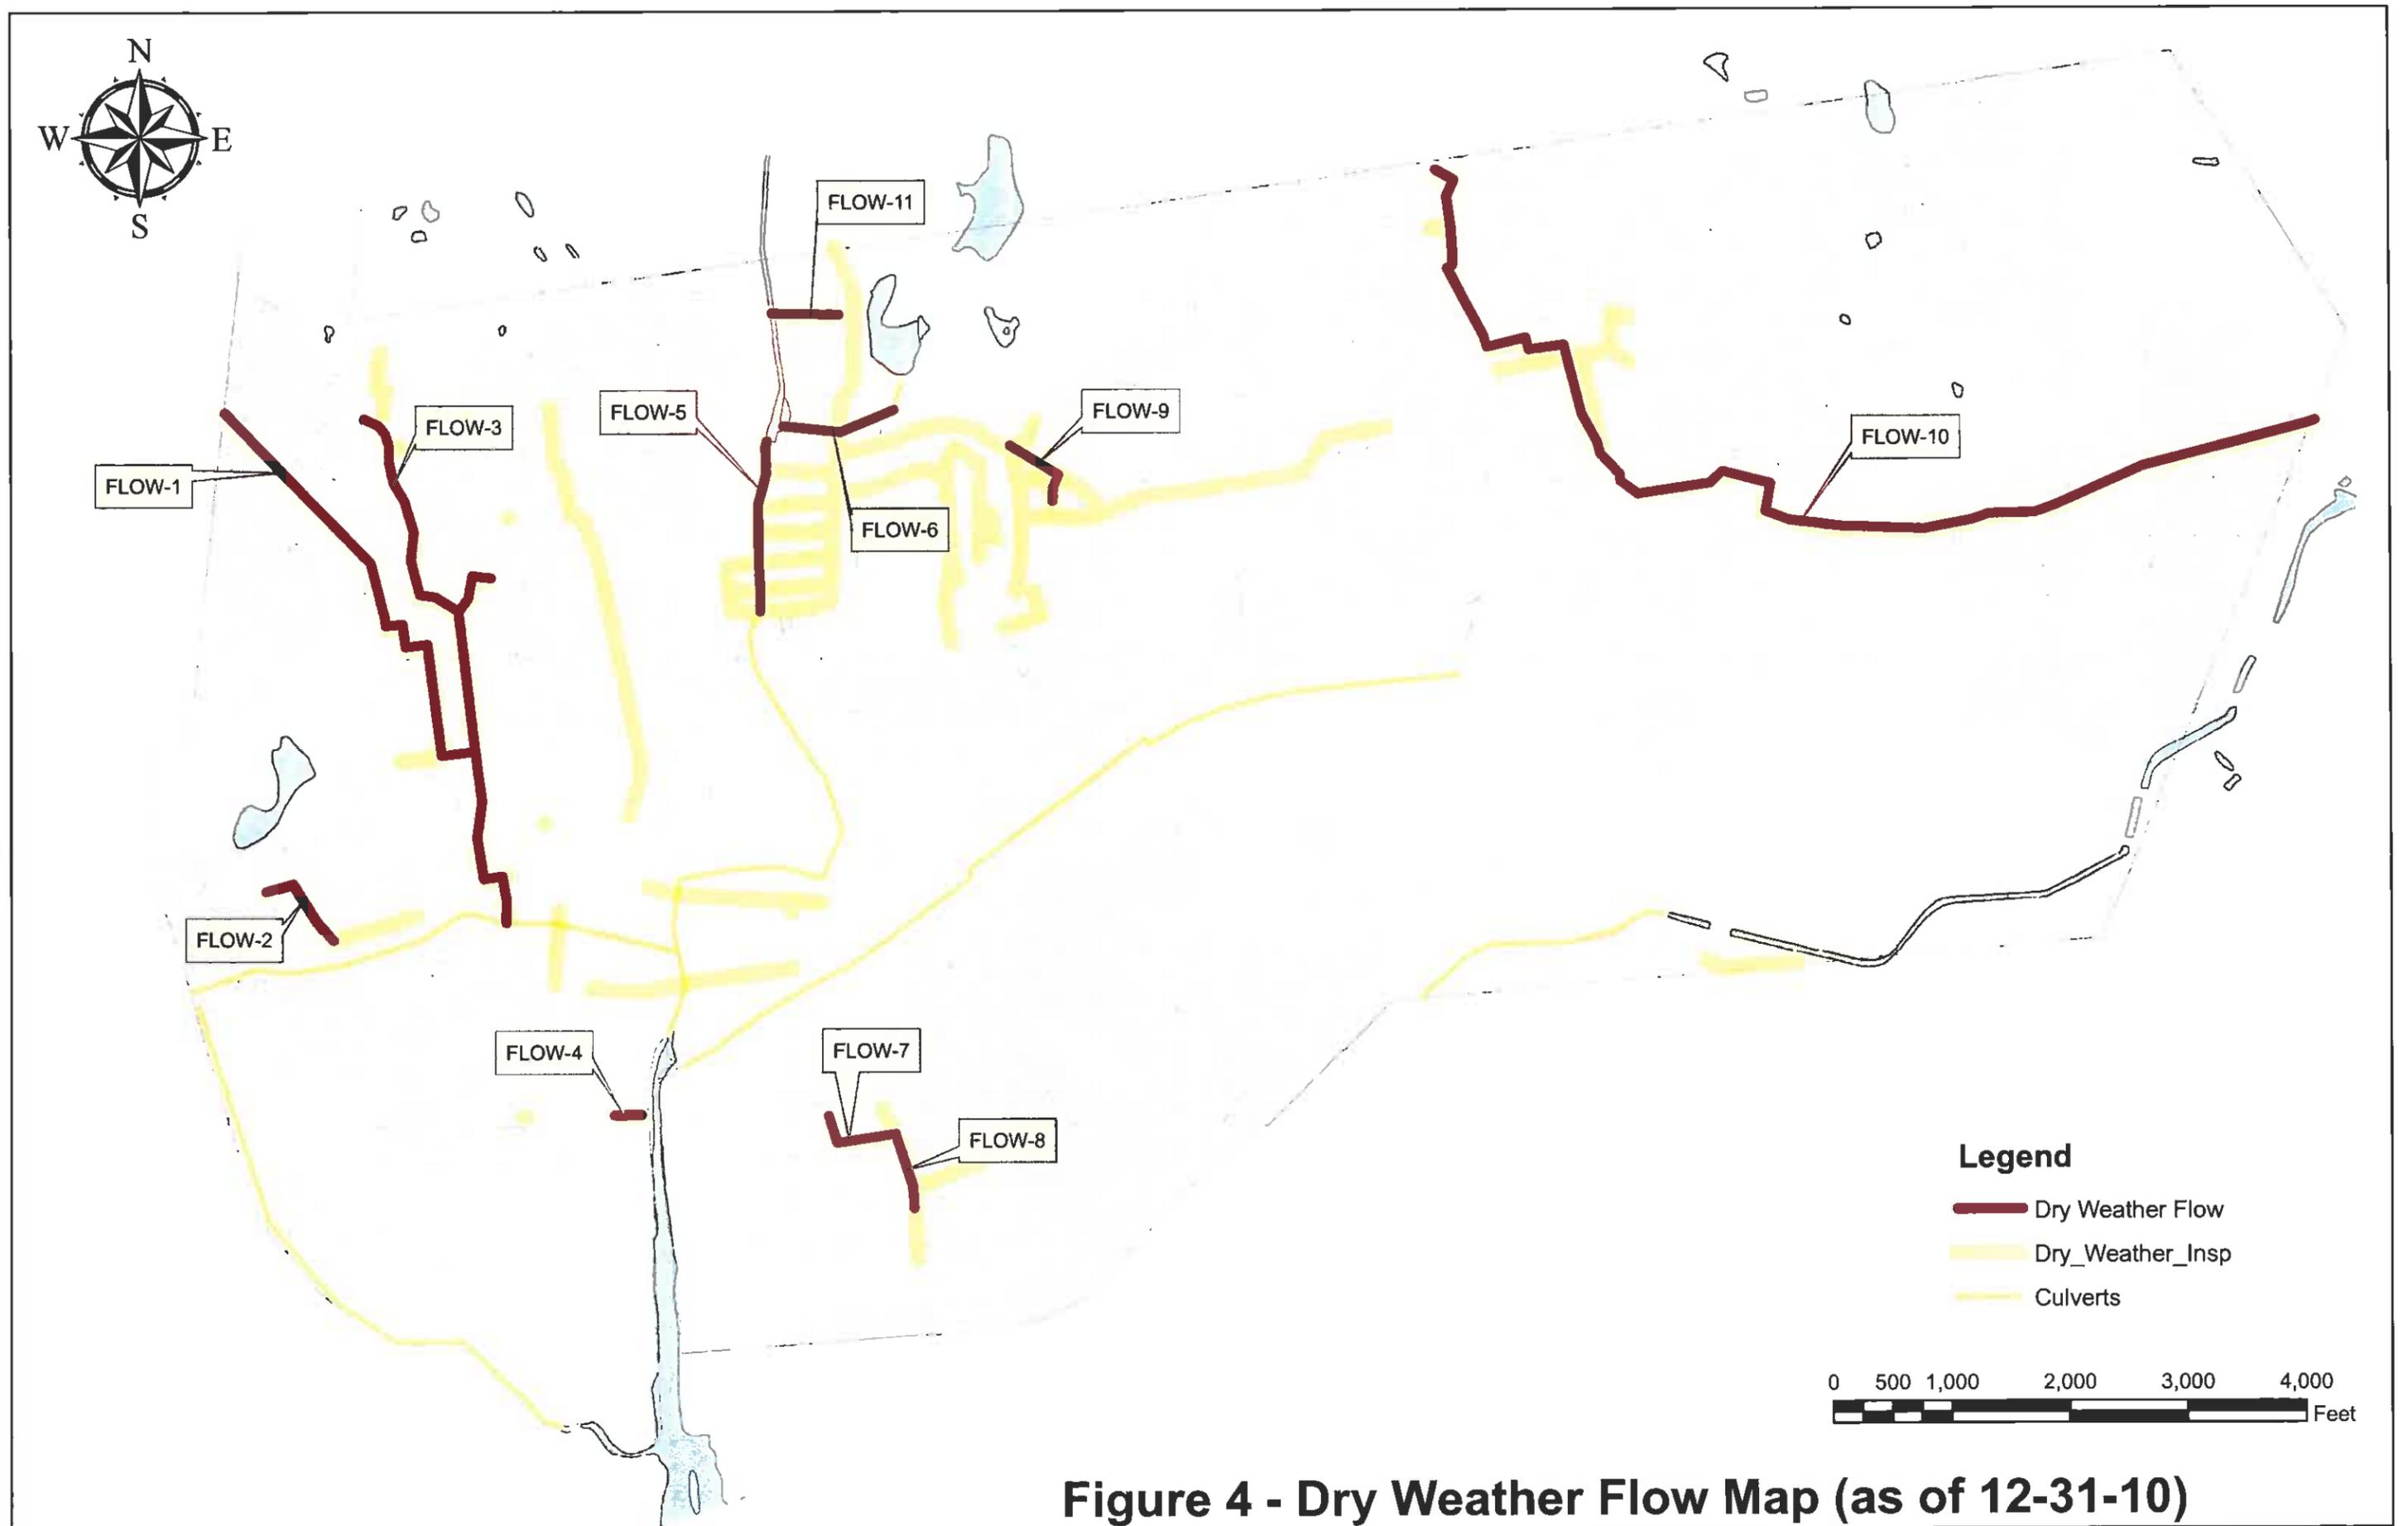
**Figure 4 - Dry Weather Flow Map (as of 12-31-10)**

During the course of the dry weather inspections, a number of dry weather flows, consisting primarily of waterline leaks and culverted surface waters have been identified. A summary of these flows within the municipal system that have been identified to date are shown on Figure 4, and are described as follows.

- Flow 1 – City of Medford water line leak (**removed**)
- Flow 2 – Groundwater breakout near St. Mary's Street
- Flow 3 – Fellsmere Reservation base flow
- Flow 4 – Malden River surcharge (submerged invert)
- Flow 5 – DCR Spot Pond Brook base flow
- Flow 6 – Base flow, Forestdale-Pine Banks Park
- Flow 7 – Groundwater breakout, illicit discharge (**removed 8/09**)
- Flow 8 – Waterline Leak (under investigation)
- Flow 9 – Groundwater breakout
- Flow 10 – Linden Brook base flow
- Flow 11 – LSP-4 dry weather flow

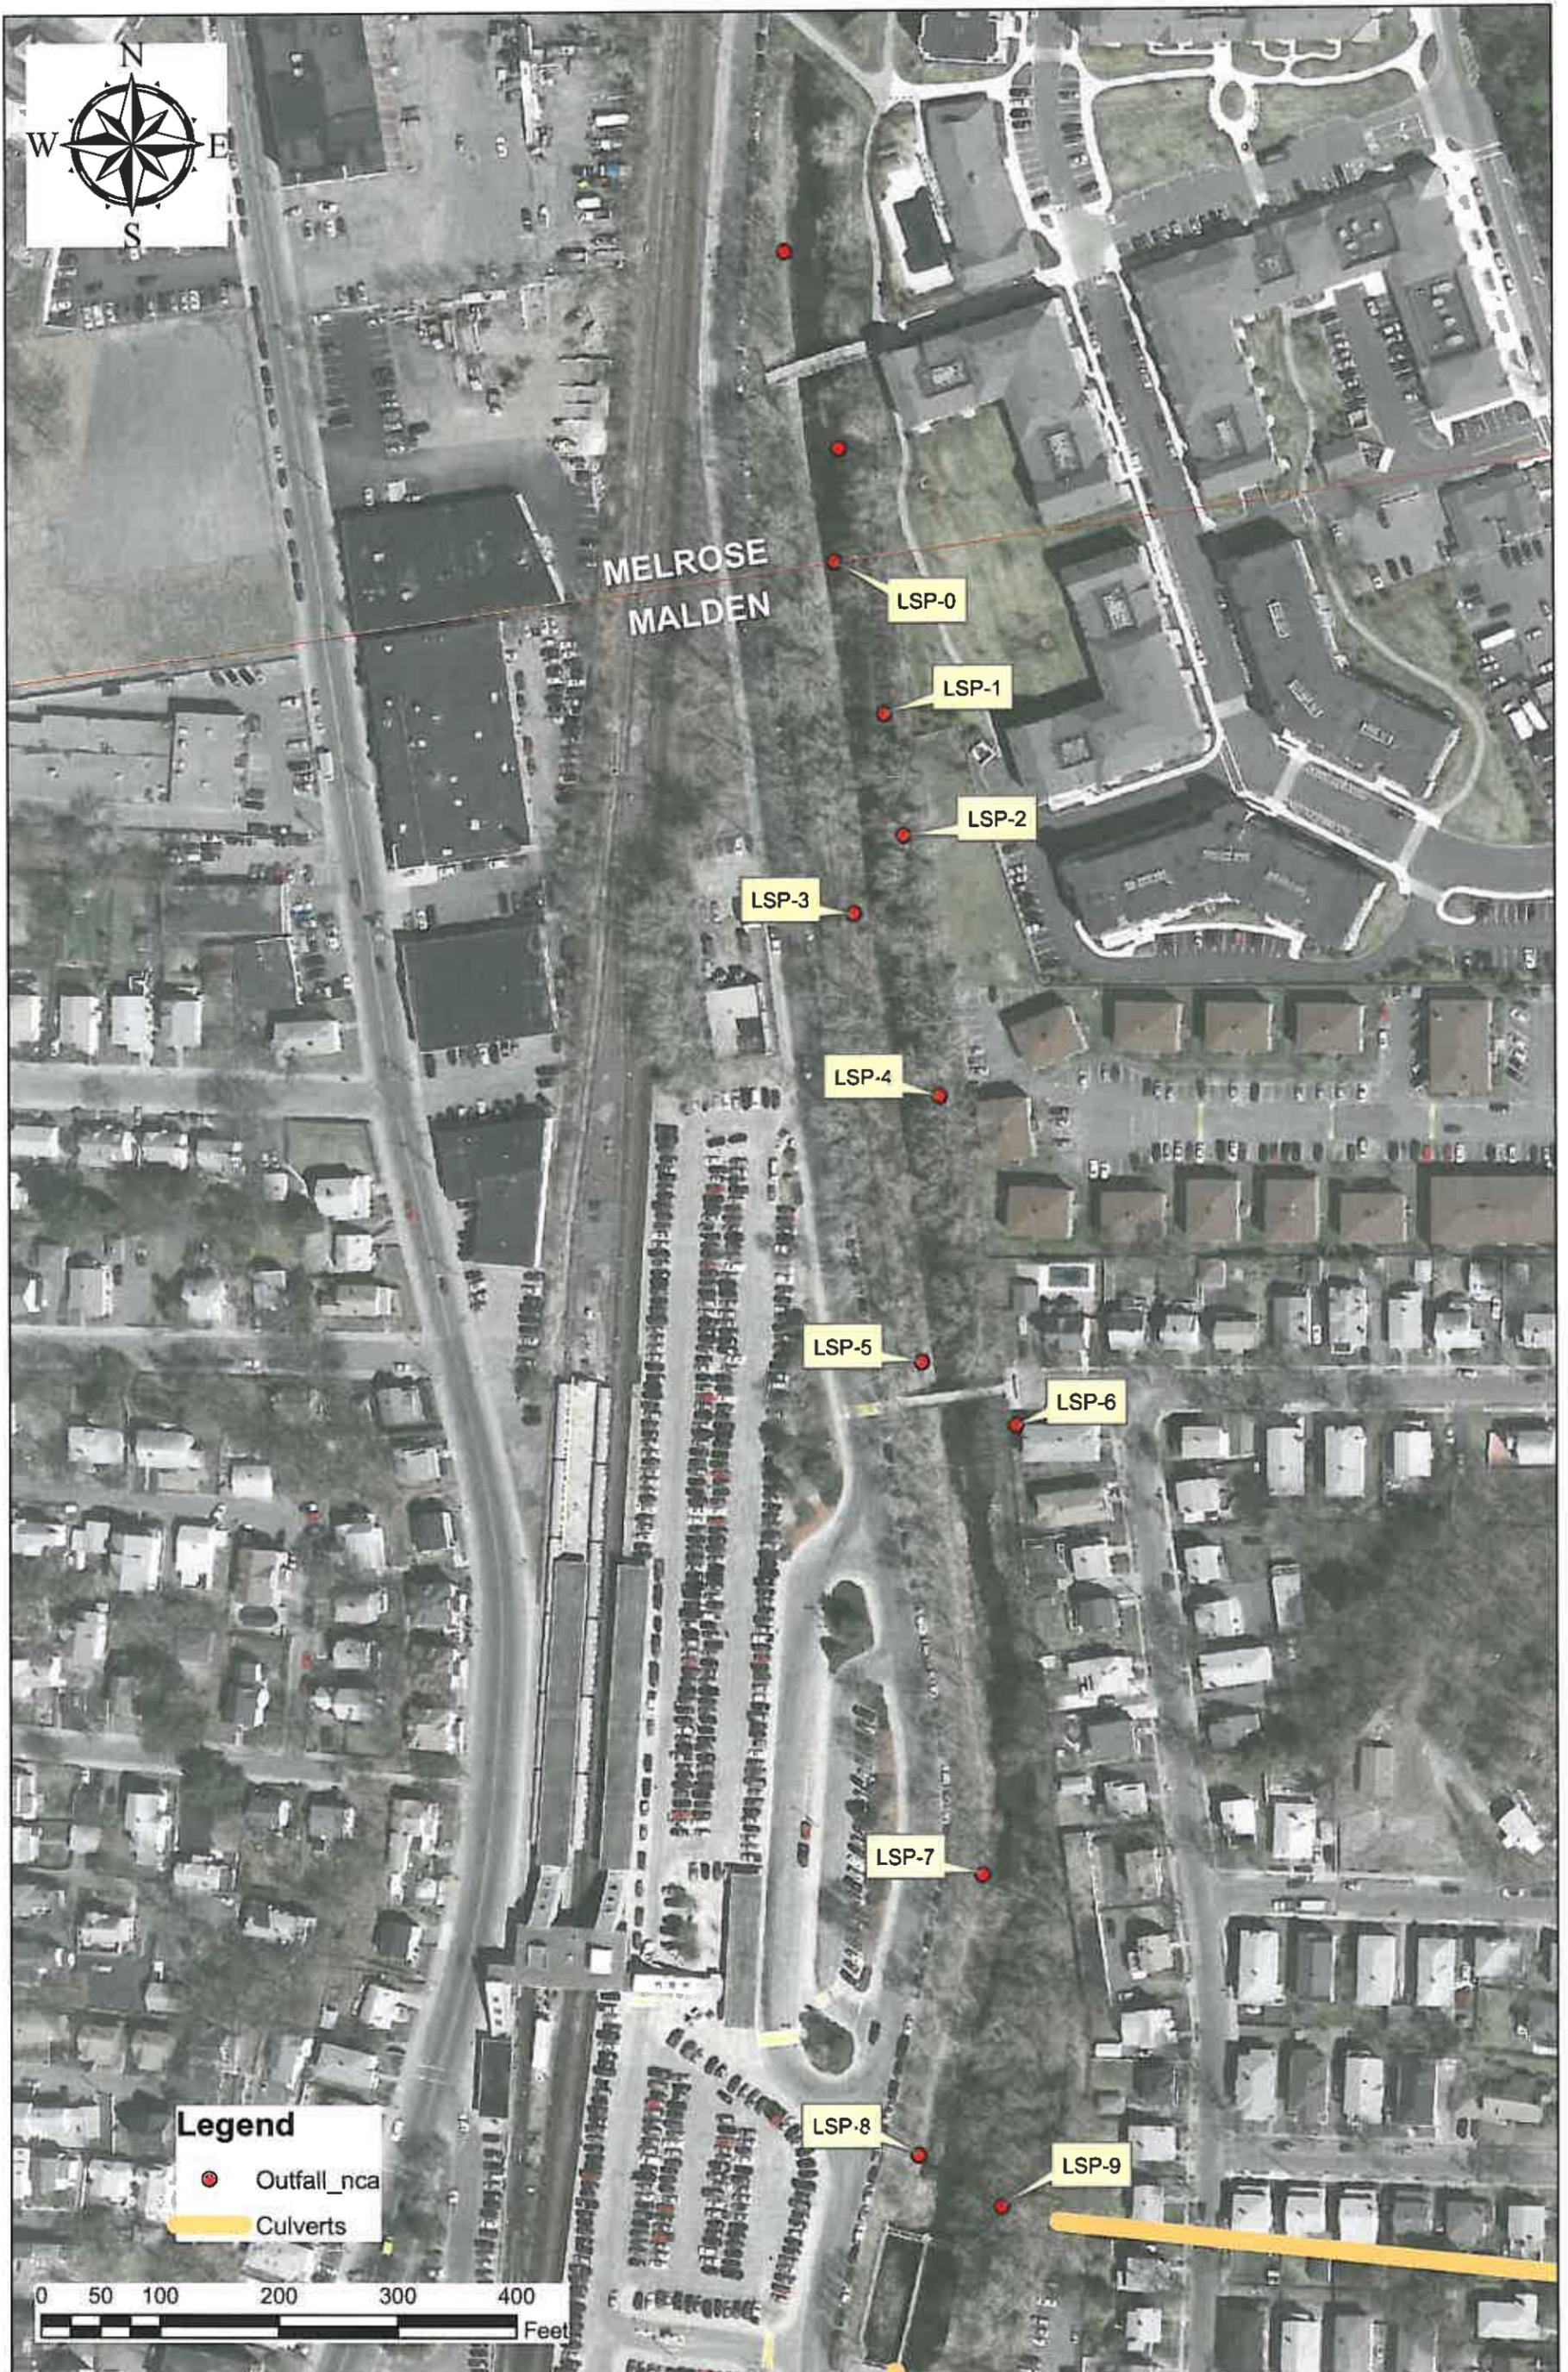
**Figure 5 - Lower Spot Pond Brook Outfalls**

During the 14 August dry weather sample event, an elevated E. coli level (14,000 col/100ml) was also identified at outfall LSP-4, which is located approximately 462 feet downstream of the Malden/Melrose sample location (Figure 5). A targeted investigation of this condition was performed by NCA/DPW personnel, which revealed that a portion of this flow appeared to be emanating from a housing complex located on Elrich Drive. An inspection of the drainage system within the housing complex revealed dry weather flow and water quality samples collected from upgradient drain manholes M3-MH2 and M3-MH4 revealed E. coli levels of 98 and 2,400 col/100ml, respectively. It is to be noted that M3-MH4 is the closest to LSP-4 and based upon field observations, M3-MH2 is the upstream most manhole of the housing complex drainage network. Based upon the volumes of flow at outfall LSP-4 and the upstream sample location (M3-MH2) within the Elrich Drive complex, it appeared that additional contributions were occurring between these two sampling points, however, a detailed assessment of the drainage system by NCA/DPW did not identify any additional dry weather flows. However, during the assessment of this condition, several drain manholes and catch basins were discovered within the housing complex in close proximity to sewer lines. Further investigations will be performed in the spring of 2011 in an attempt to isolate potential dry weather flows. As indicated on Table 2.0, a subsequent sampling of LSP-4 on 31 August revealed a significant decrease in E. coli levels (2,000 col/100ml)
