Municipality/Organization: Town of Blackstone

Annual Report Number & Reporting Period: Year 14  
April 1, 2016 – March 31, 2017

## NPDES PII Small MS4 General Permit Annual Report (Due: May 1, 2017)

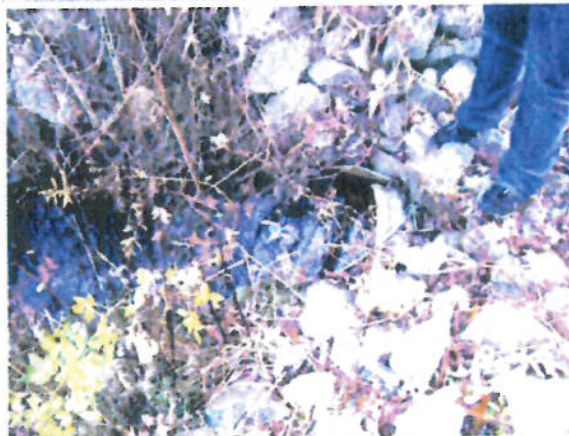
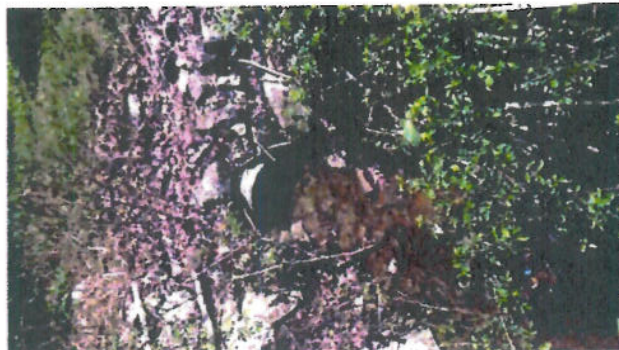
Photo Name: OF\_002RathburnSt2011-14-11.JPG

**Outfall 2:** This outfall, located at the end of Rathburn Street, is situated behind a municipal pumphouse. It is a circular 12-inch concrete outfall that discharges to a wooded/wetland area. This outfall was added to the "High Priority" list in 2014 due to the presence of what appeared to be biological growth adhered to the rocky bottom of the waterway. The outfall was inspected on 5/11/16. A biological sheen as well as iron staining and adhered growth was visible in the waterway. Because of the obvious presence of dissolved iron in the waterway, as well as the fact that the sheen broke apart and did not flow back together immediately when disturbed, it is believed that the sheen is the result of the natural activity of iron consuming wetland bacteria such as *leptothrix discophora*, not an illicit discharge of petroleum. However, this outfall will remain on the "High Priority" list in an effort to monitor the effluent quality the outfall.

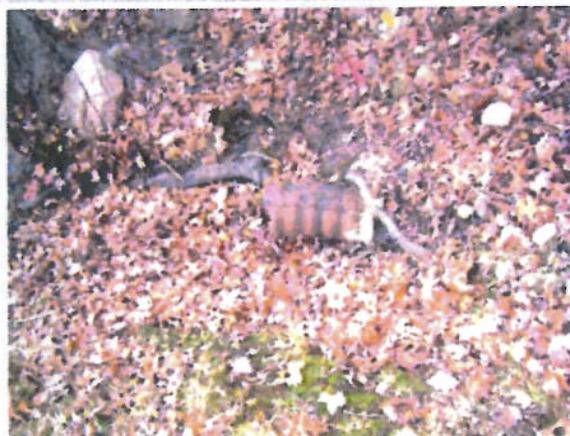
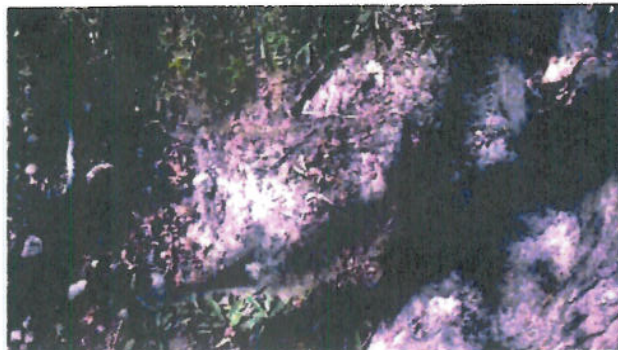
Photo Name: OF\_014EdgewaterDr2011-14-11.JPG

| <b>Outfall No.</b> | <b>Finding</b> | <b>Action Item</b> |
|---|---|---|
| 14 | Excessive washed out road sand; invert has rusted away. | Clear flow channel. Sweep roadway tributary area. Clean catch basin sumps, which may be washing out because they are full. In the long term, consider replacing the outfall pipe. |

Structural Damage: Squashed Laterally

~18 in of bottom (measured lengthwise into pipe) rotted out

Several of the outfalls in Table 1 (14, 49, and 84) appear to be nearing the end of their useful lives. The Town should consider a replacement program, prioritizing areas where pipe failure may damage other property or infrastructure. As is the nature of stormwater outfalls, a majority of these structures are located in wooded areas, along the banks of rivers or other bodies of water, and in other areas that are not easily accessible. A path to each outfall should be established and kept clear for ease of inspection and maintenance. In addition, each outfall should be inspected semi-annually for structural integrity and signs of illicit discharge. The town should develop and implement an outfall maintenance program to address structural issues identified during inspections. Maintenance of drainage manholes and catch basins should be included as part of this plan as rocks, sediment and other debris may damage or obstruct the outfalls. The town should also stencil or otherwise label all catch basins with a "no dumping" message. It may also be productive to post a permanent sign (with the outfall number) in the vicinity of each outfall to make them easier to locate for inspections and in the case of emergencies.

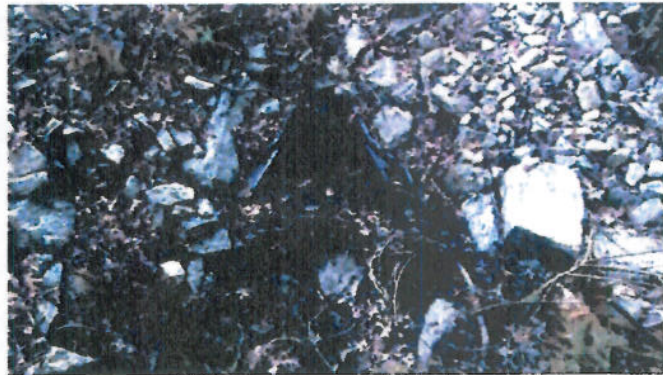
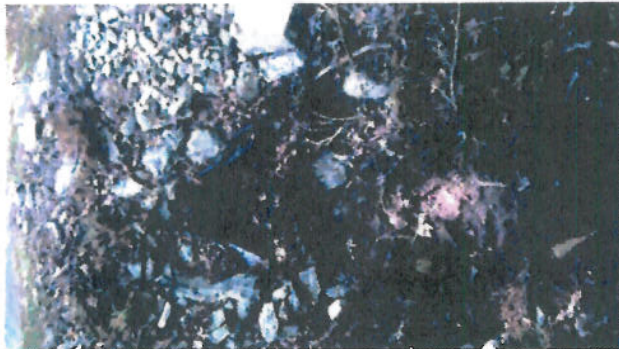
Photo Name: OF\_022New2016-05-25.jpg

**Revised Outfall 22:** Since the last period of inspections, a developer has undertaken work on Farm Street which led to the replacement and relocation of outfall 22. This revised outfall was noted as town owned by town personnel. The revised outfall 22 is a 12-inch corrugated plastic pipe on the west side of Farm Street. No flow or indicators of illicit discharges were noted during this inspection. The attached map has been revised to show the new location of outfall 22 (see Appendix B). AECOM has updated the information and location of outfall 22 in the GIS database. See Appendix A.

New

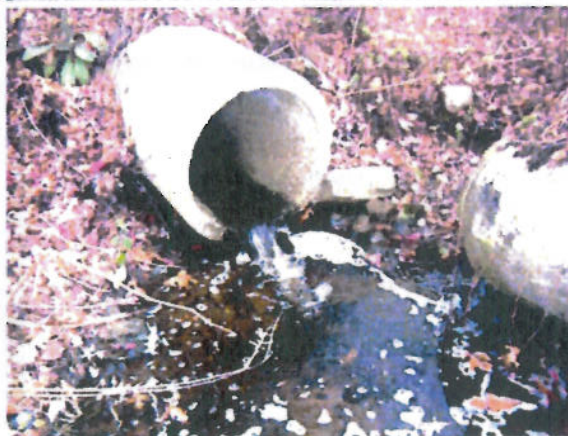
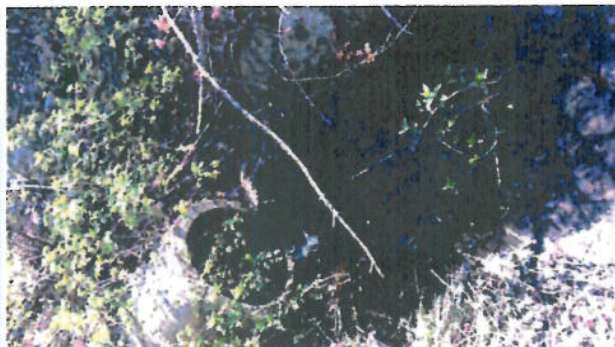
Photo Name: OF\_032SummerSt2011-14-11.JPG

**Outfall 32:** This circular, 30 inch concrete outfall is located on the south side of Summer Street. During the initial 11/14/11 inspection, dry weather flow and the presence of foam was noted. A follow up inspection was recommended to verify that the foam was not caused by illicit discharges of chemical surfactants. The follow up inspections in 2013 through 2016 showed the continued presence of flow and small amounts of foam. However, as noted in 2013 inspection report, it is not believed at this time that these are indicators of illicit discharges. The foam was not chemically perfumed, broke apart easily when disturbed, and generally appeared to be natural, biological foam which occurs when organic materials release compounds into water as they decompose. Additionally, outfall 32 is in a low lying area with some wetland characteristics. Dry weather flow and foam during the spring may be expected in such areas. AECOM recommends that town personnel continue to monitor this outfall during their regular operations. This outfall should remain on the "High Priority" list and be formally inspected again during the next round of annual outfall inspections. If the outfall at any time begins to show any signs of illicit discharges, its flow should be sampled and tested. If the sampling indicates an illicit discharge, the IDDE plan should be followed to eliminate the illicit discharge.

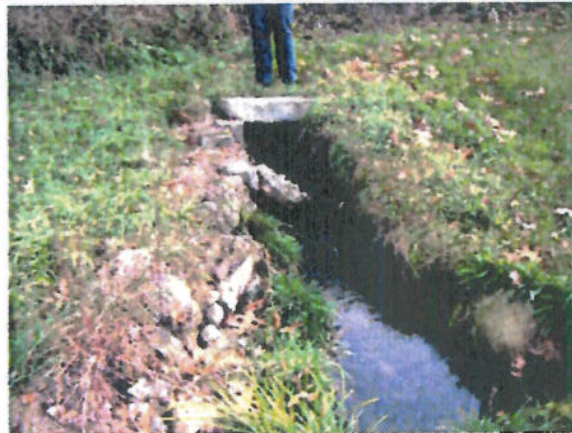
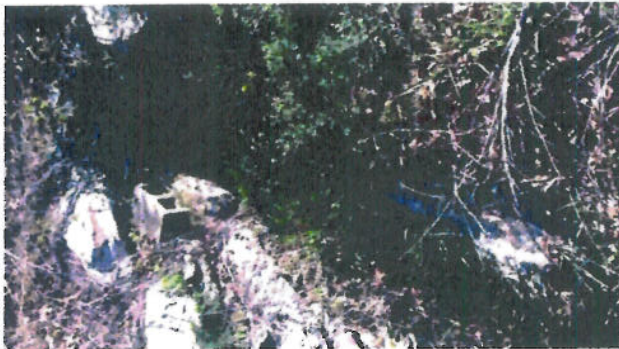
Photo Name: OF\_034\_1AFoxHillRoad2011-11-15.JPG

**Outfall 34:** This smooth plastic 24 inch outfall is located off Fox Hill Road. During the initial 11/15/11 inspection, dry weather flow and the presence of foam was noted. A follow up inspection was recommended to verify that the foam was not caused by illicit discharges of chemical surfactants. The follow up inspections in 2013 through 2016 showed the continued presence of flow and foam. However, as noted in the 2013 inspection report, it is not believed at

this time that these are indicators of illicit discharges. The foam was not chemically perfumed, broke apart easily when disturbed, and generally appeared to be natural, biological foam which occurs when organic materials release compounds into water as they decompose. Additionally, outfall 34 is in a low lying area with some wetland characteristics. Dry weather flow and foam during the spring may be expected in such areas. AECOM recommends that town personnel continue to monitor this outfall during their regular operations. This outfall should remain on the "High Priority" list and be formally inspected again during the next round of annual outfall inspections. If the outfall at any time begins to show any signs of illicit discharges, its flow should be sampled and tested. If the sampling indicates an illicit discharge, the IDDE plan should be followed to eliminate the illicit discharge.

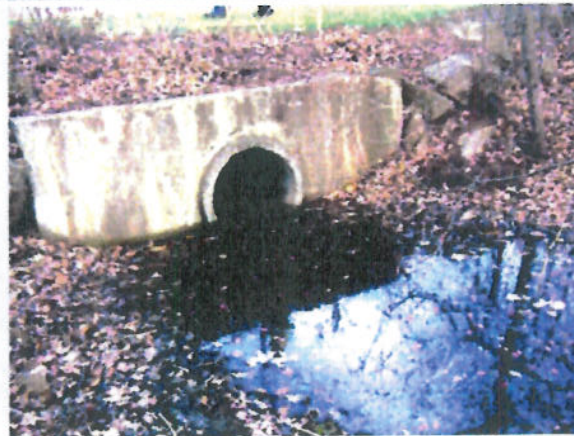
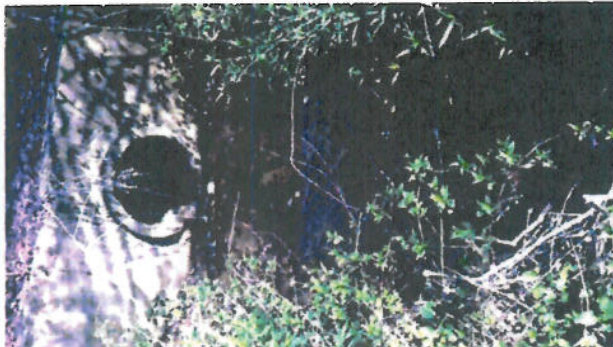
Photo Name: OF\_040\_7ACastagnaroLane(2)2011-11-15.JPG

**Outfall 40:** This circular 24 inch concrete outfall is located southeast of the cul-de-sac on Castagnaro Way. During the initial 11/15/11 inspection, dry weather flow and the presence of foam was noted. A follow up inspection was recommended to verify that the foam was not caused by illicit discharges of chemical surfactants. No foam was noted during the annual inspection on 4/22/13, but the outfall remained on the "High Priority" list and follow up inspections in 2014 through 2016 showed the presence of dry weather flow and small amounts of foam. It is not believed at this time that these are indicators of illicit discharges. The foam was not chemically perfumed, broke apart easily when disturbed, and generally appeared to be natural, biological foam which occurs when organic materials release compounds into water as they decompose. Additionally, outfall 34 is in a low lying area with some wetland characteristics. Dry weather flow and foam during the spring may be expected in such areas. No other signs of an illicit discharge were visible; AECOM recommends that this outfall remain on the "High Priority" list and that town personnel continue to monitor this outfall during their regular inspections. This outfall should be formally inspected again during the next annual round of outfall inspections. If the outfall at any time begins to show any signs of illicit connections, the flow should be sampled and tested. If the sampling indicates an illicit discharge, the IDDE plan should be followed to eliminate the illicit discharge.

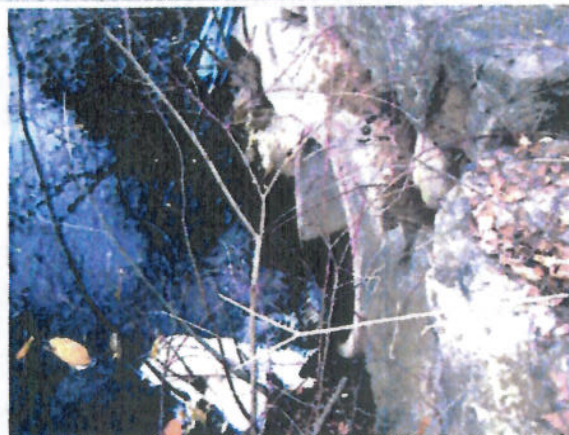
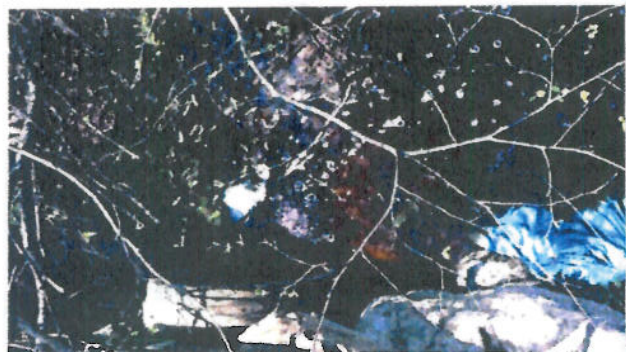
Photo Name: OF\_043\_10ACarolLn(2)2011-11-15.JPG

**Outfall 43:** This circular 36 inch concrete outfall discharges to a pond east of Carol Lane. During the initial 11/15/11 inspection, dry weather flow and the presence of foam was noted. A follow up inspection was recommended to verify that the foam was not caused by illicit discharges of chemical surfactants. The follow up inspections in 2013 through 2016 showed the continued presence of dry weather flow and small amounts of foam. However, it is not believed at this time that these are indicators of illicit discharges. The outfall is situated behind a fence, so close observation of the flow was not possible, but the small quantity of foam generally appeared to be natural, biological foam which occurs when organic materials release compounds into water as they decompose. Additionally, outfall 43 is in a low lying area with some wetland characteristics. Dry weather flow and foam during the spring may be expected in such areas. AECOM recommends that town personnel continue to monitor this outfall during their regular operations. This outfall should remain on the "High Priority" list and be formally inspected again during the next annual outfall inspections. If the outfall at any time begins to show any signs of illicit connections, its flow should be sampled and tested. If the sampling indicates an illicit discharge, the IDDE plan should be followed to eliminate the illicit discharge.

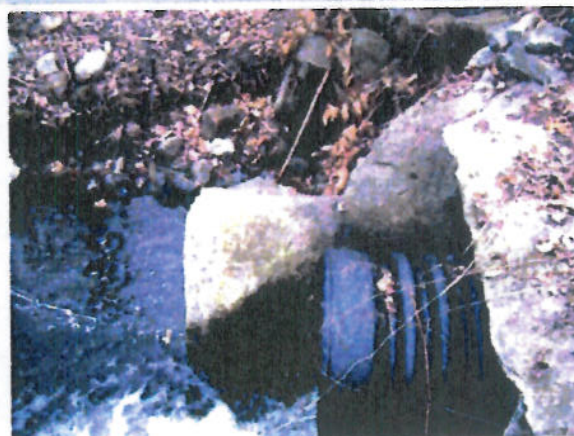
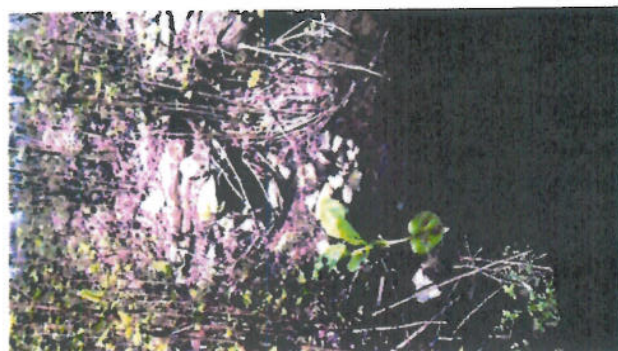
Photo Name: OF\_049\_16AMilkStreet(5)2011-11-15.JPG

| <b>Outfall No.</b> | <b>Finding</b> | <b>Action Item</b> |
|---|---|---|
| 49 | Outfall pipe invert has rusted away. | In the long term, consider replacing the outfall pipe. |

Structural Damage: Invert of Pipe Rotted at exit; Appr

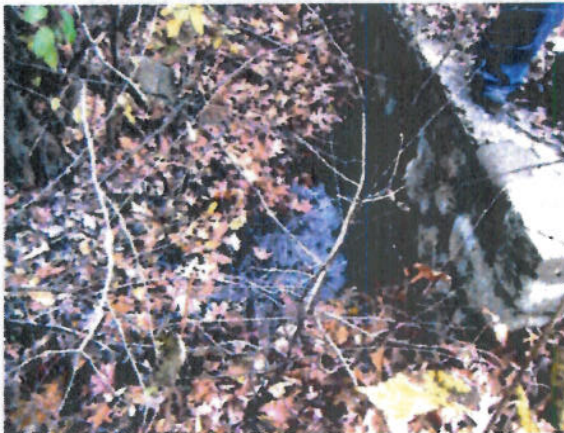
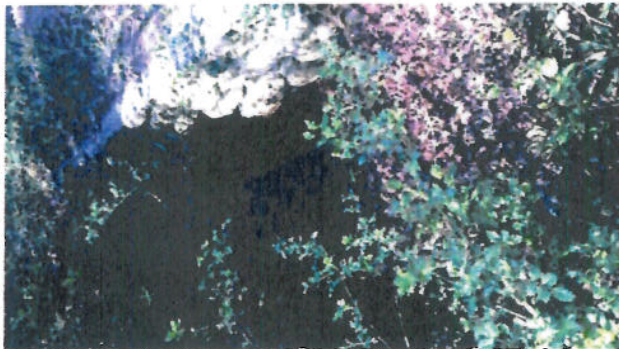
Photo Name: OF\_061\_28AFederalSt2011-11-15.JPG

**Outfall 61:** This circular 18 inch concrete outfall is located on Federal Street near house number 155. This outfall was added to the "High Priority" list due to the presence of dry weather flow and foam. This outfall has been monitored each year, but the observations did not indicate an illicit discharge. A small amount of bubbles/foam were noted during the 2016 inspection. It was observed that the foam was not chemically perfumed, broke apart easily when disturbed, and generally appeared to be natural, biological foam which occurs when organic materials release compounds into water as they decompose. Additionally, outfall 61 is in a low lying area with some wetland characteristics. Dry weather flow and foam during the spring may be expected in such areas. Therefore, the available evidence at this time indicates that sampling is not required at this outfall. AECOM recommends that town personnel continue to monitor this outfall during their regular operations. Based on this inspection and past inspections, this outfall should remain on the "High Priority" list and should be formally inspected again during the next annual outfall inspections. If the outfall at any time begins to show any signs of illicit connections, its flow should be sampled and tested. If the sampling indicates an illicit discharge, the IDDE plan should be followed to eliminate the illicit discharge.

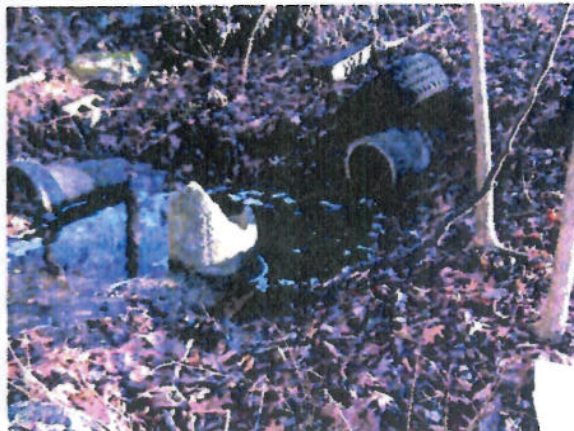
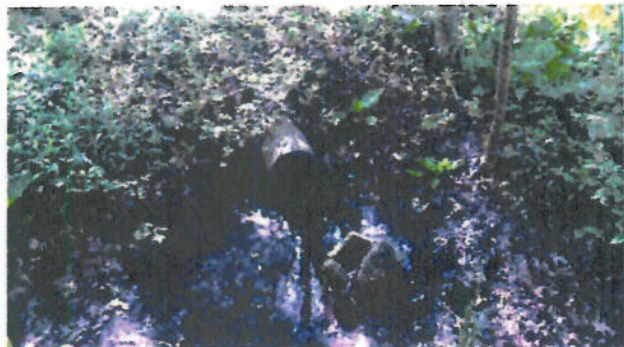
Photo Name: OF\_064\_1B\_BlackstoneSt2011-12-02(4).JPG

**Outfall 64:** This circular concrete outfall is located on Blackstone Street near house number 146. This outfall was added to the "High Priority" list due to the presence of dry weather flow and foam. This outfall has been monitored each year, but the observations did not indicate an illicit discharge. Dry weather flow was noted during the 2016 inspection. Foam was not noted. Dry weather flow during the spring may be expected in low lying areas with wetland characteristics, such as outfall 64's location. Therefore, the available evidence at this time indicates that sampling is not required at this outfall. AECOM recommends that town personnel continue to monitor this outfall during their regular operations. This outfall should be formally inspected again during the next annual outfall inspections. If the outfall at any time begins to show any signs of illicit connections, its flow should be sampled and tested. If the sampling indicates an illicit discharge, the IDDE plan should be followed to eliminate the illicit discharge. AECOM also noted that the 30 inch concrete bell end of this outfall has broken off. However, this does not appear to be affecting the outfall's performance.

Structural Damage: Good (see comment)

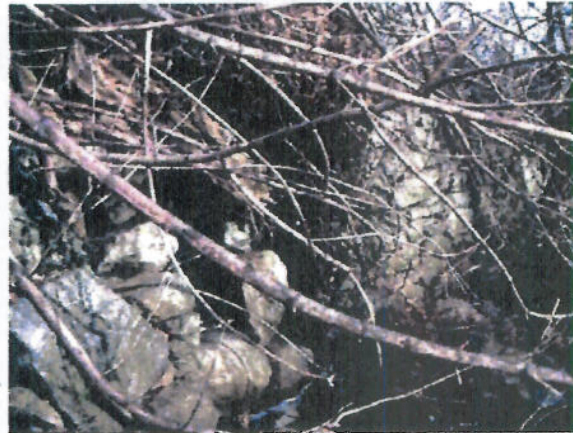
Photo Name: OF\_084\_8C\_FirstStatBlackstoneRiver2011-12-05(2).JPG

**Outfall 84:** This outfall is located in the bank of the Blackstone River at the south end of First Avenue. This outfall was added to the "High Priority" list due to the presence of dry weather flow, odor and the presence of foam. During the 2015 inspection, the outfall was found to be completely inaccessible due to dumping of residential yard waste. AECOM recommended that the town clear this yard waste and post "no dumping" signs in the area, which the town accomplished. The 2016 inspection did not show any indicators of illicit discharges. However, this outfall pipe is in poor condition. It is cracked in numerous places and the invert has broken away. The town should begin planning and budgeting for repairs/replacement of this pipe. AECOM recommends that this outfall should remain on the "High Priority" list and be formally inspected again during the next annual outfall inspections. If the outfall at any time begins to show any signs of illicit discharges, its flow should be sampled and tested. If the sampling indicates an illicit discharge, the IDDE plan should be followed to eliminate the illicit discharge.

| <b>Outfall No.</b> | <b>Finding</b> | <b>Action Item</b> |
|---|---|---|
| 84 (High Priority Outfall) | Pipe shows considerable cracking, invert has rotted away. Pipe may be approaching the end of useful life; failure could compromise the headwall it is located in, causing a collapse. | In the long term, consider replacing this outfall pipe as structural collapse could compromise the headwall. Locate record drawings and/or televise the pipe to determine length, age, condition, and probable cost to replace. |

Structural Damage: Last section at exit broken in ???
