**Municipality/Organization:** City of Malden  
**EPA NPDES Permit Number:** MA041046  
**MADEP Transmittal Number:** 041088  
**Annual Report Number  
& Reporting Period:** No. 9: April 1, 2011-March 31, 2012

## NPDES PII Small MS4 General Permit Annual Report

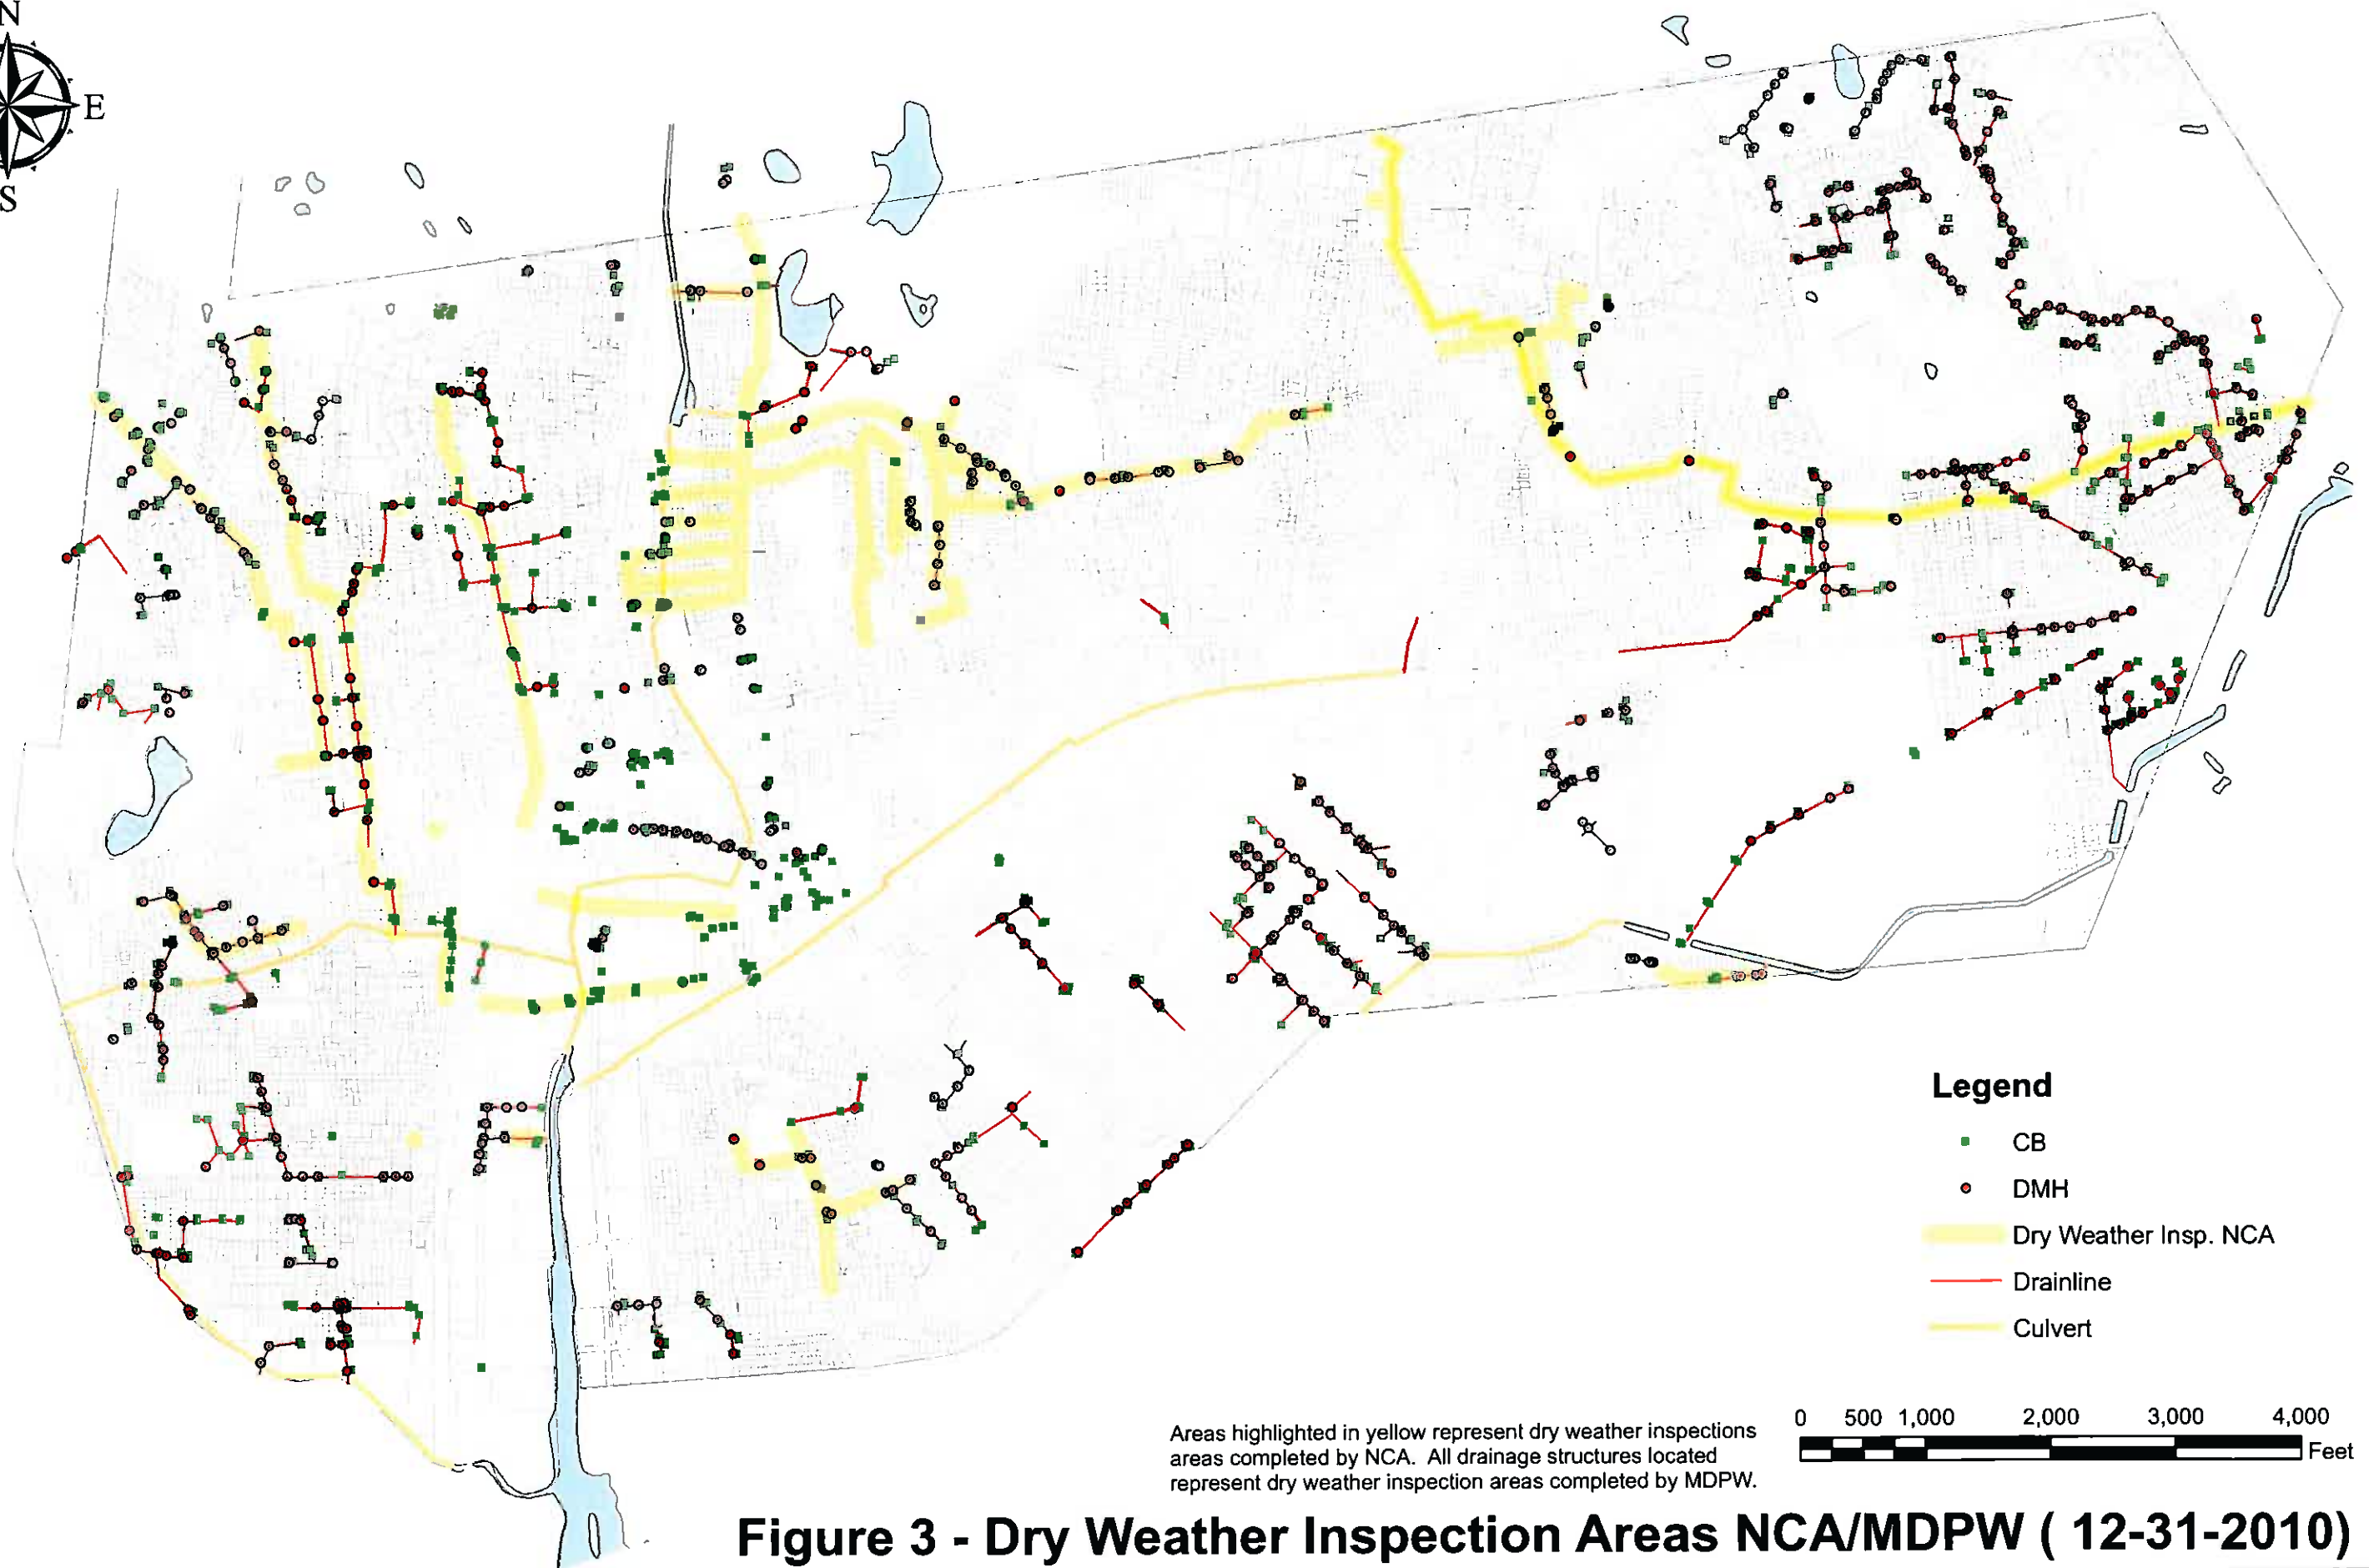
**Figure 3 - Dry Weather Inspection Areas NCA/MDPW ( 12-31-2010)**

Representatives of NCA and MDPW personnel continue to conduct targeted dry weather inspections of the City's infrastructure. This is an interactive or systematic program that has extended across the entire City, resulting in the identification and correction of infrastructure deficiencies and improvements to the general quality of stormwater discharges. Areas selected for inspection are generally based upon the results of the outfall sampling program and/or the identification of dry weather flows by MDPW staff during their routine maintenance and infrastructure locating program. Dry weather inspections conducted during this reporting period have not revealed any illicit discharges, or connections. A map depicting the approximate locations where targeted dry weather inspections have been conducted by NCA to date is presented as Figure 2. Areas inspected by DPW staff for illicit connections/discharges consist of portions of the infrastructure that are addressed during the catch basin cleaning program. During this effort, infrastructure components are mapped and the corresponding attributes are located. During this reporting period, the frequency of dry weather inspections by MDPW personnel was hindered due to a serious injury to the team leader. Overall portions of the municipal infrastructure that have been addressed by the compliance team including the targeted subset areas are summarized on Figure 3.

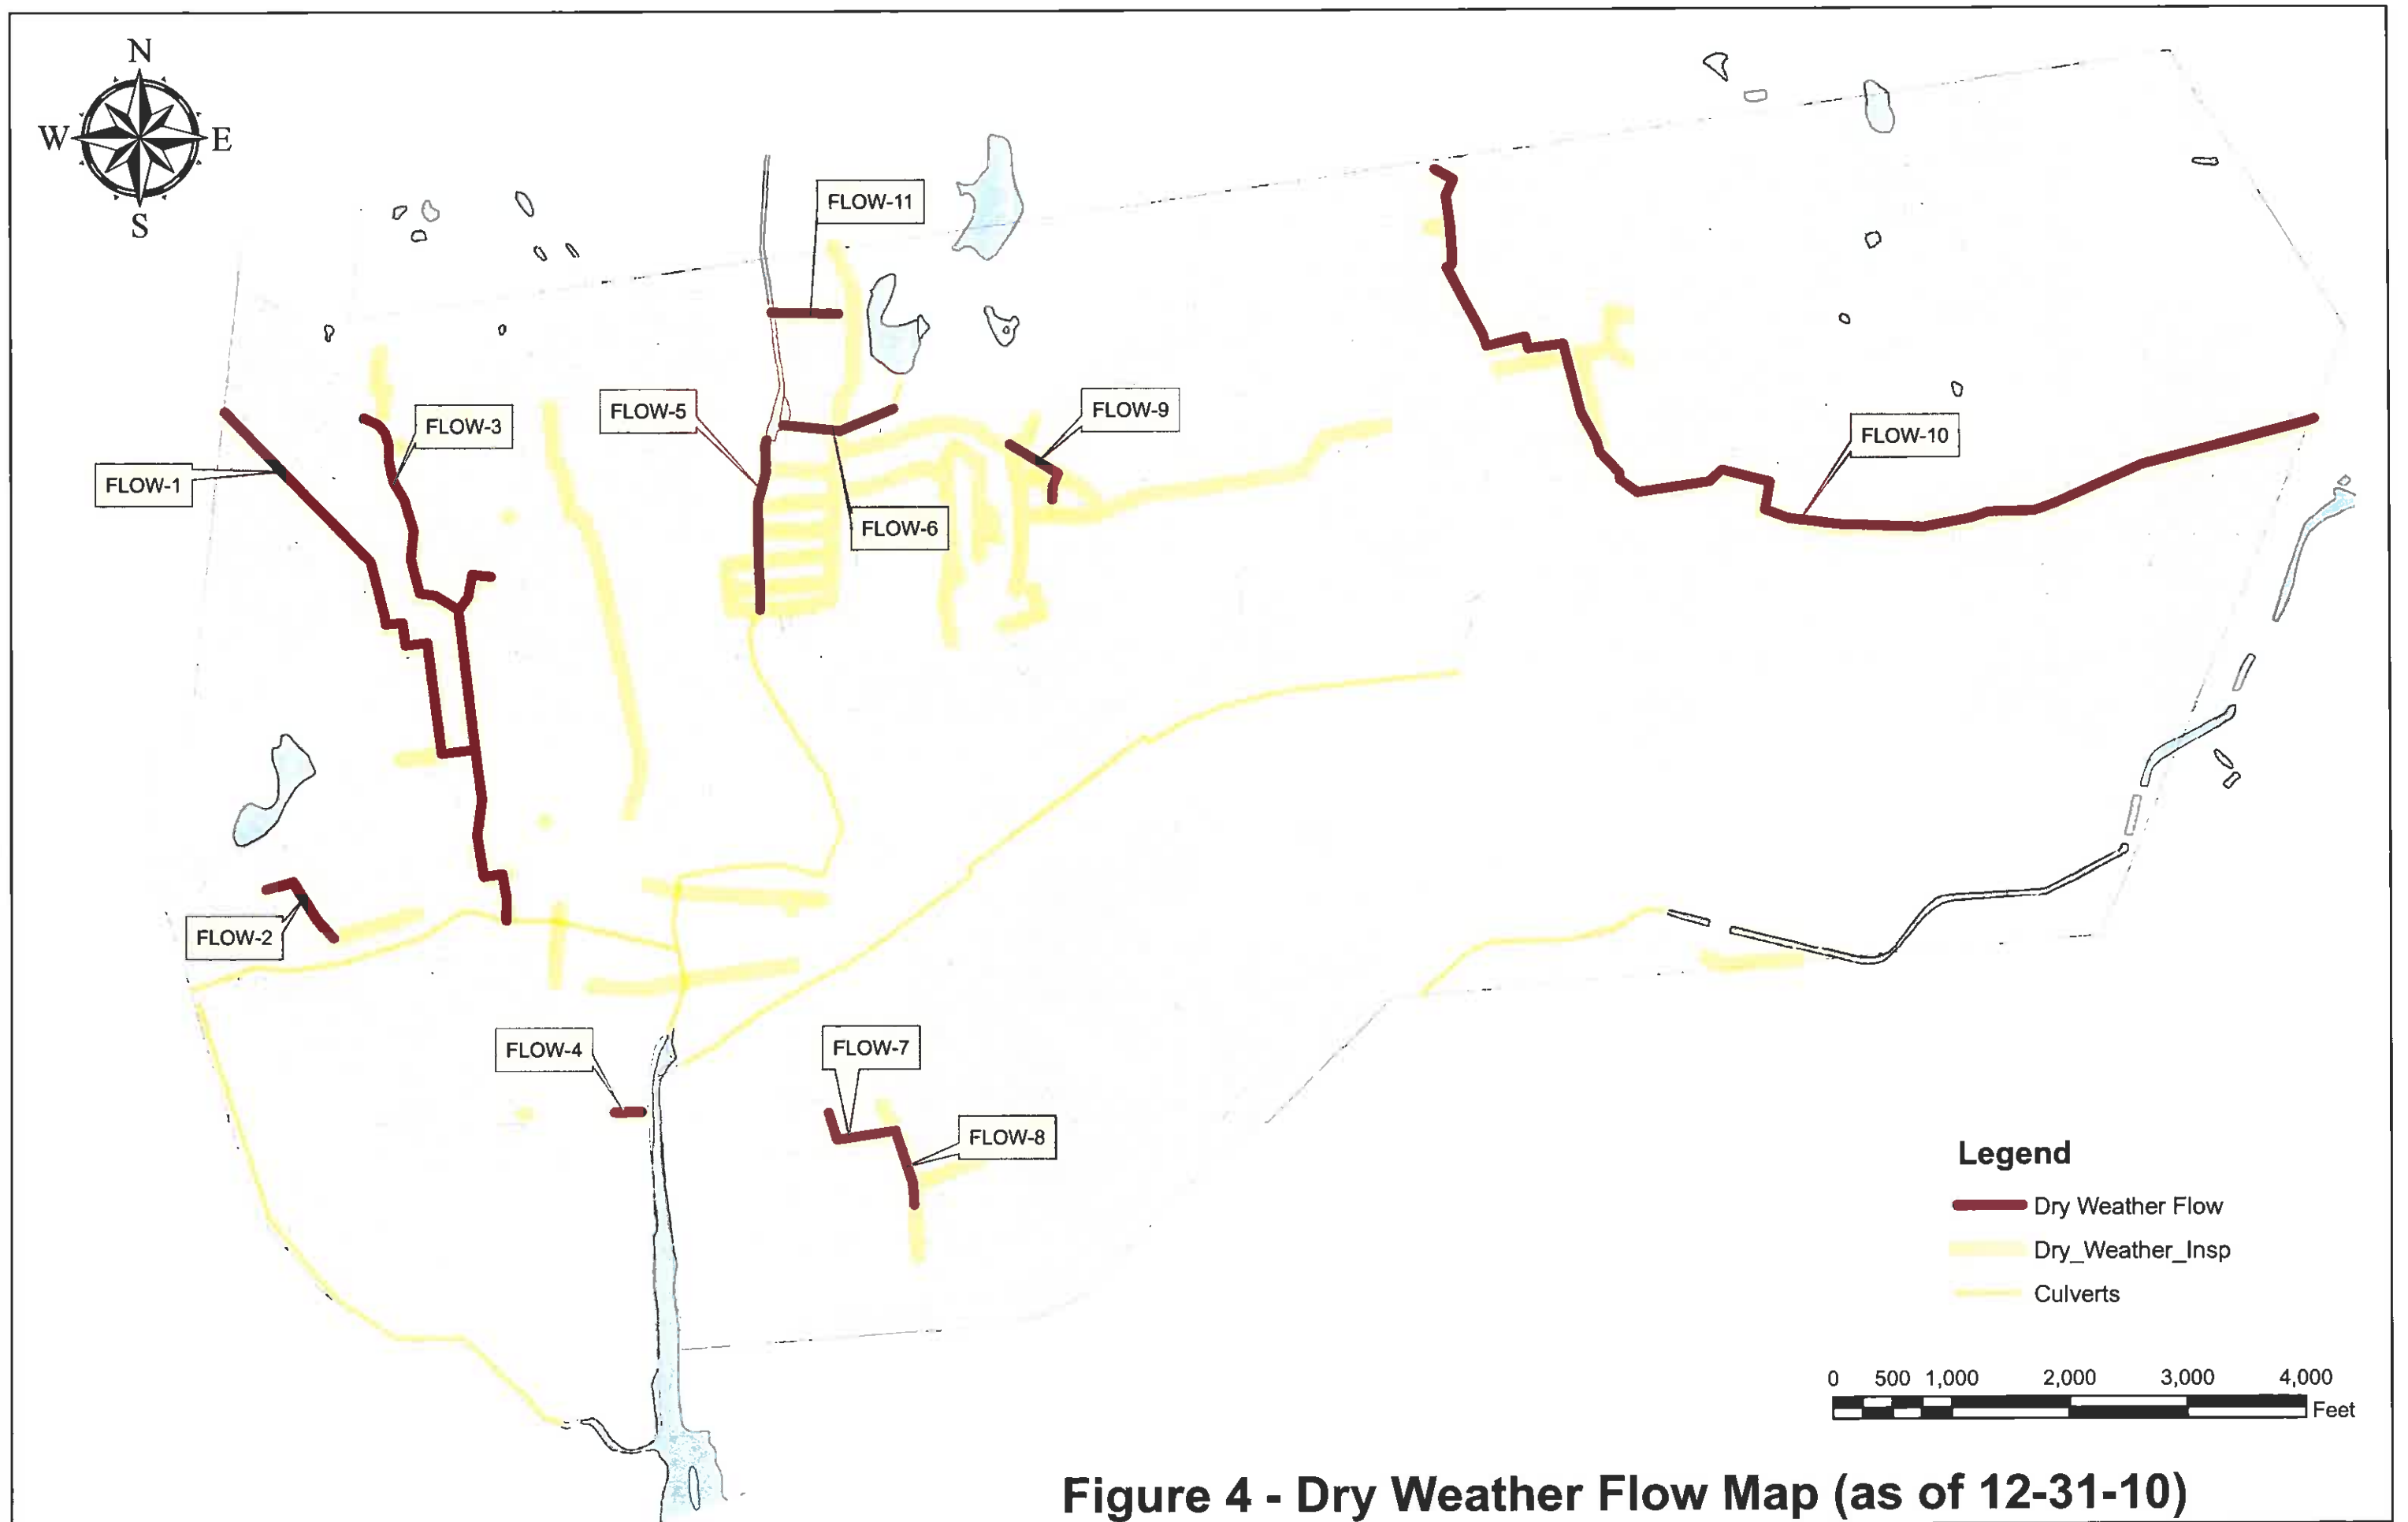
Figure 4 - Dry Weather Flow Map (as of 12-31-10)

During the course of the dry weather inspections, a number of dry weather flows, consisting primarily of waterline leaks and culverted surface waters have been identified. A summary of these flows within the municipal system that have been identified to date are shown on Figure 4, and are described as follows.

- Flow 1 – City of Medford water line leak (**removed**)
- Flow 2 – Groundwater breakout near St. Mary's Street
- Flow 3 – Fellsmere Reservation base flow
- Flow 4 – Malden River surcharge (submerged invert)
- Flow 5 – DCR Spot Pond Brook base flow
- Flow 6 – Base flow, Forestdale-Pine Banks Park
- Flow 7 – Groundwater breakout, illicit discharge (**removed 8/09**)
- Flow 8 – Waterline Leak (**removed**)
- Flow 9 – Groundwater breakout
- Flow 10 – Linden Brook base flow
- Flow 11 – LSP-4 dry weather flow

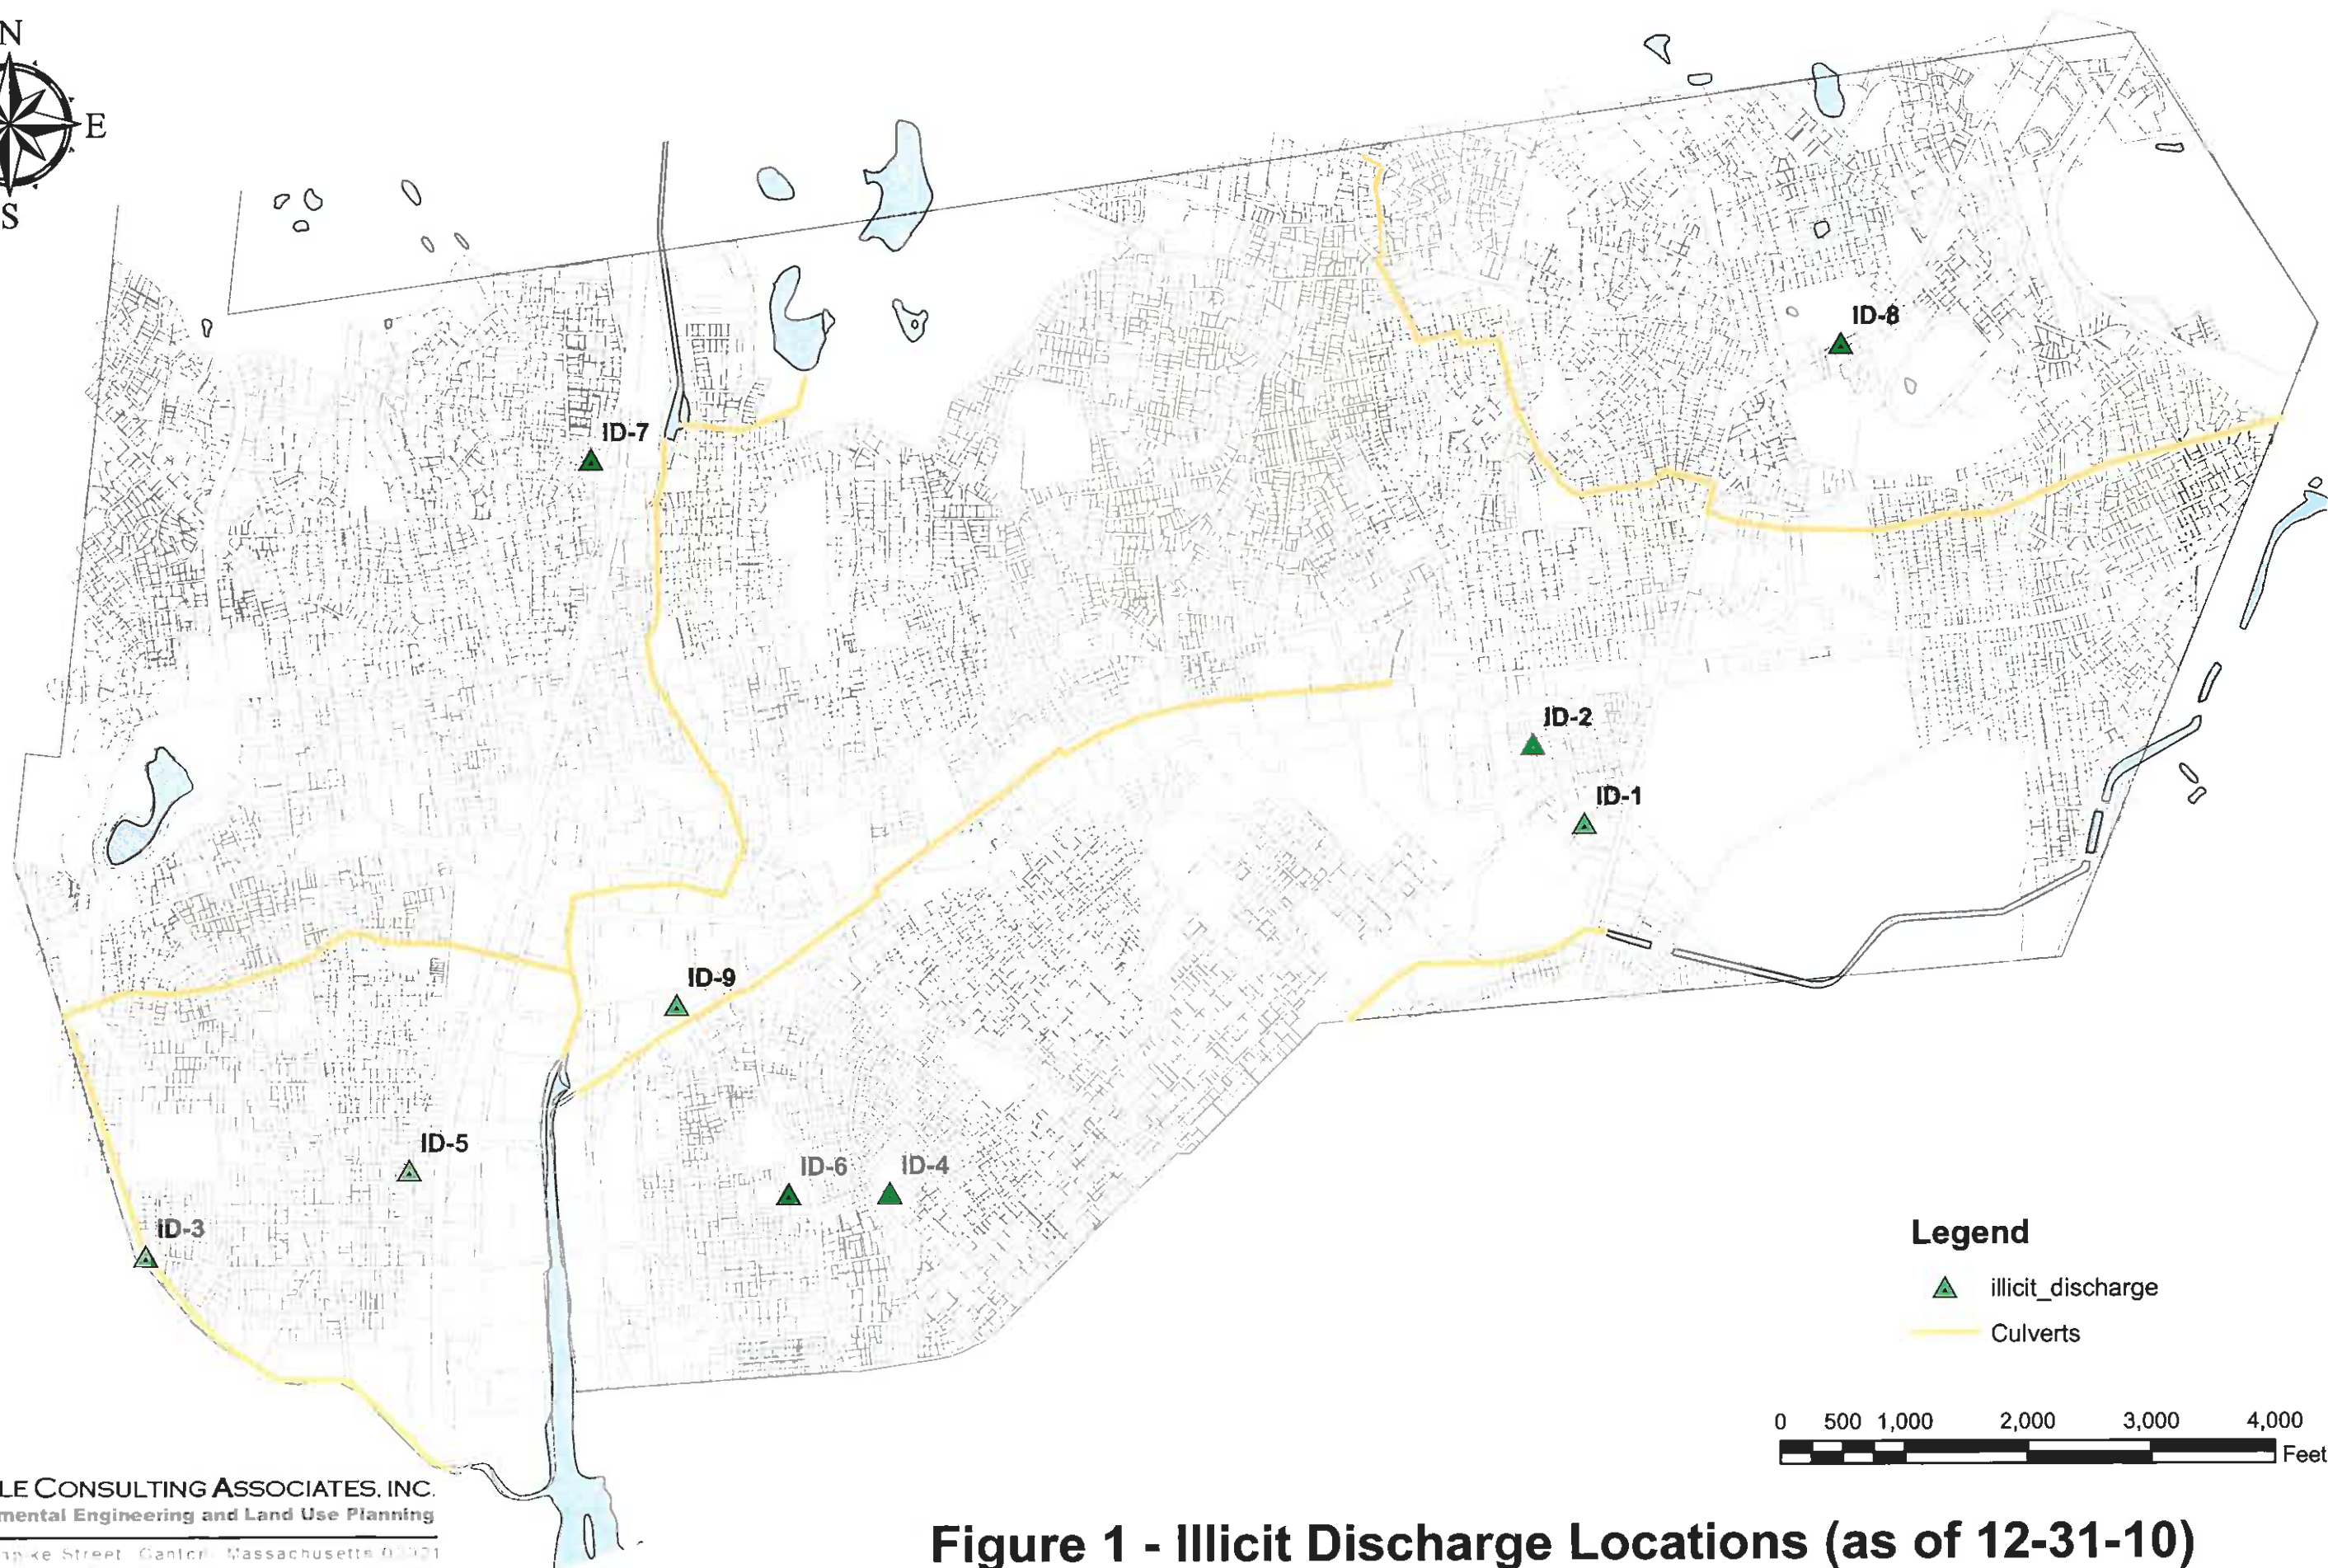
**Figure 1 - Illicit Discharge Locations (as of 12-31-10)**

During this reporting period, no illicit discharges were identified. A summary of the illicit discharges/connections identified to date is presented on Figure 1 and Table 1.0. It should be noted that due to personnel shortages and winter maintenance requirements, as well as snow melt, targeted dry weather inspections and drainage system mapping were reduced relative to the summer and fall reporting periods.

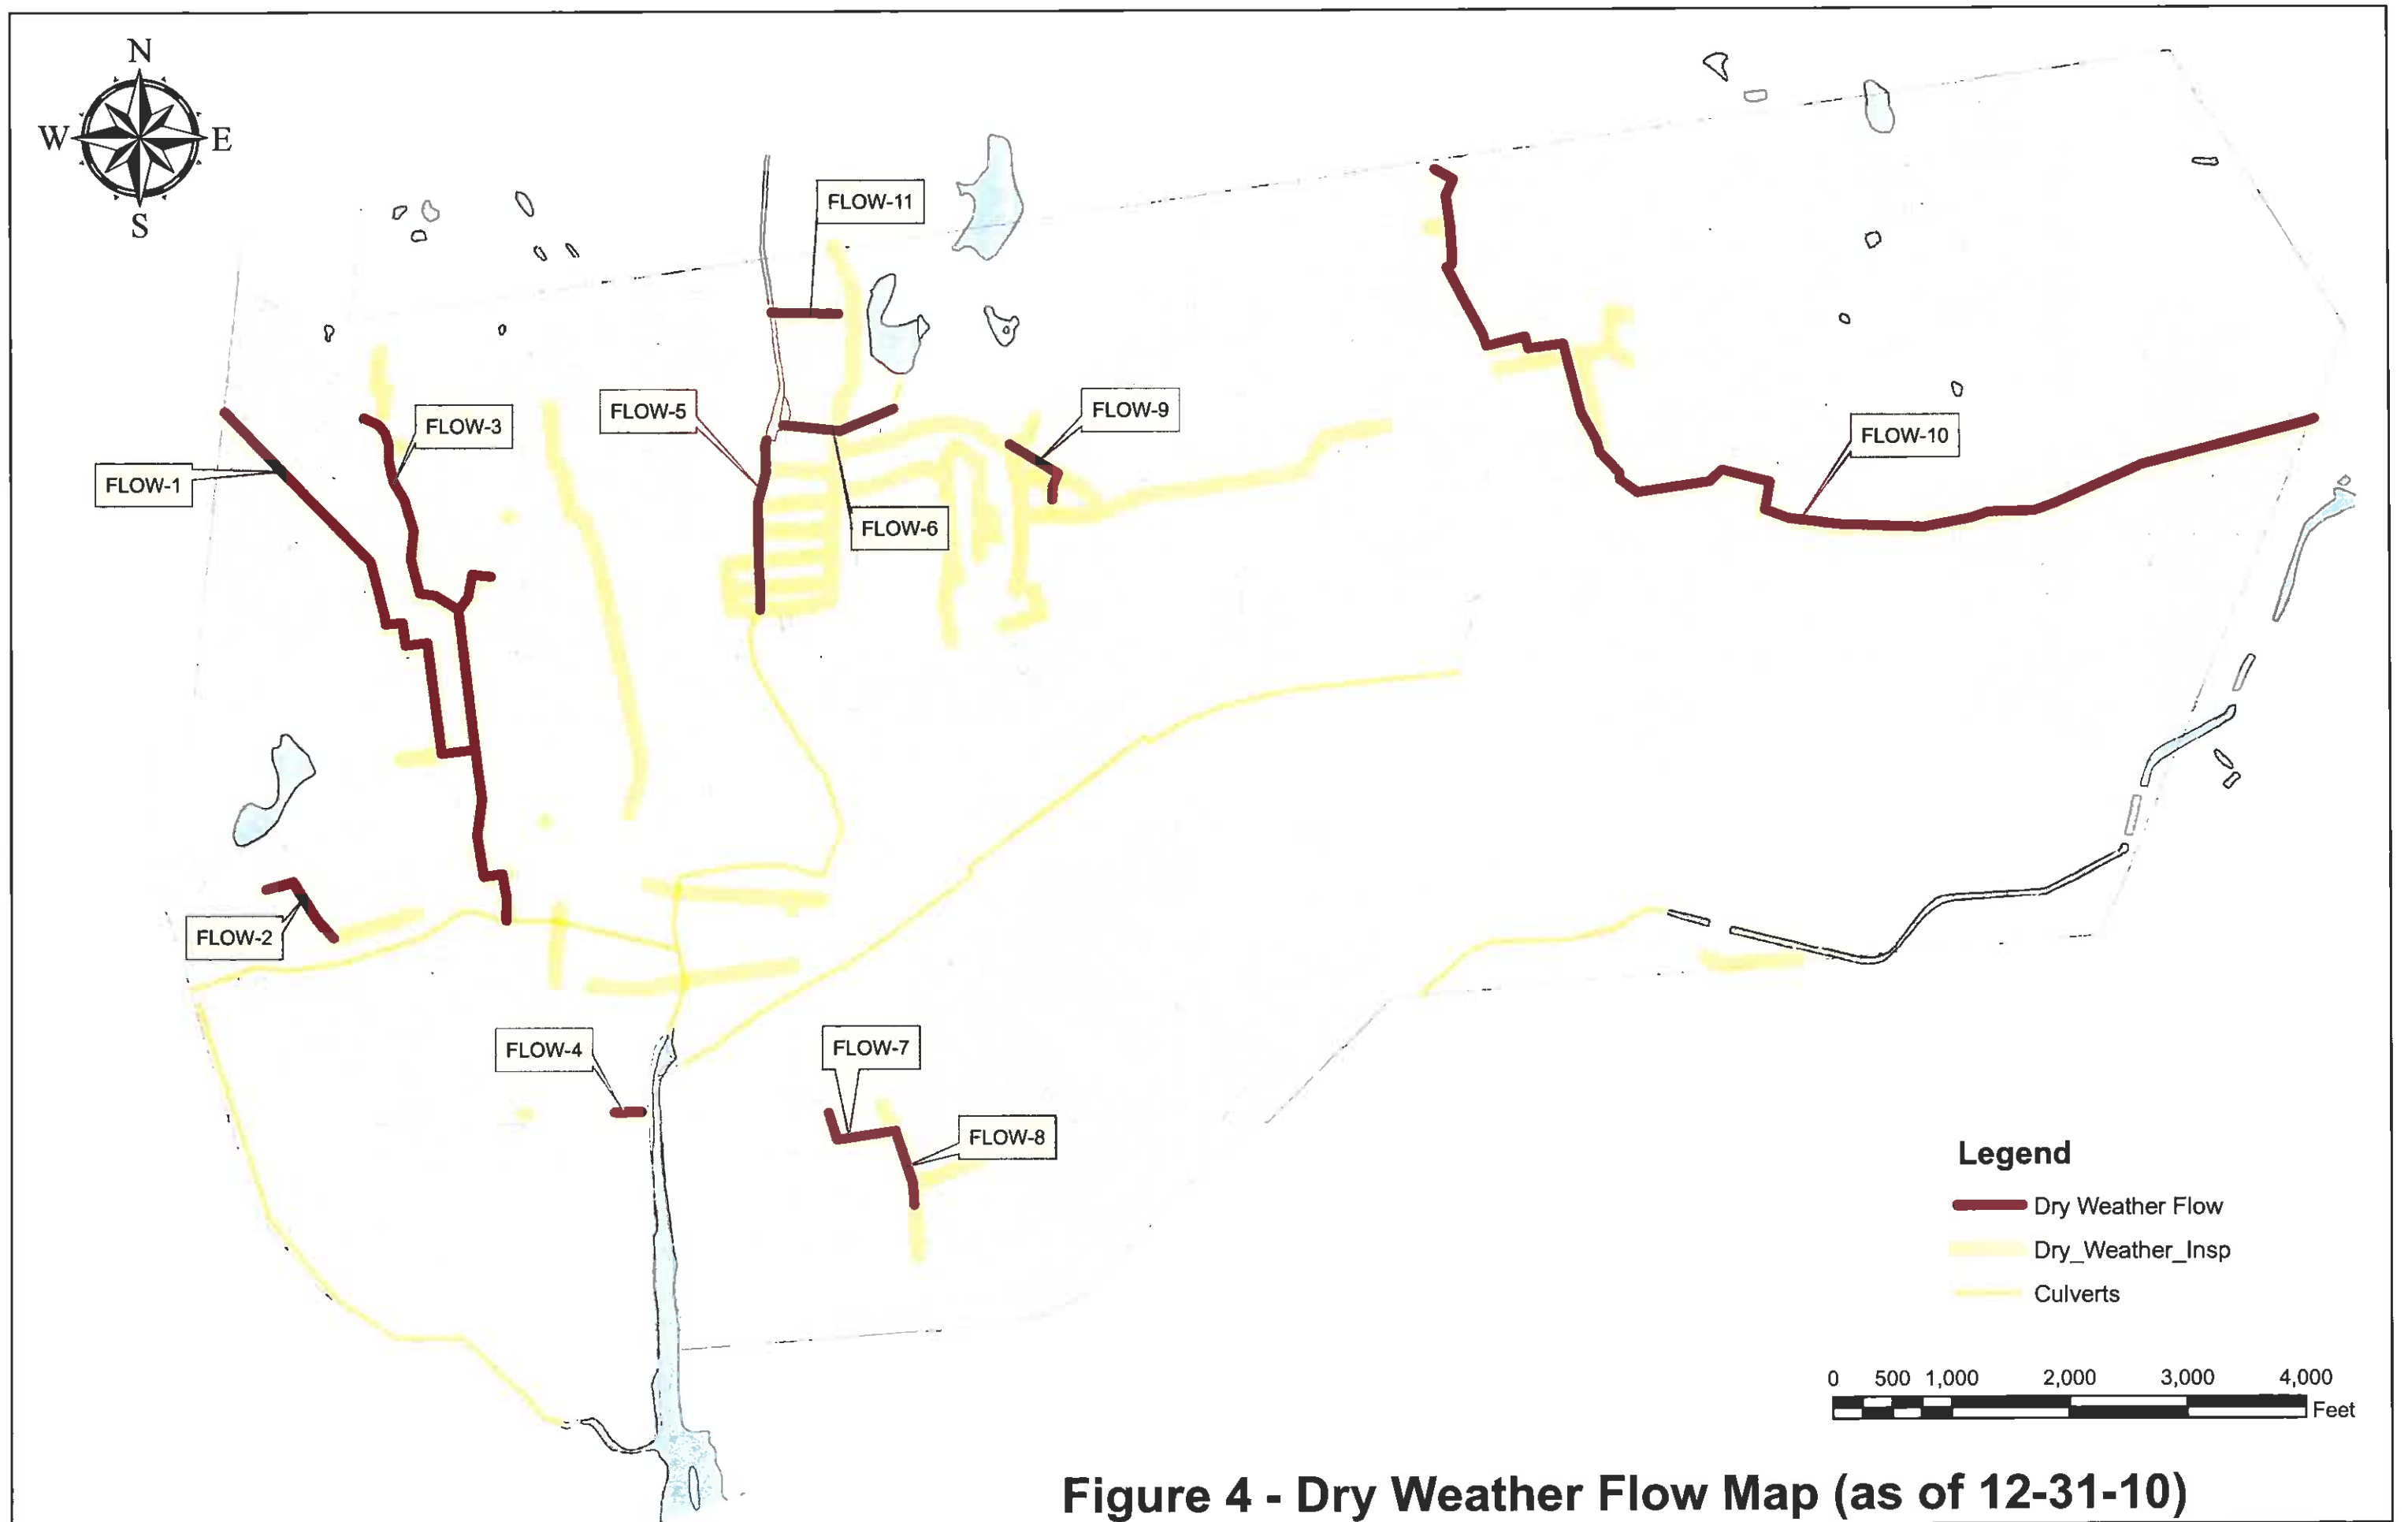
Figure 4 - Dry Weather Flow Map (as of 12-31-10)

During the course of the dry weather inspections, a number of dry weather flows, consisting primarily of waterline leaks and culverted surface waters have been identified. A summary of these flows within the municipal system that have been identified to date are shown on Figure 4, and are described as follows.

- Flow 1 – City of Medford water line leak (**removed**)
- Flow 2 – Groundwater breakout near St. Mary's Street
- Flow 3 – Fellsmere Reservation base flow
- Flow 4 – Malden River surcharge (submerged invert)
- Flow 5 – DCR Spot Pond Brook base flow
- Flow 6 – Base flow, Forestdale-Pine Banks Park
- Flow 7 – Groundwater breakout, illicit discharge (**removed 8/09**)
- Flow 8 – Waterline Leak (**removed**)
- Flow 9 – Groundwater breakout
- Flow 10 – Linden Brook base flow
- Flow 11 – LSP-4 dry weather flow
