SUBJECT: PUBLIC WATER SYSTEM NO. 360, JOINT BASE PEARL HARBOR
HICKAM (JBPHH) WATER SYTEM SANITARY SURVEY REPORT

JBPHH Water System No. 360
Significant Deficiency Corrective Action Photos
September 2014

SANITARY SURVEY OF THE JOINT BASE PEARL HARBOR-HICKAM (JBPHH) WATER SYSTEM

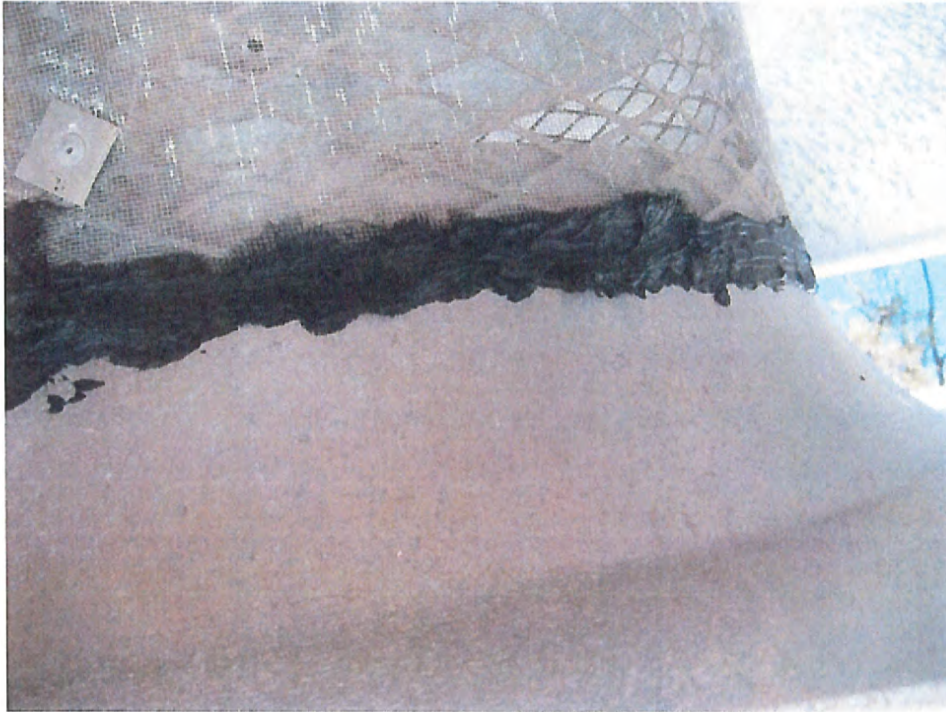
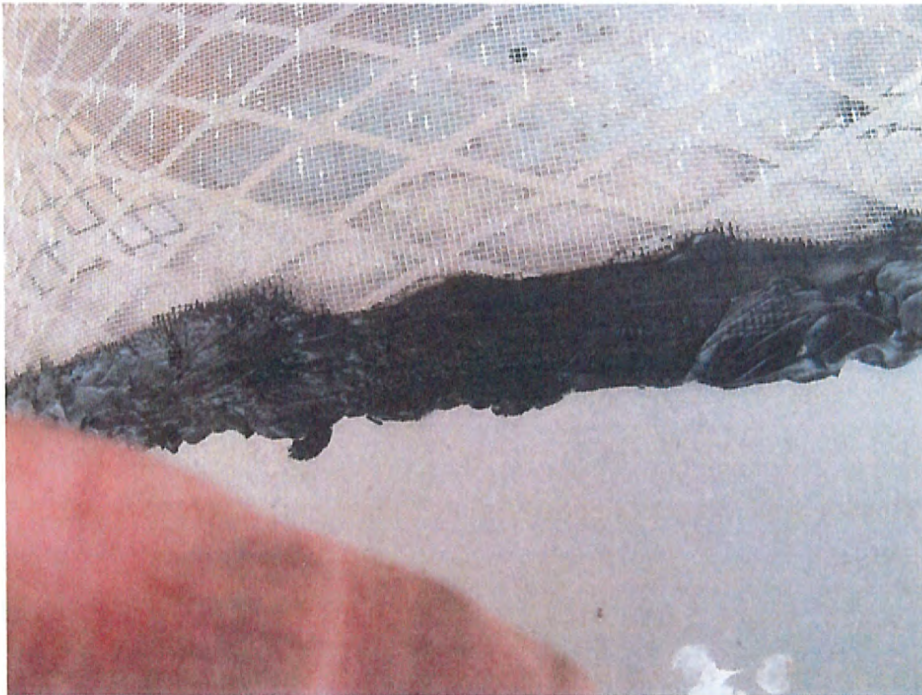
Photo 1: Camp Smith Tank S-327 – Secured bottom edge of vent screen

Photo 2: Camp Smith Tank S-327 – Secured bottom edge of vent screen (CLOSEUP).

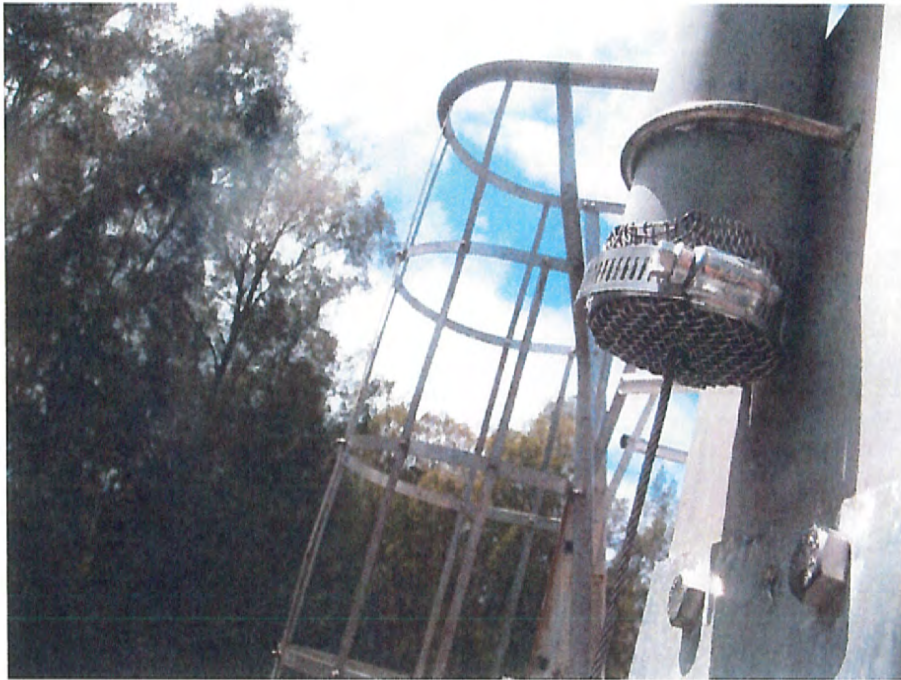
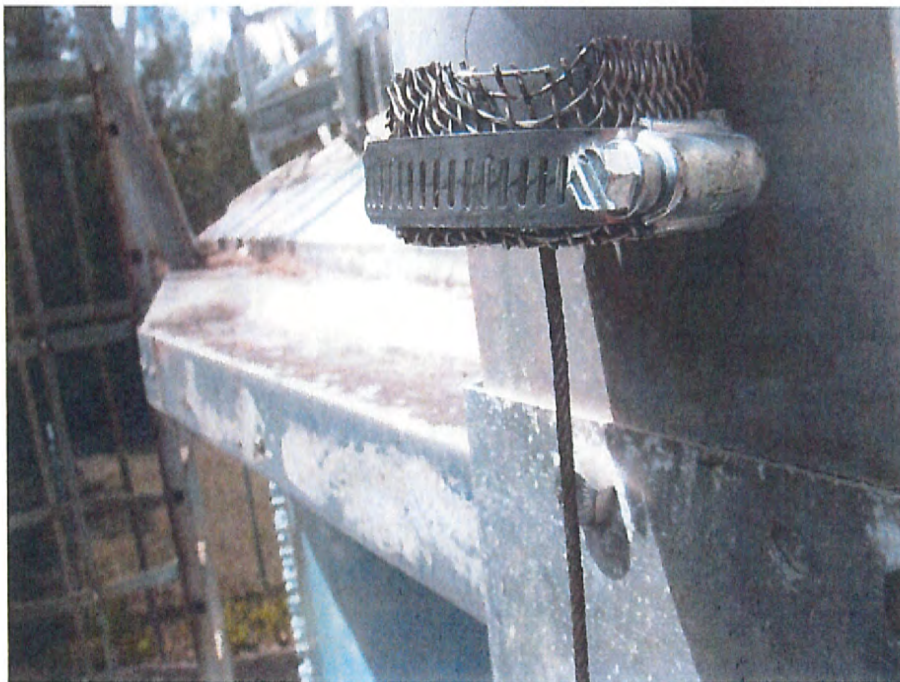
Photo 3: Camp Smith Tank S-327 – Water level cable pipe screened

Photo 4: Camp Smith Tank S-327 – Water level cable pipe screened (CLOSEUP).

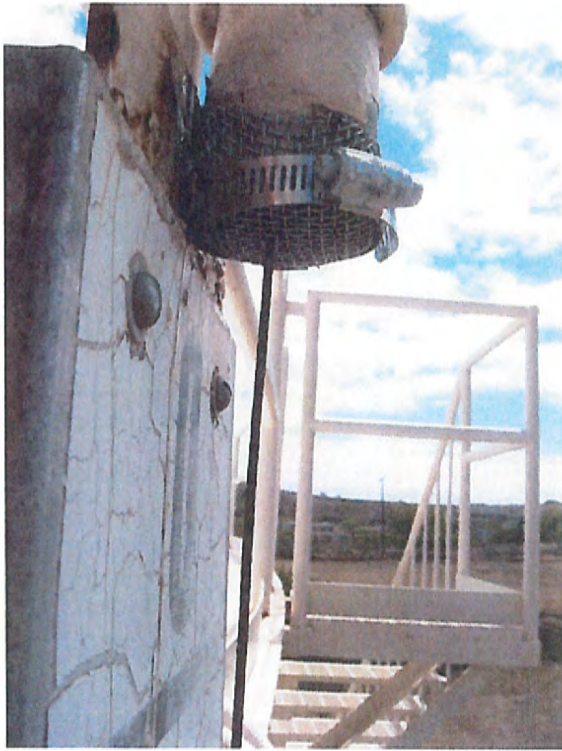
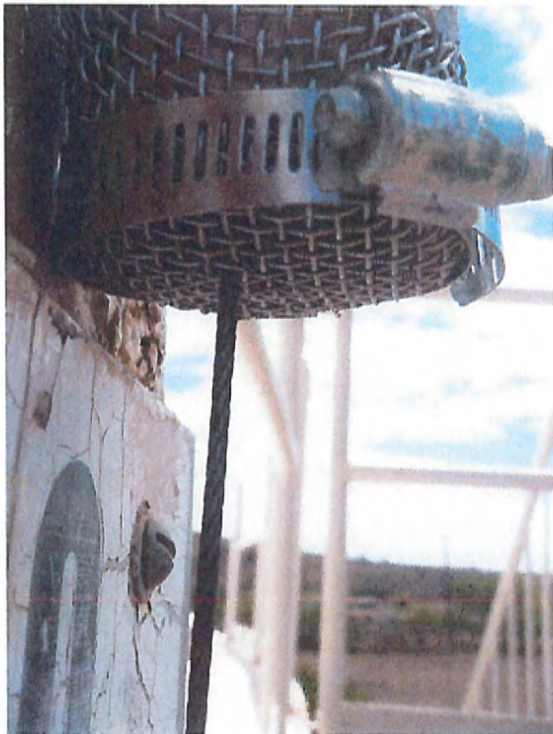
Photo 5: Halawa Tank S-2 – Water level cable pipe screened

Photo 6: Halawa Tank S-2 – Water level cable pipe screened (CLOSEUP).

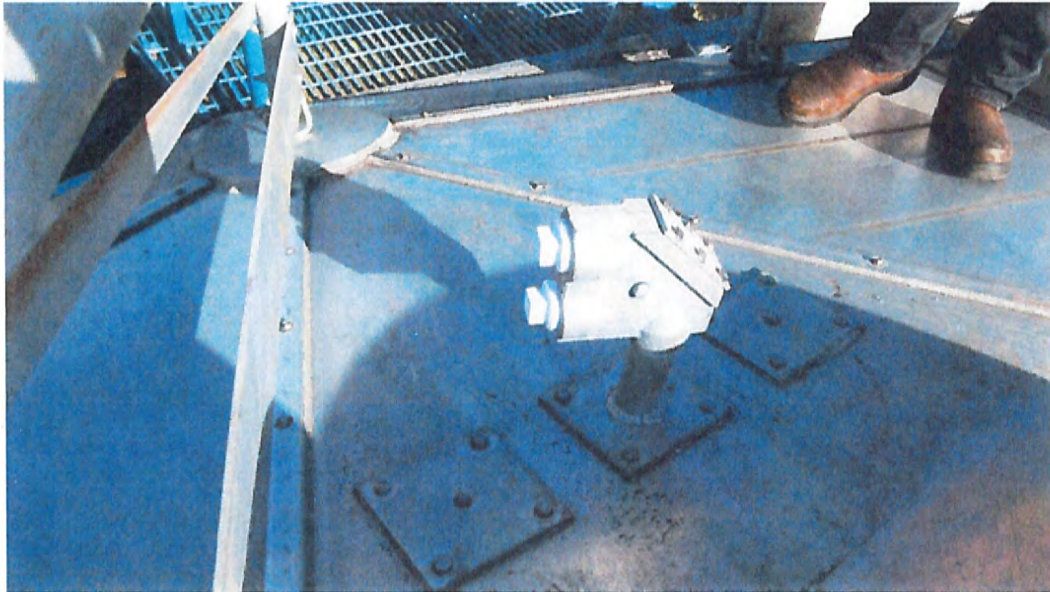
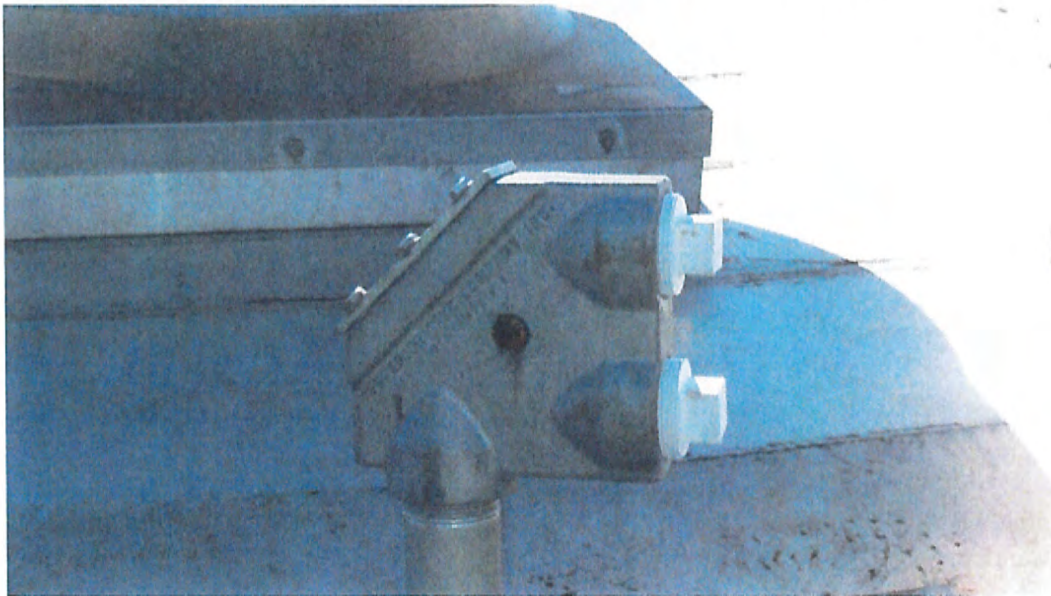
Photo 7: Red Hill Tank – Water level assembly completely removed and plugged.

Photo 8: Red Hill Tank – Water level assembly completely removed and plugged (CLOSEUP).

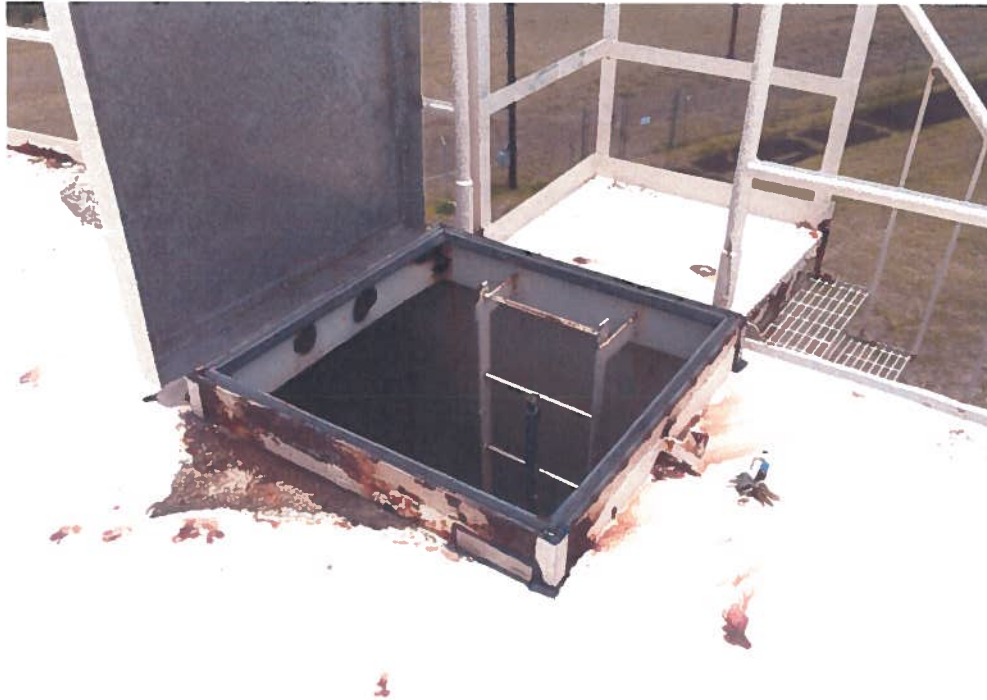
Photo 1: Overall view of roof hatch

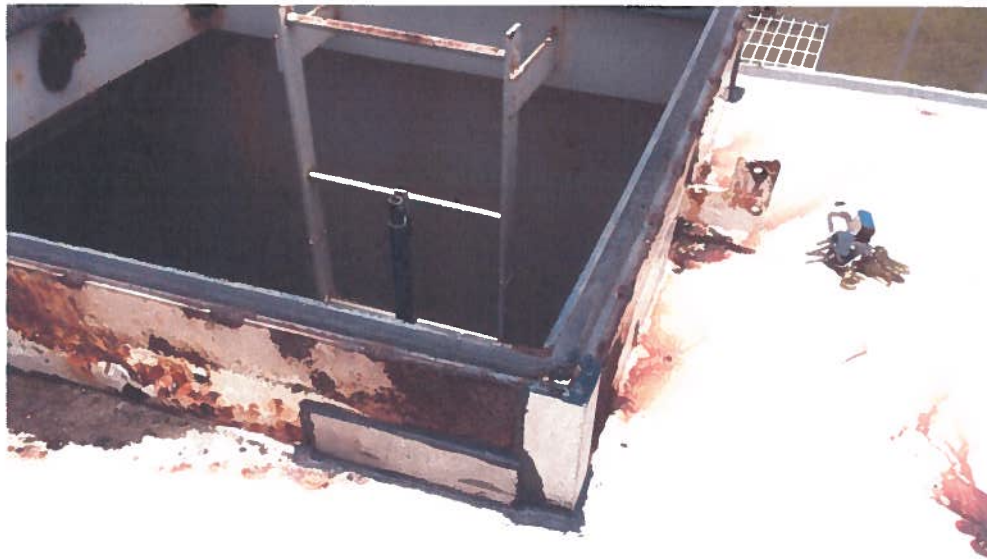
Photo 2: Closer view of patch over rusted corner

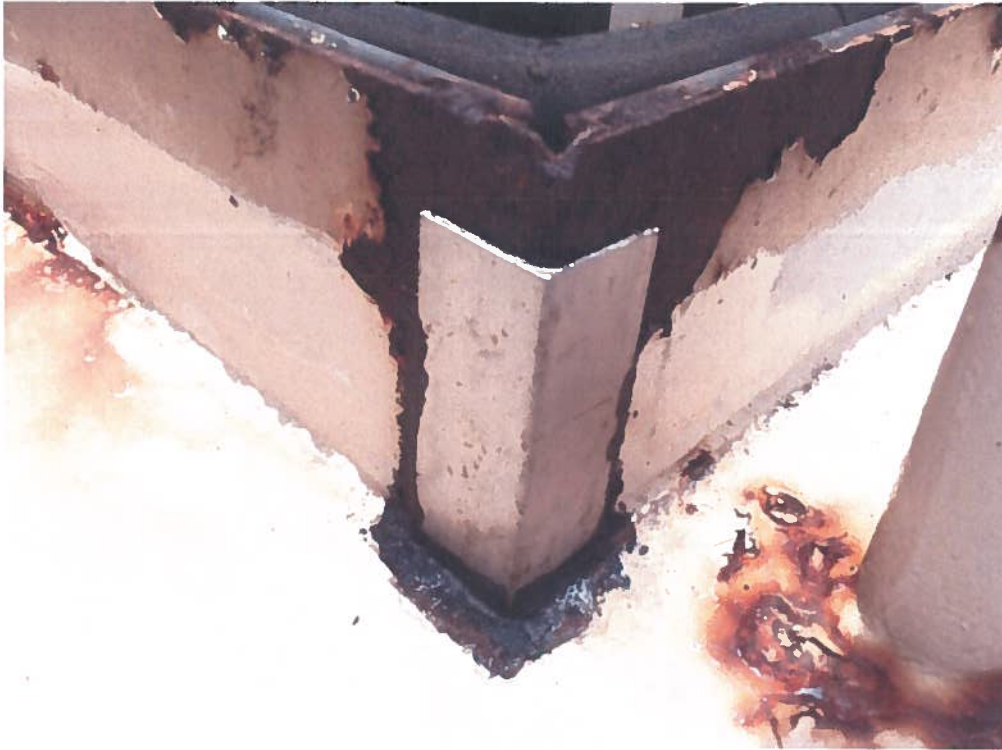
Photo 3: Close up view of patch on opposite corner of hatch

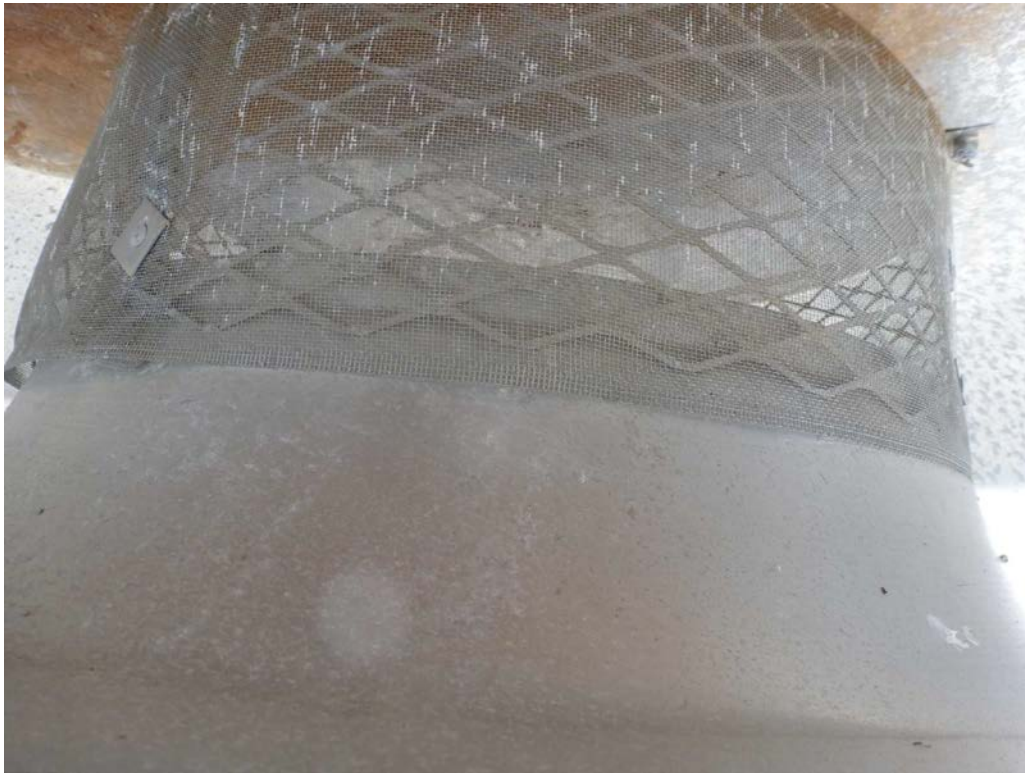
Tank 327: Secure loose bottom edge of roof vent screen.

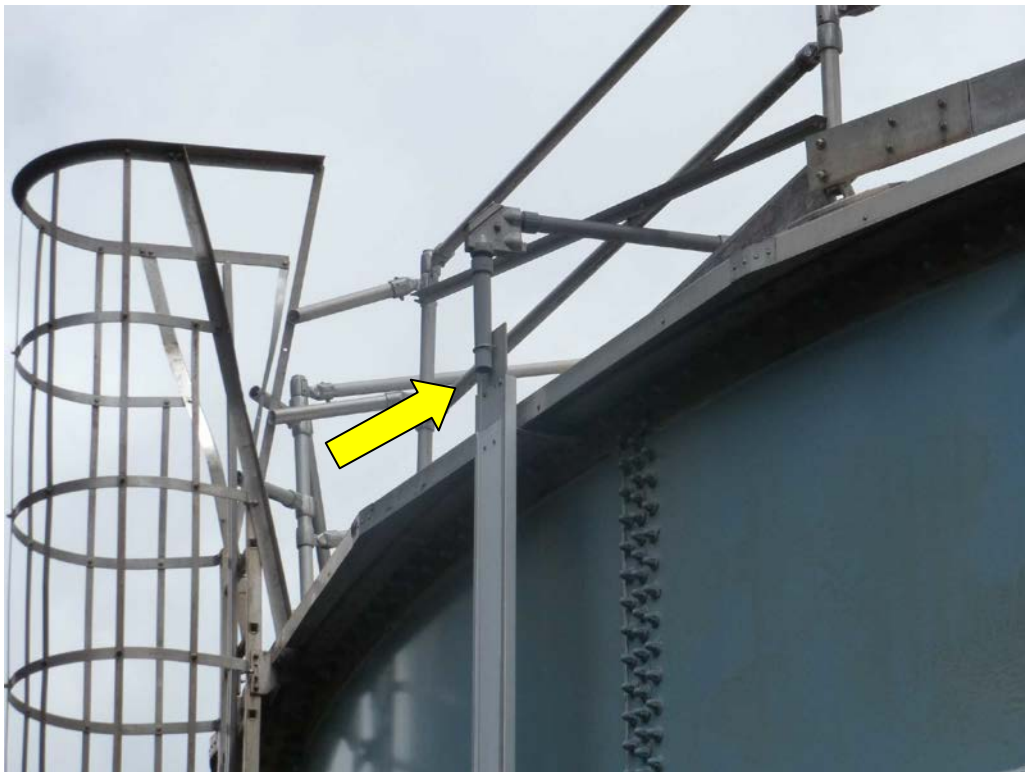
Tank 327: Plug open end of water level cable pipe.

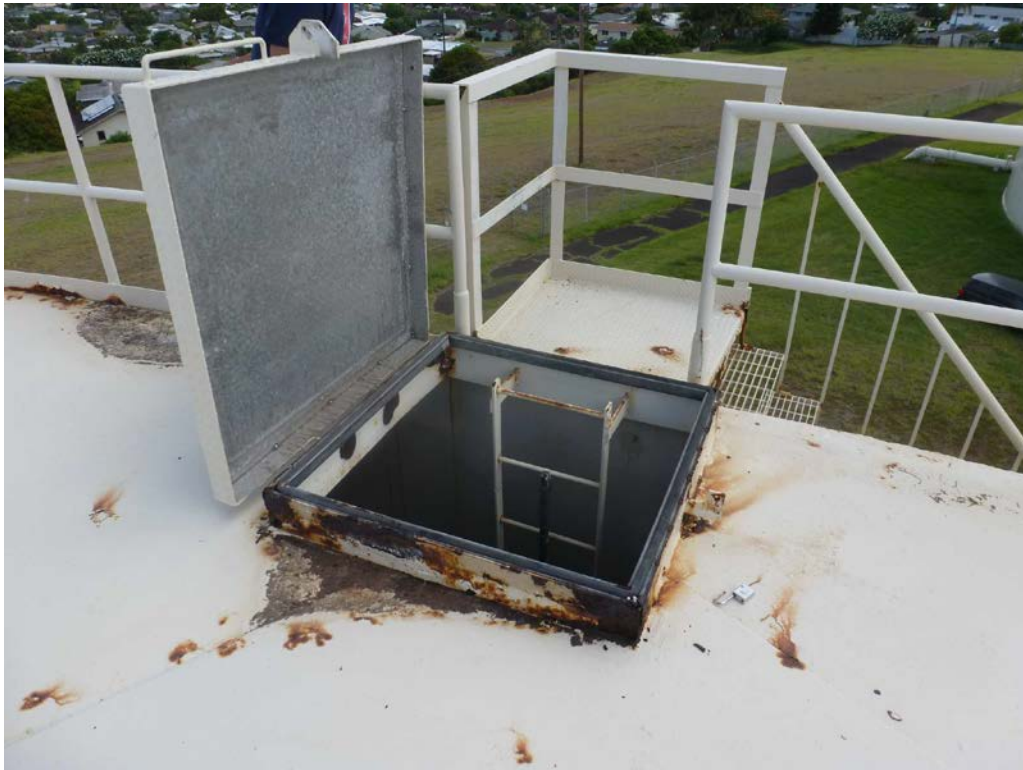
Halawa Tank S-1: Severe rust in the roof hatch has created holes in the raised steel curb providing an entryway for contaminants, insects and geckos. The openings should be repaired and sealed in the interim. The current project to reconstruct the roof hatch should be expedited.

Poor condition - severe rust. All four corners of frame have rusted completely through with open holes. There is a contract to replace the hatch that is expected to begin end of August 2014 and take 4 months to complete. Recommend temporary repair until contract work can be done.

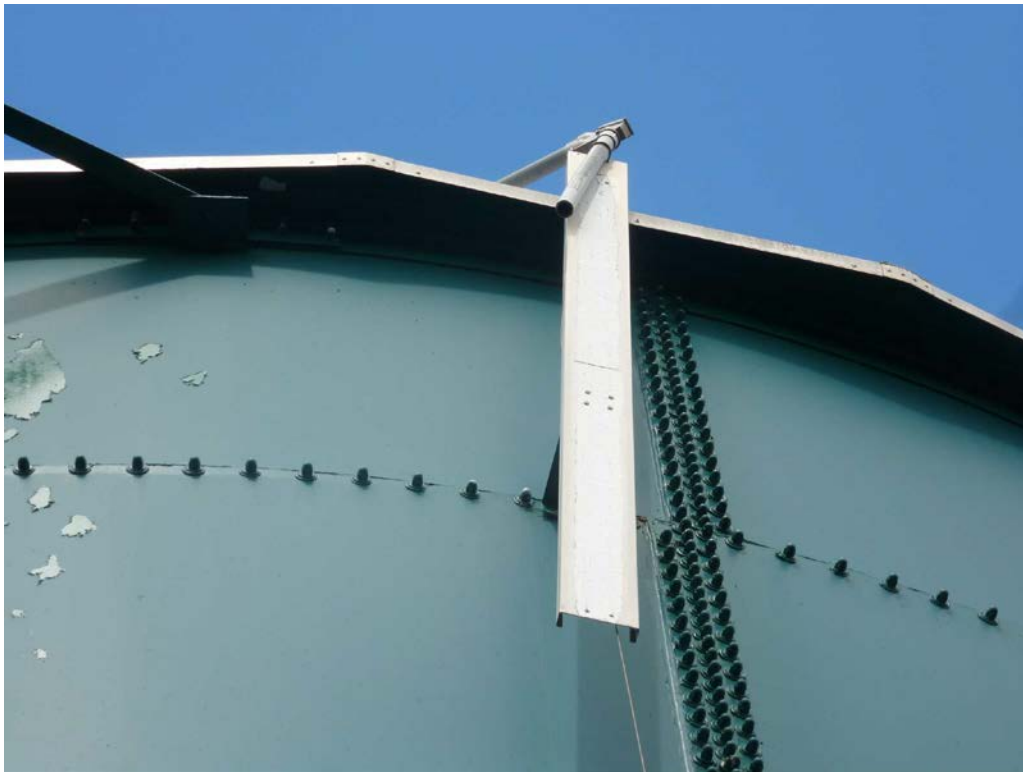
Red Hill Tank: Plug open end of water level cable pipe or completely remove water level assembly and plug any openings.

Level indicator OK. Partially dismantled. **Recommend fully removing apparatus and plugging openings.**

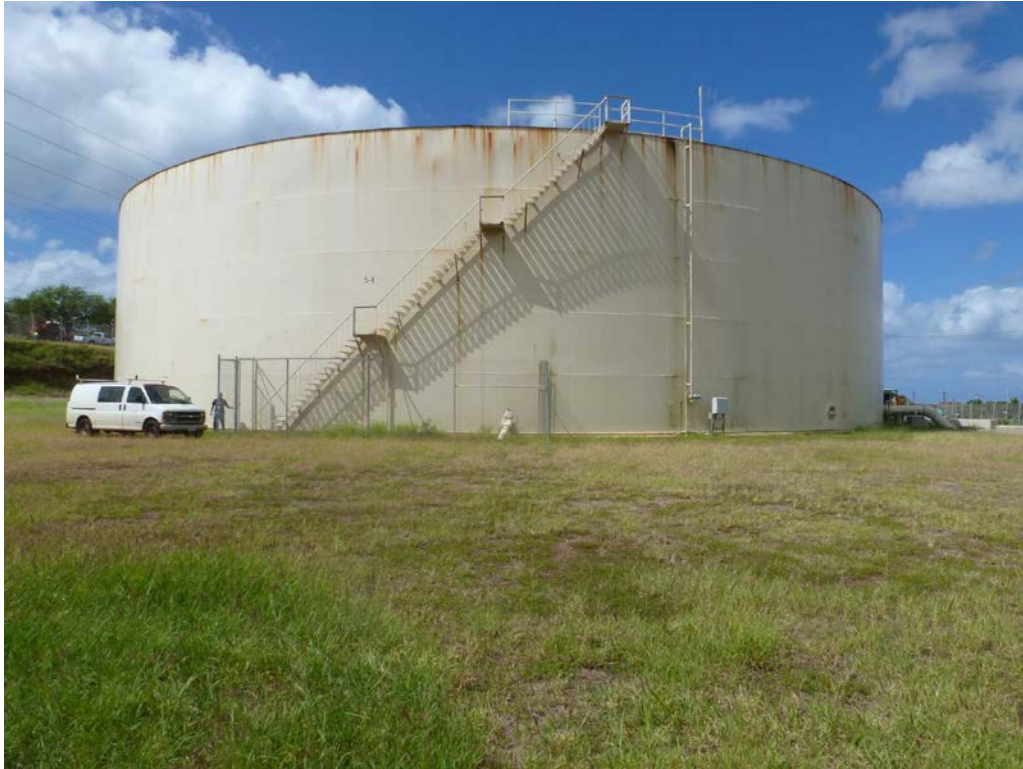
Halawa Tank S-1: The rust observed on the exterior tank walls near the roofline, on the roof surface and in the steel stairway should be addressed before the rust progresses further.

OK but moderately rusty with numerous areas with significant rust on exterior of tank walls, roof and in stairway. Recommend removing rust and repainting as soon as possible. Tank is reportedly outfitted with cathodic protection. Cathodic protection should be investigated for proper functioning.

The rust observed on the exterior tank walls near the roofline, on the roof surface and in the steel stairway should be addressed before the rust progresses further. Although both tanks have been outfitted with cathodic protection systems, there is visibly a greater amount of rust in Tank S-1. The cathodic protection system should be investigated for proper functioning. The existing rust should be removed and the areas repainted.

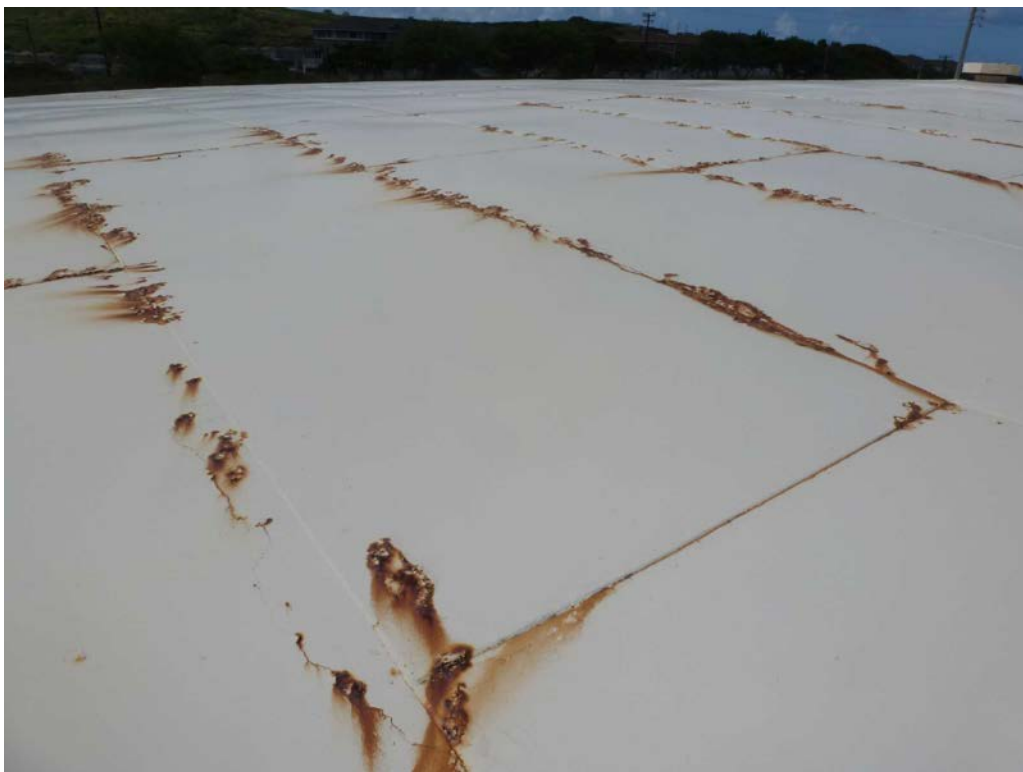
Halawa Tank S-1: Rust observed on the roof should be addressed.
