SUBJECT: PUBLIC WATER SYSTEM NO. 360, PEARL HARBOR WATER SYTEM
SANITARY SURVEY REPORT

PEARL HARBOR WATER SYSTEM PWS 360
NAVY RESPONSE TO DOH SANITARY SURVEY OF NOV 2, 2009

SANITARY SURVEY OF THE PEARL HARBOR WATER SYSTEM

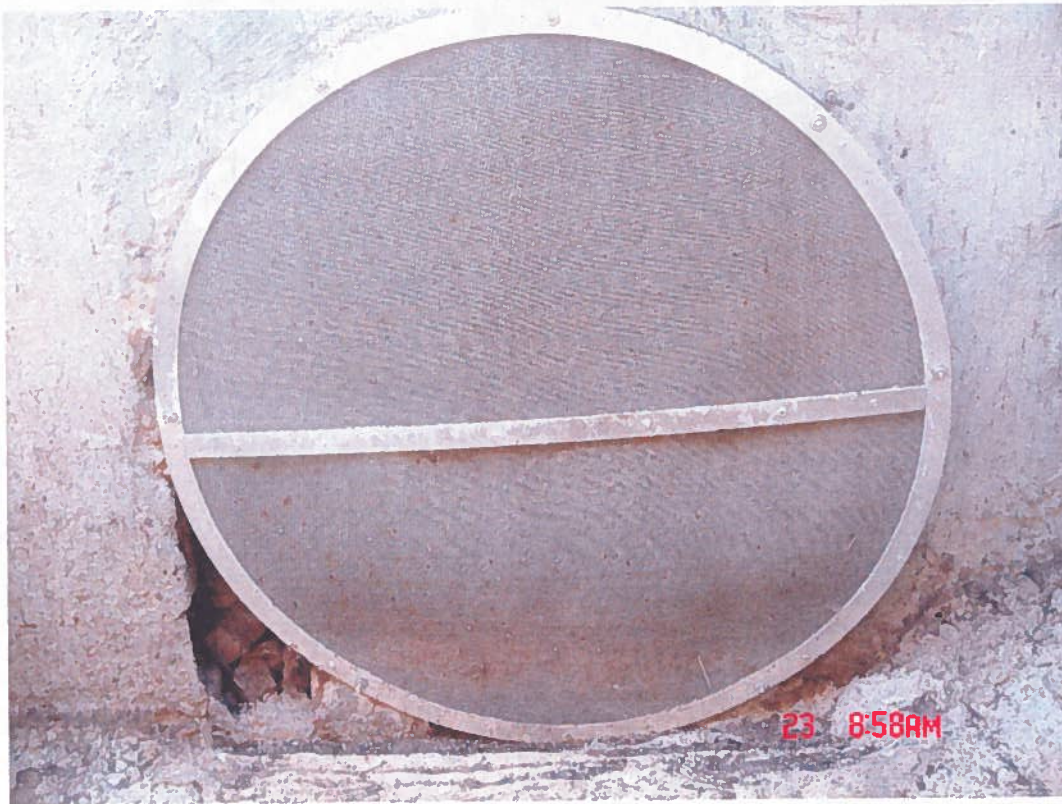
Photograph of stainless steel screen at combined overflow outlet for the Halawa storage tanks S-1 and S-2.

Significant Deficiency	Corrective plan of action	Action Complete or Incomplete	Expected date of completion
n/a	NONE			
	DOH Recommendation	Corrective plan of action	Action Complete or Incomplete	Expected date of completion
1	<u>Halawa Storage Tanks S-1 and S-2:</u> There are some areas of light rusting on the roof, sidewalls, and around the roof access hatch for both tanks. Recommend keeping a close eye on these rust areas and repair, resurface, and repaint as necessary.	The tanks will be periodically checked. Repairing, resurfacing and repainting will be done, as necessary.	Ongoing	Ongoing
2	<u>Halawa Storage Tanks S-1 and S-2:</u> The SDWB was not able to inspect the overflow outlet pipes for both tanks in order to verify the condition and if the outlets had either a screen or flapper valve. Recommend providing photo evidence of the outlets and installing either a stainless steel screen or flapper valve if needed.	Halawa Storage Tanks S-1 and S-2 have a combined overflow outlet with a stainless steel screen. A picture of the stainless steel screen at the combined overflow outlet is provided on the following page.	Complete

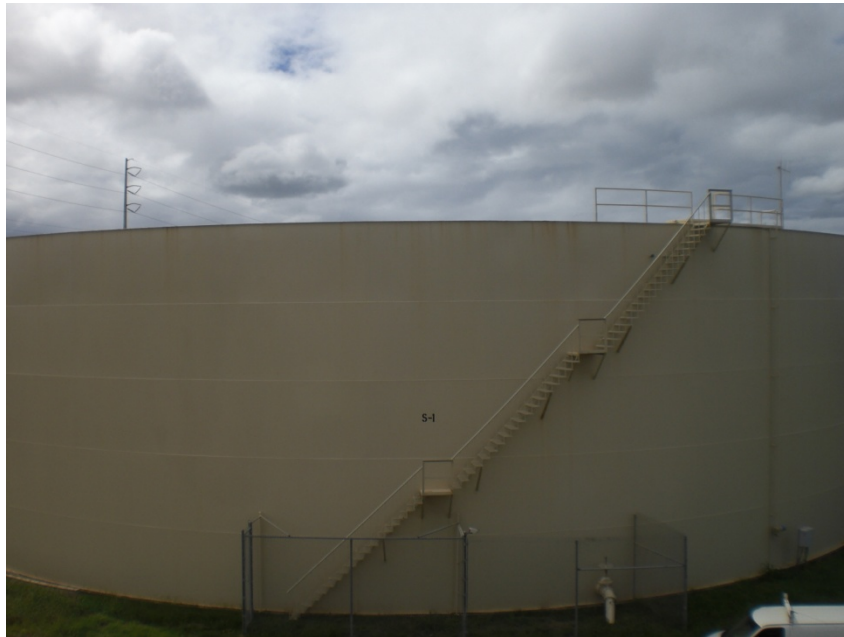
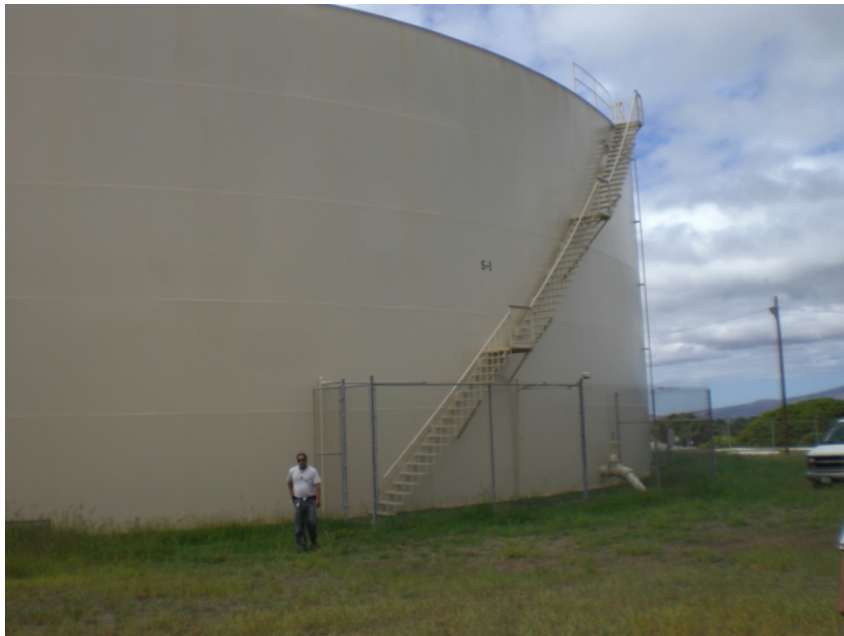
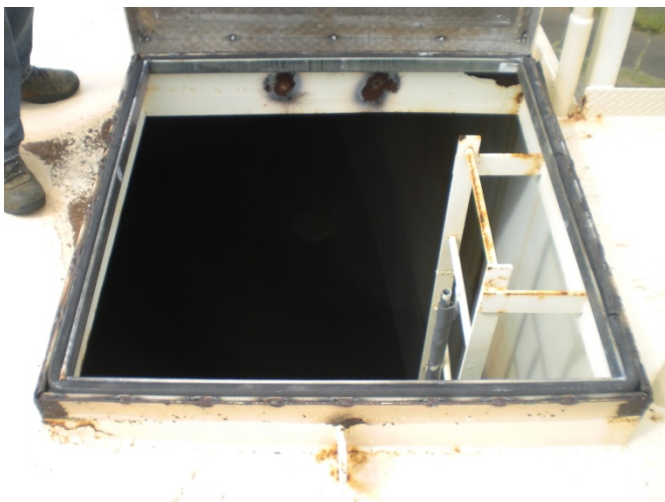
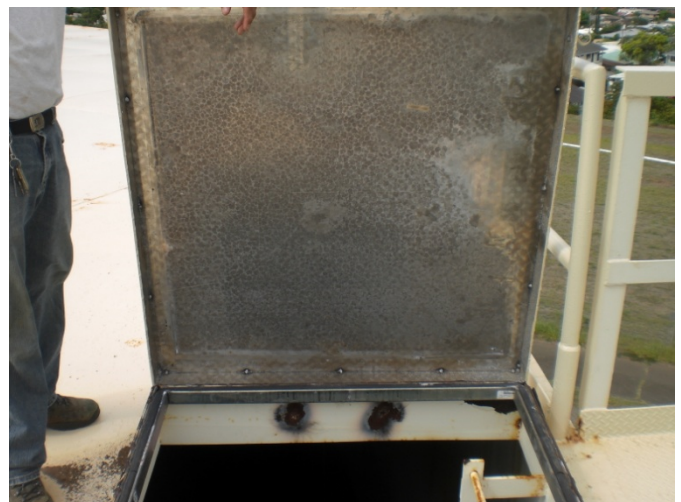
Halawa Storage Tank S-1, 6 MG, steel

1. Halawa Storage Tanks S-1 and S-2
 - a. There are some areas of light rusting on the roof, sidewalls, and around the roof access hatch for both tanks. Recommend keeping a close eye on these rust areas and repair, resurface, and repaint as required.
 - b. The SDWB was not able to inspect the overflow outlet pipes for both tanks in order to verify the condition and if the outlets had either a screen or flapper valve. Recommend providing photo evidence of the outlets and installing either a stainless steel screen or flapper valve if needed.

comments: There are some areas of light rusting on the roof, sidewalls, and around the roof access manhole hatch. Recommend keeping a close eye on these rust areas and repair, resurface, and repaint as required. SDWB was not able to inspect the overflow outlet. Recommend providing photo evidence of the outlet and install a flapper valve or stainless steel screen if required.

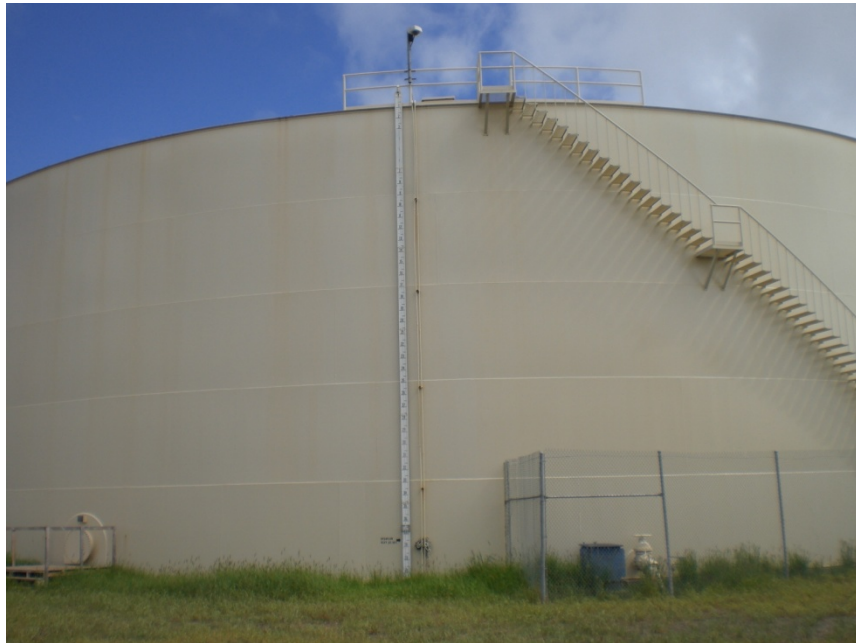
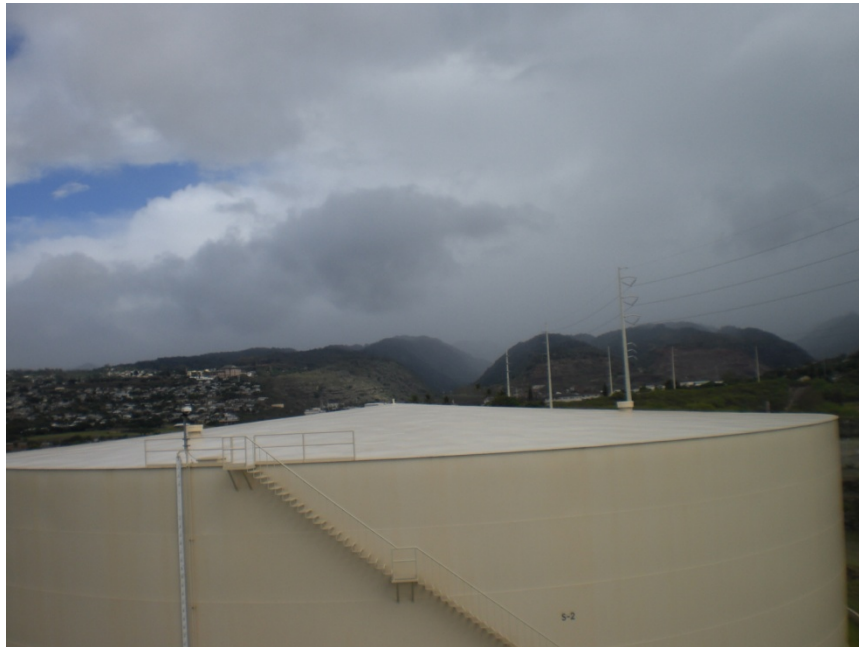
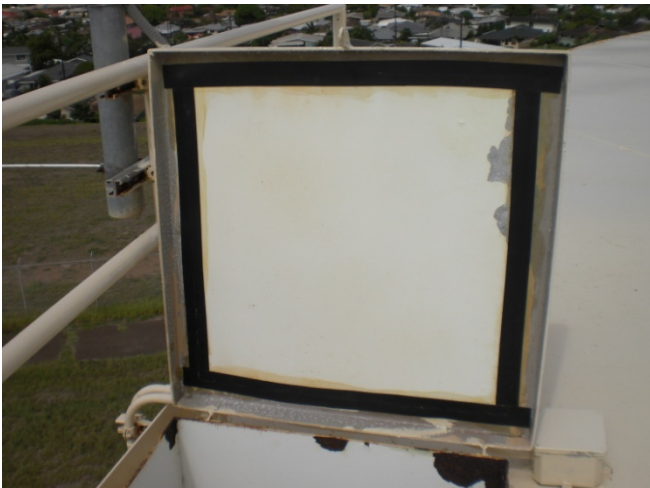
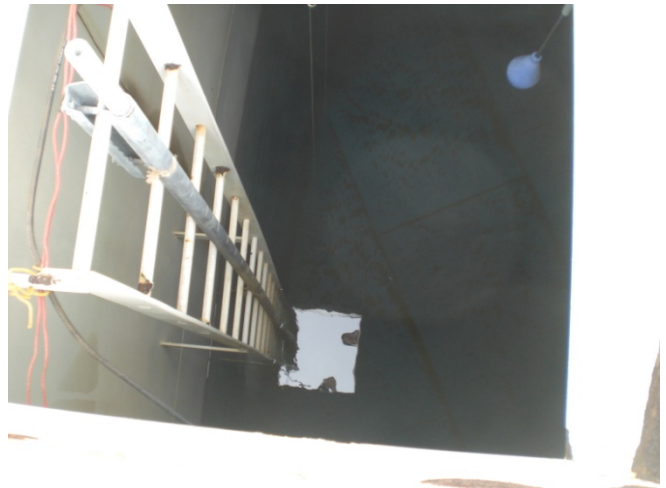
Halawa Storage Tank S-2, 6 MG, steel

comments: There are some areas of light rusting on the roof, sidewalls, and around the roof access manhole hatch. Recommend keeping a close eye on these rust areas and repair, resurface, and repaint as required. SDWB was not able to inspect the overflow outlet. Recommend providing photo evidence of the outlet and install a flapper valve or stainless steel screen if required.

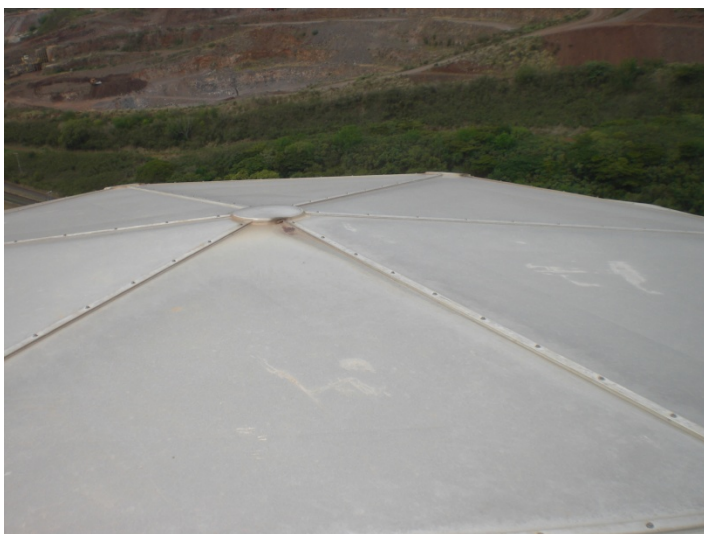
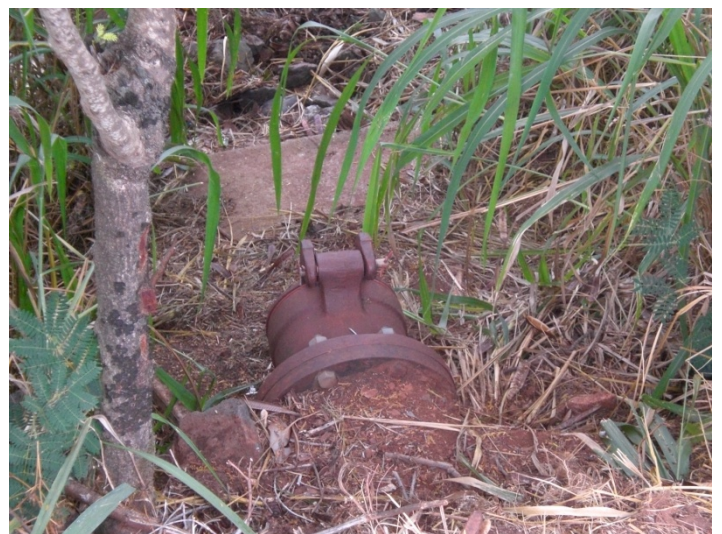
Tank roof

Overflow outlet pipe with flapper valve
