DEPARTMENT OF THE ARMY
HEADQUARTERS, UNITED STATES ARMY GARRISON, HAWAII
DIRECTORATE OF PUBLIC WORKS
947 WRIGHT AVENUE, WHEELER ARMY AIRFIELD
SCHOFIELD BARRACKS, HAWAII 96857-5013

U.S. Army Garrison, Hawaii
DOH Sanitation Survey Aliamanu
Public Water System #337 Official Findings
November 30, 2016*

SUBJECT: REPORT OF SANITARY SURVEY
PUBLIC WATER SYSTEM NO. 337, ALIAMANU

U.S. Army Garrison, Hawaii
DOH Sanitation Survey Schofield Barracks
Public Water System Findings
October 26, 2016

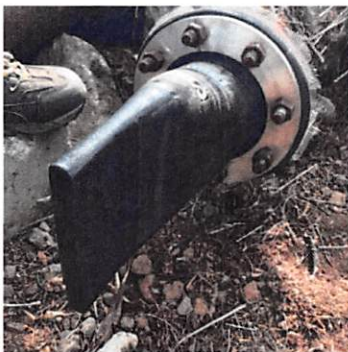
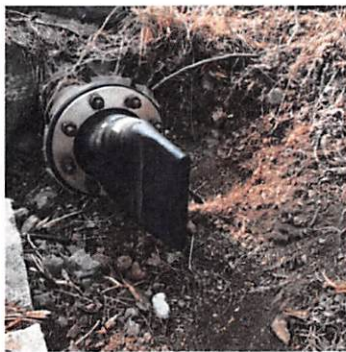
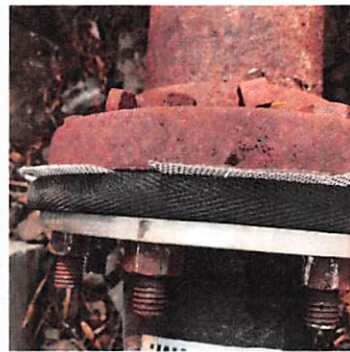
AMR South Tank

- **Significant Deficiency:** The flapper at the end of overflow line is unable to seal due to the rusty condition. Refurbish or replace. **CORRECTED:** Temporary fix completed 12/13/2016. Permanent repairs completed 1/17/17 – replaced with new duckbill valve. Double mesh stainless steel screen for added protection.

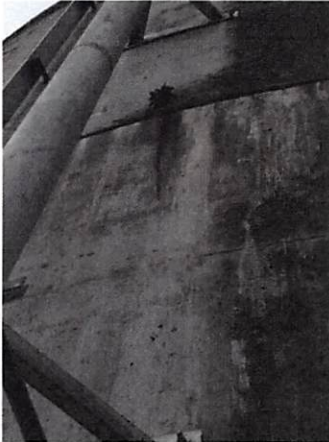
- **Recommendation #1:** Repair the potential spalling spots and the exposed rebar. Remove the vegetation on the tank exterior. **IN PROGRESS:** Facilities Engineering Work Request (FEWR) submitted for project completion, possible FY18 funding.

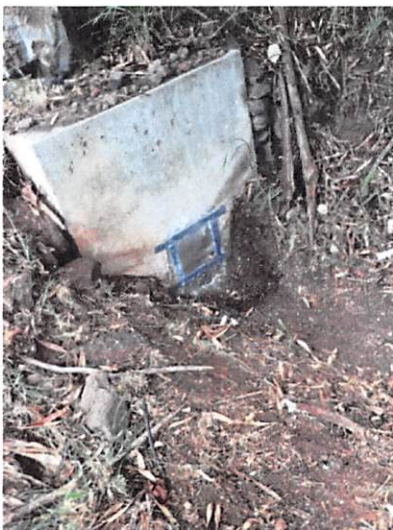
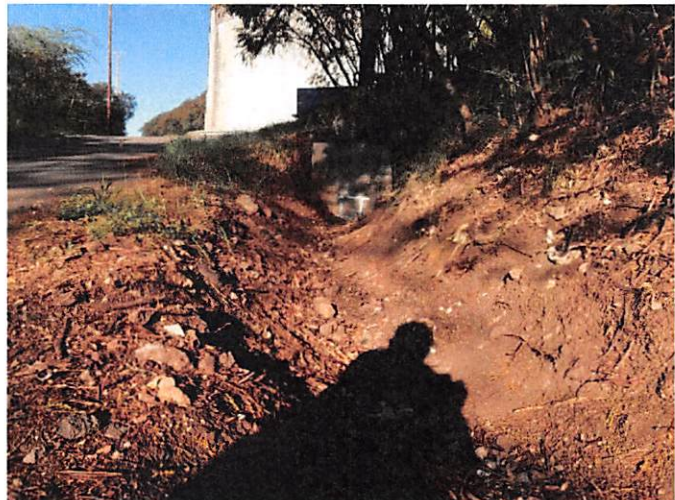
- **Recommendation #2:** Remove the sump condition in front of the overflow line and provide a free flowing trench that is graded away from the end of overflow line. **CORRECTED:** Sump conditions removed, trench cleared away from overflow line and graded to slope away from outlet.

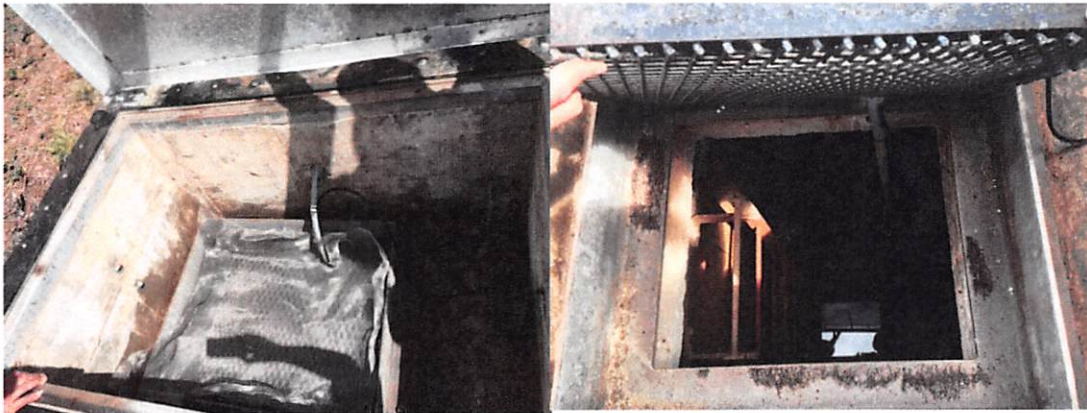
- **Recommendation #1:** Make sure the roof access hatch screen is installed and mounted on the frame instead of covering the frame. **IN PROGRESS:** *Maintenance/Repair Work Report requested through electrical/mechanical contractors to install and mount screen to completely cover the frame. Contract Number: W912CN-15-D-0008, Work Request Number: WTP 101.*

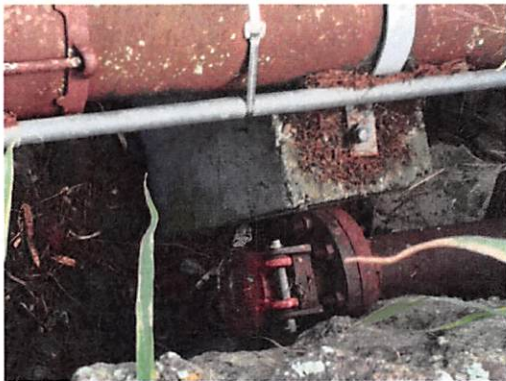
- **Recommendation #2:** Clean the vegetation and shrubbery near the end of the overflow line. **IN PROGRESS:** *Operations and Maintenance Division notified to clear overflow line free of vegetation, dirt and debris.*

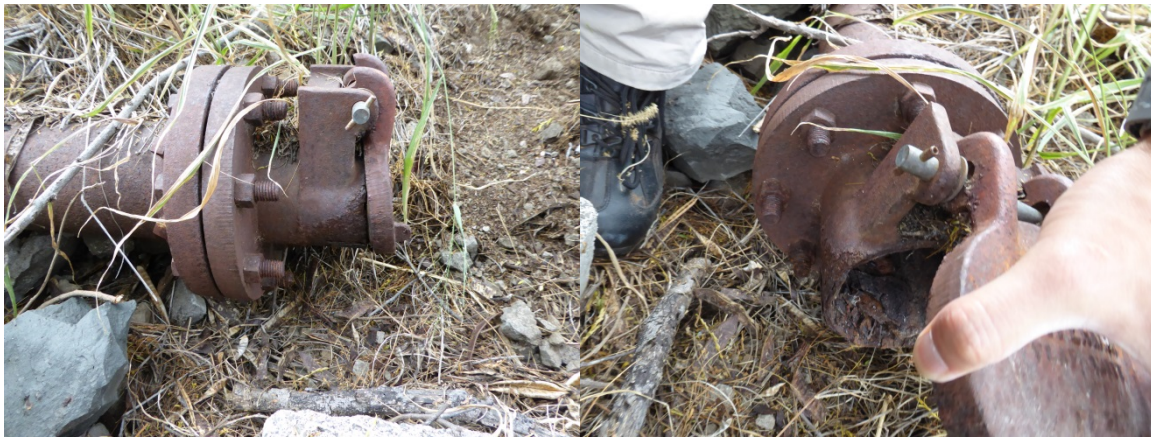
The flapper at the end of the South Tank overflow line is unable to seal due to the rusty condition.

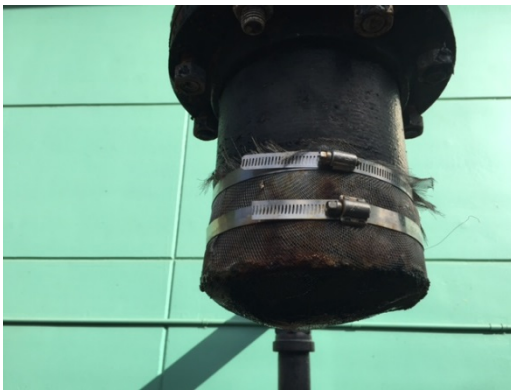
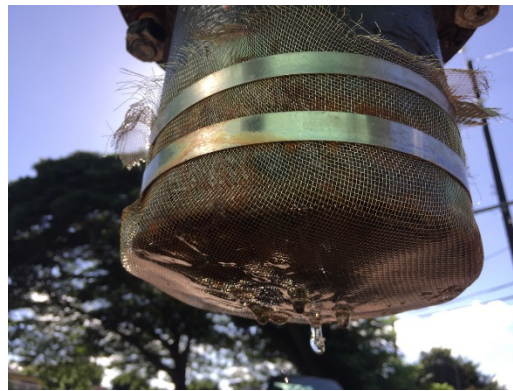
Recommendation #2: Clean or replace the dirty screen at the end of pump-to-waste line. **CORRECTED:**
Debris removed and screen cleaned.

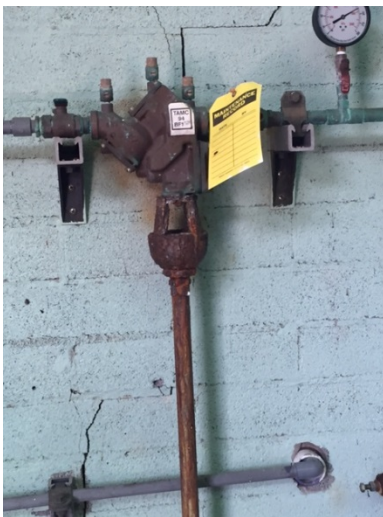
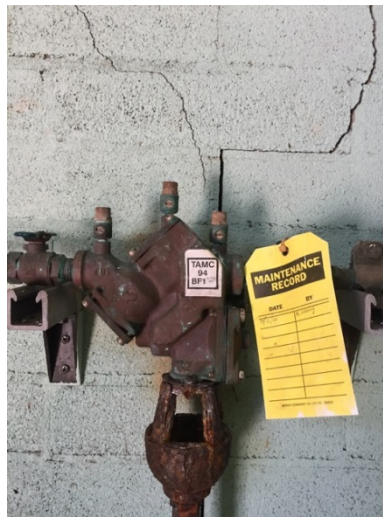
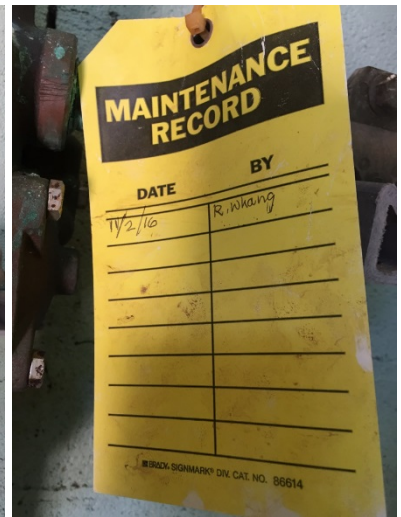
Recommendation #3: Disconnect old Chlorine injection pump system by removing connection at backflow preventer. Alternative action is to conduct annual testing on the pump. **CORRECTED:**
Serviced backflow preventer on November 2, 2016

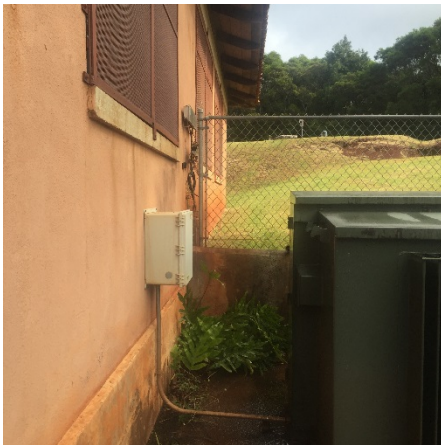
*****Recommendation #2:** An out-of-service electrical panel within the transformer enclosure should be removed. **CORRECTED:** Removed electrical box

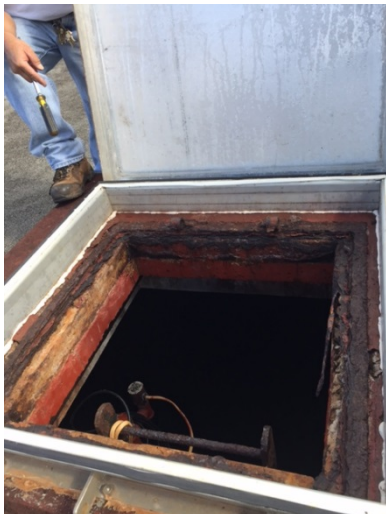
Recommendation #3: Remove or refurbish the rusty iron frame inside the hatch to prevent rusted frame pieces from falling into the tank.

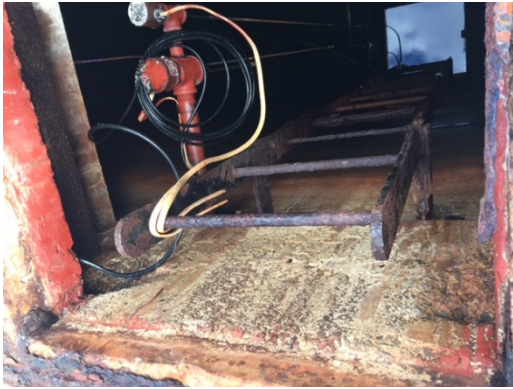
Recommendation #4: Replace/fix the rusty iron ladder inside the tank.

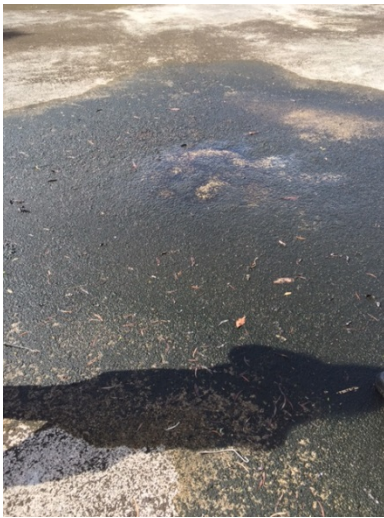
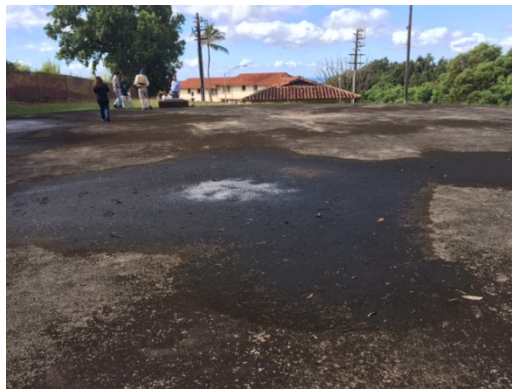
Recommendation #5: Power wash the tank top to remove the bio-mess.

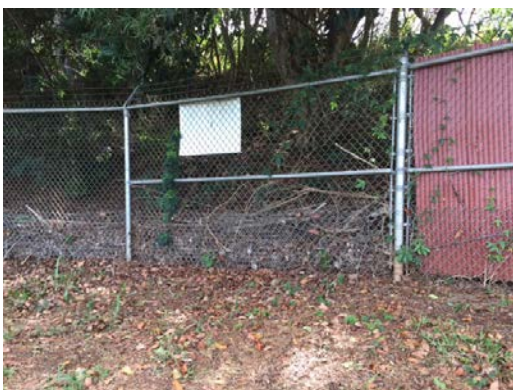
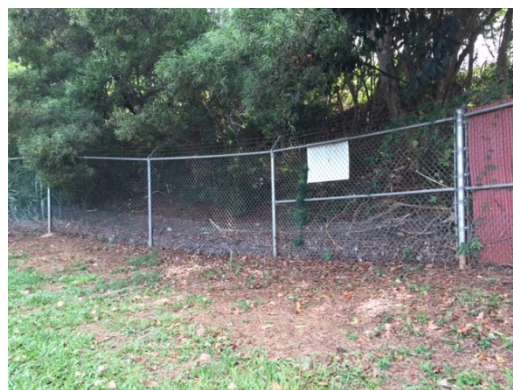
Recommendation #6: It is clear that there is runoff from hill, provide a presentational solution/plan, e.g. graded swale around the back side.

Yesterday, we conducted a site visit of TAMC 240 to assess storm drainage concern noted in Recommendation #6. The site visit included our stormwater program staff, facilities manager and agronomist. Based on the site visit we determined the best way to address the Recommendation #6 is to cut back the vegetation. The debris that is observed along the fence was accumulated over several years and not a result of a single, recent rain event.

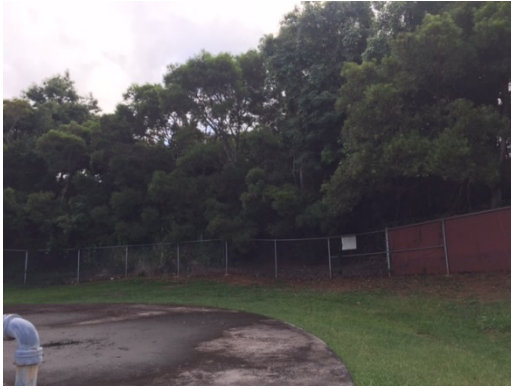
Recommendation #7: Cut the trees around the fence with 10-20 feet wide clear space. **IN PROGRESS:** Wayde contacted Contract Services to have landscapers cut back vegetation.

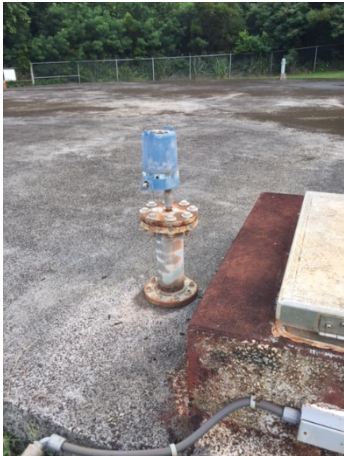
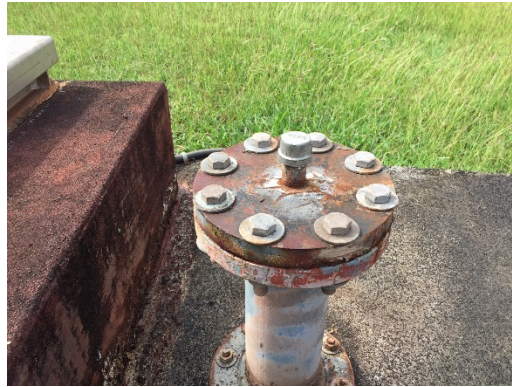
Recommendation #8: Remove the unused level control equipment and electrical conduit penetrations on the tank roof and seal the opening. **CORRECTED:** Removed old, not-in-use level transducer and capped opening.

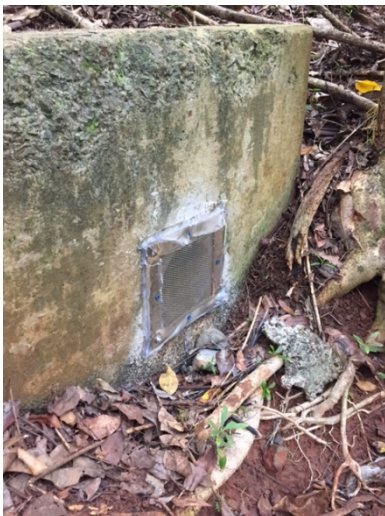
*****Recommendation #9:** Overflow discharge pipe (daylight) should be extended and a screen attached that is secure but can still be easily removed if cleaning is required.

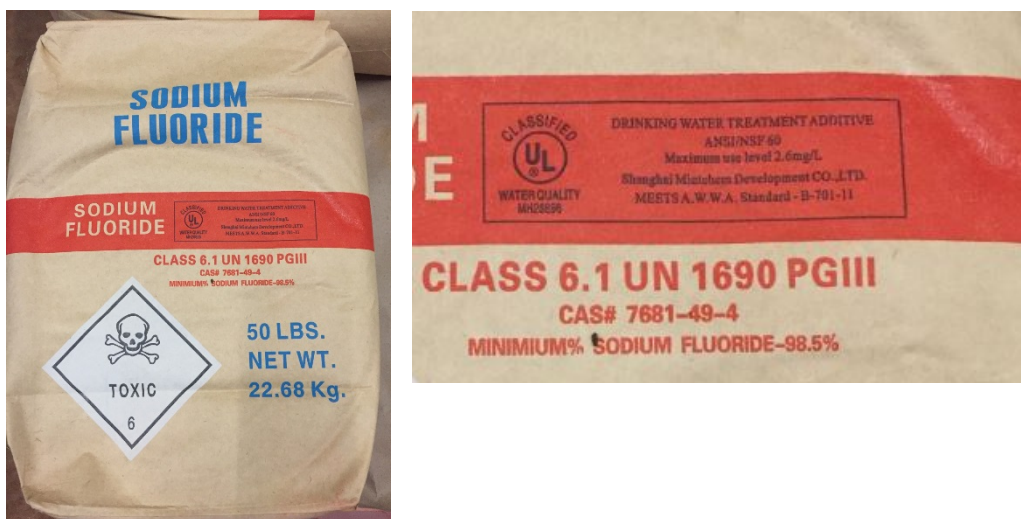
*****Recommendation #10:** Provide evidence of the sodium fluoride manufacturer's NSF 60 certification.
CORRECTED: Provided photo of sodium fluoride packaging with NSF 60 certification label.

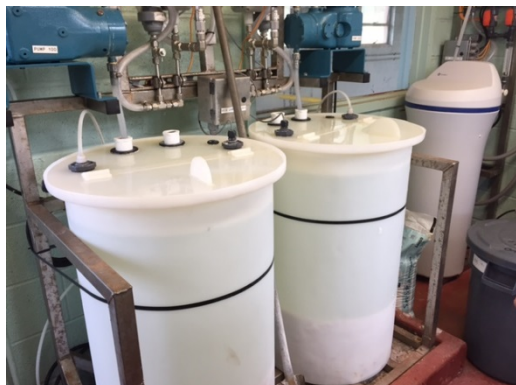
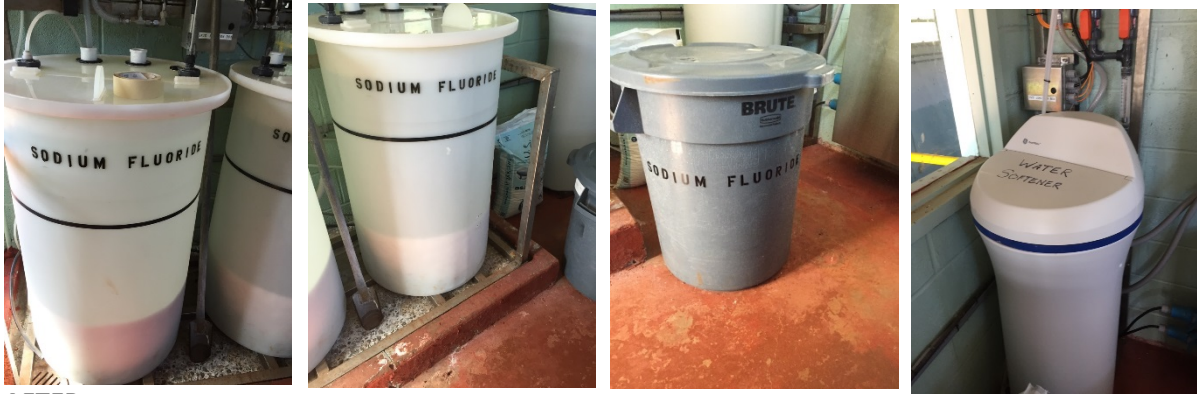
Recommendation #11: Label 2 containers for fluoride solution, the container of fluoride powder and the container of softener. **CORRECTED:** Labeled fluoride vats and storage container, and water softener.

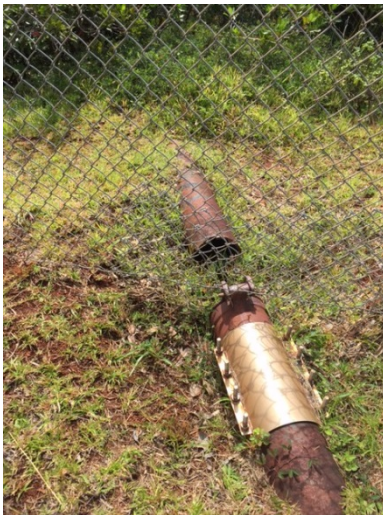
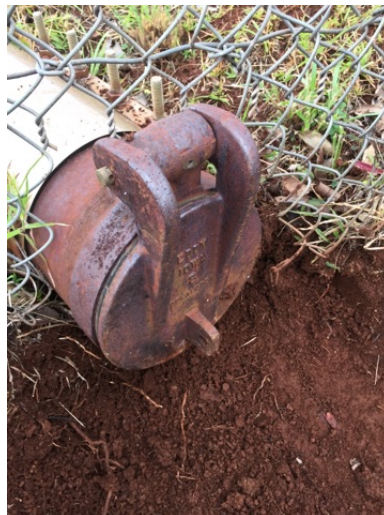
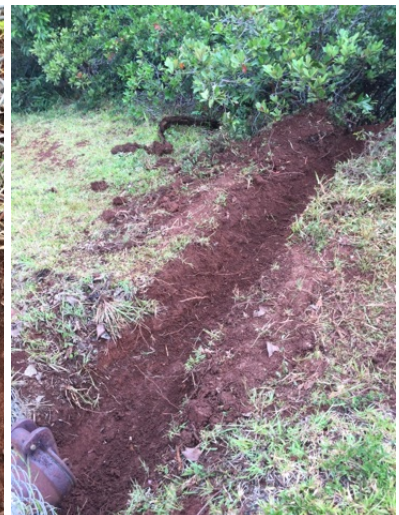
TAMC 600

Significant Deficiency: Overflow outlet flapper valve is stuck open with soil and vegetation. The flapper will not open completely due to soil and vegetation blocking the valve. Grading at the outlet doesn't allow for adequate drainage away from the flapper. Re-grade the surrounding area to allow drainage away from outlet. **CORRECTED:** cleared soil and vegetation around flapper valve, removed old piping from site and dug trench for water flow.

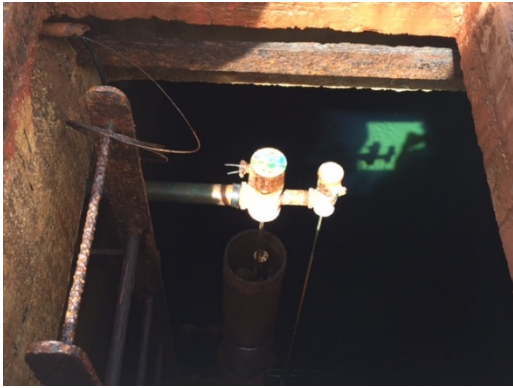
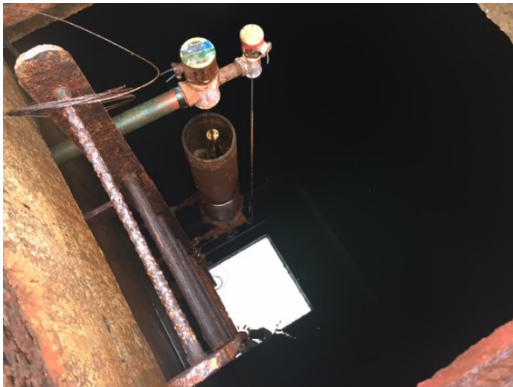
Recommendation # 1: Please overflow the tank to clean the sheen on the top of water.

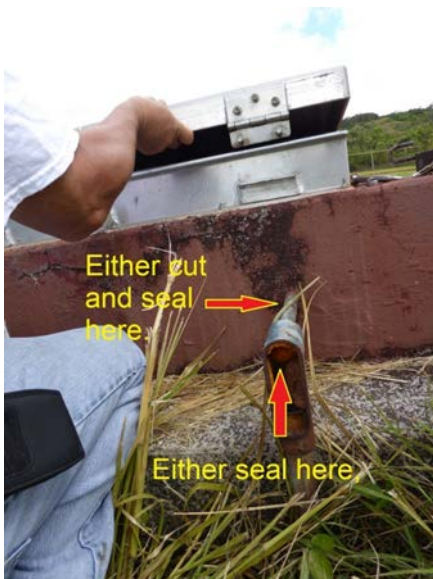
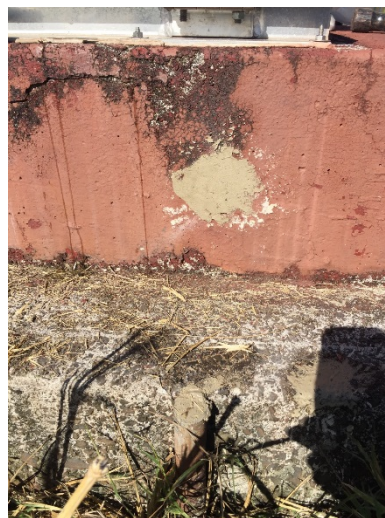
Recommendation #3: Remove and cap old/not-in-use conduit. **CORRECTED:** Removed old conduit from water tank wall and patched opening.

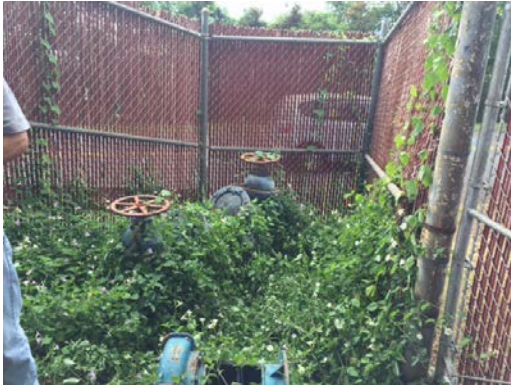
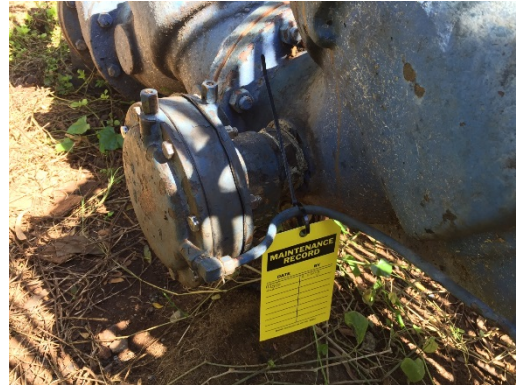
TAMC 162

Significant Deficiency: Backflow preventer has not been tested annually. Please provide evidence of testing. **CORRECTED:** Cleared vegetation and inspected BFP

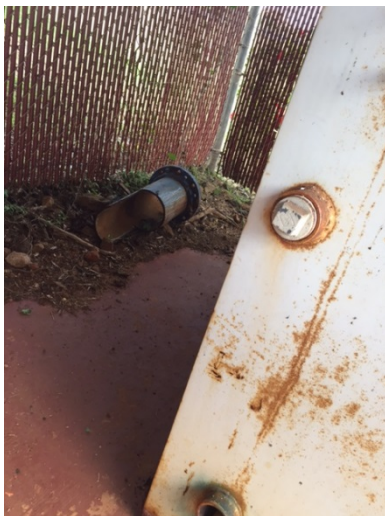
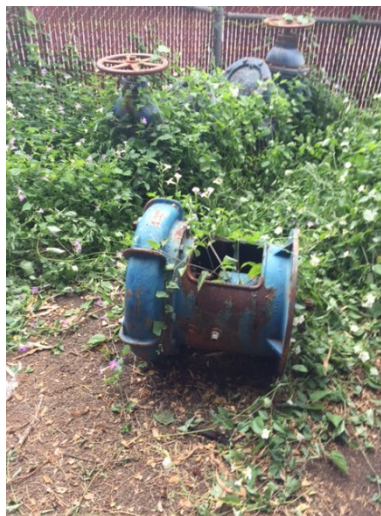
Recommendation #1: Basic housekeeping, remove the old parts and pipe from the yard, remove the overgrown vegetation.

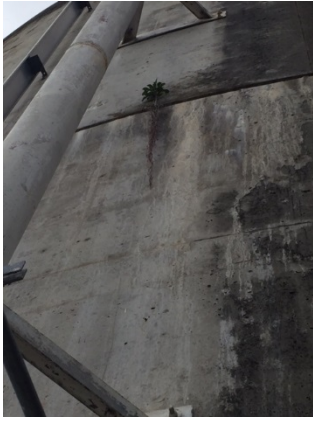
AMR 2070

*****Recommendation #1:** Take care the potential spalling and the exposed rebar. Remove the vegetation on the tank exterior.

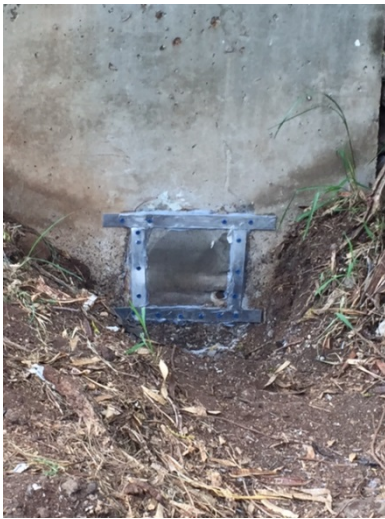
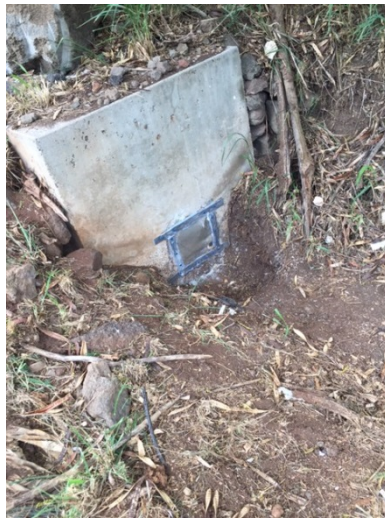
Recommendation #2: Clean the vegetation and shrubbery near the end of the overflow line. (Verbal note: Grade the area around the overflow outlet so that water flow is directed away from the outlet)

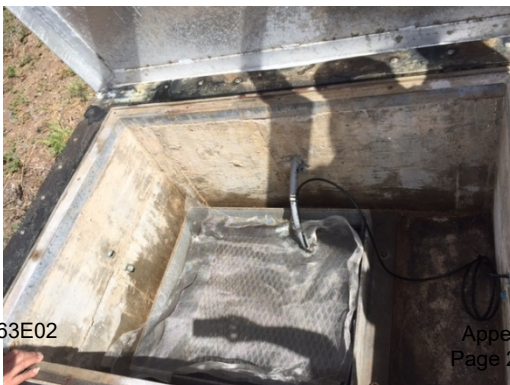
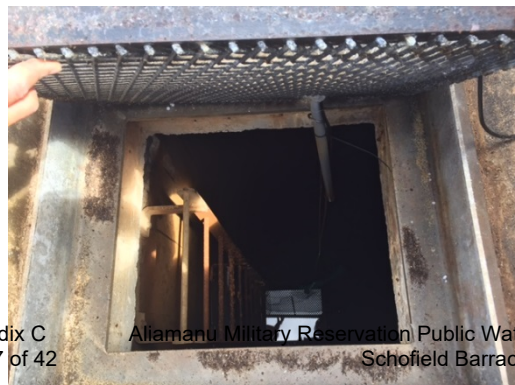
AMR 181 NORTH TANK

Recommendation #1 *(Revised from SD)*: Make sure the roof access hatch screen is installed on the frame instead of covering the frame.

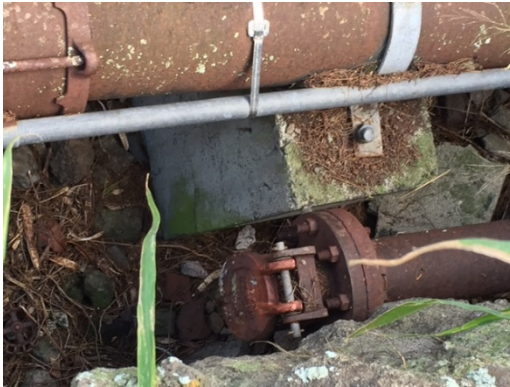
*****Recommendation #2:** Clean the vegetation and shrubbery near the end of the overflow line. (Verbal note: Replace rusty overflow outlet valve with “duckbill”)

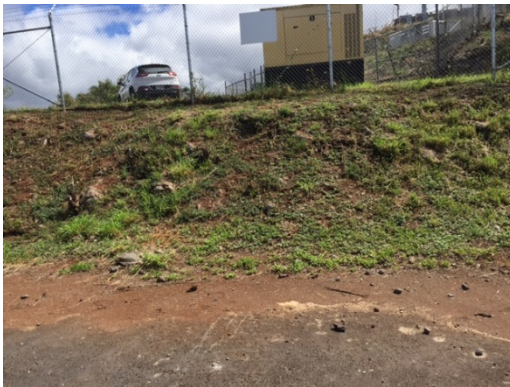
Verbal note: Keep observation on the slope on the East side of the tank. Soil erosion running onto the top of the tank. May need mitigation if erosion continues.

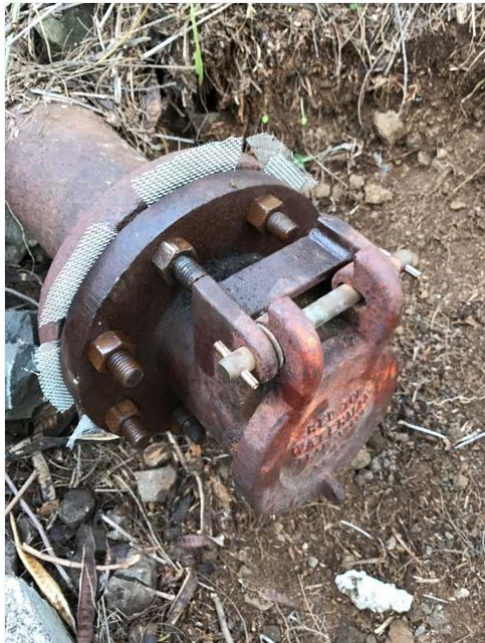
Significant Deficiency: The flapper at the end of overflow line is unable to seal due to the rusty condition. Refurbish or replace.

Photo of screen installed between the flange.

CORRECTED: Temporary fix completed 12/13/2016: Disconnected at the flange to install stainless steel screens and bolted the flange back together. A duckbill valve has been ordered and will be installed permanently once the part is received.

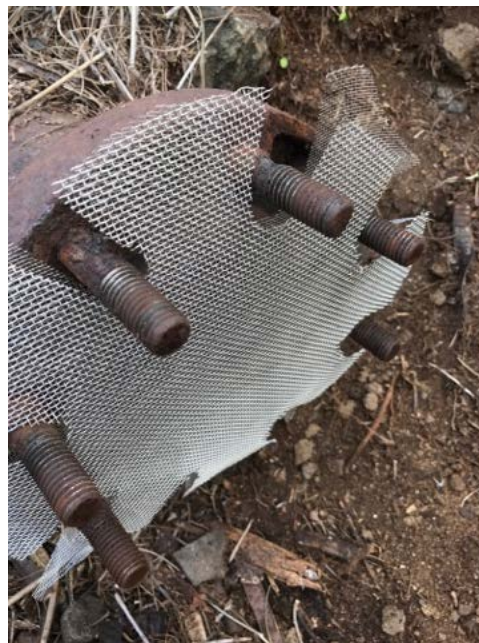
Photo of double SS wire screens

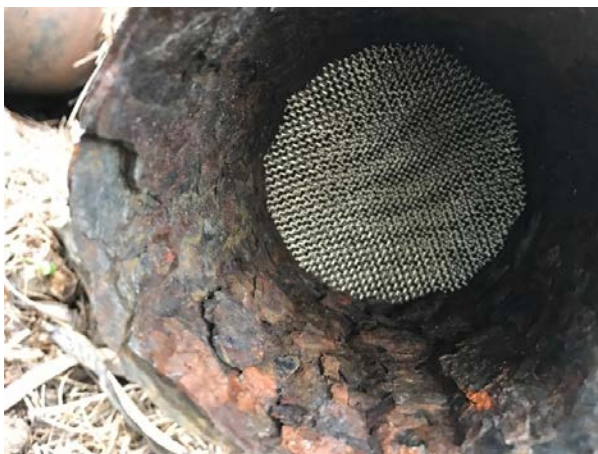
Picture of screen inside pipe.
