EPA Region 8 - Significant Deficiencies

WWQ-PCA Fall Conference October 2020

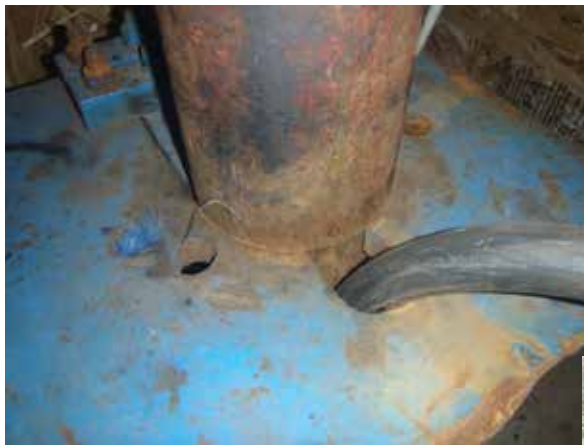
No Wellhead
Sanitary Seal;
Conduit & Wires
Not Properly
Sealed

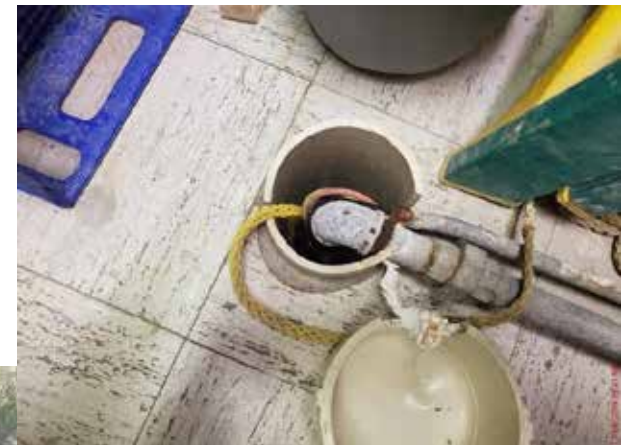
Lack of a sanitary
seal on the well
casing

Conduit
not sealed

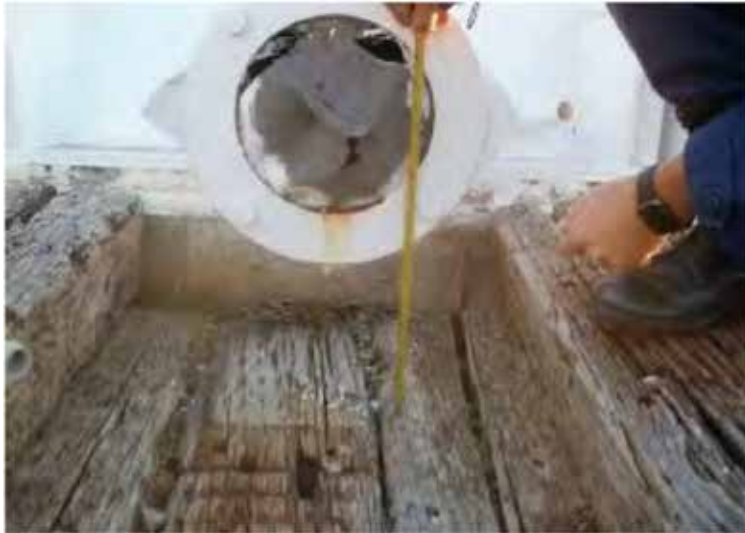
Overflow screening is torn
and needs replaced

Lack of #24 mesh screen on
the air vent

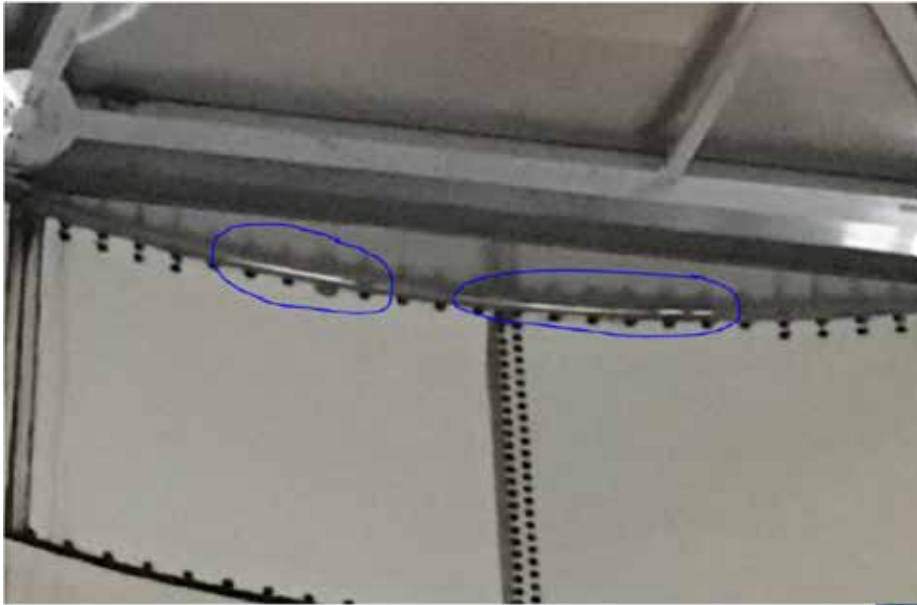
Unprotected openings in storage tank.

Hatch does not have a gasket.

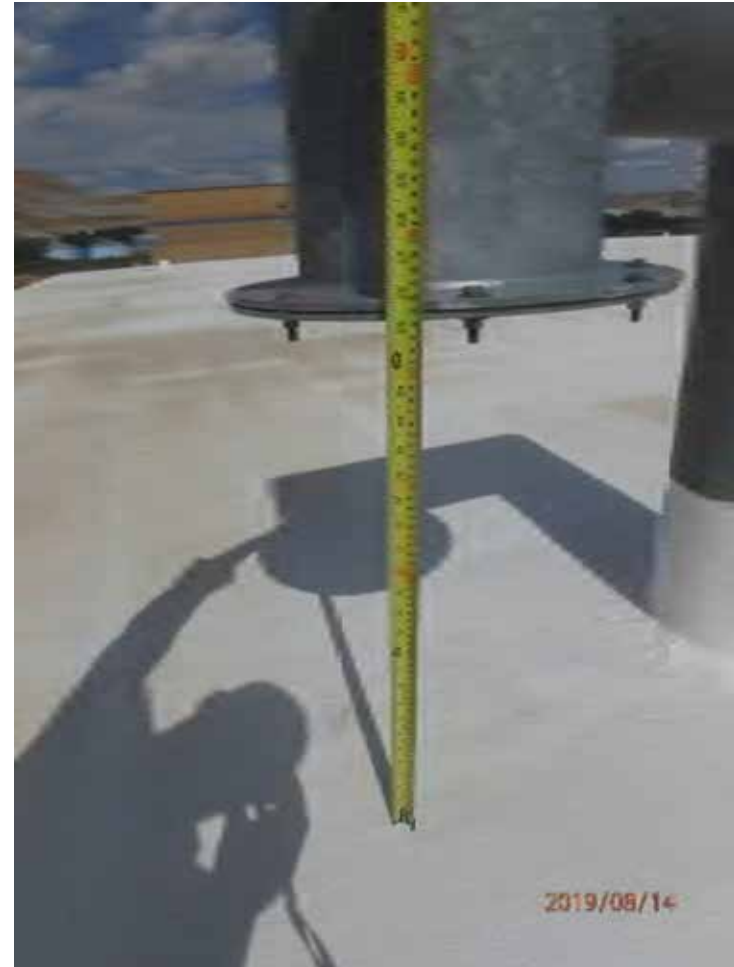
Example photo: Downturned Air Vent Height:

- Tape measure demonstrates distance from tank roof to vent opening is at least 24 inches.

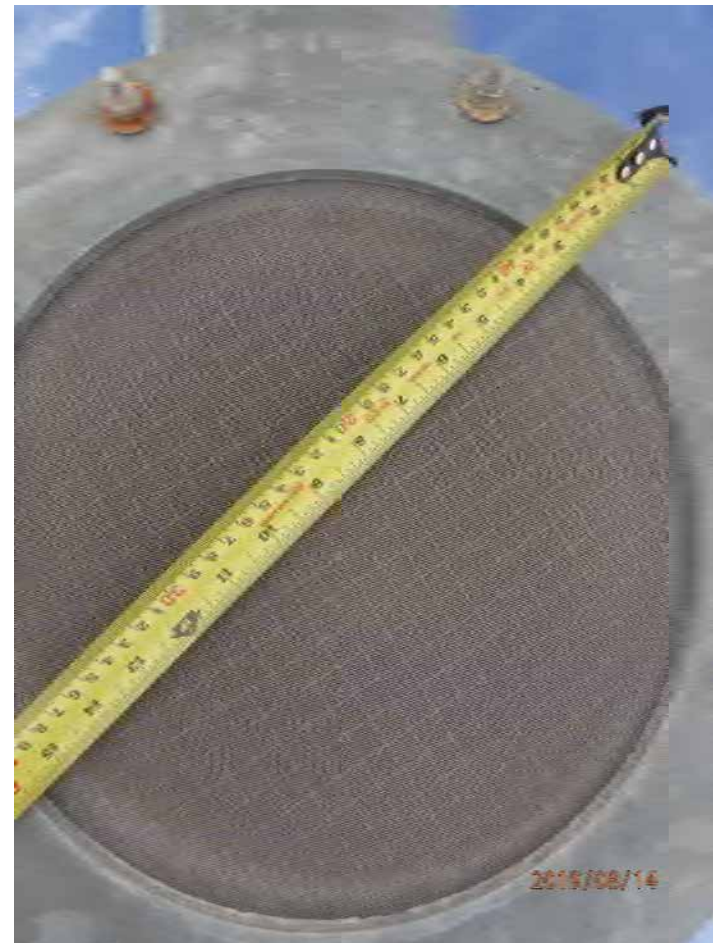
Example photo: Downturned Air Vent Screen:

- Tape measure demonstrates that screening is #24 mesh.
- Photo is adequate, but could be improved by zooming in closer to the mesh screen.

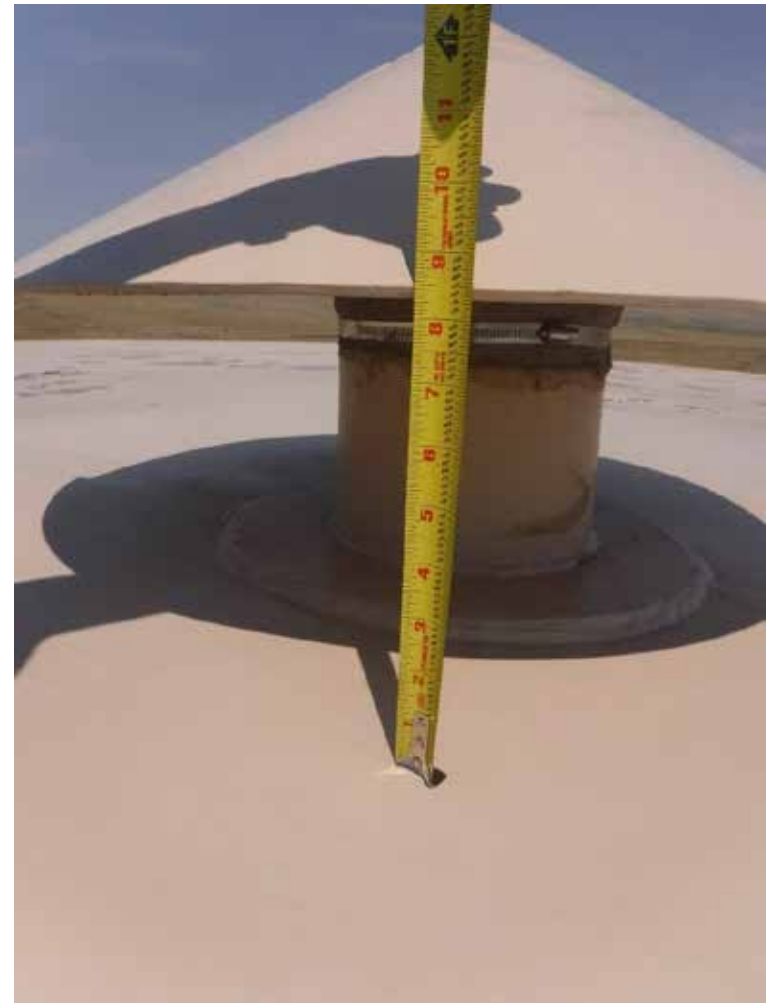
Example photo: Non-downturned Air Vent Height:

- Tape measure demonstrates that the air vent opening is at least 8 inches above the tank roof.
- Photo demonstrates that the air vent cover comes down to the bottom of the vent opening.

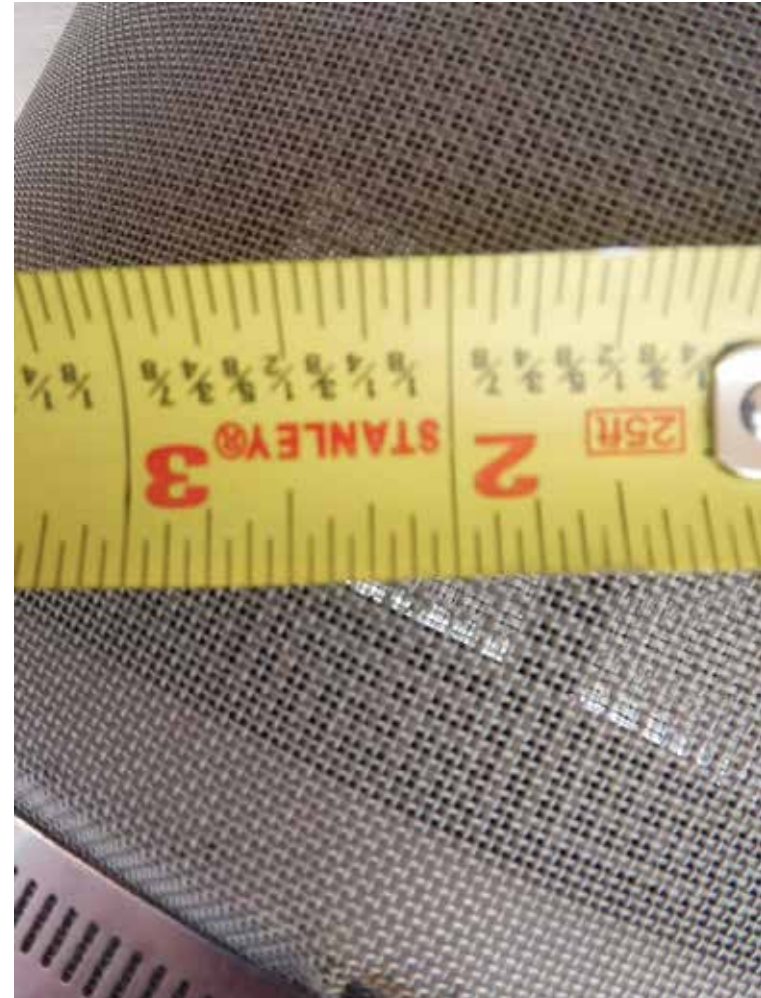
Example photo: Non-downturned air vent screen:

- Tape measure helps demonstrate that screening is #24 mesh.

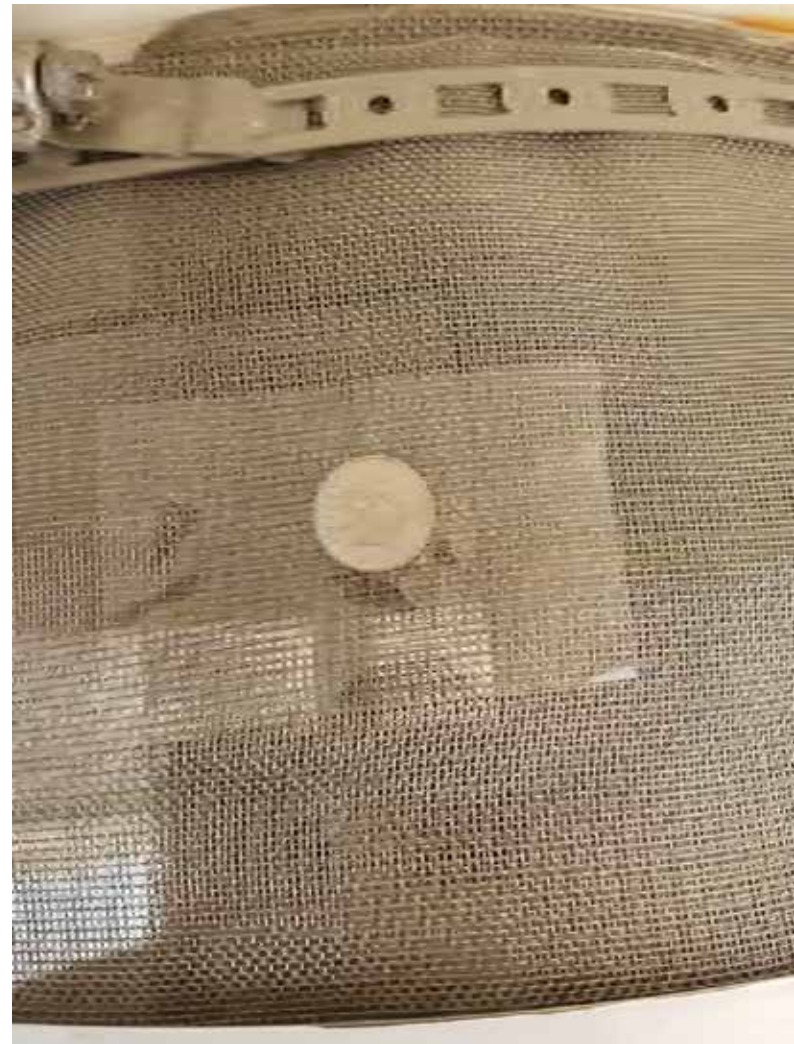
Example photo: Non-downturned air vent screen:

- Dime helps demonstrate that air vent screening is #24 mesh.

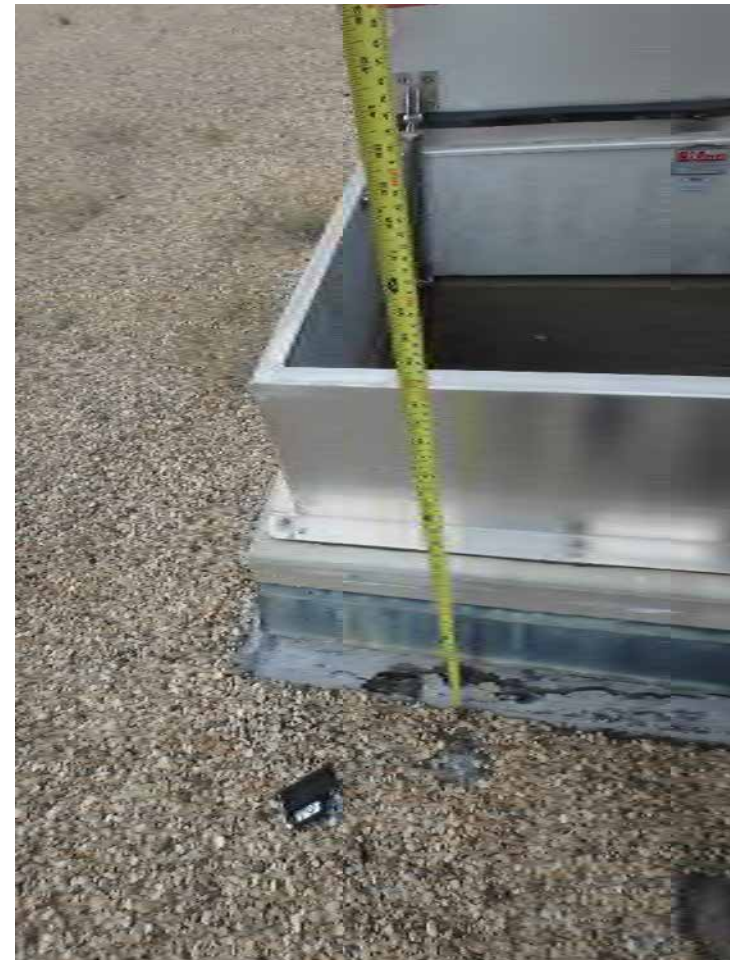
Example photo: Ground level tank hatch:

- Tape measure demonstrates that hatch height is at least 24 inches above the tank roof.

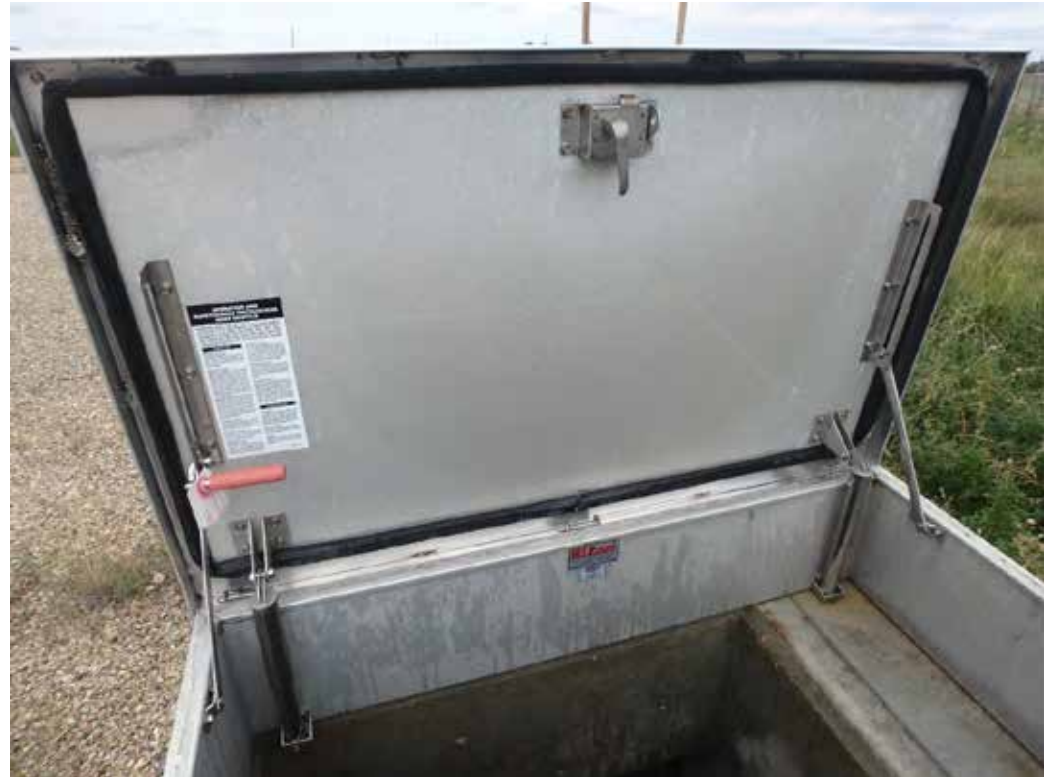
Example photo: Ground level tank hatch:

- Photo shows the presence of an adequate gasket around the entire perimeter of the hatch.
- Photo demonstrates that the hatch lid is a “shoe-box” type design (with a minimum 2” overhang)

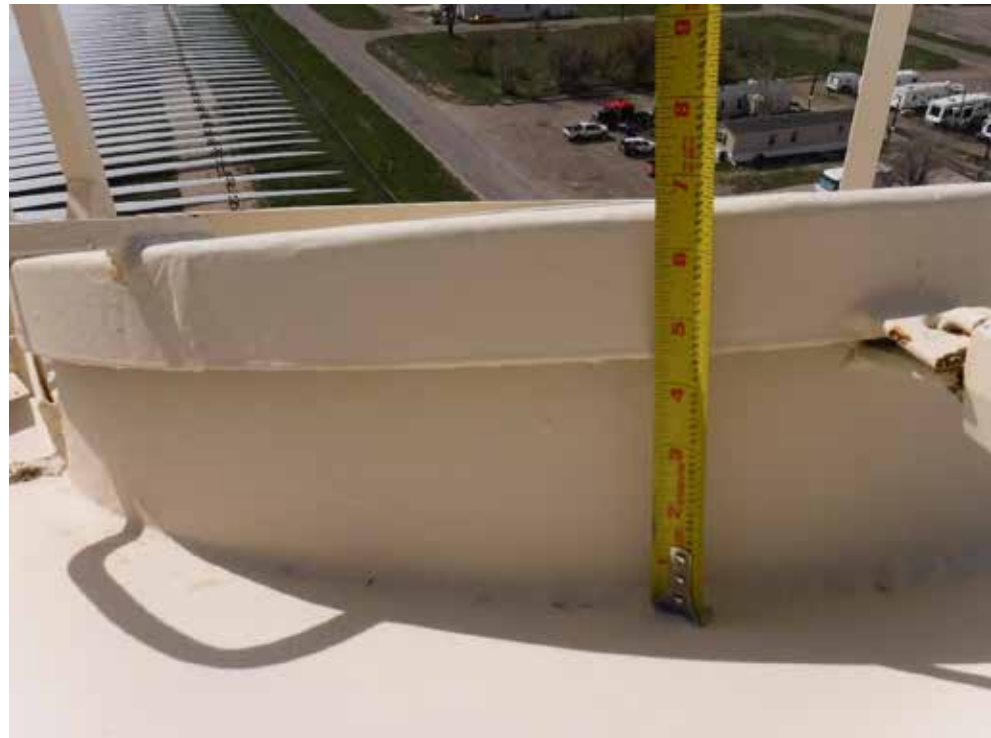
Example photo: Elevated tank hatch:

- Tape measure demonstrates that the hatch is >4 inches above the roof.
- Photo demonstrates that the hatch lid is a "shoe-box" type design with a minimum 2" overhang.

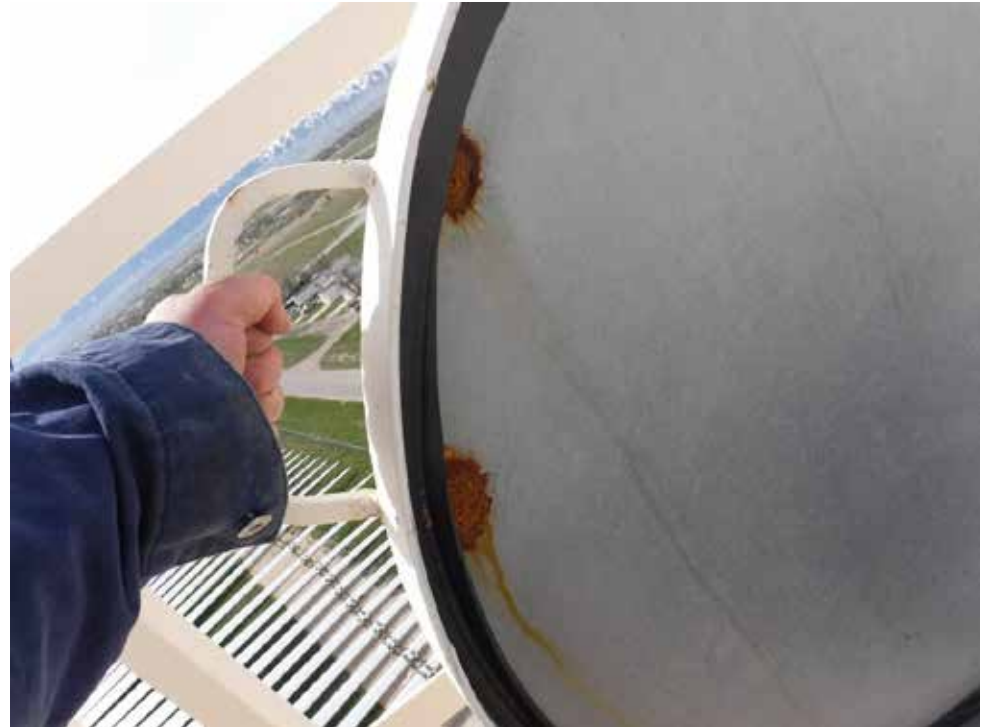
Example photo: Elevated tank hatch:

- Photo demonstrates an intact gasket.
- Given the conditions (high in the air!) the operator was not required to provide additional photos showing that the gasket went around the full perimeter of the lid.

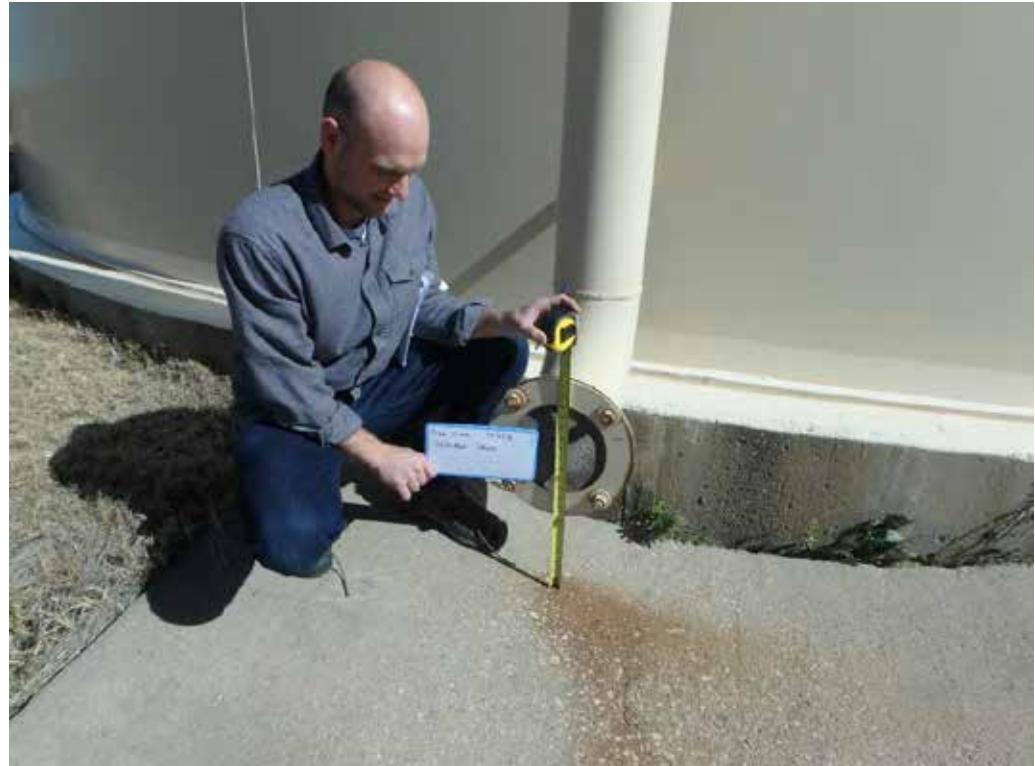
Example photo: Tank overflow discharge:

- Tape measure demonstrates discharge height between 12" and 24".
- Photo depicts a concrete drainage structure at the discharge of the overflow.

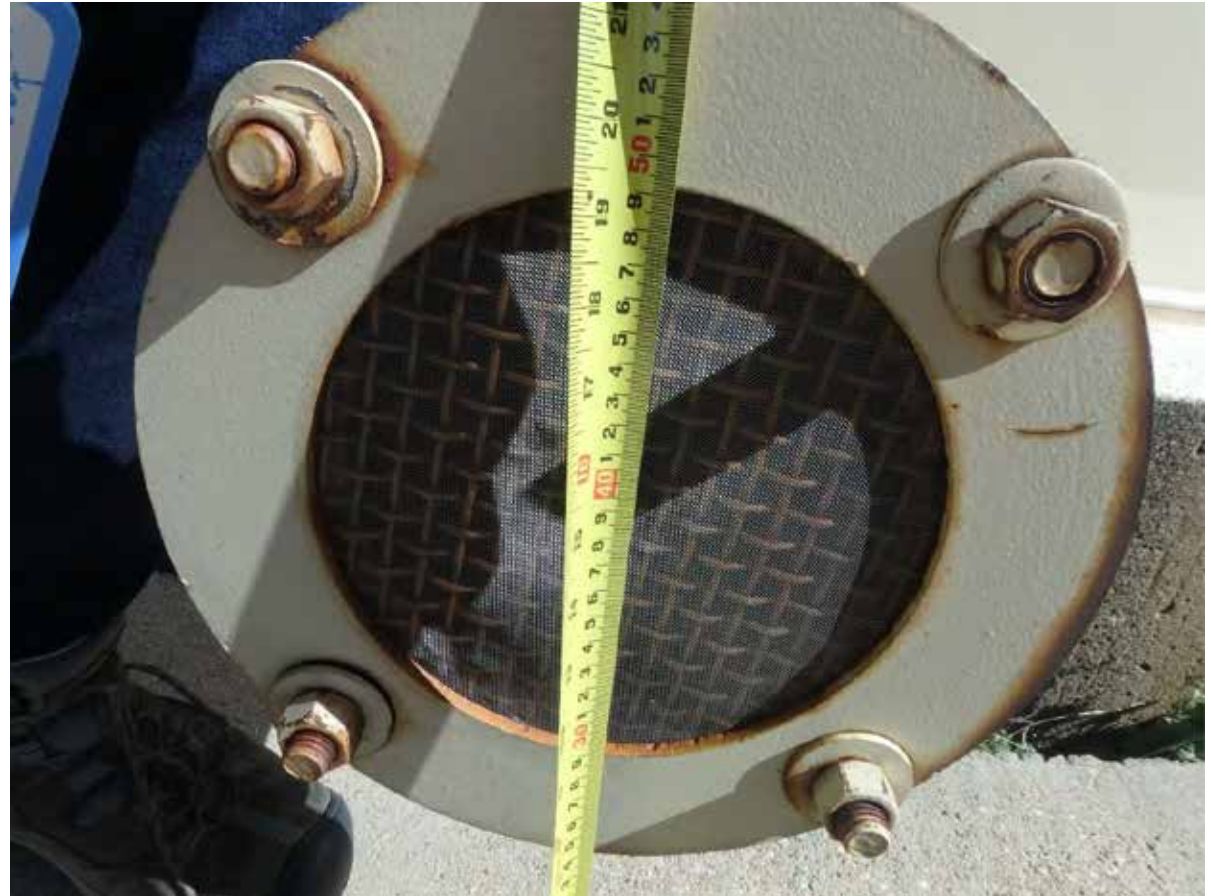
Example photo: Tank overflow discharge:

- Tape measure (roughly) demonstrates that screening is #24 mesh.
- A photo closer to the screening would improve the quality of this photo (similar to the example air vent screening photo above).

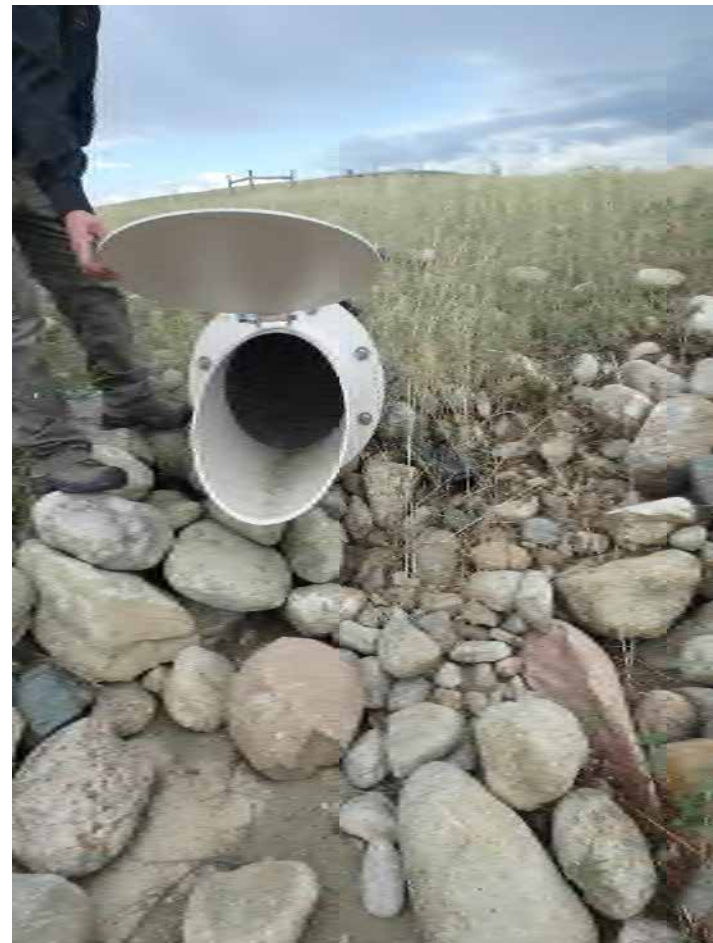
Example photo: Tank overflow discharge:

- Flap valve lifted to show presence of screening behind the valve (required).
- This photo is adequate, but a zoomed in photo that shows the internal screen more clearly would have improved the quality (the resolution is good enough that zooming in on the photo file makes the screen viewable).

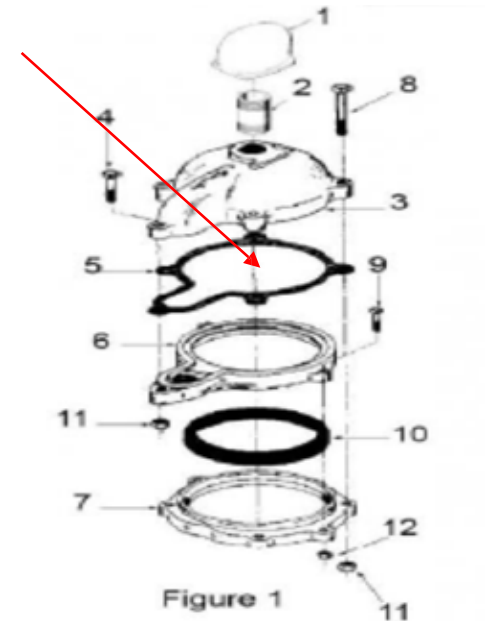
Scenario #1. The well cap is designed with an internal sanitary seal and the sanitary seal (5) *is visible* between the cap (3) and the retainer ring (6). Take a picture of the visible seal. This situation is not a deficiency if the cap is tightly bolted.

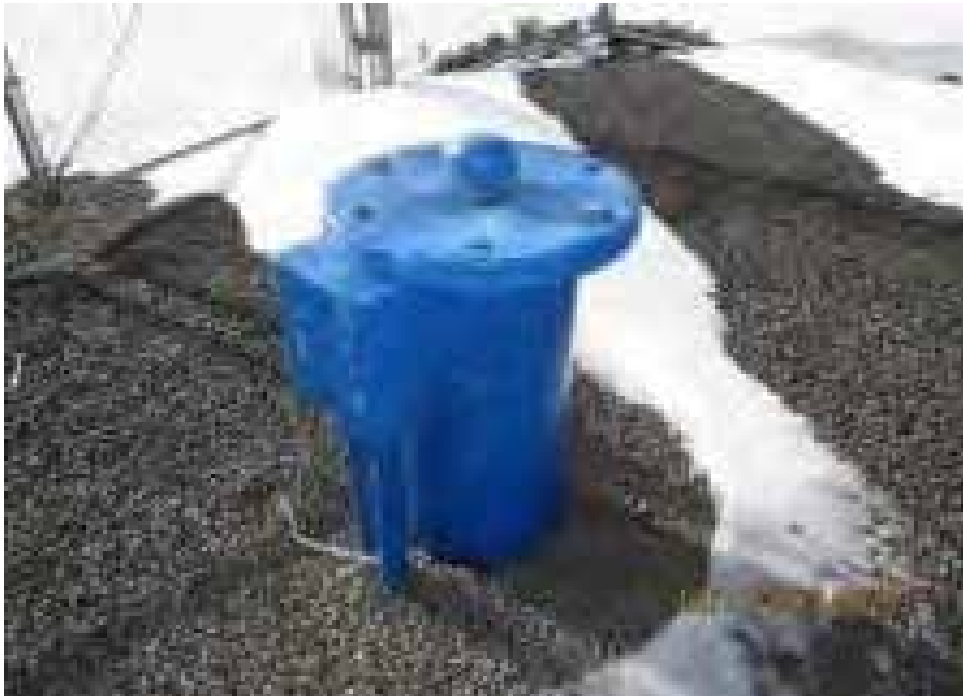
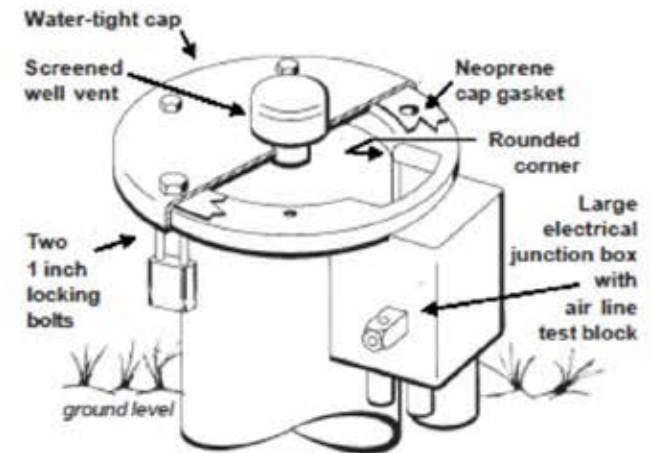
Scenario #2. The well head is designed for a sanitary seal but it is not visible between the upper and lower pieces of the cap. Remove the cap and take pictures of the internal neoprene gasket.

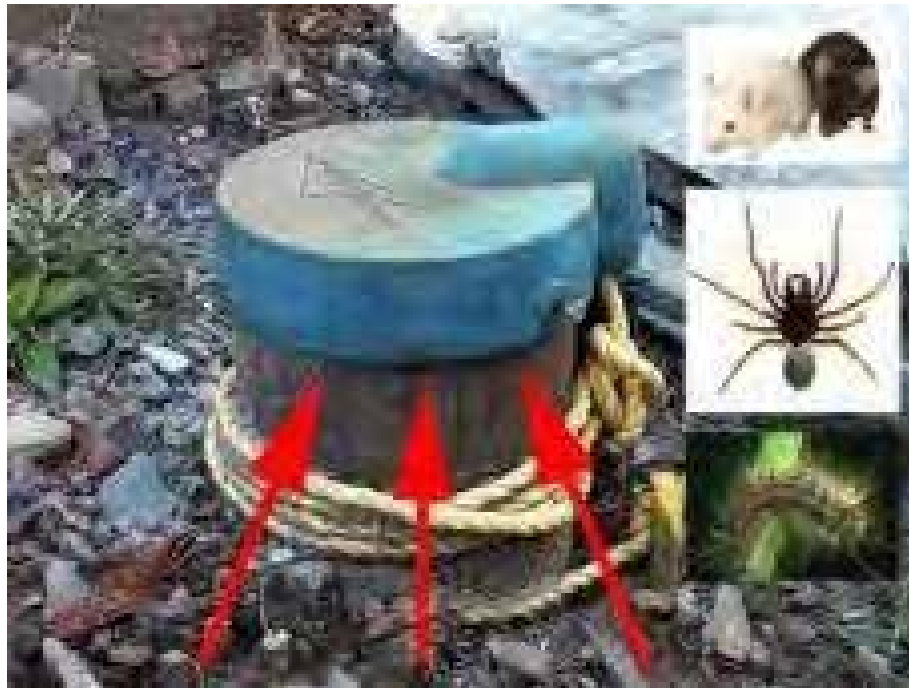
Scenario #3. Well caps is not designed to be bolted down with a compression seal, elastic gasket or O-ring. **This type of cap usually does not provide a sanitary seal and may be a deficiency.**

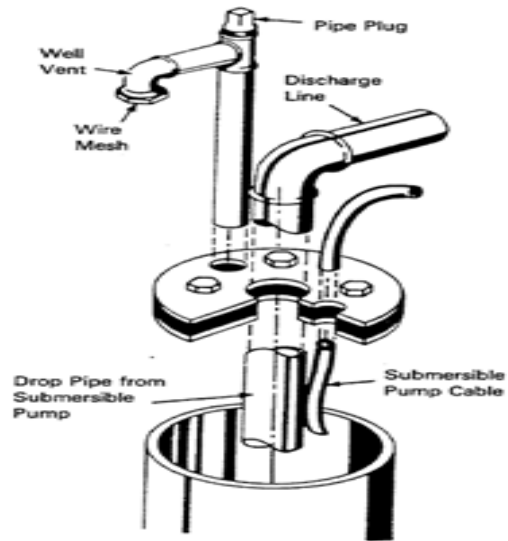
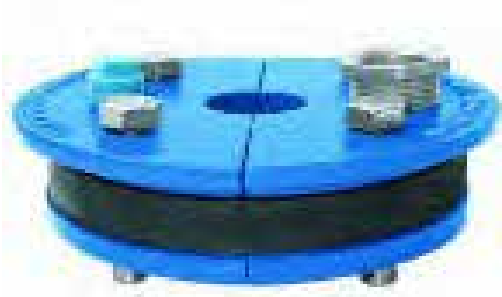
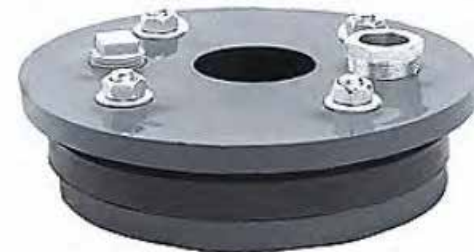
Scenario #4. "Split Plate" and "Non-Split Plate Compression Seal Well Cap" type sanitary seals or well caps with piping exiting the top of the cap. Do not open split plate type sanitary seals or wells with piping exiting the top of the well cap. This will not be an automatic deficiency unless there are other concerns (cap is loose, corroded, missing bolts, etc.).
