# NONPOINT SOURCE PROGRAM SUCCESS STORY

# New Hampshire

## Project Improves Water Quality and Saves Eroding Farmland

EPA 841-F-06-003E  
June 2006

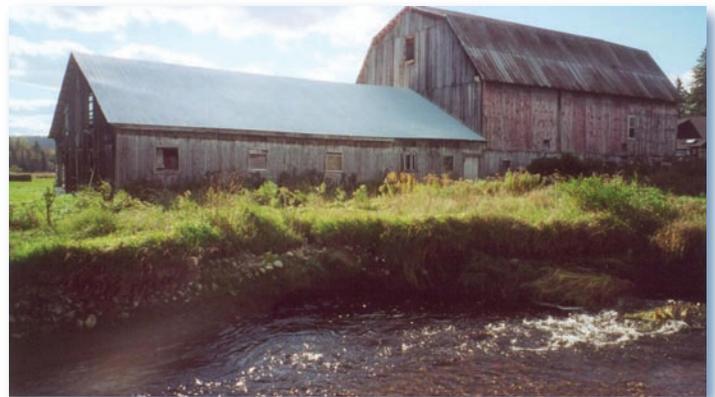
Bog Brook is in the Connecticut River Basin, near the town of Stratford in northern New Hampshire. Much of the area is in agricultural use. Decades ago, riparian vegetation was removed along the streambank, presumably to increase the amount of arable land. The absence of deep-rooted shrubs made the bank vulnerable to erosion. The once meandering stream channel became marked by a sharper bend as the bank eroded. This change in stream channel geometry caused erosion to accelerate even further. The eroding stream channel eventually threatened a barn and septic system on private property, prompting a need for action.

Analysis of aerial photographs showed that the stream channel had eroded laterally up to 35 feet between 1999 and 2003, consuming 4,000-square feet of land. This translated to 120 tons of sediment—approximately the amount needed to fill 9 dump trucks—entering the stream each year to worsen water quality and smother fish habitat. Had this been allowed to continue, the stream likely would have cut a new channel into valuable farmland, sending several thousand tons of additional sediment downstream.

Bog Brook before restoration. Removing riparian vegetation facilitated channel erosion, which ultimately threatened the barn.

- Increase the meander radius, or curvature of the bend in the stream, to reduce stress on the eroding bank
- Increase the channel slope to improve the stream's ability to transport sediment
- Plant a vegetated buffer of deep-rooted shrubs along the streambank to help hold sediments in place

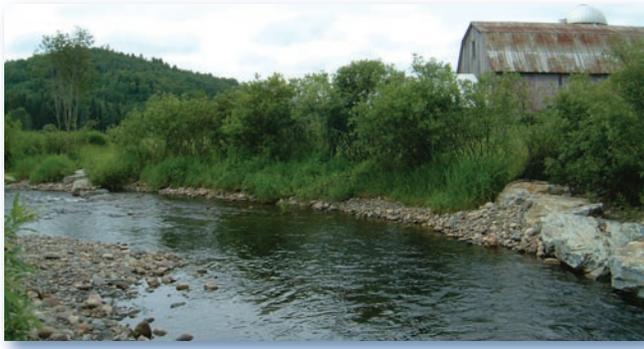
Bog Brook after restoration. The project saved the barn and stopped several thousand tons of sediment from smothering fish habitat.

One year after construction, the relocated stream reach had become more narrow and deeper—a positive trend indicative of channel stability. The vegetation along the bank was found to be well-established and firmly rooted.

Construction occurred in May 2004. Using an excavator, a small bulldozer, and several dump trucks, project leaders realigned the stream channel, filled in the former channel, and planted riparian vegetation along the streambank.
