# NONPOINT SOURCE SUCCESS STORY

### Remediating Abandoned Mines Improves Water Quality in Turkey Creek

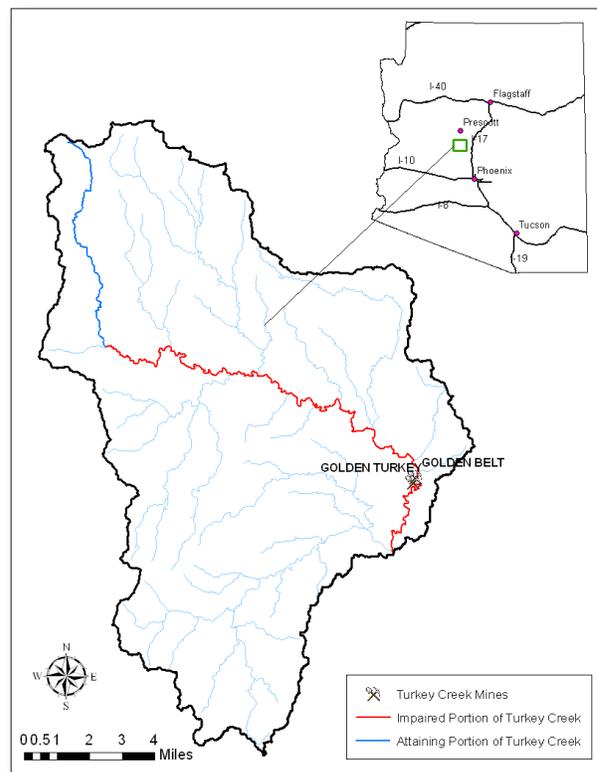
Figure 1. Pollutant loads in the impaired section of Turkey Creek have declined since mine land restoration occurred.

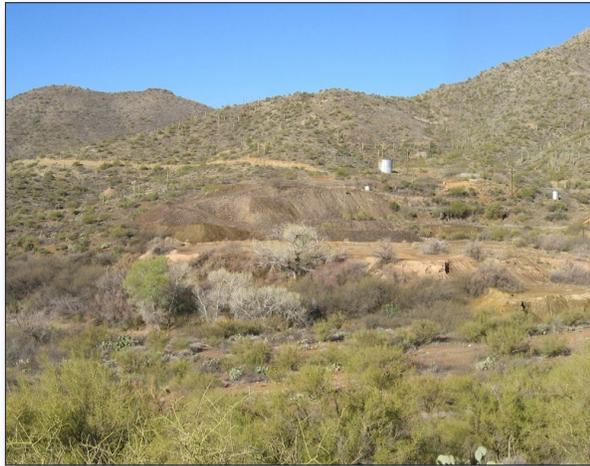
The Golden Belt and Golden Turkey mines, located along the banks of Turkey Creek, were identified as the major contributors to the copper and lead impairments. Elevated concentrations of copper and lead occur when runoff flows over and erodes abandoned tailings piles. A lead load is also originating from above the abandoned mine sites, but it is unknown if the load is from natural background or anthropogenic sources.

Figure 2. Photo of site before remediation work.

The USFS completed remediation on the Golden Belt and Golden Turkey mines in 2007. Before remediation, there were approximately 190,000 cubic yards of mine tailings and almost 54,000 cubic yards of waste rock along Turkey Creek. The USFS moved the contaminated mine tailings and waste rock away from the floodplain, and these contaminated piles were contained onsite using a variety of surface control measures. One such measure is a cap that was constructed for stabilization and to prevent any further runoff or erosion of the waste piles. Additional surface control measures implemented in the project area include regrading and revegetating, establishing proper drainage channels, minimizing runoff erosion, and aiding in restoring plant growth. AZDEQ has continued effectiveness monitoring following remediation in order to document water quality improvements. Figures 2 and 3 show the Turkey Creek floodplain before and after removal of mine tailings and waste rock.

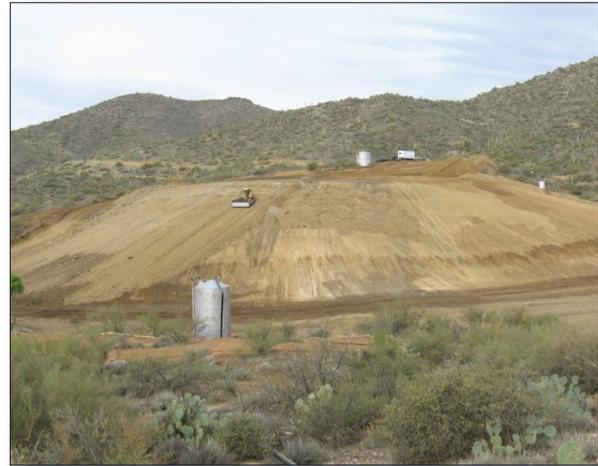
Figure 3. Photo of site after work was completed.

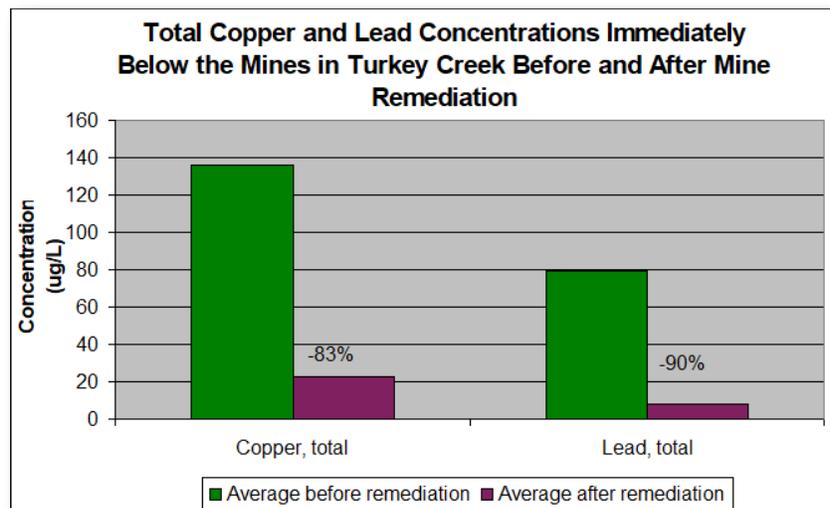
waste rock piles from the Turkey Creek floodplain decreased copper and lead loads in Turkey Creek by 58% and 80%, respectively (Figure 4). Further water quality monitoring needs to be completed before Turkey Creek can be removed from the state's impaired waters list.

Figure 4. Total copper and total lead levels have declined in Turkey Creek.
