NONPOINT SOURCE SUCCESS STORY

Fish Return to Boulder Creek After Legacy Mine Remediation

EPA 841-F-22-001D
February 2022

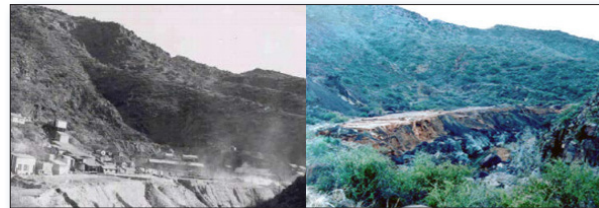
Historic metal mining from the inactive Hillside Mine was identified as a source of pollution to Boulder Creek (Figure 2). Open from the late 1800s through 1951, Hillside Mine primarily produced silver and gold, with subordinate lead and zinc. An adit (i.e., a horizontal mineshaft usually used for dewatering) was continuously discharging contaminated water at a rate of five gallons per minute. Stormwater interacted with the tailings piles to release additional metals to the creek. Sulfide-bearing minerals in the tailings were weathered and oxidized, creating high concentrations of metals and acidic water leaching into Boulder Creek, which was discolored before remediation (Figure 3).

Figure 2. The Hillside Mine location as it appeared in January 1940 (left) and January 2001 (right).

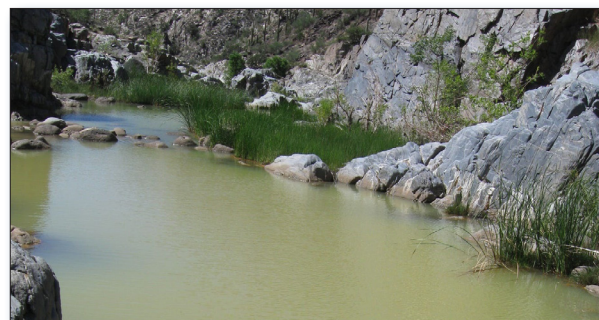
Figure 3. A discolored Boulder Creek flows near an eroding tailings pile (before remediation).

In 2019 ADEQ and Tetra Tech dewatered and plugged the adit using primary and secondary concrete hydrostatic plugs (Figure 4). All three tailings piles were graded to minimize erosion and to direct stormwater flow away from the piles. Water pumped from the adit was used for construction dust control. The tailings were then covered with geotextile and capped with waste rock and clean soil (Figure 5). A layer of native seeds was added to promote vegetation growth. Additional openings and shafts to the mine were closed for public safety. See ADEQ's YouTube [project video](#) for more details.

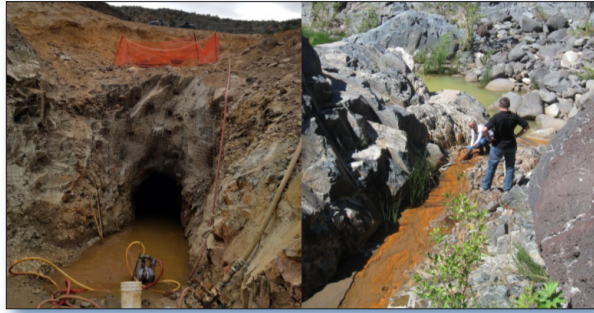
Figure 4. Before remediation, the adit discharged about 2.6 million gallons of contaminated water annually.

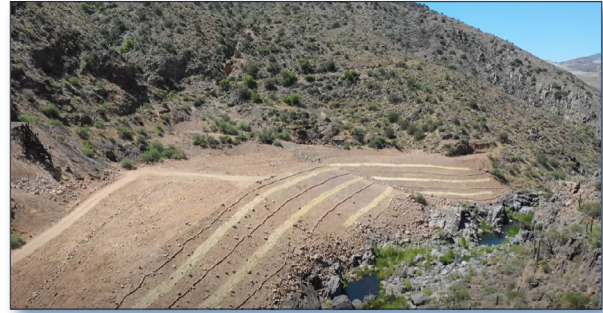
Figure 5. The remediated middle tailings pile area at Hillside Mine is adjacent to Boulder Creek.
