#### Region 6 - Enforcement & Compliance Assurance Division INSPECTION REPORT

Westlake Styrene LP / Styrene Marine Terminal Inspection Date 04/13/2022

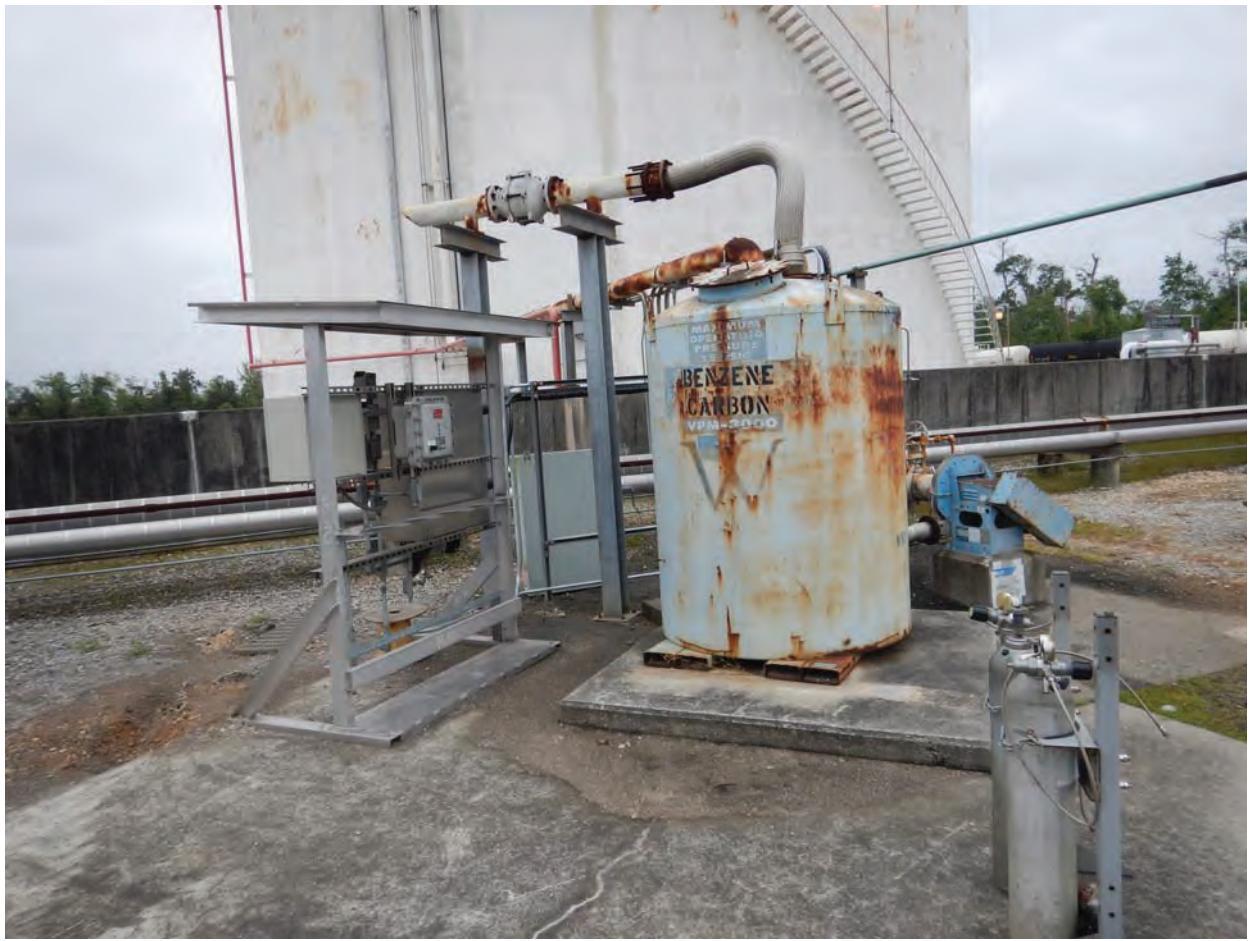
Photo No. 1

Photo File Name: DSCN0701.jpg Date of Photo: 4/13/2022 Time of Photo: 11:00 Photographer: Ben Rosenthal Description: Carbon canister controlling emissions from the benzene tank.

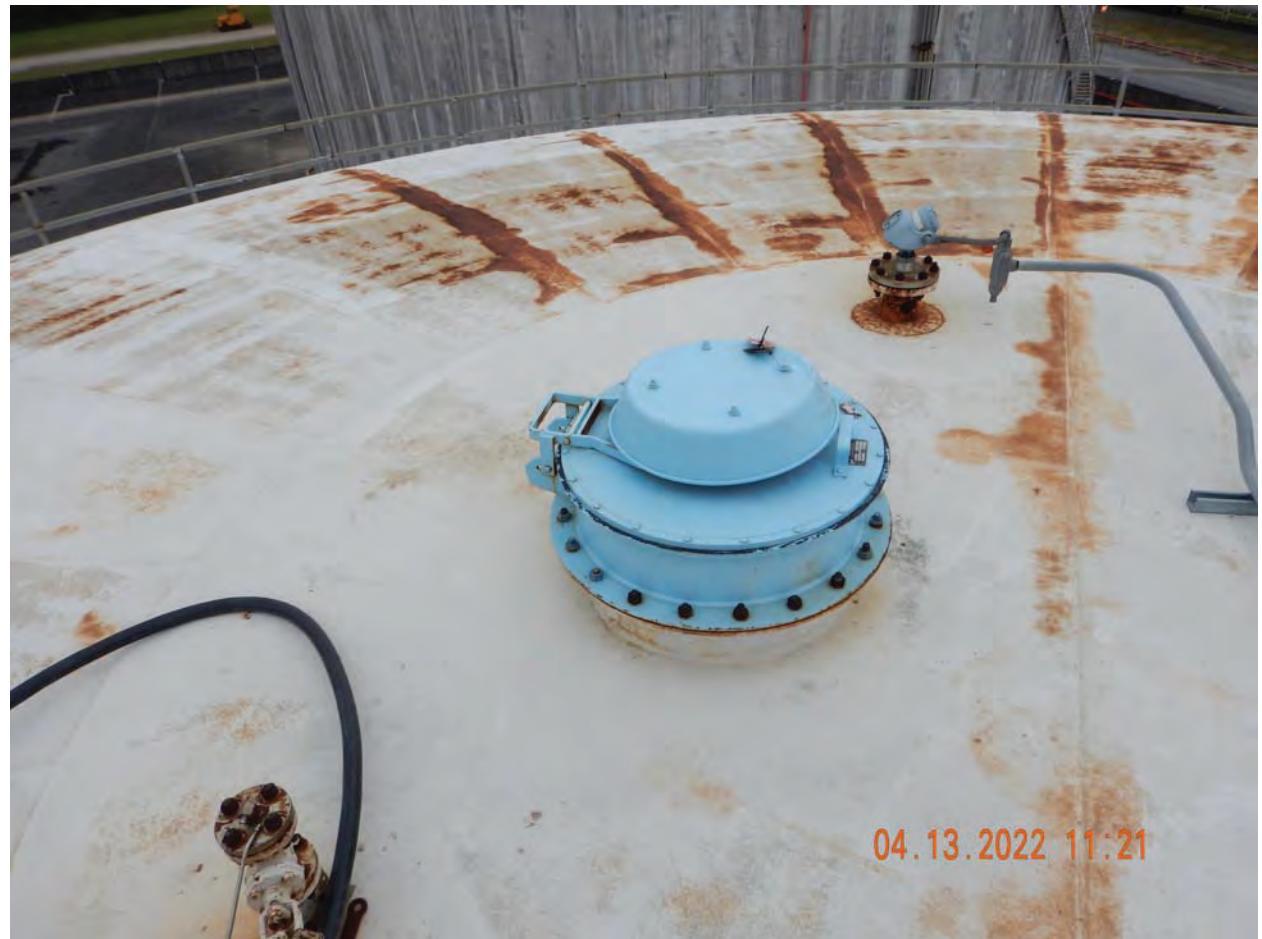
Photo No. 2

Photo File Name: DSCN0702.jpg Date of Photo: 4/13/2022 Time of Photo: 11:21 Photographer: Ben Rosenthal Description: Roof of the benzene tank. A blue thief hatch and sample valves are visible.
