PHRT Feb. 7, 2023 Letter to U.S. EPA  
Enclosures

# **DOCUMENTATION OF AMINE REPAIRS**

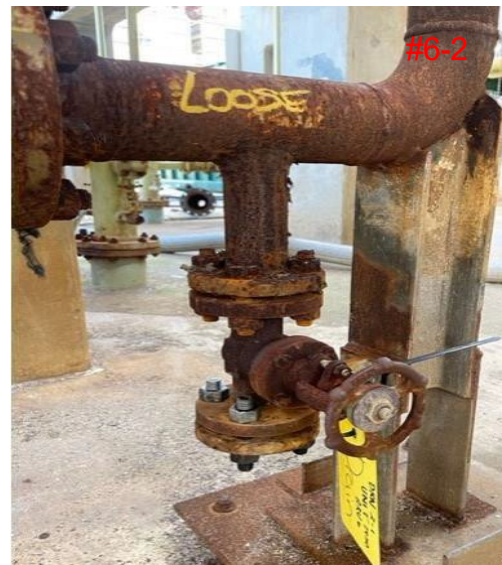
### **Amine Unit No. 6: Item #2 - See attached Amine Units Advisian Recommendations Tracking Report**

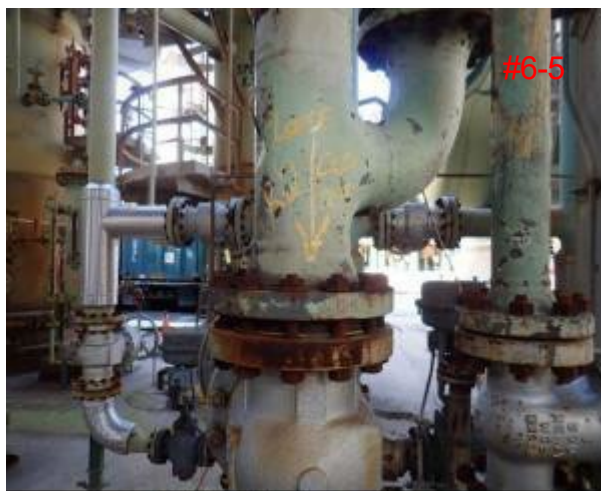
**Bolting Hardware Loose**

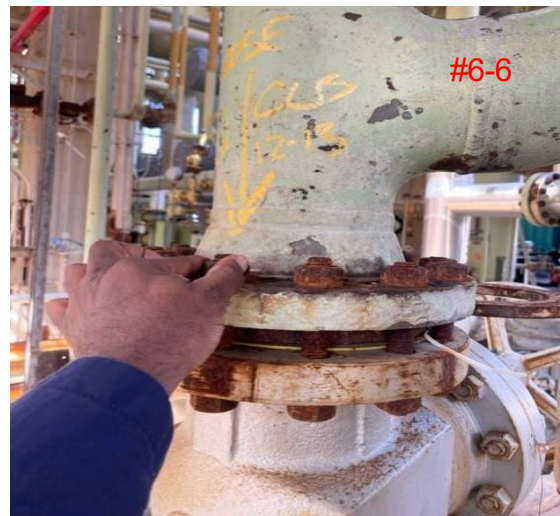
# Port Hamilton Refinery and Transportation LLLP

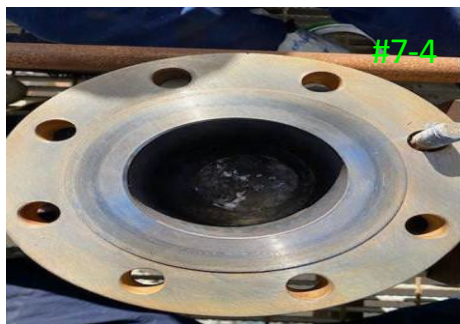
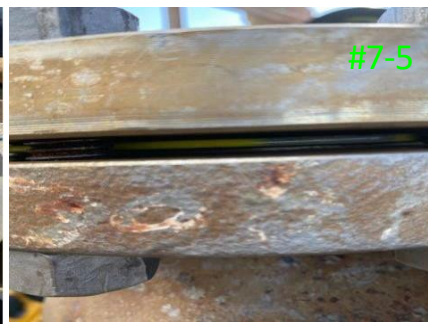
# **AMMONIA REPAIR INFORMATION**
