NONPOINT SOURCE SUCCESS STORY

Private Landowners Partner with the State to Clean Up Abandoned Mine Area Affecting the Hassayampa River

EPA 841-F-24-001B
February 2024

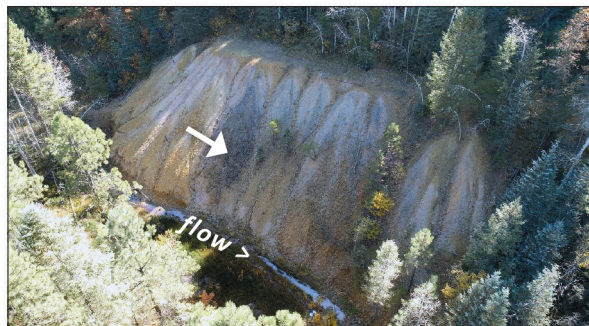
Spring snowmelt and monsoon and fall rains drive the high flows in the Hassayampa River. During low-flow episodes, groundwater is the primary source of the Hassayampa River. On the McKinley Mill site, a waste pile covering approximately a half-acre was deposited at a steep grade, situated above the stream channel and wetland area (Figure 2).

Figure 2. McKinley Mill mining waste pile.

In 2021, in cooperation with conscientious private landowners and contractors, ADEQ removed the old mill's hopper structure from the property. Between October and December 2022, the waste pile was regraded, and it was capped to prevent water from infiltrating. At the same time, a gabion wall was constructed along the toe of the waste pile (Figure 4). Consistent communication with stakeholders in this small, tight-knit community was critical to the success of this project. Neighboring property owners also contributed by sharing their local knowledge and insights from living in and visiting Potato Patch.

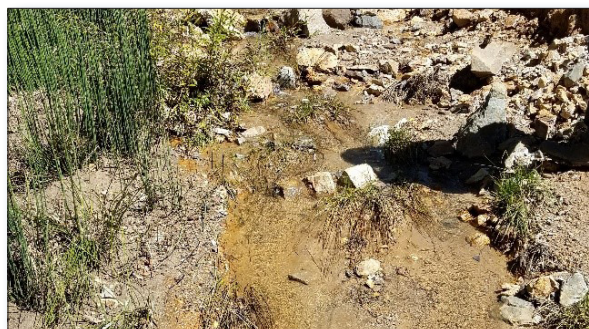
The toe of the waste pile was in the channel; the high flows from rains and seasonal snowmelt would wash mine waste into the channel, where it was then carried downstream (Figure 3). At low flows, sulfide in the waste material contributed metal contamination to the stream and visually impacted plant communities in the adjacent wetland. Of particular concern was a small lake downstream from the waste pile that is used for recreation by the residents.

Figure 3. Mine waste in the stream channel.

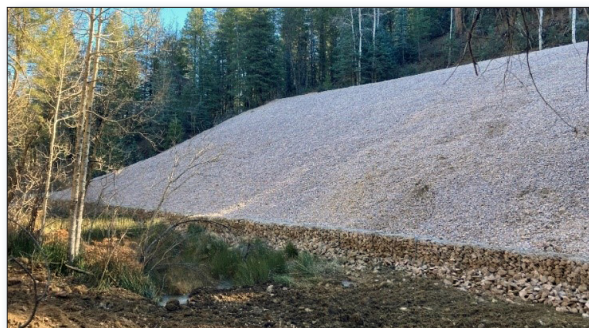
Figure 4. Regraded and capped waste pile with new gabion wall at the toe.
