**Municipality/Organization:** City of Malden  
**EPA NPDES Permit Number:** MA041046  
**MADEP Transmittal Number:** 041088  
**Annual Report Number  
& Reporting Period:** No. 12: April 1, 2014-March 31, 2015

## NPDES PII Small MS4 General Permit Annual Report

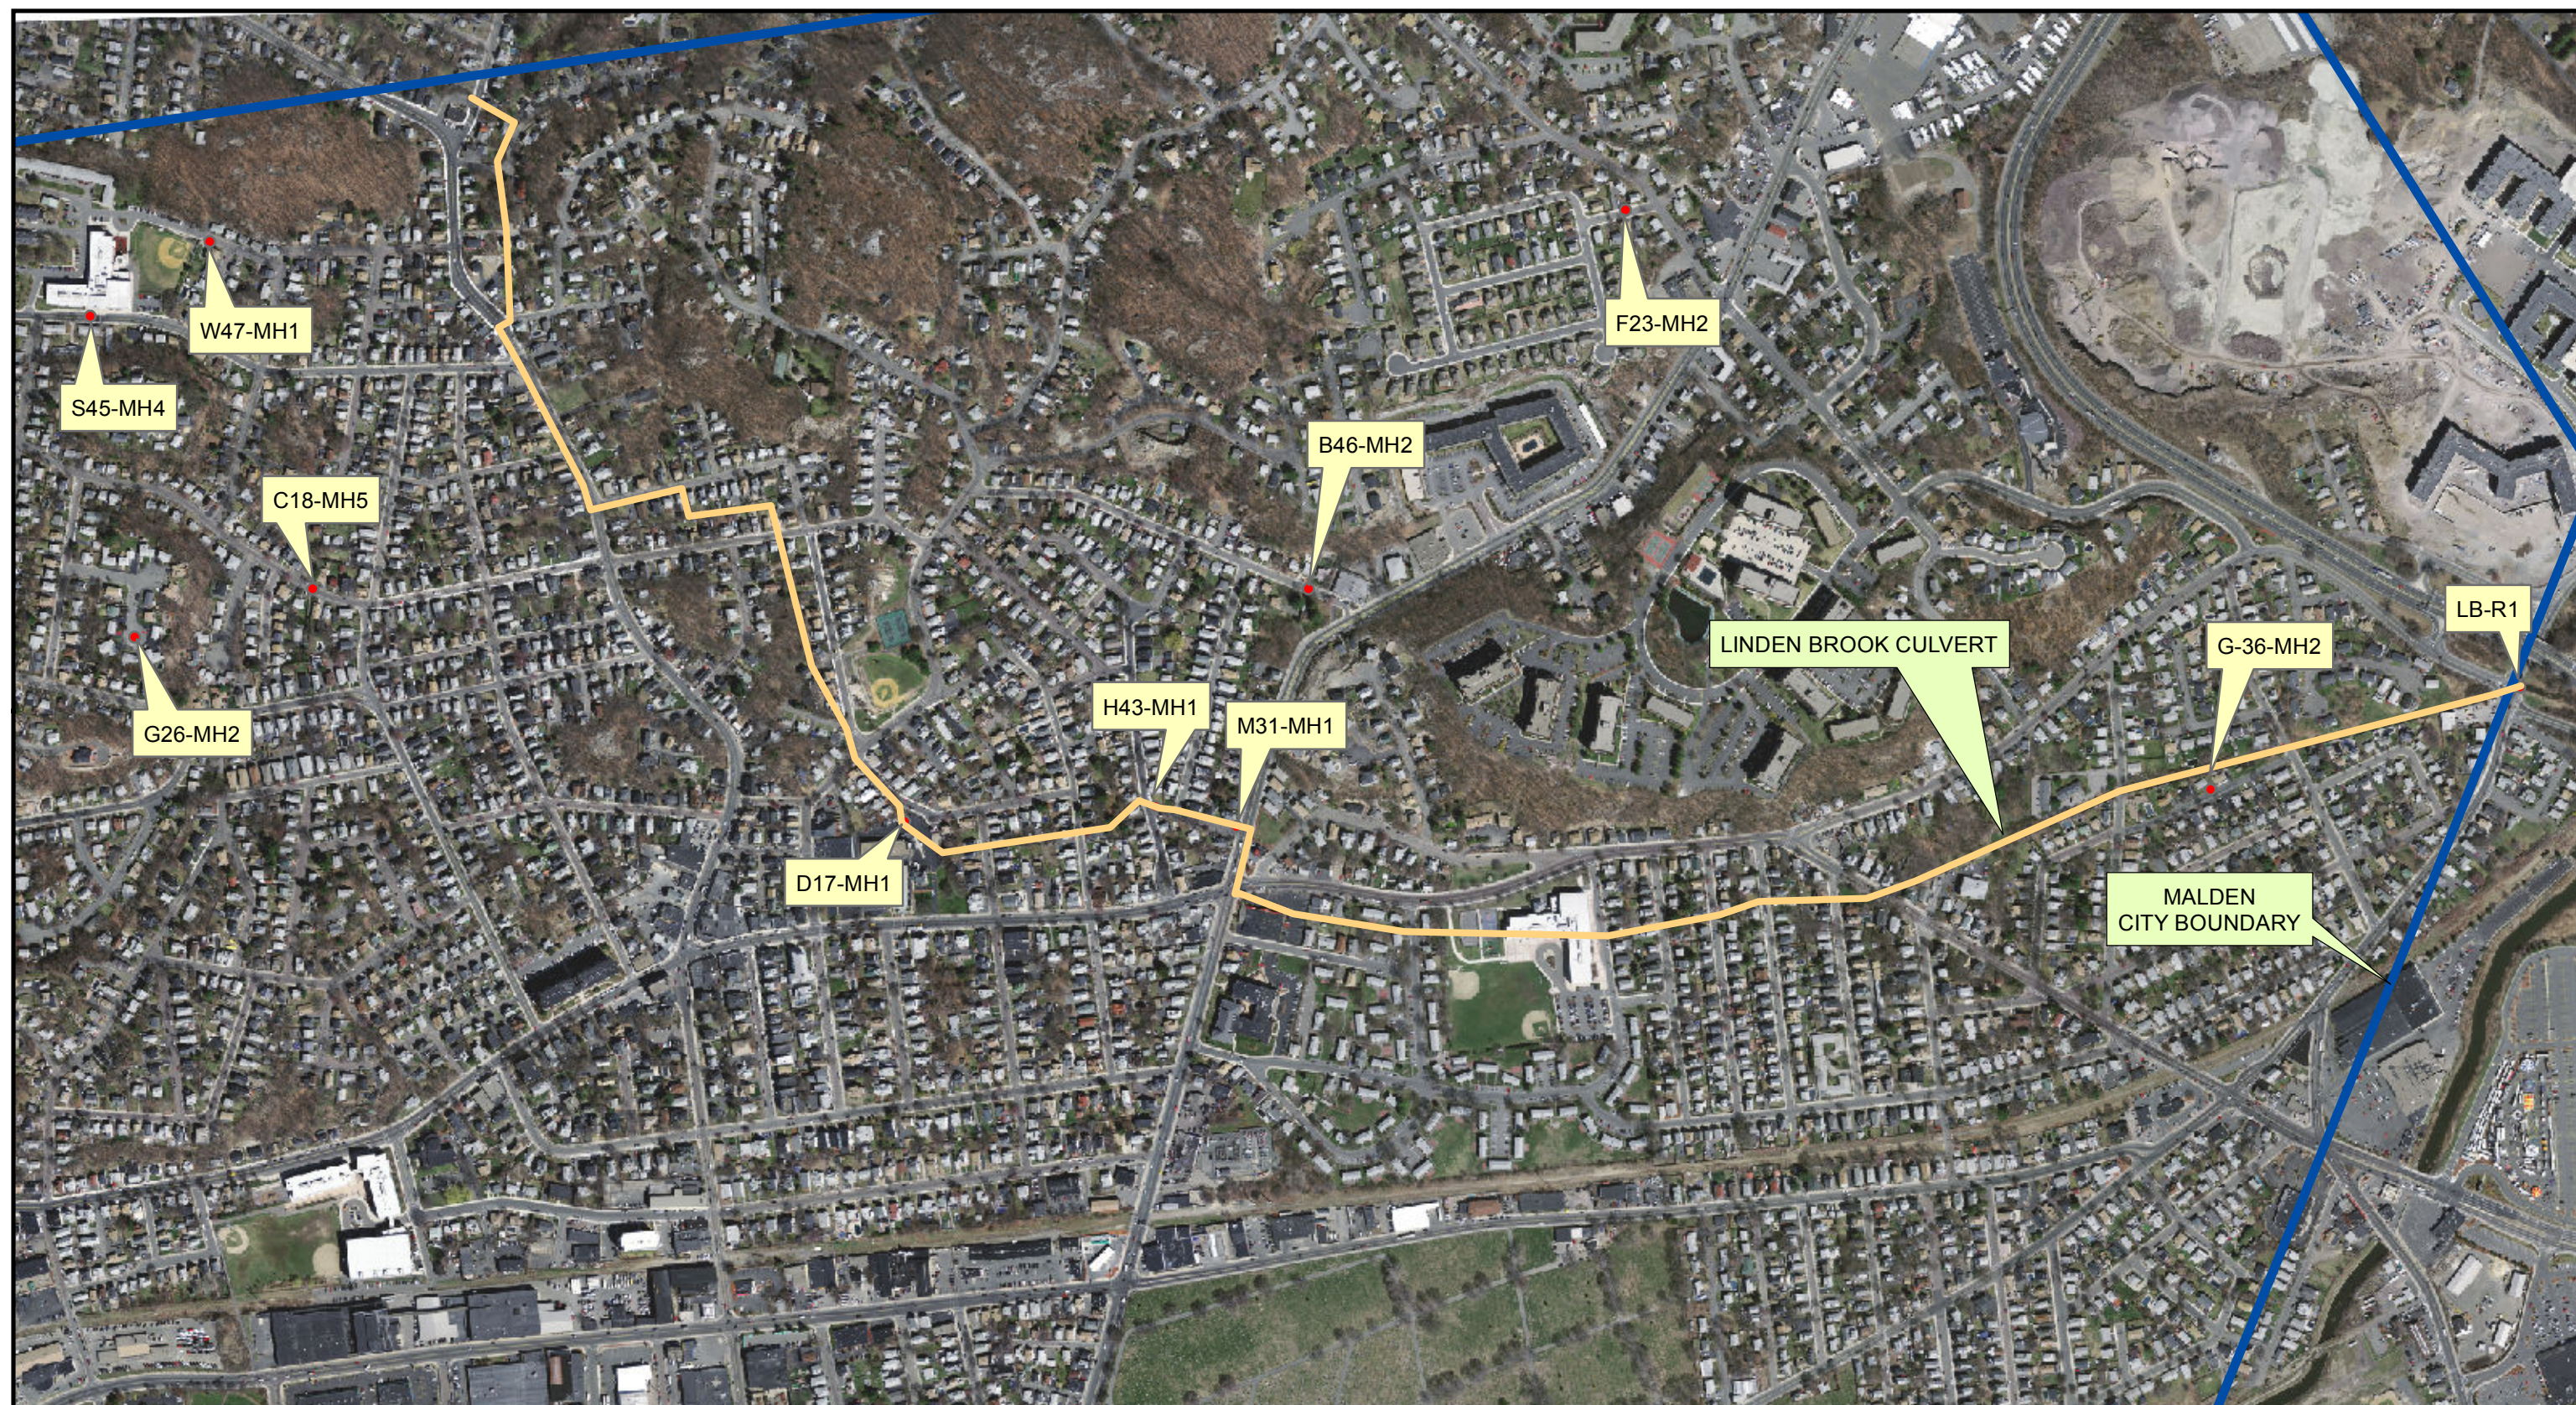
**Figure 5 - Dry Weather Sampling Program-Linden Brook**  
MALDEN, MASSACHUSETTS

Flow isolation studies performed to date within Linden Brook Culvert had not revealed any specific source conditions for the results of prior sampling. During this reporting period flow isolation studies were continued on a dry weather flow (Flow 18) in the area of Cherry Street and Sylvan Street which contributes to the western portion of the Linden Brook Culvert. Several dry weather flow samples collected from drainage manhole (C18-MH5) located on Cherry Street contained higher E. coli levels and to further assess this condition, dry weather flow samples were collected on 5 November 2014. E. coli levels encountered at drainage manhole C18-MH5 contained an E. coli level of 1,300 MPN/100 ml. An upstream dry weather flow sample relative to C18-MH5 was also collected from a manhole located on Winship Street (W47-MH1), with a level of 1,700 MPN/100 ml of E. coli identified. This concentration is in the range of the E. coli level quantified at C18-MH5 (1,300 MPN/100 ml) this reporting period. As this flow (Flow 18) originates along Sylvan Street, proximate to the Forestdale School, a dry weather flow sample was collected from

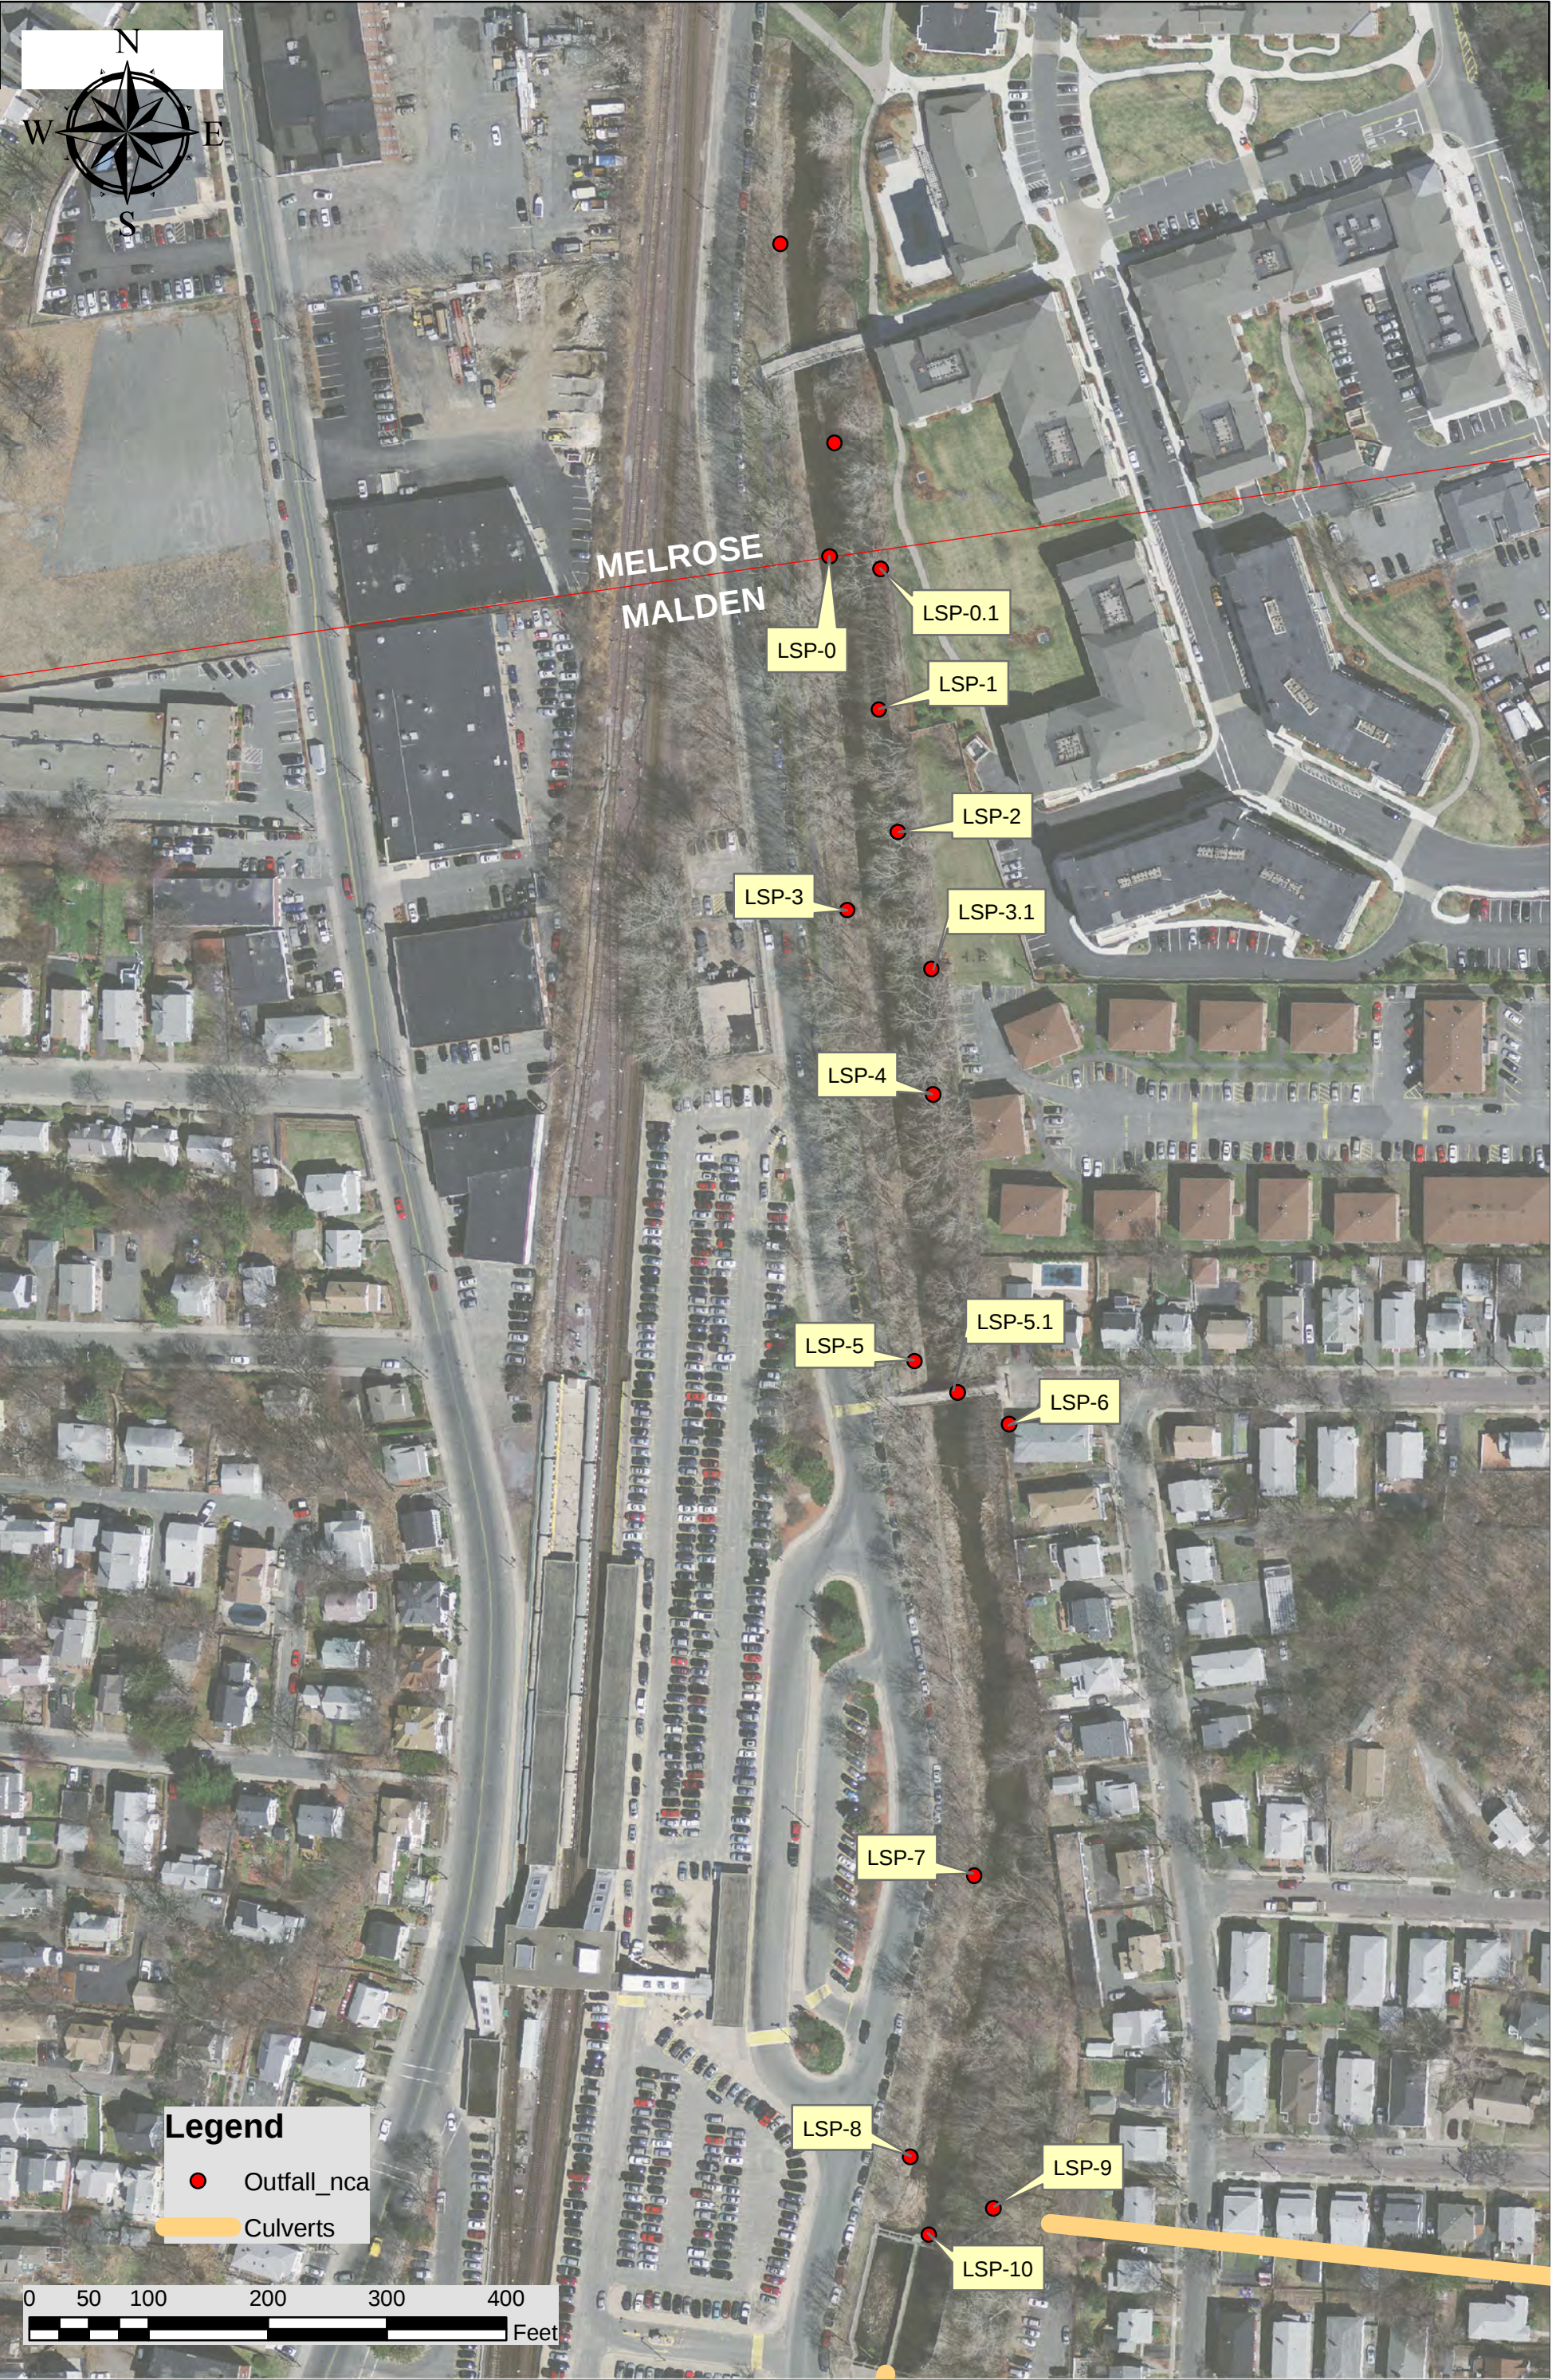
Figure 5 - Lower Spot Pond Brook Outfalls

The Stormwater Compliance Team has conducted numerous dry weather sampling events to investigate the elevated *E. coli* levels encountered previously at LSP-4, an outfall for the drainage system located within Eldrich Drive (Figure 5). Base flow, as groundwater, is consistently observed within this drainage network and to isolate potential sewage contributions to this base flow, a comprehensive evaluation of the flow conveyance network associated with LSP-4 was completed in February 2012. Given the proximity of the sewer and drain lines to LSP-4, as well as the settlement of the drain line in the area of Buildings 1054 and 1056 Elrich Drive, the focus of assessment activities was directed towards the sewer laterals and nearby drainage line servicing the two apartment buildings. Following dye testing by the Compliance Team, camera surveys performed by representatives of the property owner confirmed that compromises to the laterals servicing two (2) residential building had occurred. Recommendations made by the SCT involved restoring the integrity of the main drainage line to stop the discharges that have been documented at LSP-4.

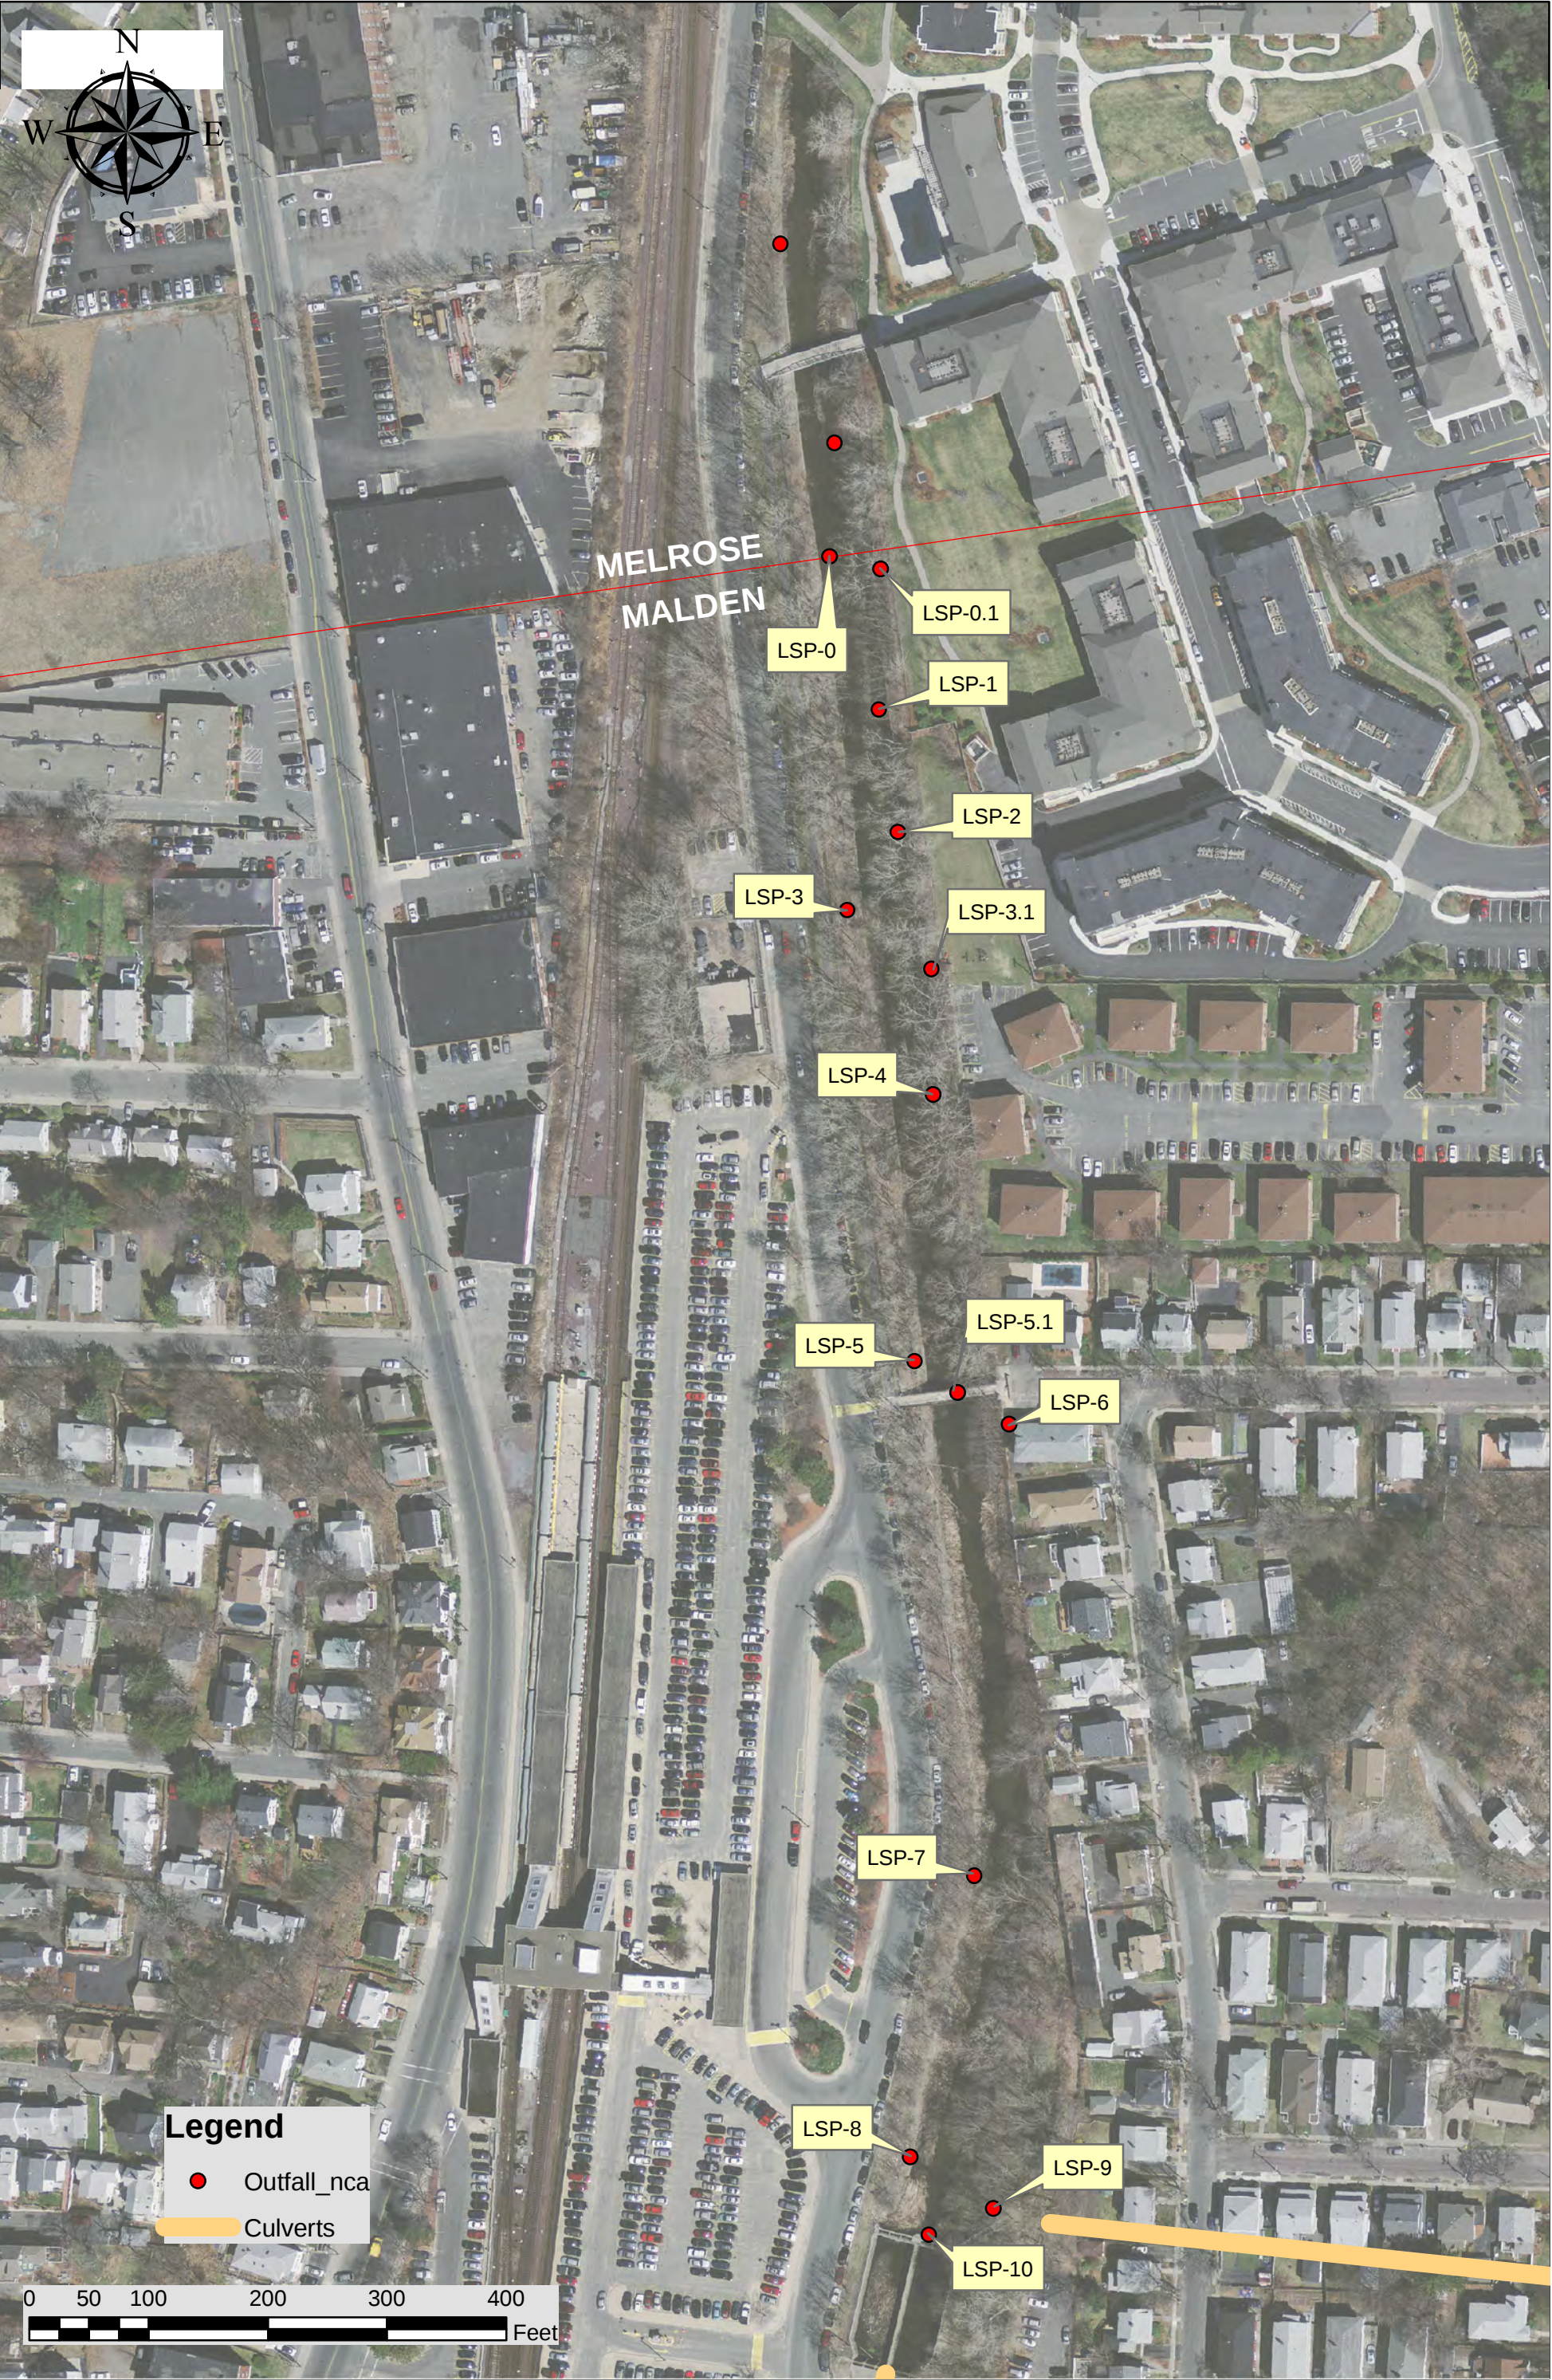
Figure 5 - Lower Spot Pond Brook Outfalls

The Stormwater Compliance Team has conducted numerous dry weather sampling events to investigate the elevated E. coli levels encountered previously at LSP-4, an outfall for the drainage system located within Eldrich Drive (Figure 5). Base flow, as groundwater, is consistently observed within this drainage network and to isolate potential sewage contributions to this base flow, a comprehensive evaluation of the flow conveyance network associated with LSP-4 was completed in February 2012. Given the proximity of the sewer and drain lines to LSP-4, as well as the settlement of the drain line in the area of Buildings 1054 and 1056 Elrich Drive, the focus of assessment activities was directed towards the sewer laterals and nearby drainage line servicing the two apartment buildings. Following dye testing by the Compliance Team, camera surveys performed by representatives of the property owner confirmed that compromises to the laterals servicing two (2) residential building had occurred. Recommendations made by the SCT involved restoring the integrity of the main drainage line to stop the discharges that have been documented at LSP-4.
