WaterSense Labeled Irrigation Products

Oklahoma Makes Median Irrigation OK

City Strips Inefficient Sprinkler Systems of Water Waste

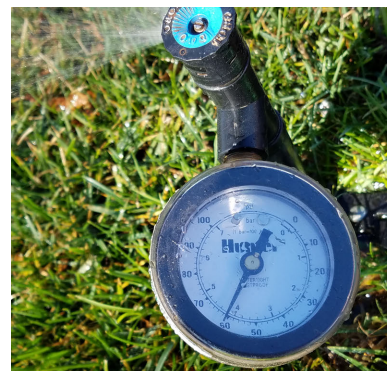
Water pressure can be tested at the valve or the sprinkler head.

To get to the root of the water waste, the three median strips were tested to determine the water pressure going to their sprinkler systems. Optimum pressure for most sprinkler systems is about 30 psi, but the medians' sprinklers were operating at 60 psi. High incoming water pressure can prevent sprinklers from working as intended, causing misting, overspray, puddles, and runoff (see photo at right). However, the U.S. Environmental Protection Agency's WaterSense program developed criteria for sprinkler bodies with integral pressure regulation to earn the WaterSense label, which means they are independently certified for water efficiency and performance. WaterSense labeled spray sprinkler bodies reduce the effects of high incoming water pressure to prevent misting and overspray.
