Abandoned Mine Lands Case Study

Elizabeth Mine

Protecting People, Ecosystems, and Heritage – A Shared Legacy

Elizabeth Mine, VT

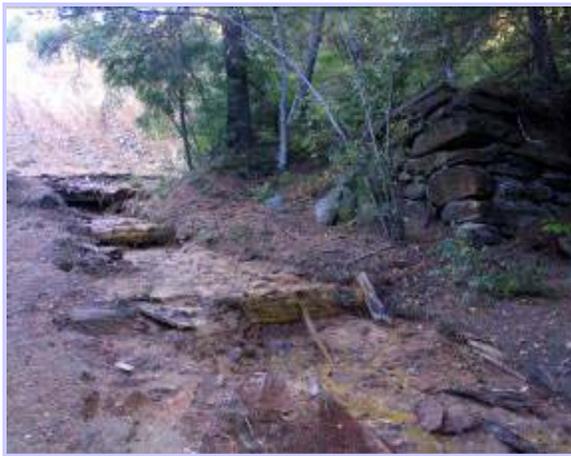
Figure 2: The ARD-laden Copperas Brook below the North Open Cut. Up the slope TP-3 can be seen. The stone foundation of one of the Copperas Factories is an example of the historic features of the Elizabeth Mine.

AMD has most likely been a part of the Elizabeth Mine since work first began at the site. The oldest tailing pile, TP-3, near the North Open Cut, produces the greatest amount of acidity since it contains the oldest and least-processed sulfide-bearing material. This is exacerbated by the topography of the mining site and the location of the TP-3 waste piles in the headwaters of the natural drainage of the Copperas Brook watershed. Air and water interact with the remaining sulfides in the piles to create AMD, which is then channeled through the waste rock while flowing downgrade and then across TP-2 and TP-1. Due to the high acidity of the runoff coming from TP-3, the leachate more readily dissolves and suspends toxic metals such as aluminum, copper, cadmium, iron, and zinc found in the waste rock and native soil. These dissolved metals remain in solution until pH increases at the confluence of the Copperas Brook and the West Branch of the Ompompanoosuc River, over a mile downstream from TP-1. This causes extensive iron staining downstream of the confluence of Copperas Brook and the West Branch of the Ompompanoosuc River.

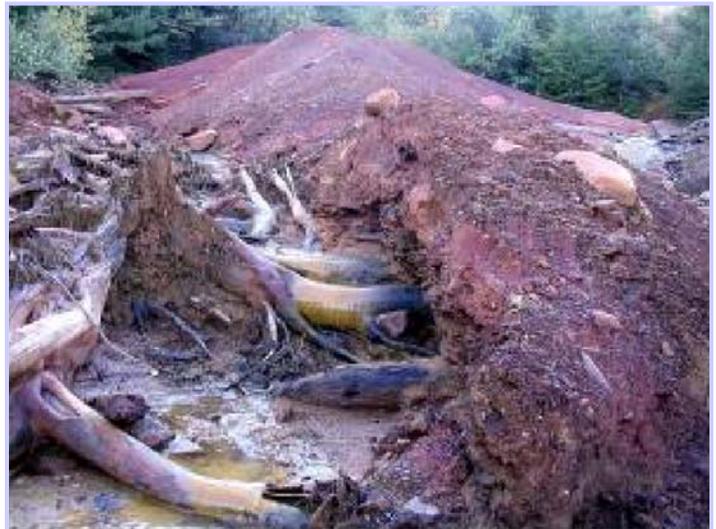
Figure 3: AMD in the Copperas Brook flows across dead vegetation along lower TP-3. The bright violet color of the roasted waste rock reveals the significant iron content of the pyrrhotite.

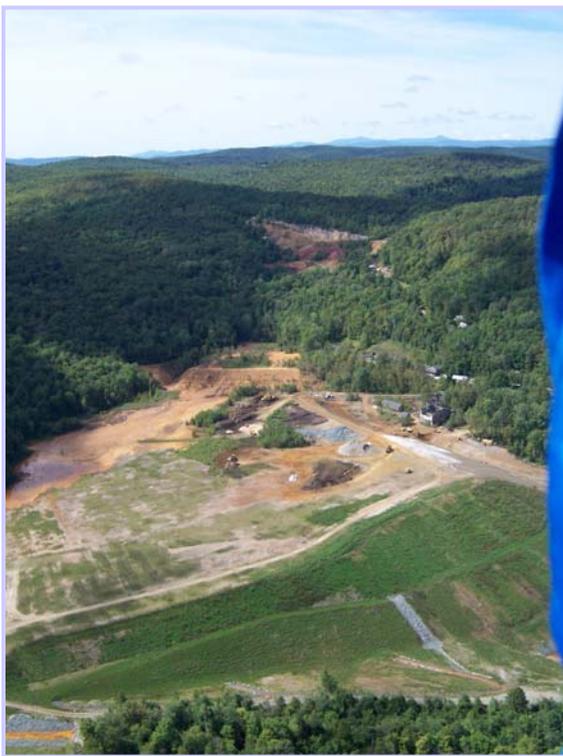
Figure 4: TP-1 and TP-2 are shown in the photo with TP-3 in the back part of the photo. The breach in the TP-2 tailing dam and the pond on TP-1 are shown along with the buttress to stabilize the TP-1 tailing dam.

system failure. This gully is now the current streambed of the Copperas Brook. This redirection of the Copperas Brook, and eventual re-channeling, also contributed to the formation of a small lake on the surface of TP-1 and the further saturation of that tailing pile. The tailing dam of TP-1 was quite steep as it had been left as-is when the mine closed in 1958 with no additional stabilization conducted prior to closure. Due to the high level of erosion on the face of this slope, the height of the dam, and the 32-acre tailing pile, there was a great deal of concern on the part of EPA that the tailing dam retaining the saturated TP-1 might fail. Such a failure would cause a mudslide downstream, burying the Copperas Brook, damaging homes, and causing severe damage to the West Branch of the Ompompanoosuc River.

To address this concern, an analysis was conducted in 2002 to investigate the potential for tailing dam failure at TP-1 and TP-2. Based on this investigation, EPA determined that the tailing dam at TP-1 was unstable and threatened downstream residents and the West Branch of the Ompompanoosuc River. There was also concern that the high levels of rainfall in New England, the freeze-thaw that took place each spring, the fine grain size of the tailings, and the location of tailings over relatively impermeable glacial till would all increase the chance for catastrophic failure. In 2004, the concern for catastrophic failure in addition to the lack of funding to initiate the NTCRA spurred EPA and the State of Vermont to start a time-critical action – the TCRA – for slope stabilization. EPA began installation of a soil buttress and a new conveyance system for Copperas Brook. EPA repaired dam erosion, installed drainage pipes, constructed wetlands,

and removed tailings material as part of the stabilization effort. Over 30,000 cubic yards of material were removed from TP-1 during stabilization, which should also reduce the amount of AMD generated by the site. Within a year, EPA completed the TCRA and began the design for the NTCRA.

As of October 2006, EPA has completed the TCRA and has begun activities under the NTCRA. EPA constructed a soil buttress; stabilized the tailing dam; graded the slope above the buttress to reduce erosion; relocated 30,000 cubic yards of mine tailings; repaired the deteriorating drainage pipe that carries the flow

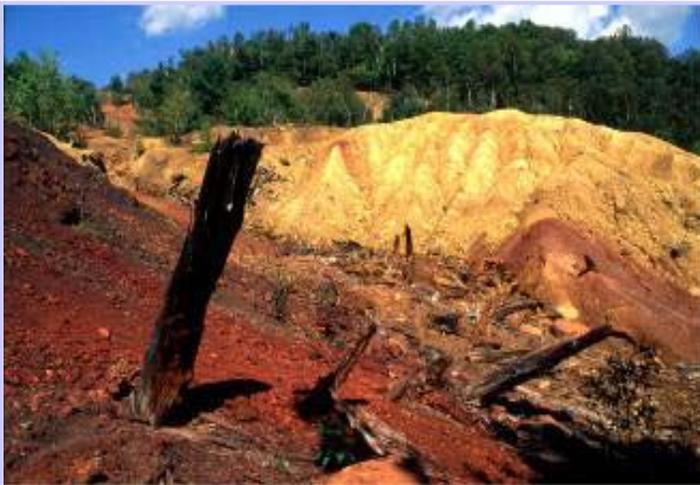
Figure 6: TP-3 and the old roasting beds with the North Open Cut to the left and up the hill.
