**SIKES DISPOSAL PITS
SUPERFUND SITE
Harris County, Texas**

**EPA Region 6
EPA ID: TXD980513956
Site ID: 0602488
State Congressional District: 09**

Last Updated: April 2013

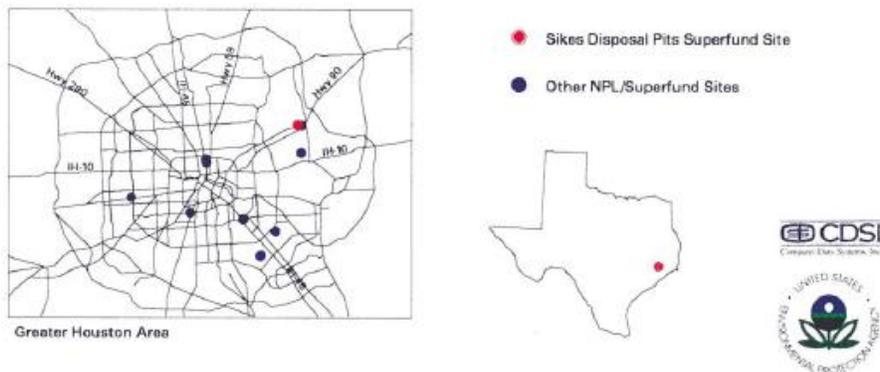
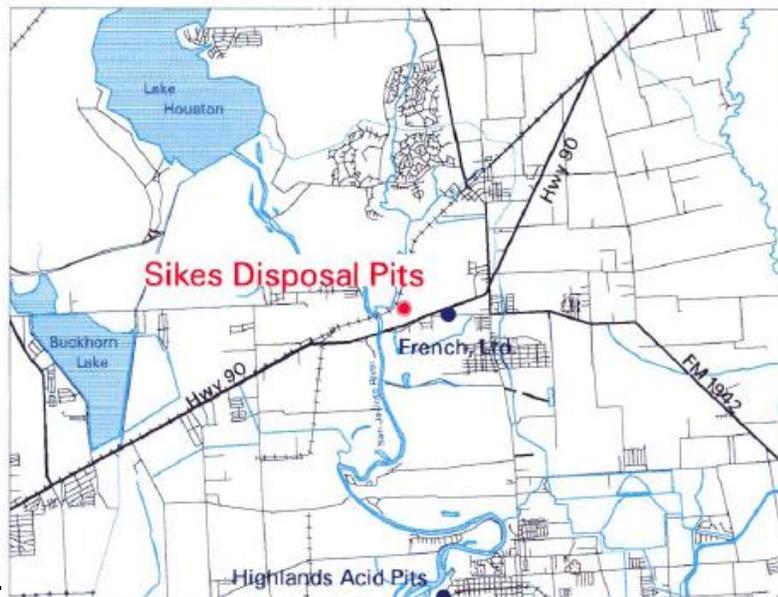
Site Map

SIKES DISPC Area surrounding Sikes Disposal Pits site.

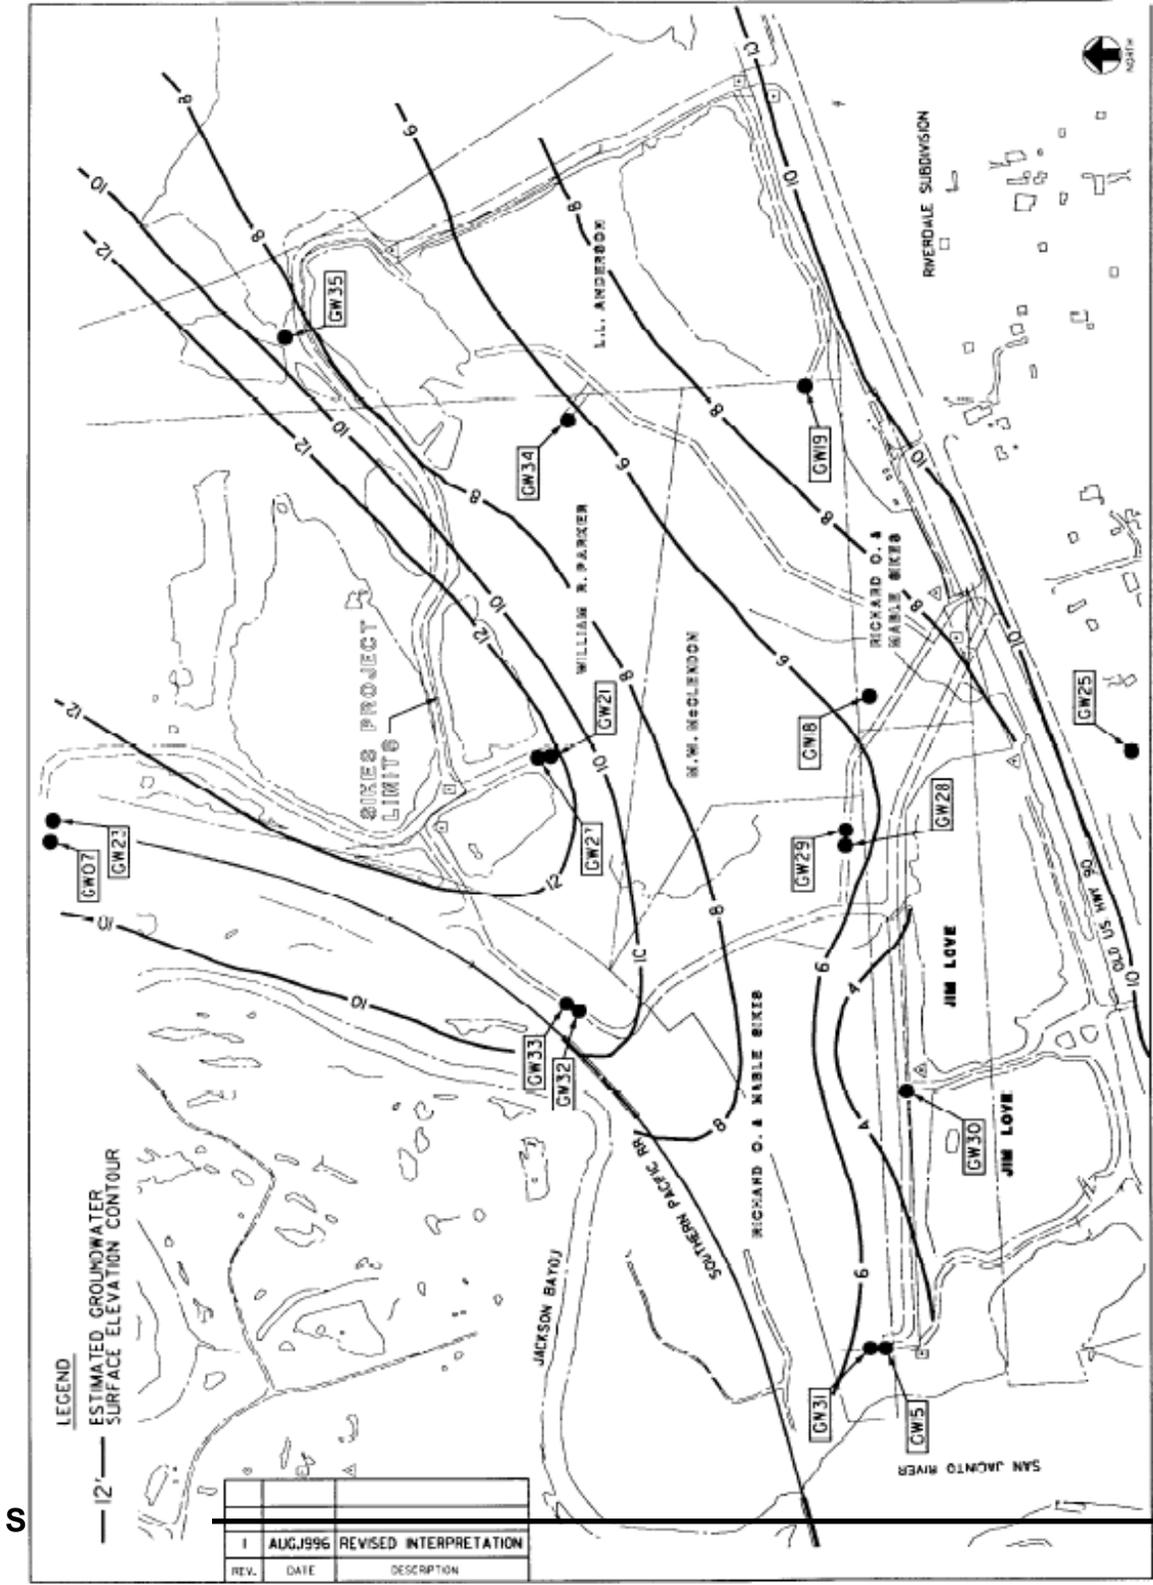
Figure 2 - Site Map
 Sikes Disposal Pits Superfund Site
 Crosby, Harris County, Texas

FIGURE NO. 3-1	PREPARED FOR TNRCC	REVISED DATE AUG.7, 1996	OPERATION AND MAINTENANCE PHASE SIKES DISPOSAL PITS SUPERFUND SITE CROSBY, TEXAS	
	SHEET NO. POTENTIOMETRIC MAP - SEPTEMBER 1995	TITLE NONE		
JOB NO. 1633-20-013-000	DRAWING NO. SAKS0995.DCN	DATE NONE

Hydrology: Soils at the Site consist of river alluvium overlying Texas Coastal Plain deposits. Shallow water-bearing zones occur in the alluvium, which varies in thickness between 17 and 34-feet. Ground water in the shallow aquifer flows to the southwest. A deeper water-producing zone is found in a sandy-silt zone of the Coastal Plain deposits at about 65-foot below the alluvial aquifer. A clay stratum separates these two uppermost aquifers. The Chicot and Evangeline Aquifers occur beneath several hundred feet of clay, which is below the Coastal Plain aquifer.
