Re: Contract No. 68-W6-0008, Technical Direction Document No. 98-06-0001
Medite Corporation Stud Mill Preliminary Assessment

**Medite Corporation
Stud Mill Site
Preliminary Assessment**

PRELIMINARY ASSESSMENT
MEDITE CORPORATION STUD MILL SITE
WHITE CITY, OREGON

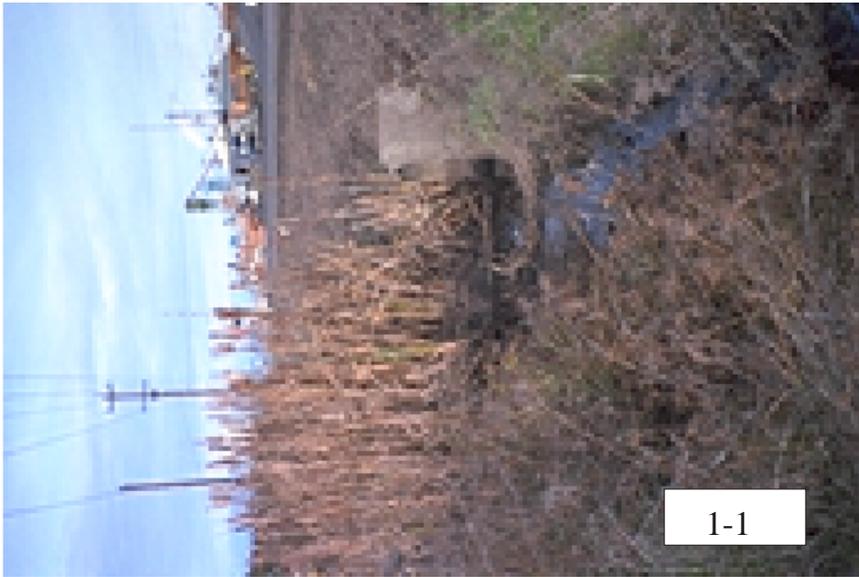
Photo No.	Date	Time	Dir.	By	Description
1-1	12/3/98	1407	N	JK	Northeast drainage ditch. Drain comes from under Agate Road east of the facility.
1-2	12/3/98	1415	N	JK	Storm drain.
1-3	12/3/98	1424	W	JK	Hydraulic oil spill area at debarker location.
1-4	12/3/98	1428	W	JK	Former location of Truck Shop. Monitoring well on right side of the photograph.
1-5	12/3/98	1433	WSW	JK	Underground storage tank west of former Truck Shop area. Contaminated soil estimated at 45 cubic yards.
1-6	12/3/98	1435	S	JK	Former aboveground storage tank area south of former Truck Shop. Three tanks were used for diesel, lube oil, and used oil.
1-7	12/3/98	1437	Down	JK	Inside of containment area for aboveground storage tanks.
1-8	12/3/98	1440	W	JK	Former Bone Yard area.
1-9	12/3/98	1445	S	JK	Pile of debris that was removed from the basement of the former sawmill; awaiting disposal; some refuse may contain oil/petroleum products.

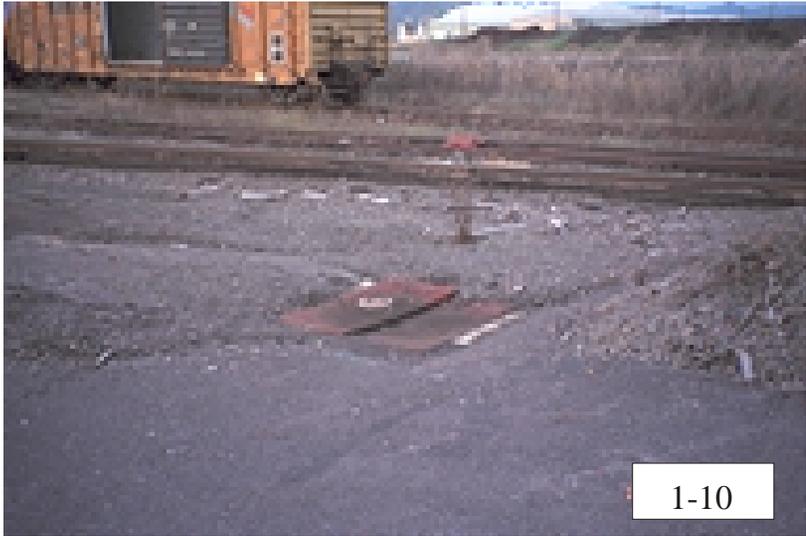
1-10	12/3/98	1446	NNW	JK	Central storm drain for mill site, located north of the sawmill.
1-11	12/3/98	1448	N	JK	Sump location in the sawmill.
1-12	12/3/98	1453	W	JK	Overview of western portion of the old sawmill filled with groundwater; groundwater sump located on right side of the photograph.
1-13	12/3/98	1459	S	JK	Location of the former Teepee Burner (where yellow pole is located).
1-14	12/3/98	1500	E	JK	Location of former Teepee Burner at the east side of the sawmill.
1-15	12/3/98	1501	NNW	JK	Location of storm drain in relation to the Teepee Burner at east end of the sawmill.
1-16	12/3/98	1505	W	JK	Overview of the former sawmill location.
1-17	12/3/98	1507	SE	JK	Photograph of northeast storm drain and Royal Oak Charcoal Company in the background.
