CASCADE CHEMICAL SITE INSPECTION REPORT

TDD: 96-07-0005

December 19, 1996

**SITE INSPECTION REPORT
CASCADE CHEMICAL
Clackamas, Oregon**

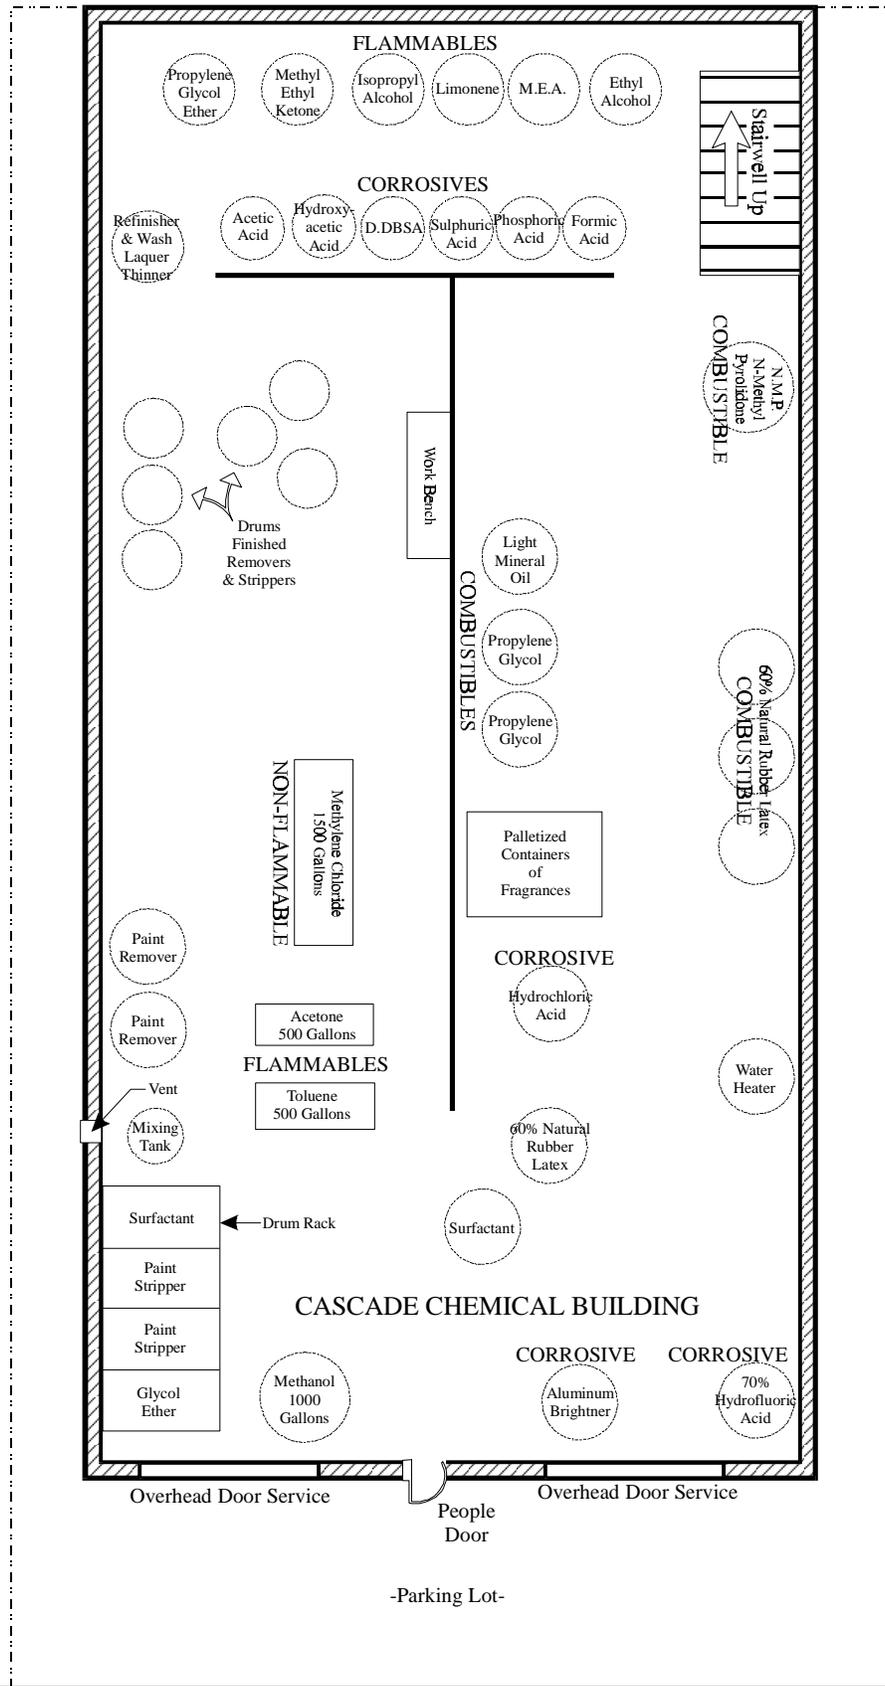
Property Line of Cascade Chemical

The START conducted a site visit at Cascade on August 29, 1996. During the visit, several [tanks](#) and [drums](#) and numerous [small containers](#) of chemicals were observed within the building. A comprehensive inventory of chemicals in the facility was not conducted, however, the general types of chemicals observed is provided below (E&E 1996):

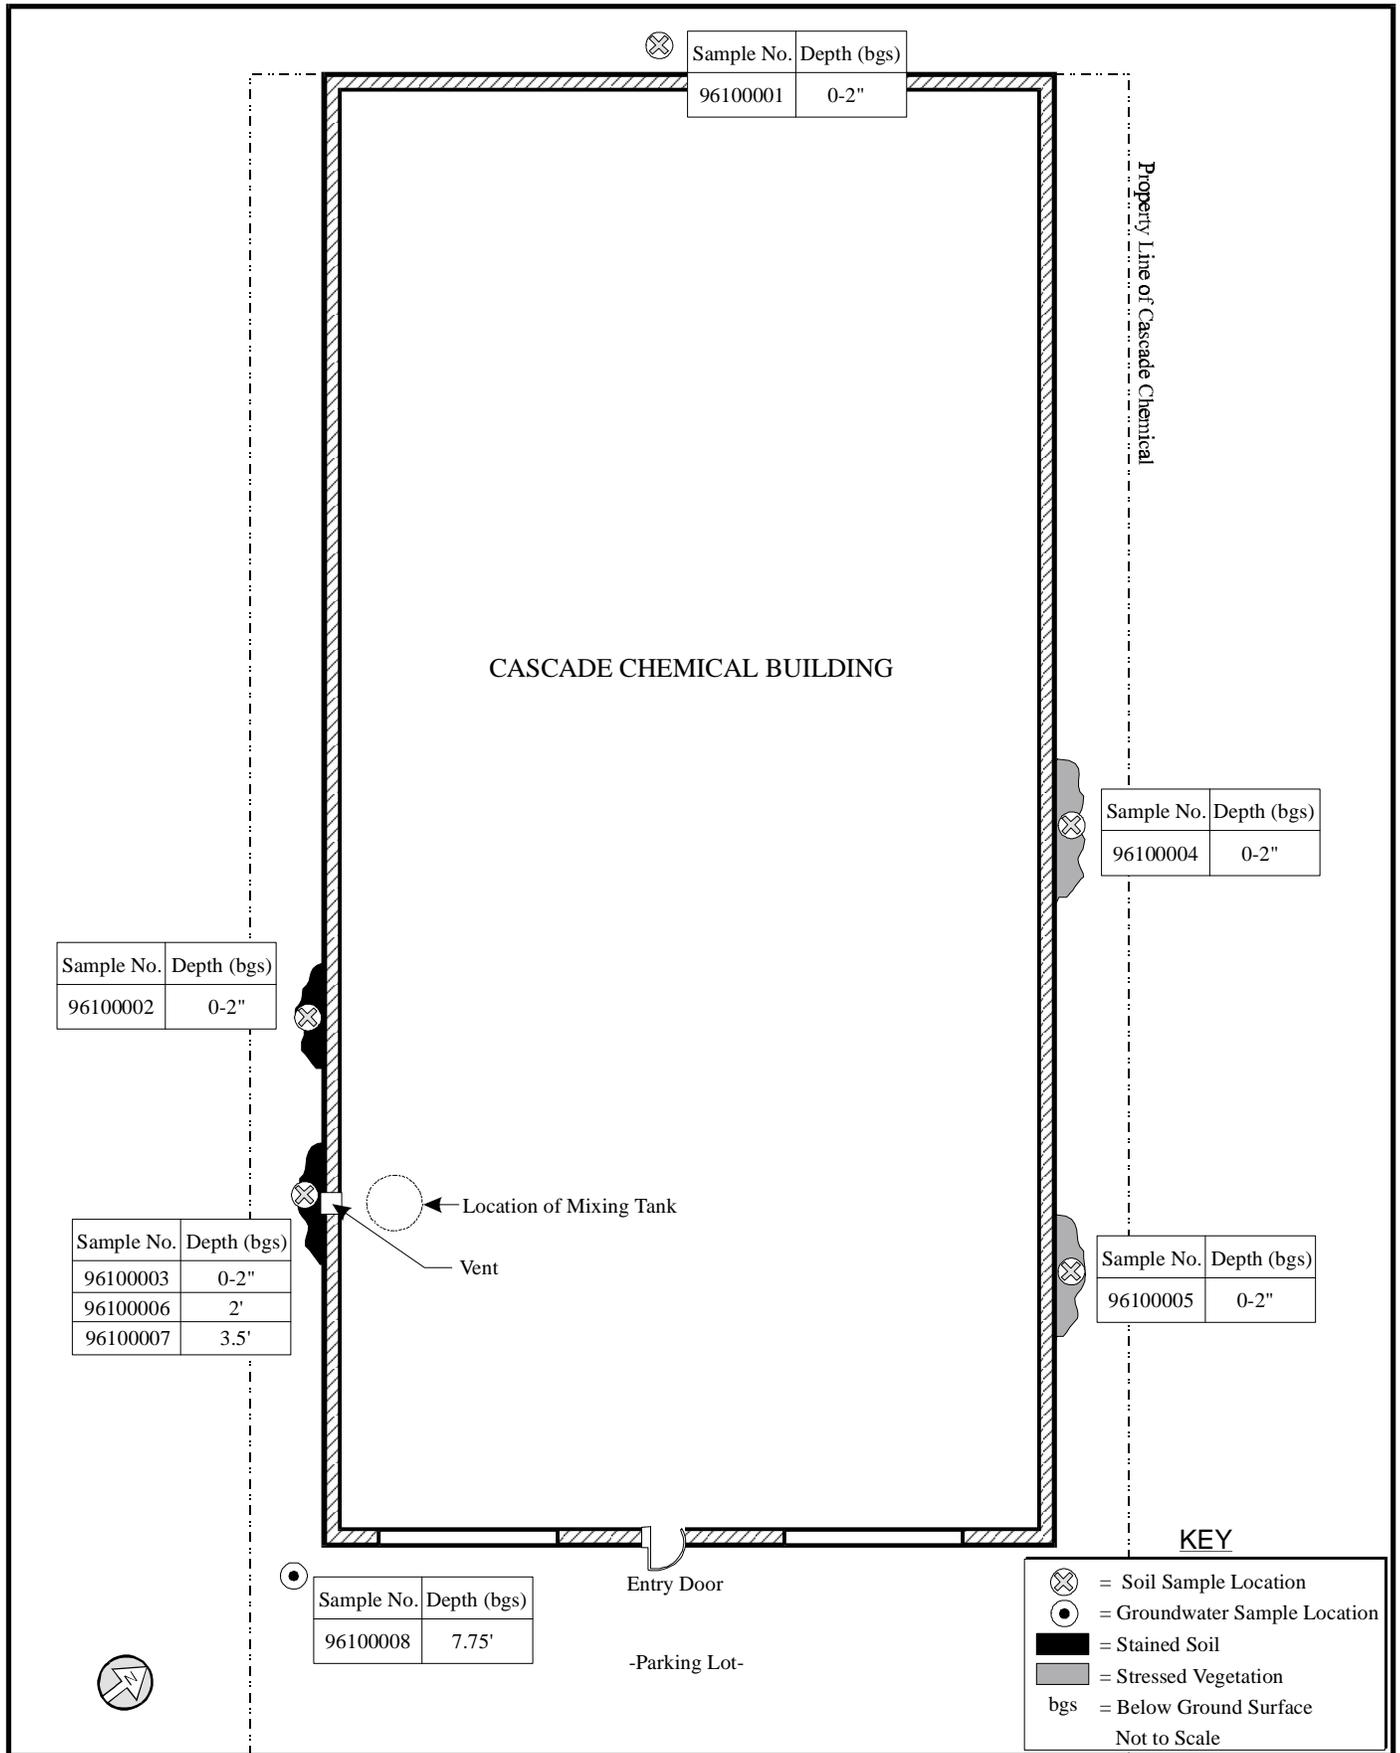
Figure 3-1
SAMPLE LOCATION MAP

[Figure 3-1](#) depicts the general locations of samples collected during the SI. [Table 3-2](#) provides a list of sample numbers, sample depths, collection date and time, and a brief description of sample locations. The following sections describe matrix-specific sample locations and rationale, and sampling methodologies employed.

Two areas of stained soil and two areas of stressed vegetation were investigated as potential sources of contamination at the site. The [two areas of stained soil are located on the southwest side](#) of the Cascade building: one approximately 14 feet northwest of the south corner of the building and one approximately 18 feet northwest of the south corner of the building. Both have approximate dimensions of 1 foot by 2 feet and both appear to be the result of spills originating from within the building that seeped through the foundation to wall interface, then ran down the side of the foundation to the soils. The stain located approximately 14 feet northwest of the south corner of the building was adjacent to the mixing tank vent. Further, the floor surrounding the mixing tank was heavily stained indicating numerous spills in the area and could have been the source of the soil stain. The extent of subsurface contamination is not known, but it is suspected that soils beneath the building foundation also may be contaminated. A surface soil sample was collected from each of these two areas (96100002 and 96100003, respectively). In addition, [two subsurface soil samples were collected from one boring](#) drilled in the stained soil area adjacent to the mixing tank vent (i.e., at the same location as surface soil sample 96100003) at 2 feet and 3.5 feet bgs (96100006 and 96100007, respectively).

The [two areas of stressed vegetation are located on the northeast side](#) of the Cascade building, [one approximately 32 feet from the east corner](#) of the building (covering an area approximately 4 feet by 1 foot) and [one approximately 11 feet from the east corner](#) of the building (covering an area approximately 3 feet by 1 foot). One surface soil sample was collected from each of these areas (96100004 and 96100005, respectively).

A [background soil sample](#) (96100001) was collected from soils approximately 4 feet from the northwest side (rear) of the Cascade building, between Cascade and Architectural Metalcrafters.
