Allendale Dam

November 2001

Centredale Manor Restoration Project: Site Activity Update

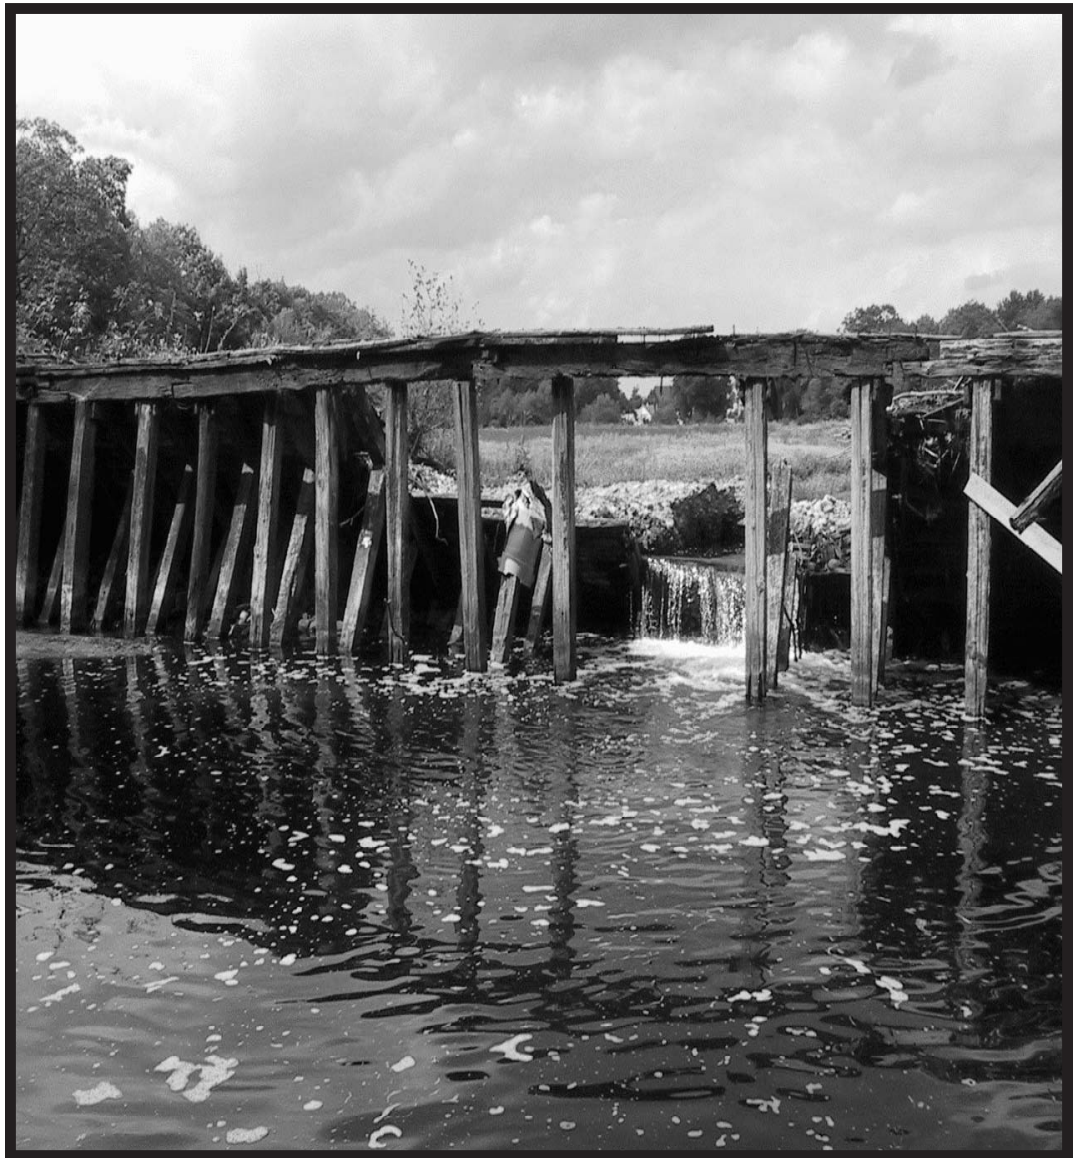
The existing dam structure at Allendale Pond

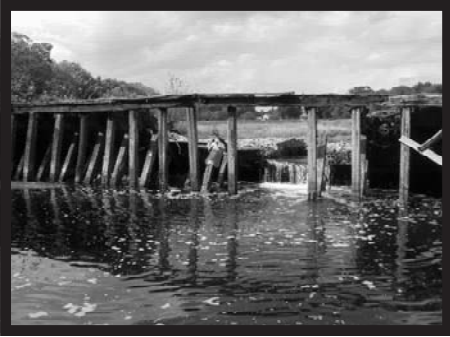
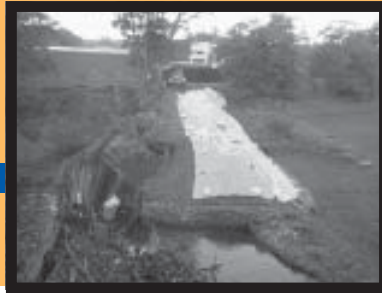
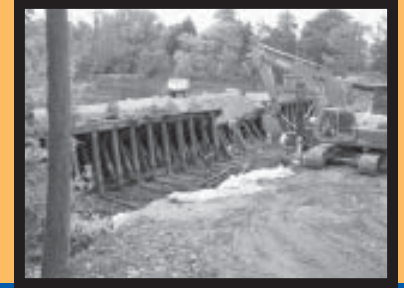
The photo on the left shows the original Allendale Dam with the river flowing through the breach in the dam. Two coffer dams (second and third photos) have been installed. One is upstream and the other is downstream of the original structure. The coffer dams keep water from flowing through the original dam and into the work area, allowing the construction work to take place in dry conditions. The coffer dams will remain until the new dam is fully constructed.

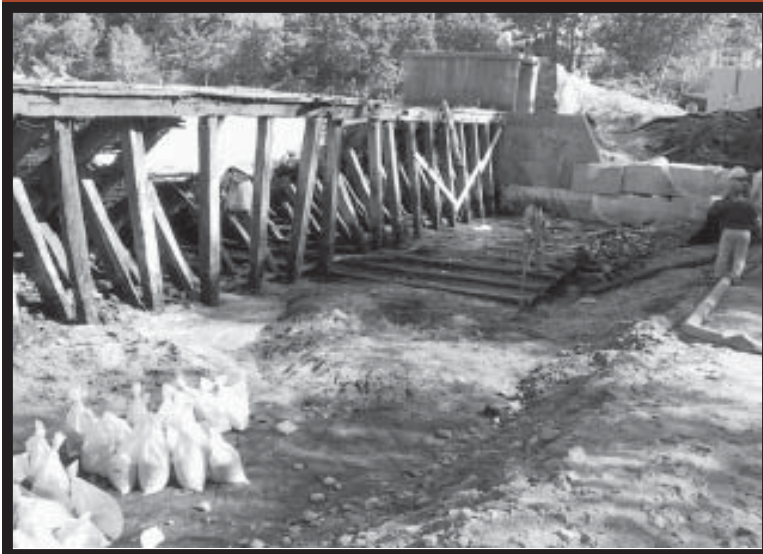
Soil, sediment and debris from the footprint of the new dam were removed, and the debris, contaminated soil and sediment are being sent to an off-site facility for treatment and disposal. In addition to diverting the river around the construction site, the work area was continuously dewatered and the water treated before it was returned to the river.

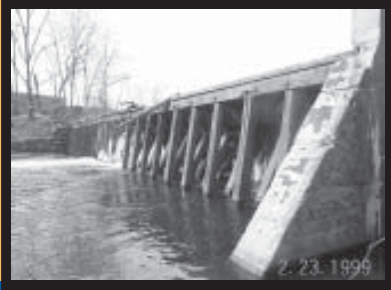
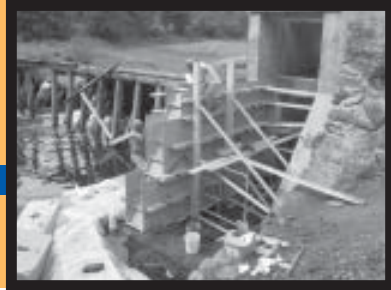
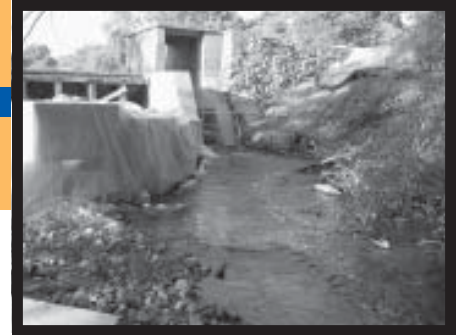
Water is being diverted around the work area and through the sluiceway. The wing wall of the dam, shown in the first photo, has been rebuilt and lengthened (second and third photos) so that the river water flows through the sluiceway until it is below the downstream coffer dam.
