RE: 40s Other Ground Covering Feature Area and Slab Area Inspection

On behalf of the Pittsfield Economic Development Authority (PEDA), O'Reilly, Talbot & Okun Associates, Inc. (OTO) performed an annual inspection of the Other Ground Covering Feature Area and Slab Area in the former 40s Complex at the William Stanley Business Park on November 9, 2011. This is the first inspection of these areas by PEDA since transfer of the property from General Electric Company (GE) to PEDA in early 2011.

APPENDIX E
PAVEMENT INSPECTION SUMMARY AND CHECKLIST
40s COMPLEX RAA

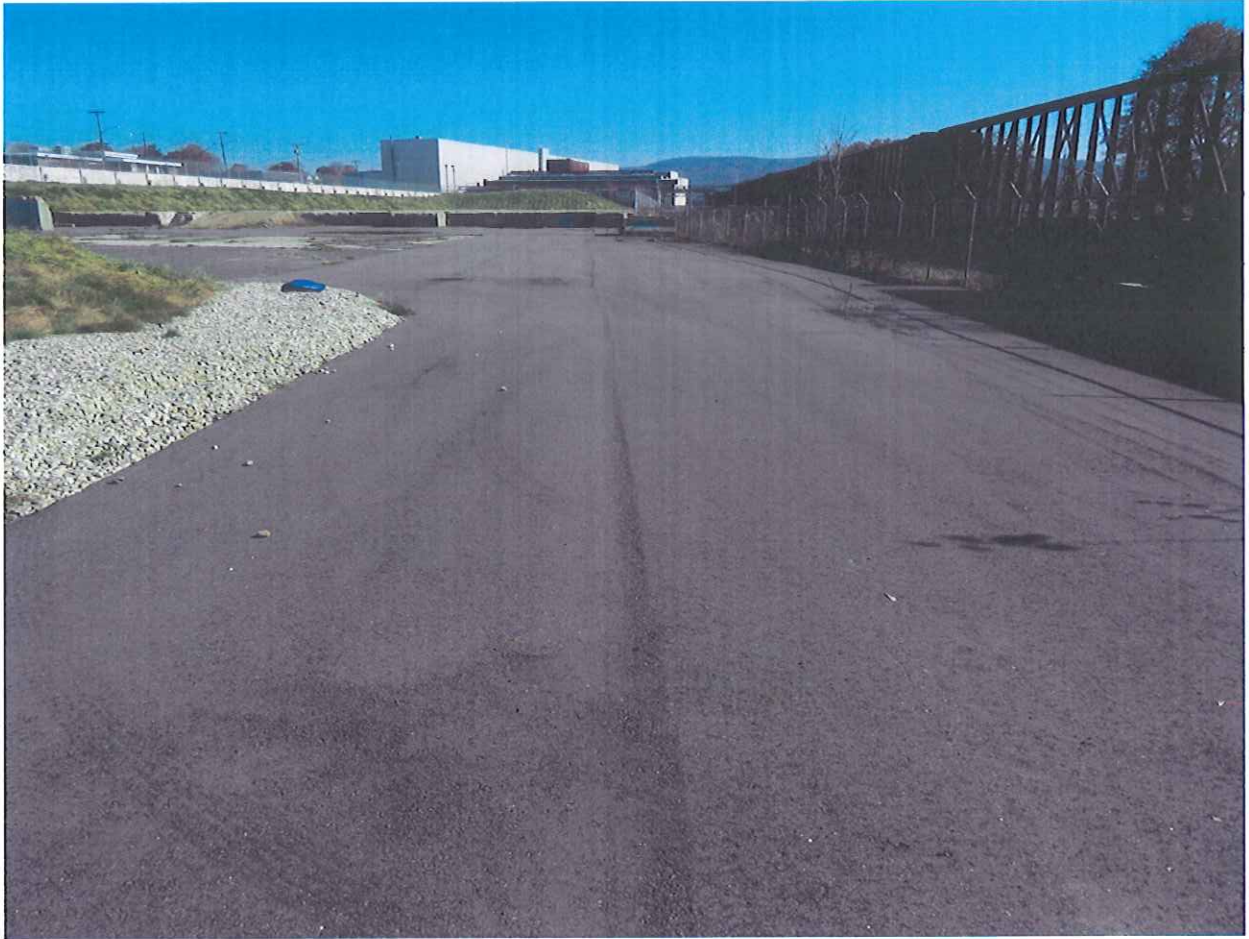
CONCRETE/ASPHALT AREAS OF OTHER GROUND COVERING FEATURE AREA show no evidence of excessive cracking, fissures, spalling, rutting, potholes or exposed subgrade material.

40s Other Ground Covering Feature Area
11/9/11

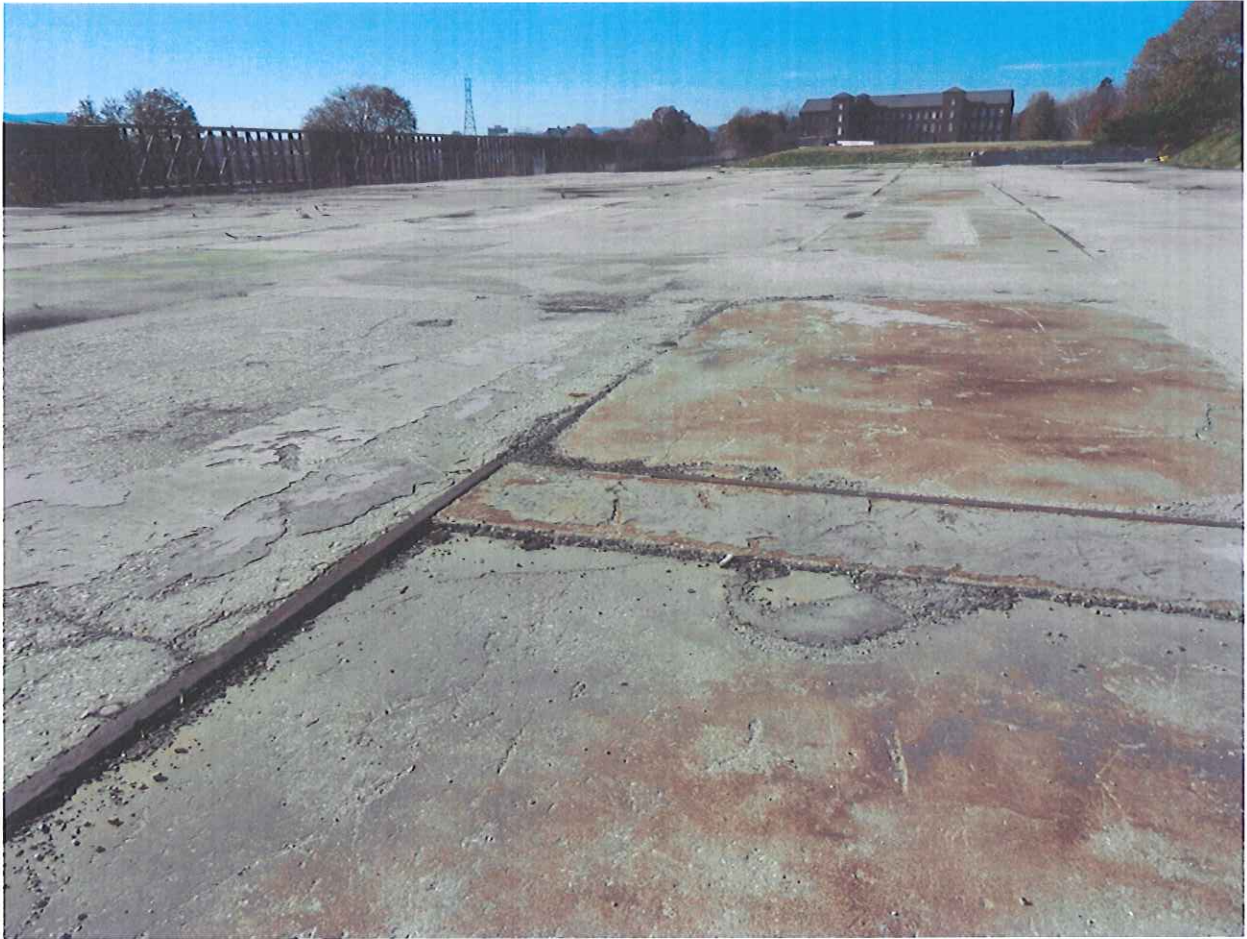
SLAB AREA shows no evidence of excessive cracking, fissures, spalling, rutting, potholes, or exposed subgrade material.

40s Slab Area – Looking West
11/9/11

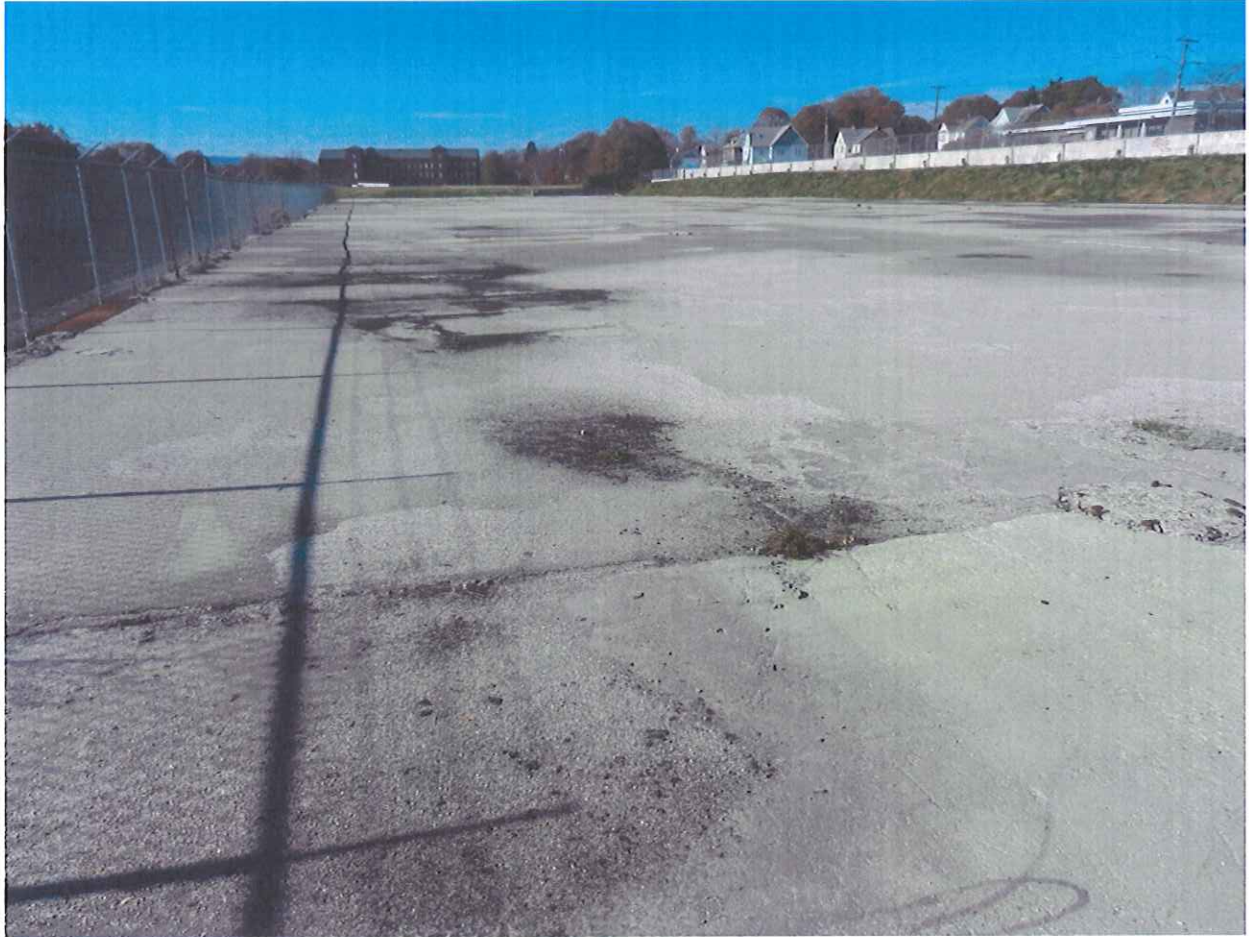
The inspection revealed that the asphalt and concrete surfaces in the Other Ground Covering Feature Area and Slab Area were in overall good conditions with no evidence of excessive cracking, fissures, spalling, rutting, potholes, or exposed subgrade material. A copy of the Inspection Checklist and Figure 5 from the Final Completion Report are attached along with representative photographs of the areas inspected.

40s Other Ground Covering Feature Area (left) and Slab Area (right) – Looking West
11/9/11

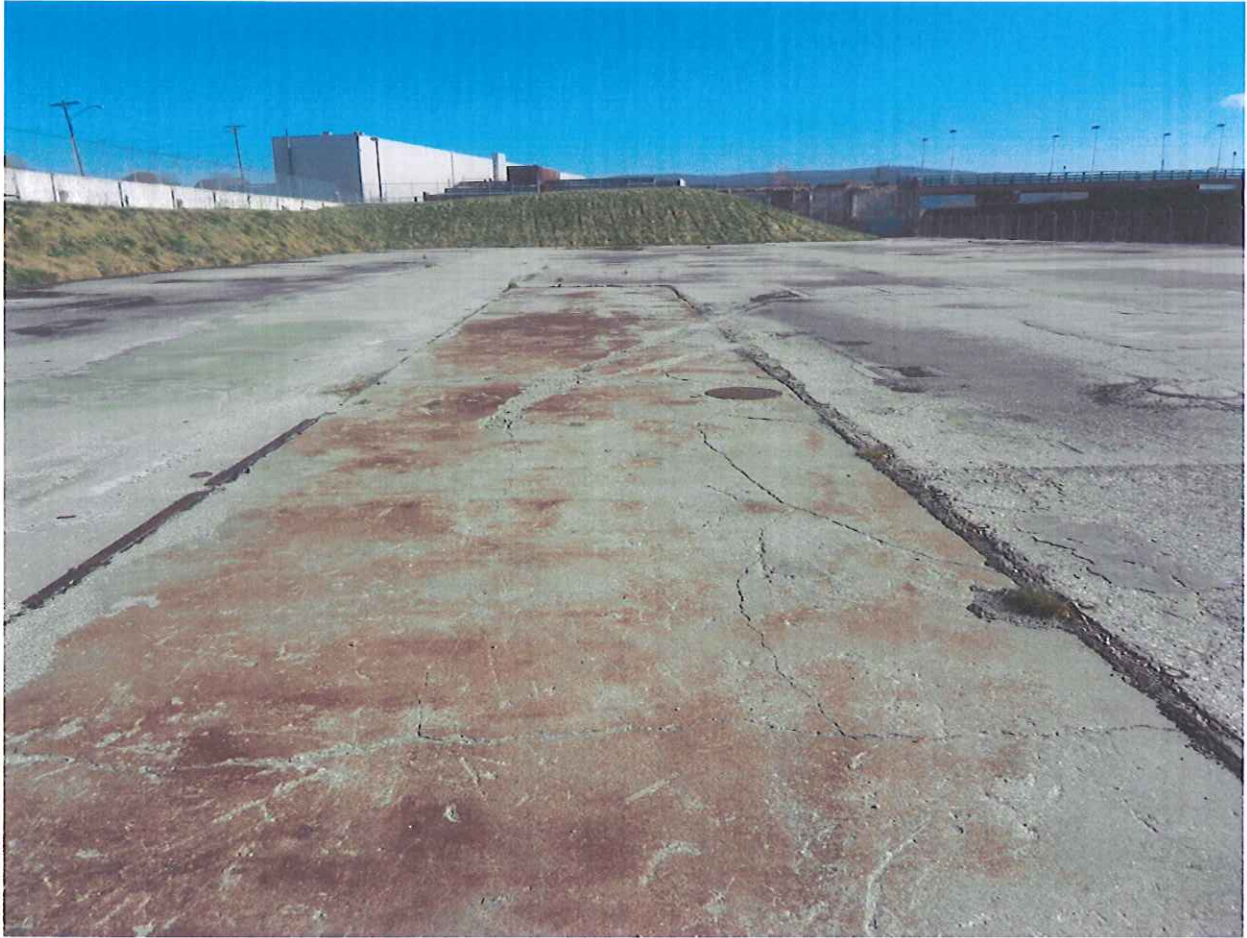
40s Slab Area – Looking East
11/9/11
