Nonpoint Source Program Success Story

Cromer Ridge Watershed

Erosion Control Best Management Practices Improve Water Quality and Restore Ecosystems in a National Forest

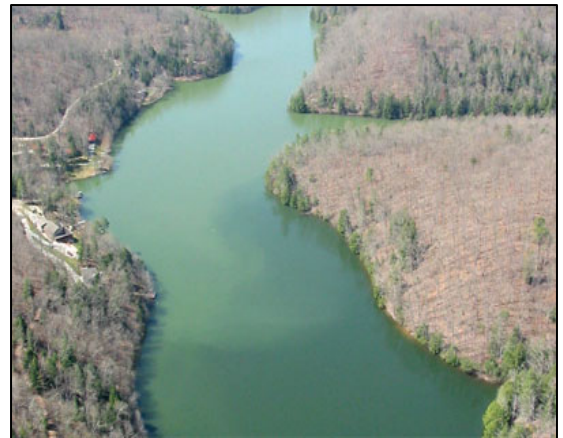
Sediment plume from OHV use - Woods Creek Lake

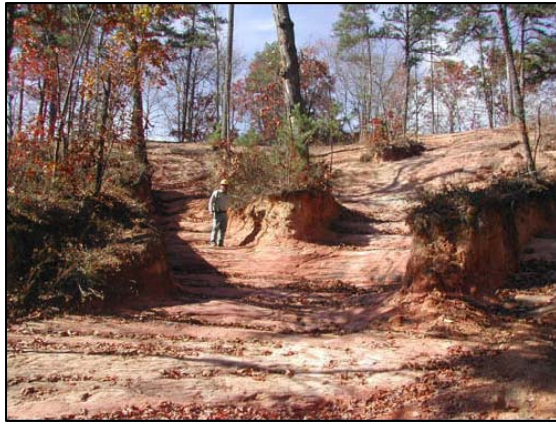
Later the project focused on the eroding ridge tops near the I-75 entrance. In this area 10 to 15 feet of soil had eroded and exposed bedrock and unfertile sand. The area was reshaped, erosion control BMP structures were installed, fertile soil was imported and the area was seeded. With the help of a private landowner, old tires and other debris were also removed.

Ridge before restoration

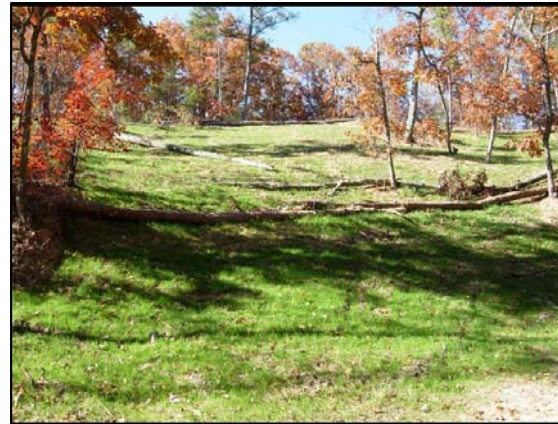
Ridge after restoration

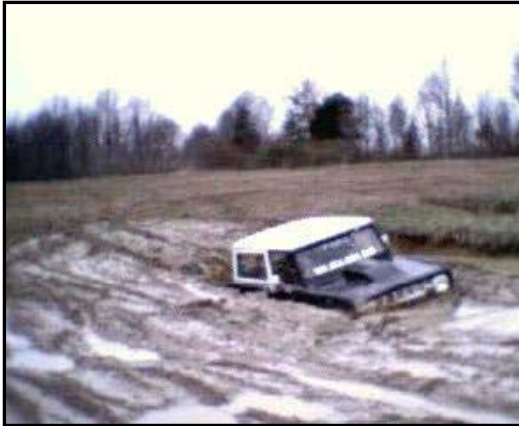
Field before restoration

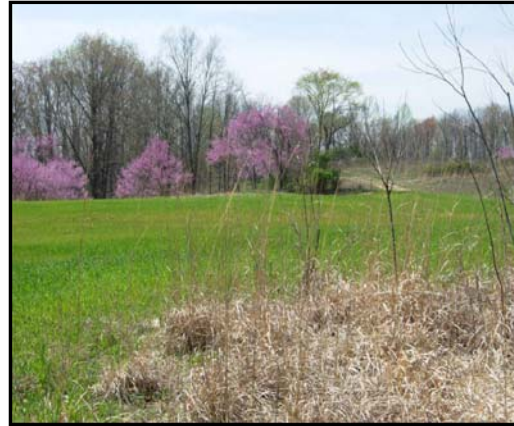
Field after restoration
