**Record of Decision  
for  
Site 6/6A, Operable Unit 2**

**Naval Air Station Patuxent River  
St. Mary's County, Maryland**

**Naval Facilities Engineering Command  
Washington**

**September 2008**

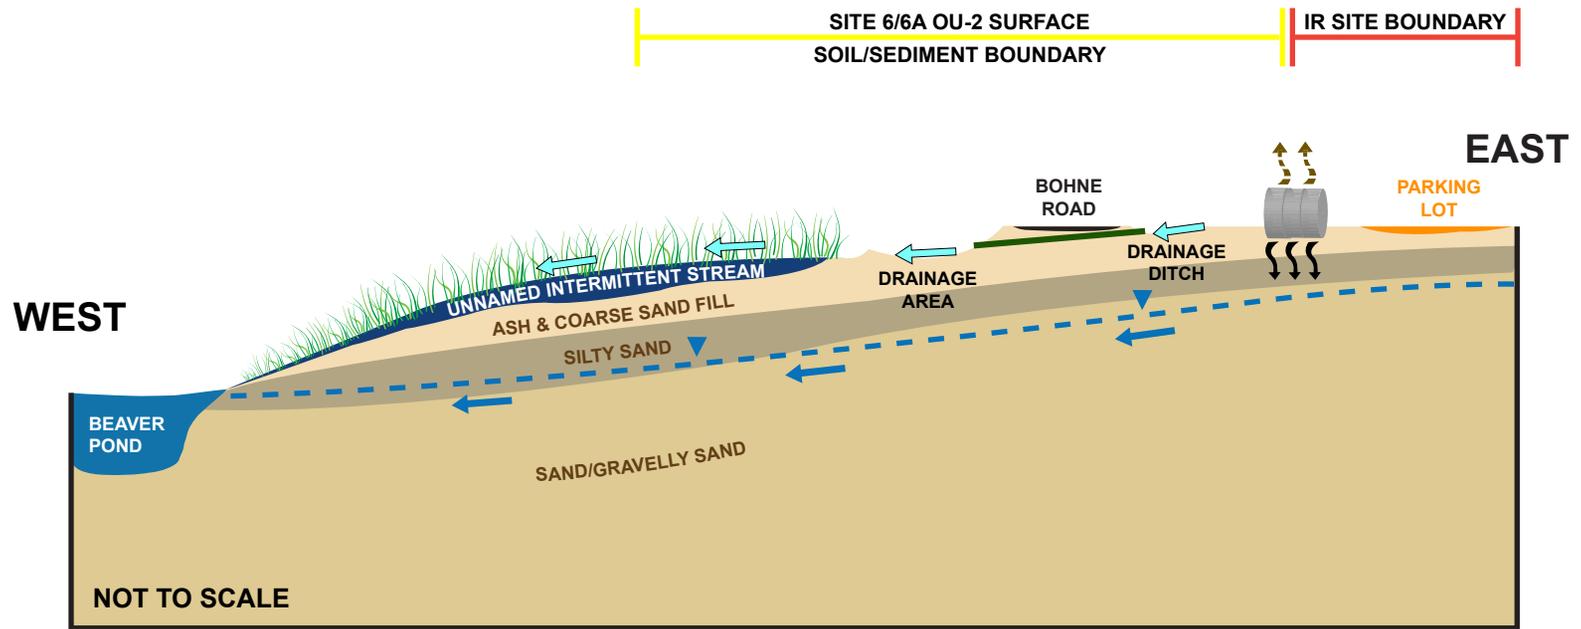
**Figure 2**  
 Conceptual Site Model  
 Site 6/6A OU-2  
 NAS Patuxent River  
 St. Mary's County, Maryland

Infiltration/Leaching

Approximate Potentiometric Surface

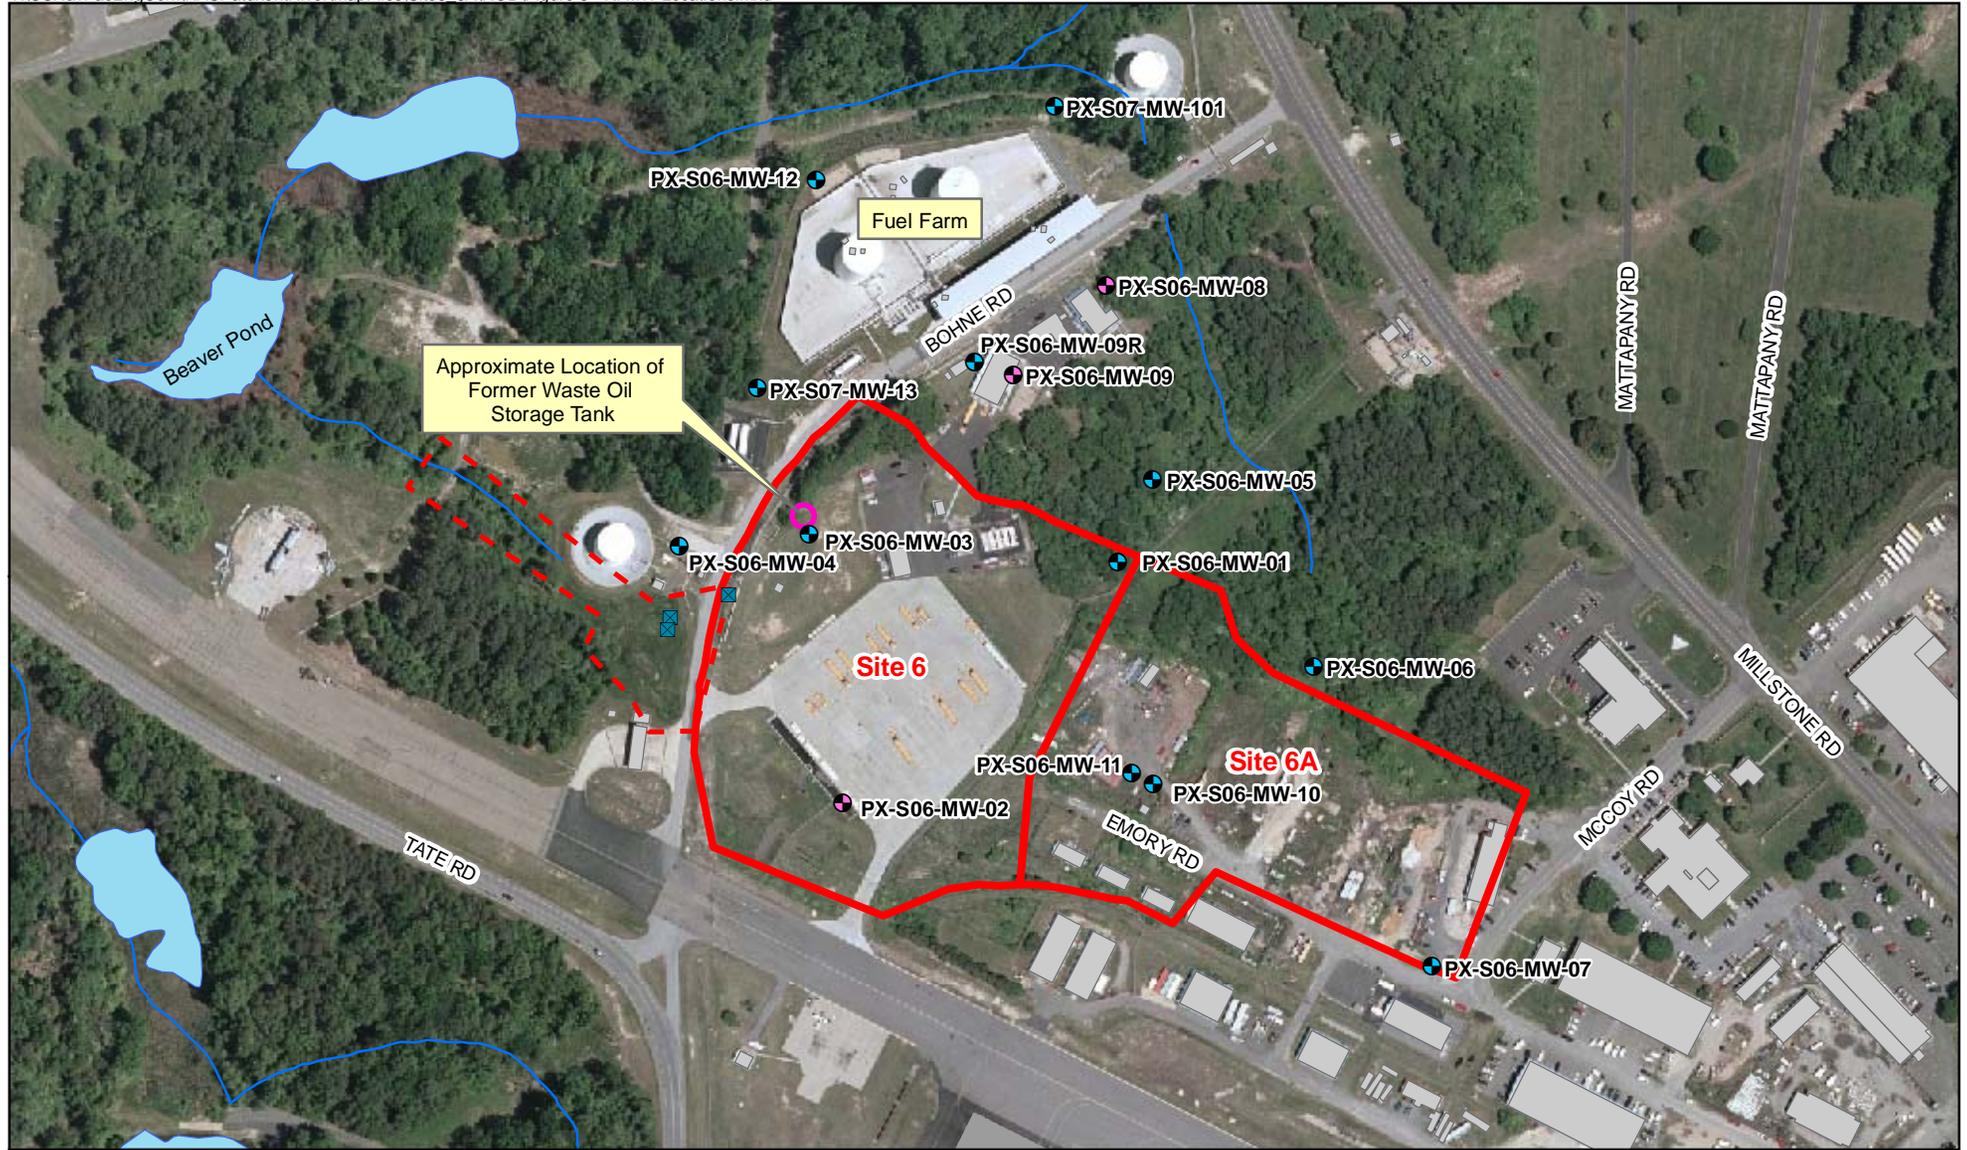
Figure 3  
Remedial Investigation Monitoring Well Locations  
Site 6/6A OU-2  
NAS Patuxent River  
St. Mary's County, Maryland

- Monitoring Well
- Abandoned or Destroyed Well
- Inlet/Outlet to Culvert Under Bohne Rd.
- IR Site Boundary
- Site 6/6A OU 2 Surface Soil/Sediment Boundary
- Surface Waterbody

Based on data obtained during the RI and previous investigations, the average depth to the water table for the unconfined surficial aquifer is between 10 and 14 feet below ground surface at Site 6/6A. Groundwater flow patterns in the shallow aquifer are generally controlled by the surface topography (CH2M HILL, 1985). Groundwater beneath the site flows to the north across the site then shifts predominantly north-northwest towards the Fuel Farm.

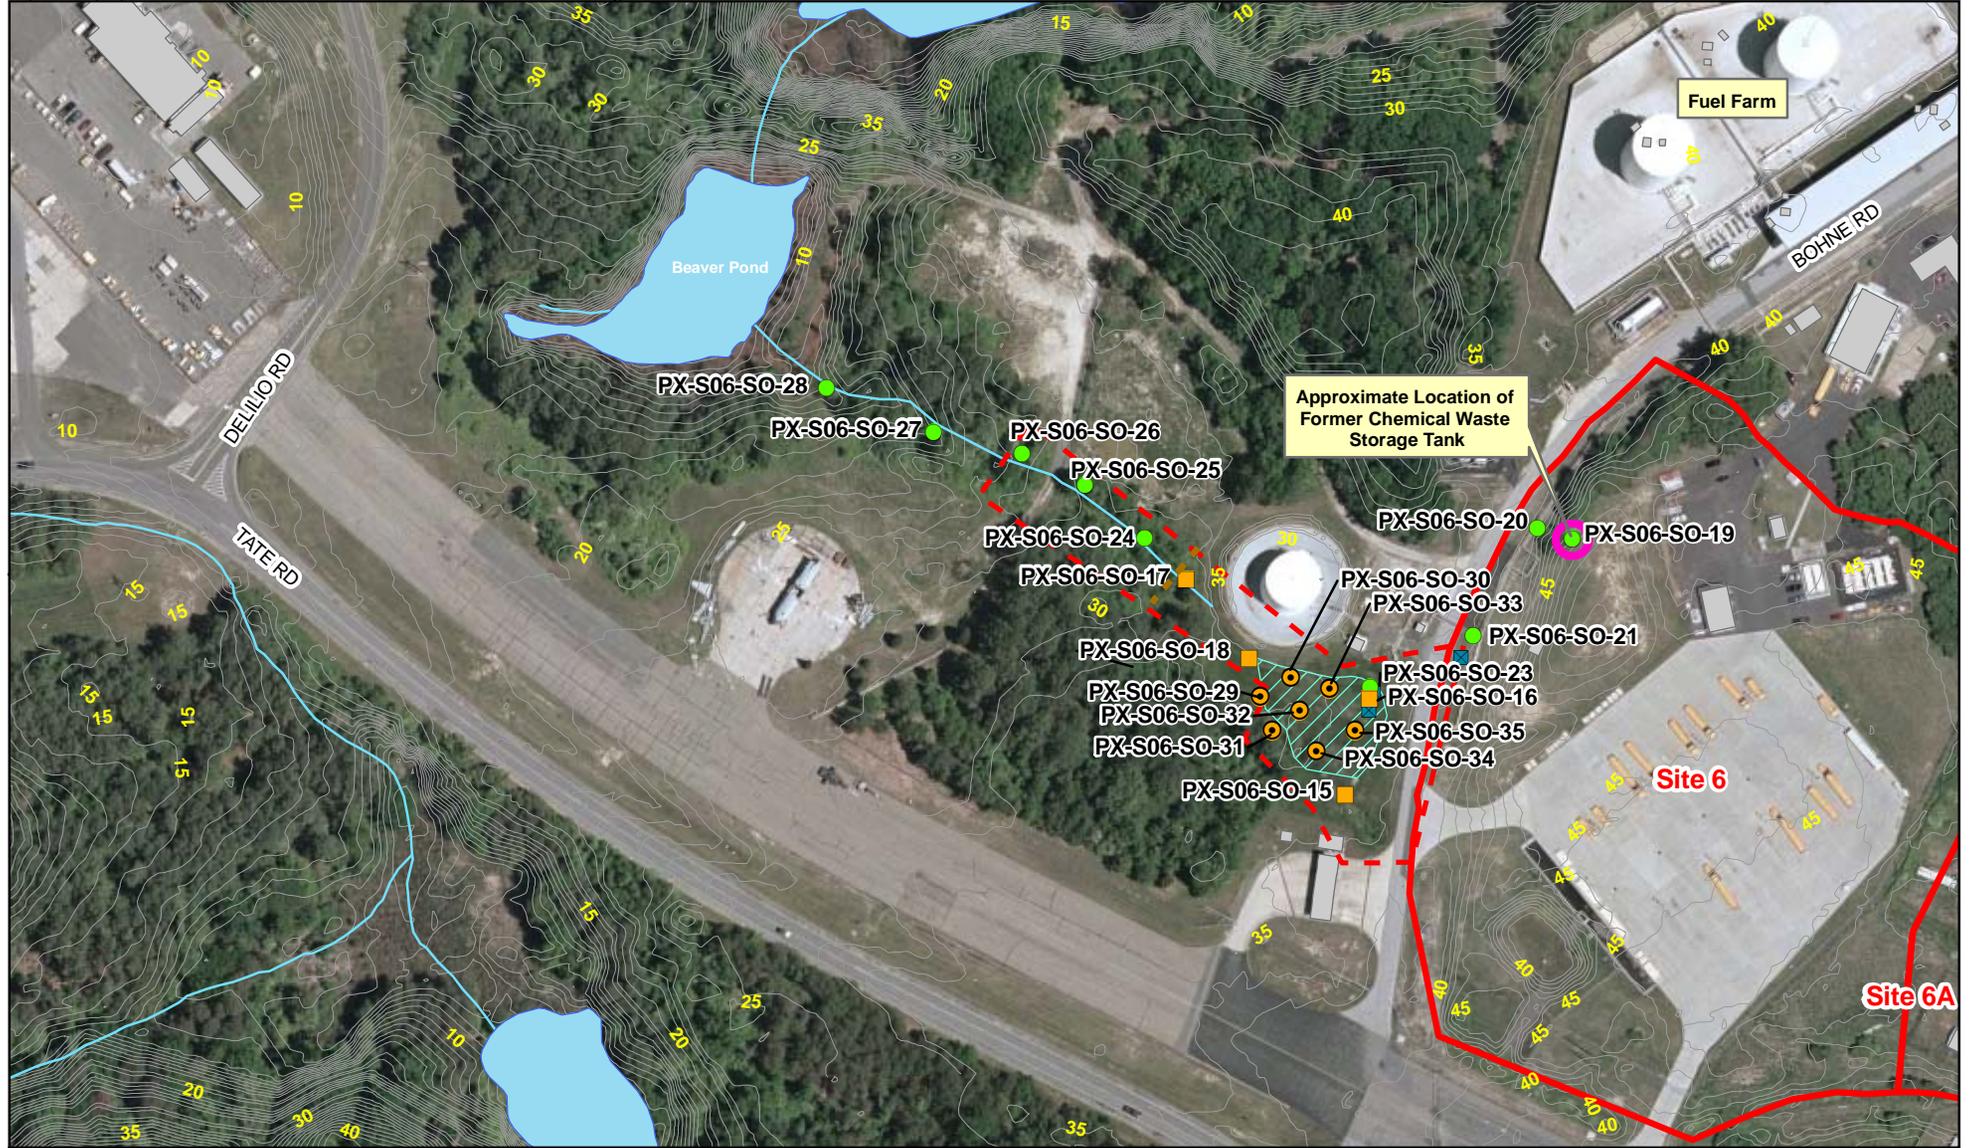
Figure 4  
Remedial Investigation Surface Soil/Sediment  
Sample Locations  
Site 6/6A OU-2  
NAS Patuxent River  
St. Mary's County, Maryland

- April 2004 Sediment/Surface Soil Sample Locations
- March 2005 Sediment/Surface Soil Sample Locations
- November 2007 Sediment/Surface Soil Sample Locations
- Inlet/Outlet to Culvert Under Bohne Rd.
- IR Site Boundary
- Surface Water
- Area Prone to Flooding
- Site 6/6A OU 2 Surface Soil/Sediment Boundary
- Transition From Soil to Sediment
- Elevation Contours - 1ft Interval

The nature and extent of chemicals and metals detected in groundwater and surface water throughout Site 6/6A, and surface soil/sediment in the drainage area and intermittent stream downgradient of Site 6 were characterized by samples collected during the RI, which was completed in November 2007. A conceptual site model is presented in Figure 2. Monitoring well locations are shown in Figure 3. Surface soil/sediment locations sampled between 2004 and 2007 are presented in Figure 4.

Twenty-five SVOCs, mainly polycyclic aromatic hydrocarbons (PAHs), were detected in surface soil/sediment samples collected between 2004 and 2007. Detected total PAH concentrations ranged from 151 micrograms per kilogram ( $\mu\text{g/kg}$ ) to a maximum of 63,480  $\mu\text{g/kg}$ . The lower concentrations were detected in samples collected along the bank of the intermittent stream channel of OU-2, and the maximum total PAH concentration was detected in a sample (PX-SO6-SO-16) collected from the low lying area just west of the Site 6 boundary (Figure 4).

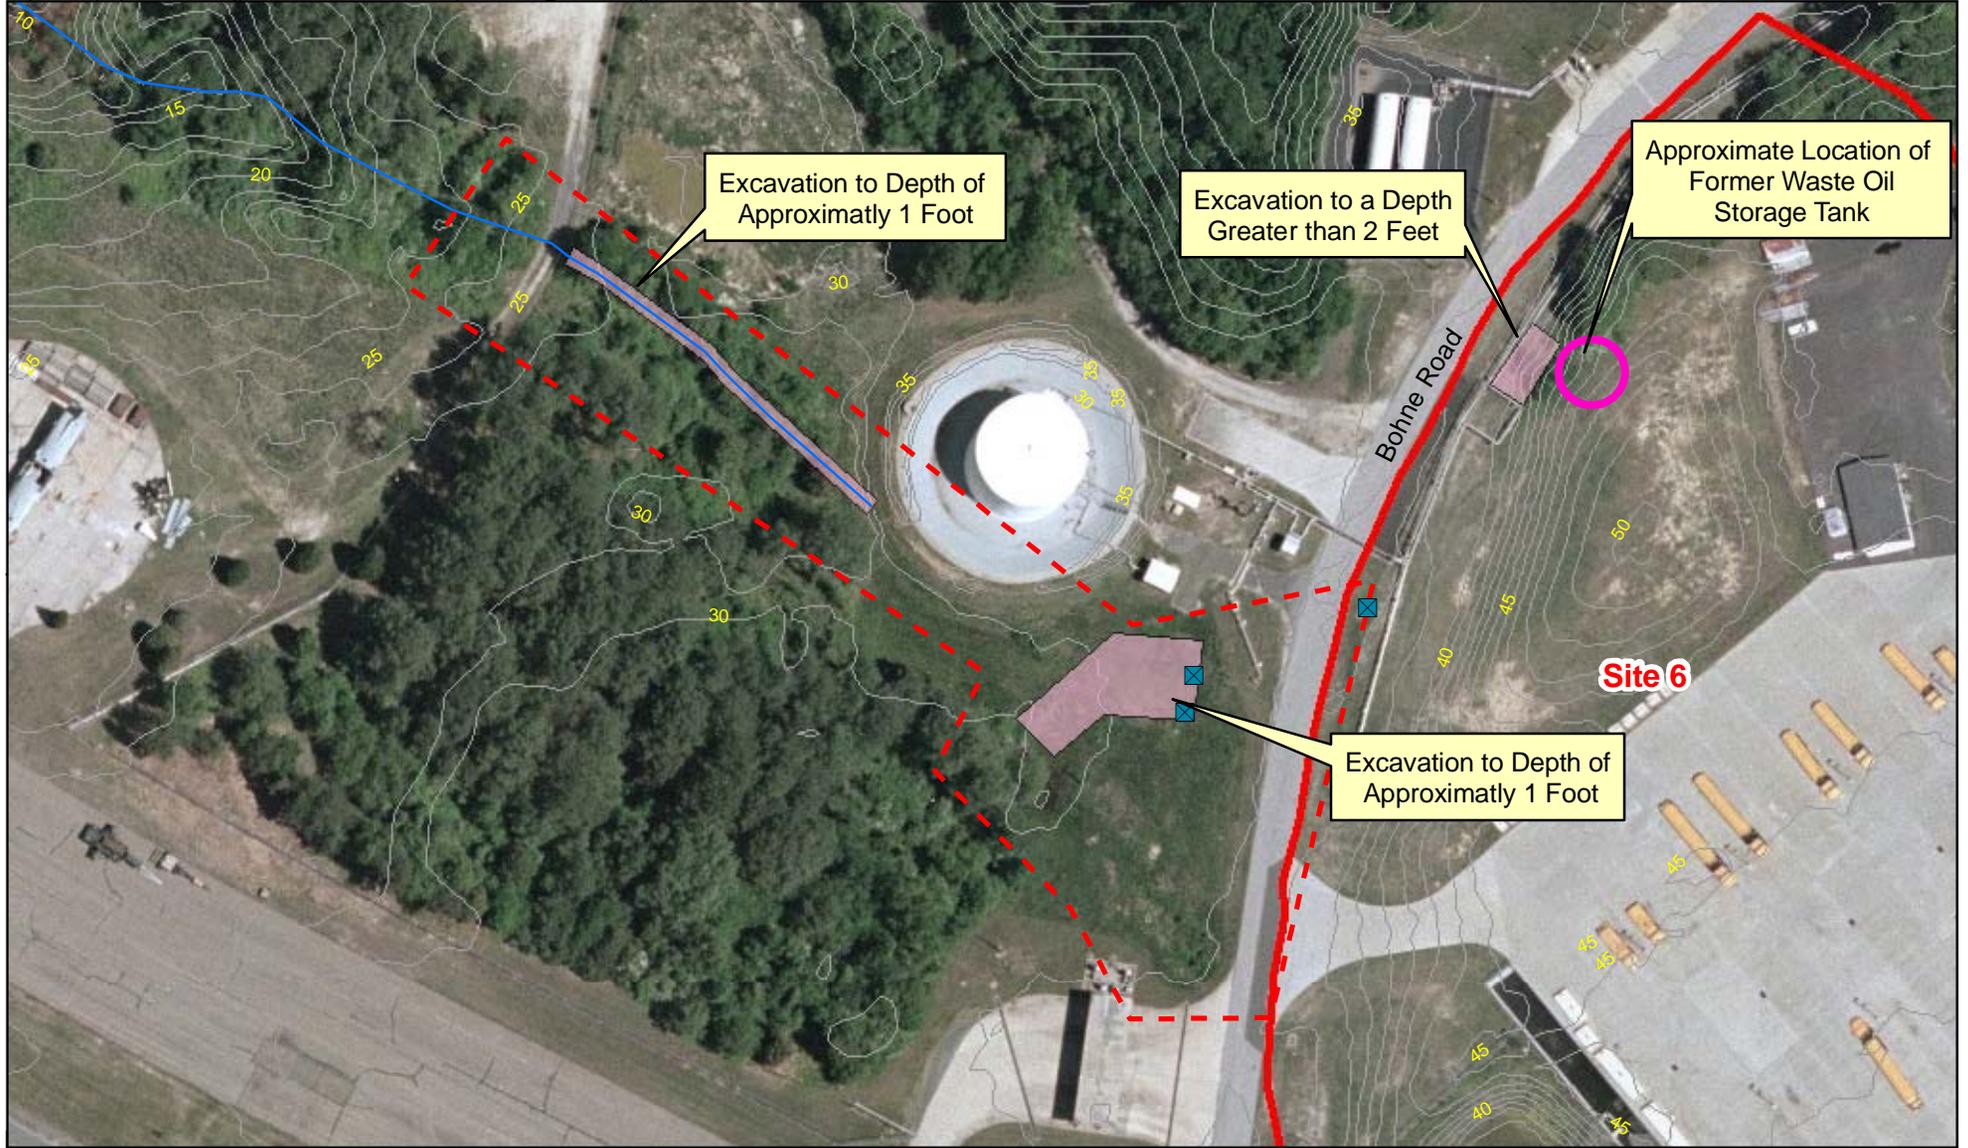
- X Inlet/Outlet to Culver Under Bohne Rd.
- IR Site Boundary
- Excavated Areas
- Intermittent Drainage Swale
- Site 6/6A OU 2 Surface Soil/Sediment Boundary
- Elevation Contour - 1ft Interval

As a result of the concentrations of PAHs and PCBs detected in the surface soil/sediment within the Site 6/6A drainage area, the Navy and USEPA, in consultation with the MDE, made a decision to conduct a removal action to remove soil and sediment posing a potential risk to ecological receptors. The removal action is summarized in Section 2.7.3.
