Improving Water Management Using Advanced Metering Infrastructure Data: A Guide for Facility Managers

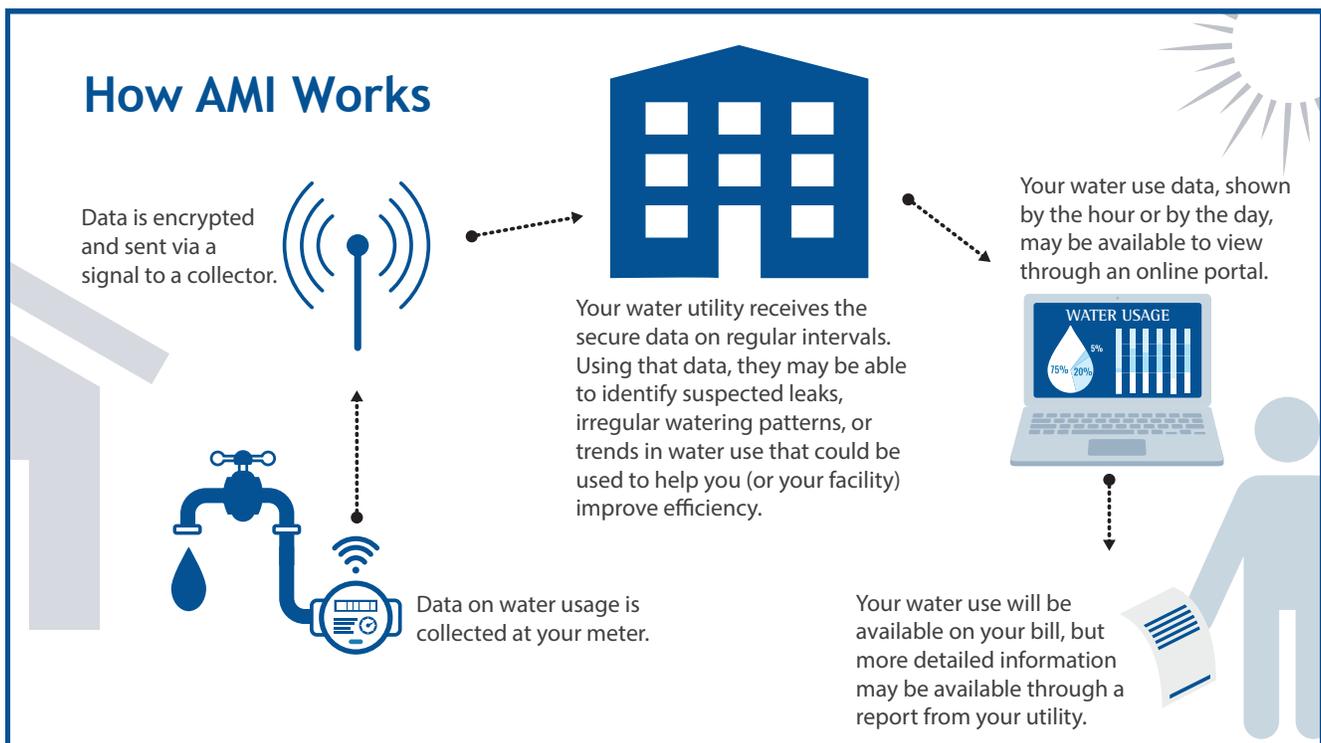
Figure 1: How AMI works

AMI is a collection of devices and systems used by utilities to collect, measure, communicate, and analyze water use data from treatment through delivery to customers. Many water utilities are embracing AMI to modernize and streamline their operations. The increase in data improves their ability to serve their customers, target and monitor conservation programs, detect and measure water loss, and increase security and reliability. AMI also improves time efficiency, allowing utilities to redirect time and resources spent reading meters to other projects.

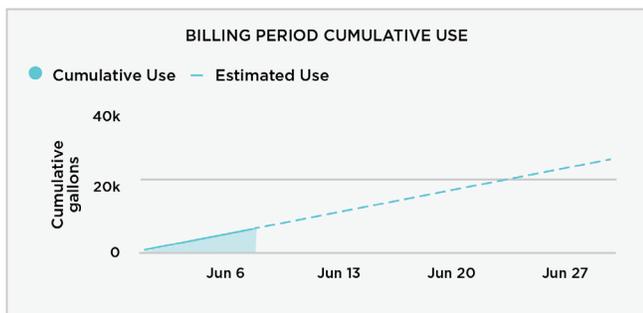
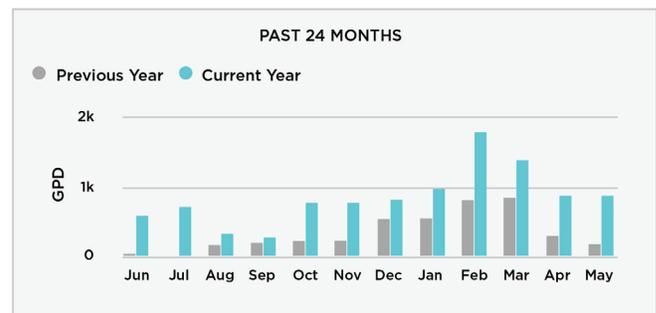
You've used 7,104.90 Gallons this billing period

At this rate we estimate you'll use about 27,909 Gallons total, which is 29% more than your typical use. These estimates are informational only.

Increasing use

You used about 130% more water during the most recent twelve-month period compared to the prior twelve-month period.

Figure 2: Some customer portals offer a monthly projection including your total bill amount, as well as total water use. They may also show a comparison of water use month-over-month or year-over-year. Image of VXengage portal (previously known as the WaterSmart portal) provided by VertexOne, care of Scotts Valley Water District.

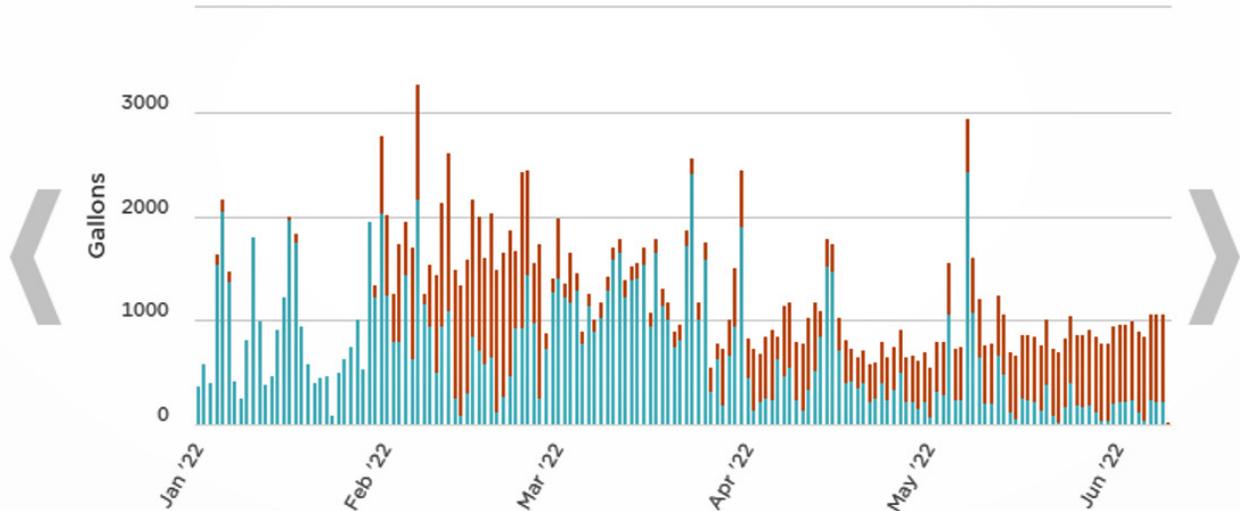
BILLING **AMI** LEAKS

● Normal Use ● Possible Leak ● Timed Irrigation ● Data Unavailable

Figure 3: Customer portal showing daily water use and the volume of daily use that may be indicative of a possible leak for the facility to investigate. Image of VXengage portal (previously known as the WaterSmart portal) provided by VertexOne, care of Scotts Valley Water District.

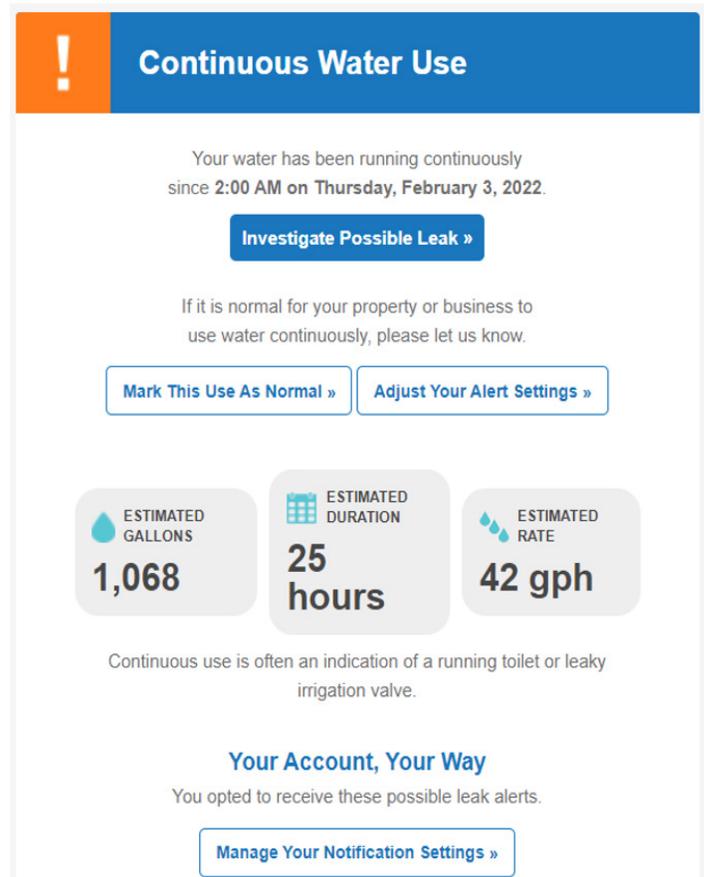
Your water has been running continuously since 2:00 AM on Thursday, February 3, 2022.

Continuous use is often an indication of a running toilet or leaky irrigation valve.

Figure 5: Additional information on continuous water use and options to resolve offered through a customer portal. Image of VXengage portal (previously known as the WaterSmart portal) provided by VertexOne, care of Scotts Valley Water District.

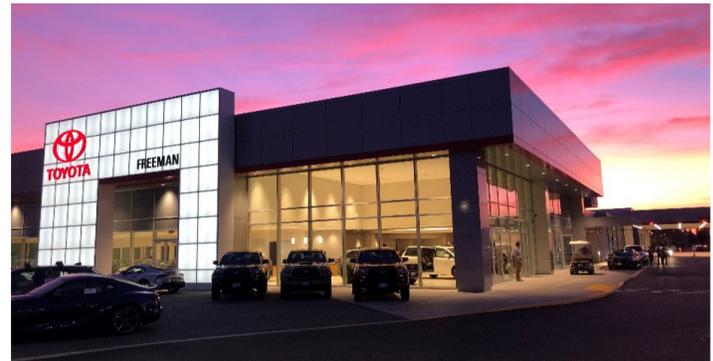
Image Courtesy Freeman Toyota

An onsite water audit revealed several toilet leaks, but these were not wasting enough water to account for the volume of continuous use. After additional investigation, Santa Rosa Water and Freeman Toyota were able to isolate an issue with the facility’s car wash. The car wash vendor

was called in and discovered the recirculating water system was malfunctioning and running continuously. The leaking toilets and car wash recirculating system were repaired (see Figure 6), and these repairs reduced Freeman Toyota’s water usage by 50 percent. “I appreciated getting a courtesy call from Santa Rosa Water after their system flagged a spike in water use on one of our meters. The onsite audit was informative and helped us quickly identify and resolve the issue,” Ryan Freeman said.

After Santa Rosa Water’s WaterSmart Portal identified continuous use of approximately 140 gallons of water per hour for 48 consecutive hours at Freeman Toyota, Ryan Freeman immediately created a customer account to access water use data for all of the dealership’s water meters. Ryan also contacted the utility’s water efficiency team for assistance finding the leak.

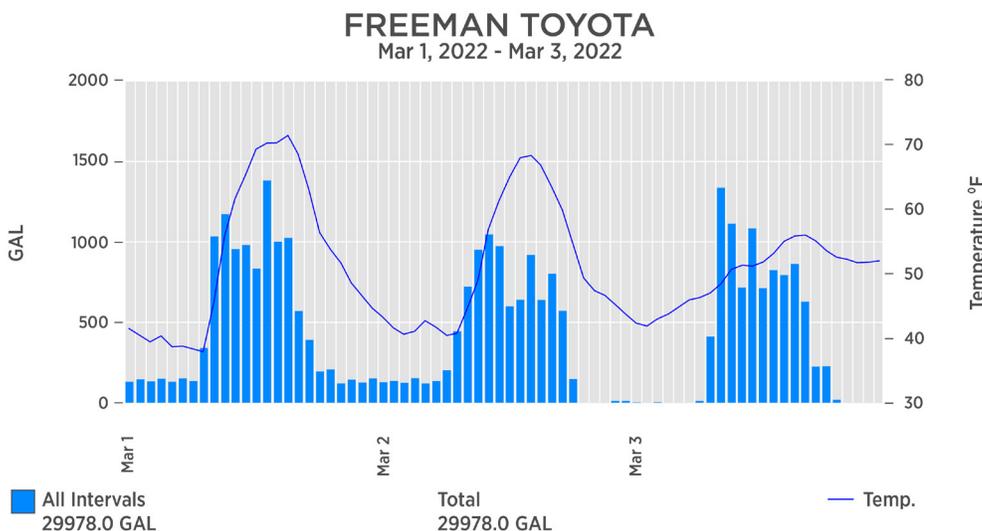
Figure 6: AMI data indicating that the car wash and toilet leaks were resolved on March 3.

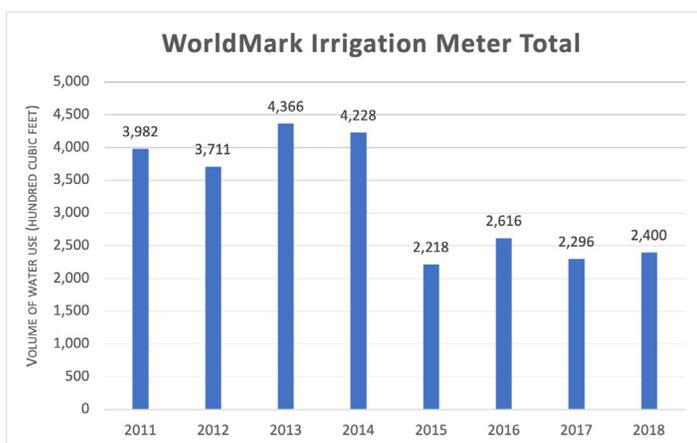
Figure 7: A BBLDWP chart using partial AMI data to indicate a drop in water use after turf removal

WorldMark compared data from 2011 to 2014, prior to the turf removal and just prior to having their AMI meter installed. During the following four years, the business was able reduce their water consumption by more than 40 percent, saving over 5 million gallons of water from 2015 to 2018 during one of California’s severe droughts. Having the ability to track daily and weekly water use using AMI meant that they could quickly begin to measure their savings and start making the case for future projects.

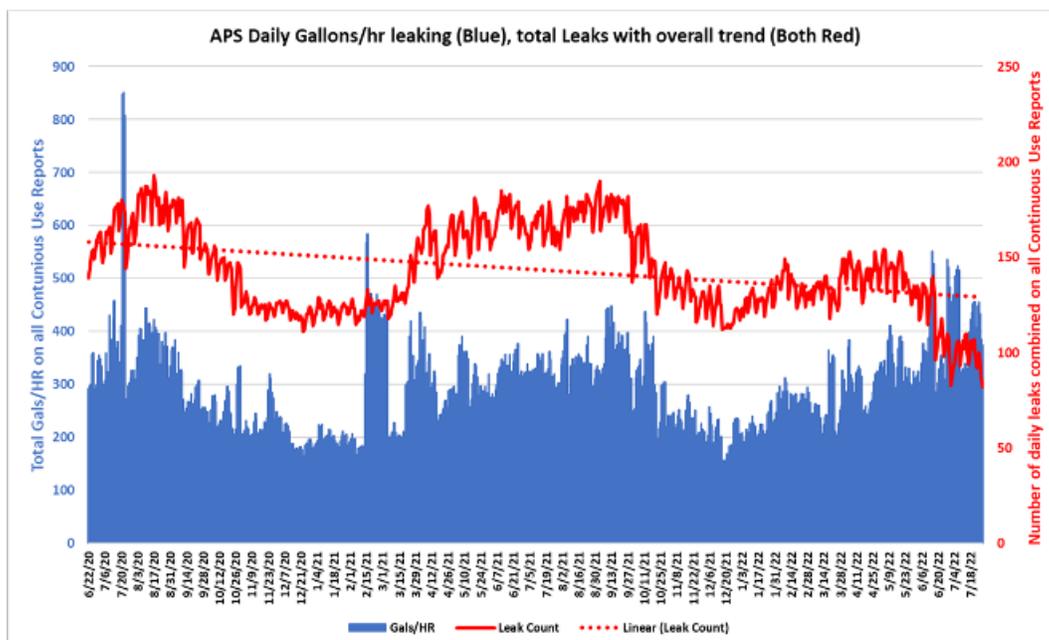
Figure 9: APS undertaking leaks at schools

Figure 9 shows the history of APS and ABCWUA working together to find and repair leaks. The dotted trendline shows how the number of leaks per day has declined from around 180 to below 100.

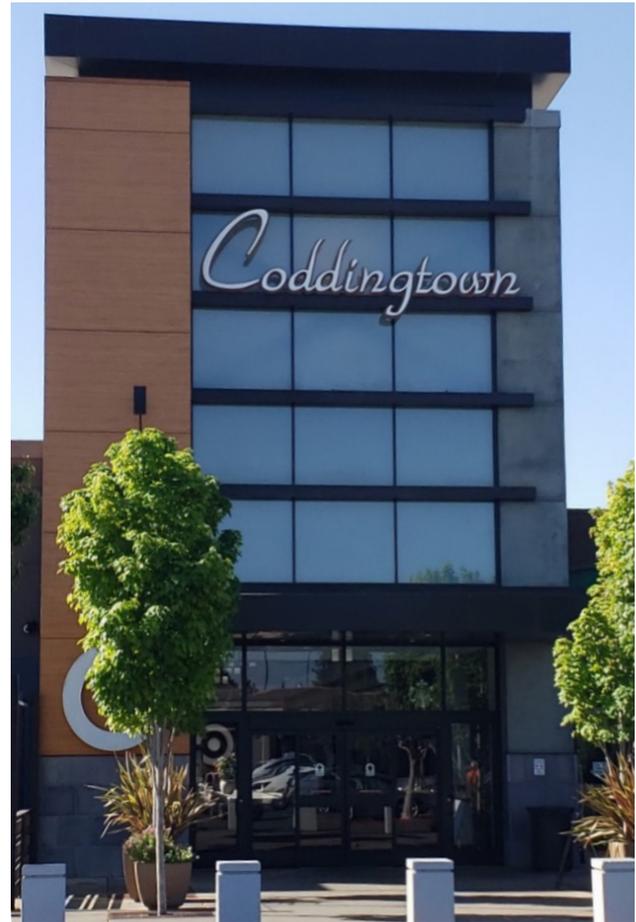
Image Courtesy Coddington Center

Santa Rosa Water's water efficiency team met with Coddington staff and performed an inspection of all areas served by the meter. No obvious leaks were found; however, a submeter to one of the restaurants in the mall showed that water usage had been increasing. This pointed to a potential mainline leak somewhere inside a restaurant.

A leak detection company was hired, which found and repaired a large mainline break under the restaurant's concrete slab. Data confirmed that the continuous usage had been significantly reduced but was not resolved. After additional investigation, another mainline break was found and repaired, then a third leak was found and repaired. Each time, utility staff provided data and informed the mall's general manager that the usage was still continuous. Ultimately, all mainline leaks were repaired, saving thousands of gallons of water per day.

“We would have never found these leaks without Santa Rosa Water's help and the AMI report data,” said Jimmy Scales, Coddington Center general manager. “The hourly usage helped us narrow down our investigation and pinpoint the exact time the usage was occurring. Without it, we may have thought the problem was solved after the first repair was done. Who knows how long it would have taken us to find all of the other mainline breaks?”
